Our Ref: LA/19-12-10

11th February 2020

Geotechnical Ground Investigation – Elmsbrook Local Centre, Bicester, OX27 8BA

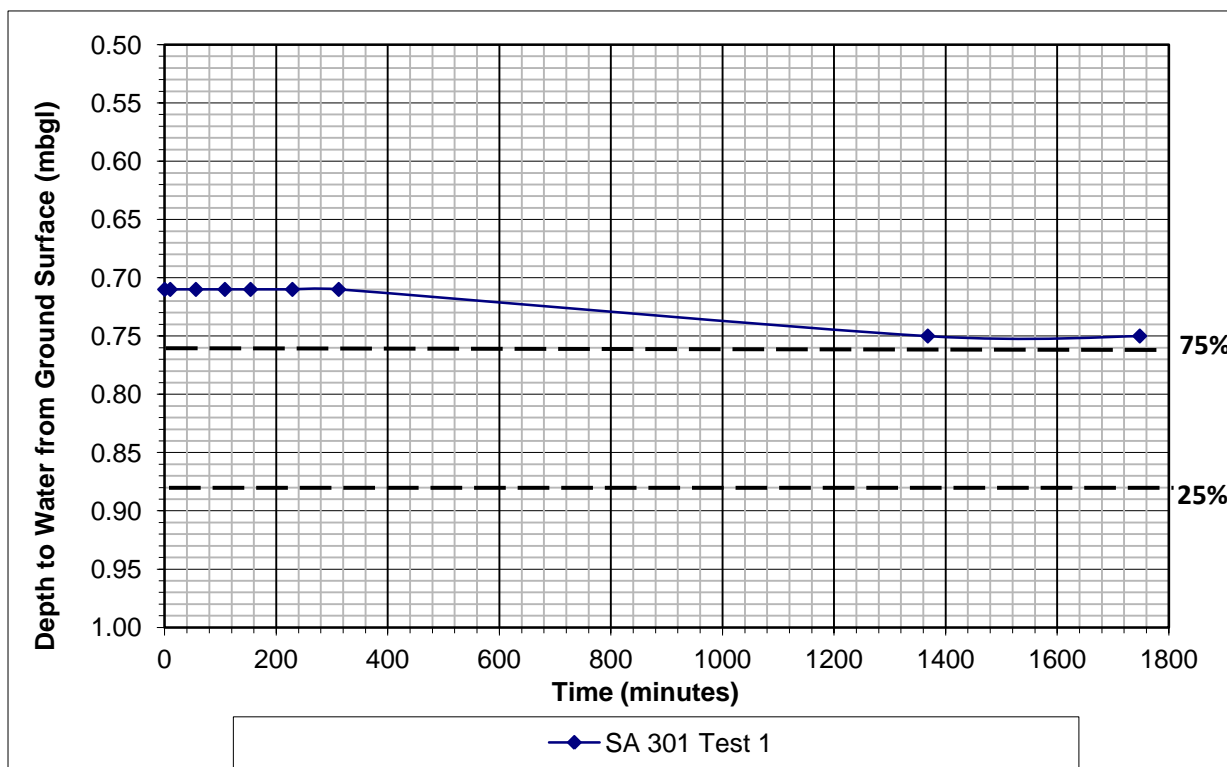
Trial Pit Infiltration Testing to BRE Digest 365

Client: A2 Dominion **Report No:** 19-12-10
Site: Elmsbrook Local Centre, OX27 8BA **Date Tested:** 07/01/20
Dimensions: 0.70m x 1.0m x 0.94m **Test Location:** SA 301
(width x length x depth)

Test Response Zone Description - : Forest Marble Formation

Unable to Calculate Average Soil Infiltration Rate

The rest of the soakaways failed to complete a single test.

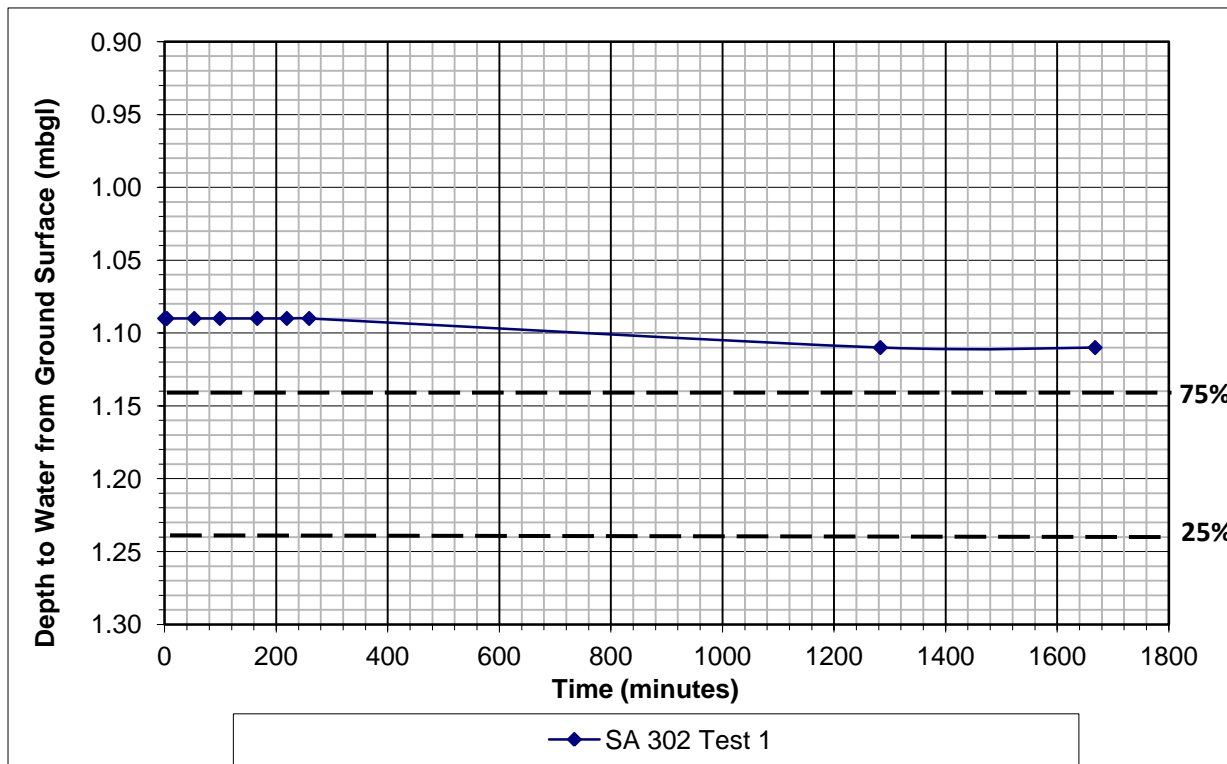
Trial Pit Infiltration Testing to BRE Digest 365

Client: A2 Dominion **Report No:** 19-12-10
Site: Elmsbrook Local Centre, OX27 8BA **Date Tested:** 07/01/20
Dimensions: 0.70m x 1.0m x 1.3m **Test Location:** SA 302
 (width x length x depth)

Test Response Zone Description - : Forest Marble Formation

Unable to Calculated Average Soil Infiltration Rate

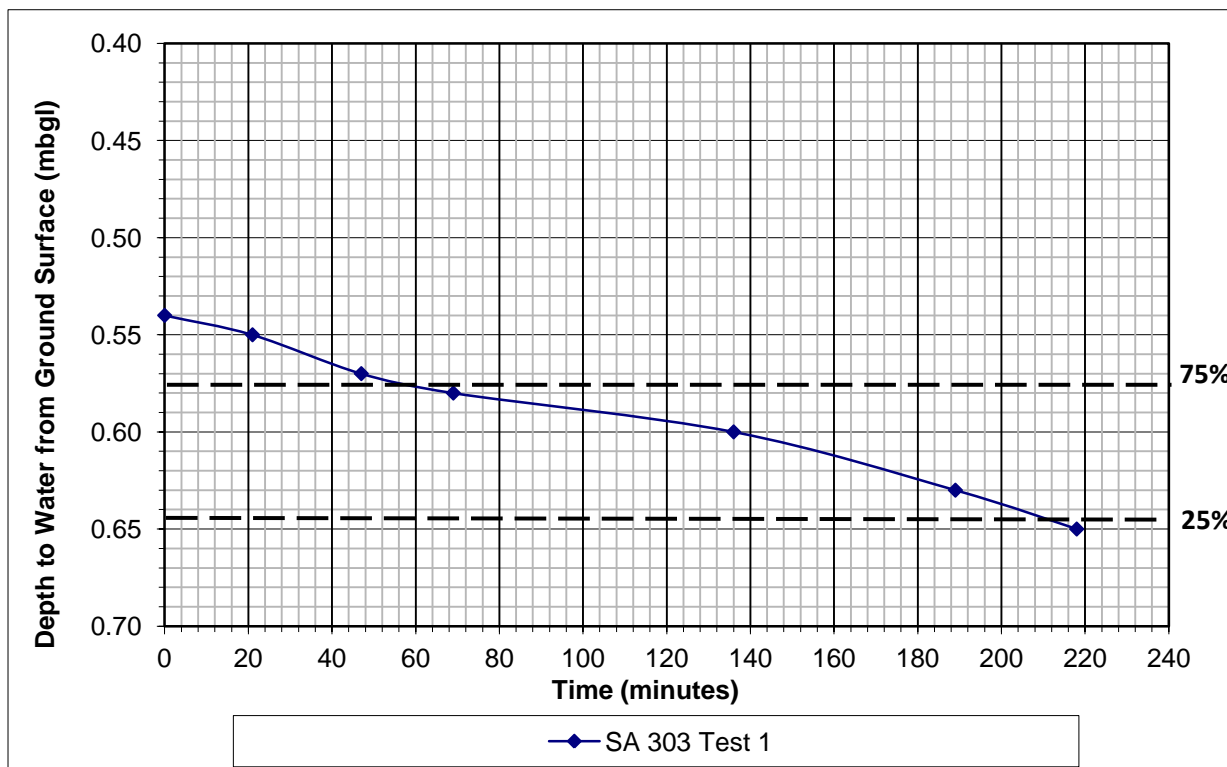
Trial Pit Infiltration Testing to BRE Digest 365

Client: A2 Dominion **Report No:** 19-12-10
Site: Elmsbrook Local Centre, OX27 8BA **Date Tested:** 07/01/20
Dimensions: 0.70m x 1.0m x 0.68m **Test Location:** SA 303
 (width x length x depth)

Test Response Zone Description - : Forest Marble Formation

Average Soil Infiltration Rate = 5.44×10^{-6} m/s

SA303 successfully completed three tests as set out in BRE 365 providing an average infiltration rate of $3.99 \times 10^{-6} \text{m/s}$.

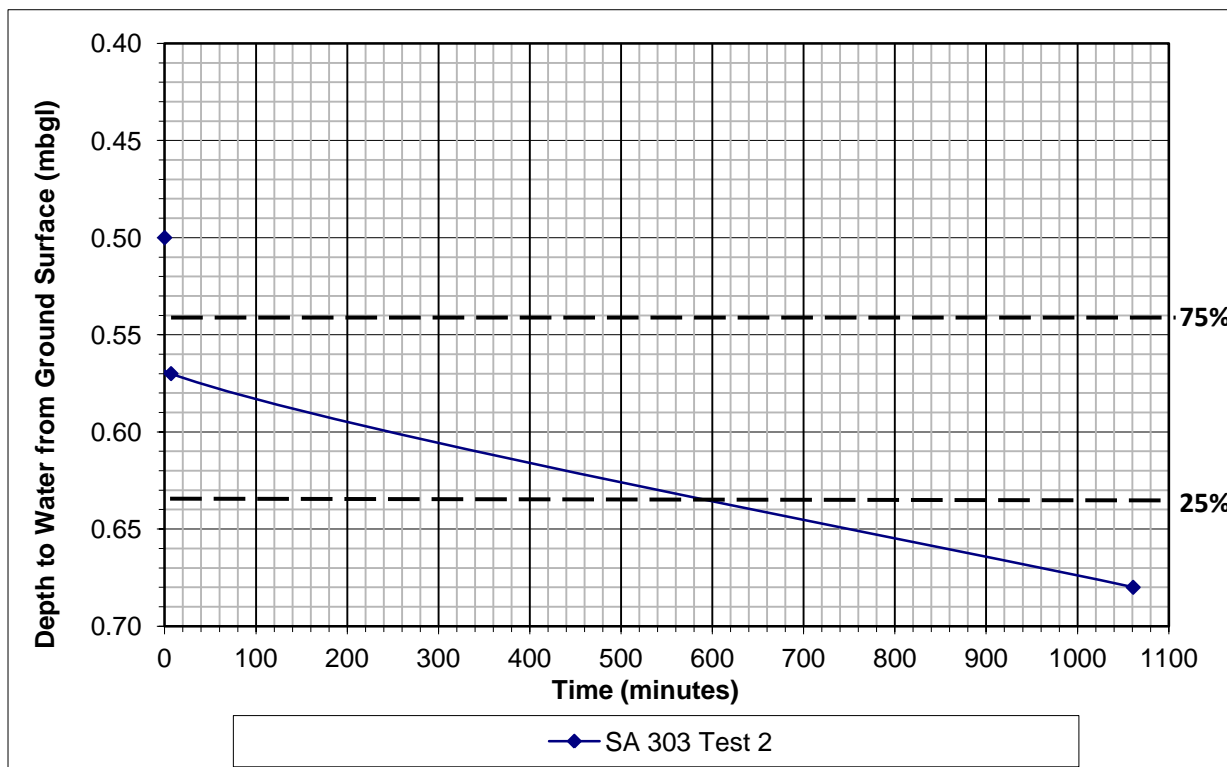
Trial Pit Infiltration Testing to BRE Digest 365

Client: A2 Dominion **Report No:** 19-12-10
Site: Elmsbrook Local Centre, OX27 8BA **Date Tested:** 07/01/20
Dimensions: 0.70m x 1.0m x 0.68m **Test Location:** SA 303
 (width x length x depth)

Test Response Zone Description - : Forest Marble Formation

Average Soil Infiltration Rate = 1.77×10^{-6} m/s

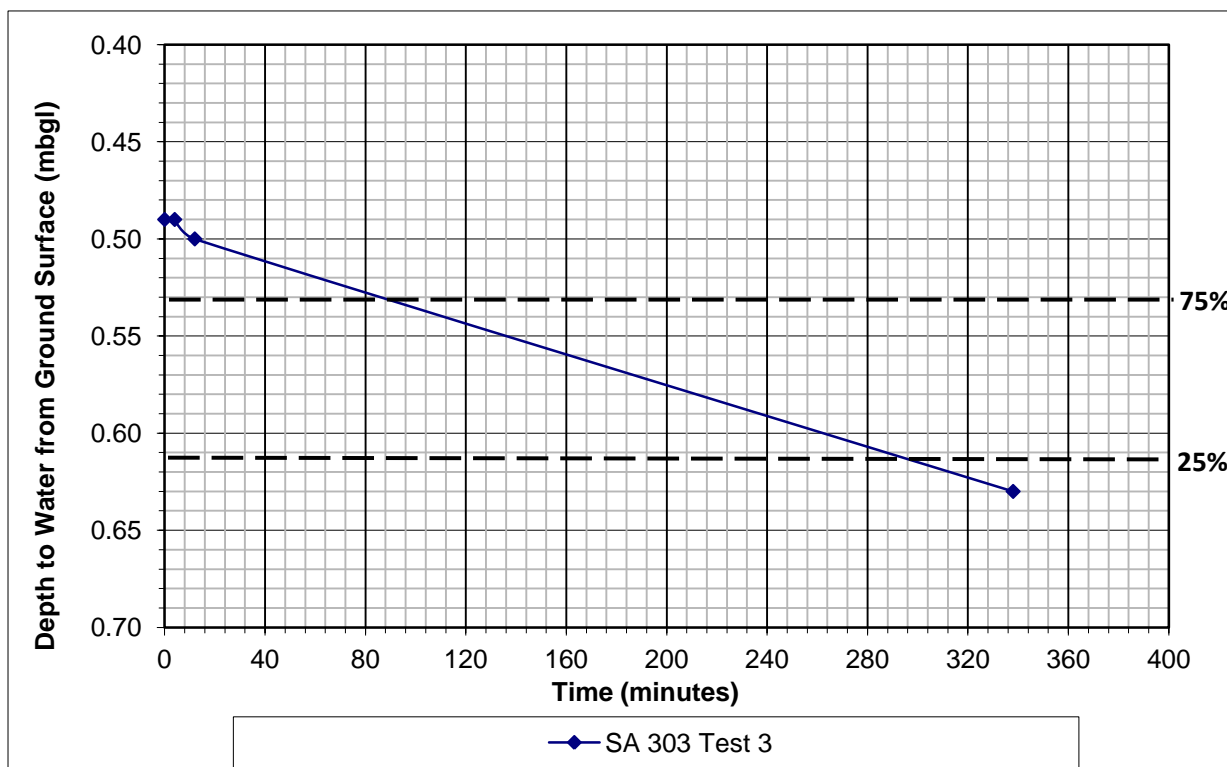
Trial Pit Infiltration Testing to BRE Digest 365

Client: A2 Dominion **Report No:** 19-12-10
Site: Elmsbrook Local Centre, OX27 8BA **Date Tested:** 07/01/20
Dimensions: 0.70m x 1.0m x 0.66m **Test Location:** SA 303
(width x length x depth)

Test Response Zone Description - : Forest Marble Formation

Average Soil Infiltration Rate = 4.77×10^{-6} m/s

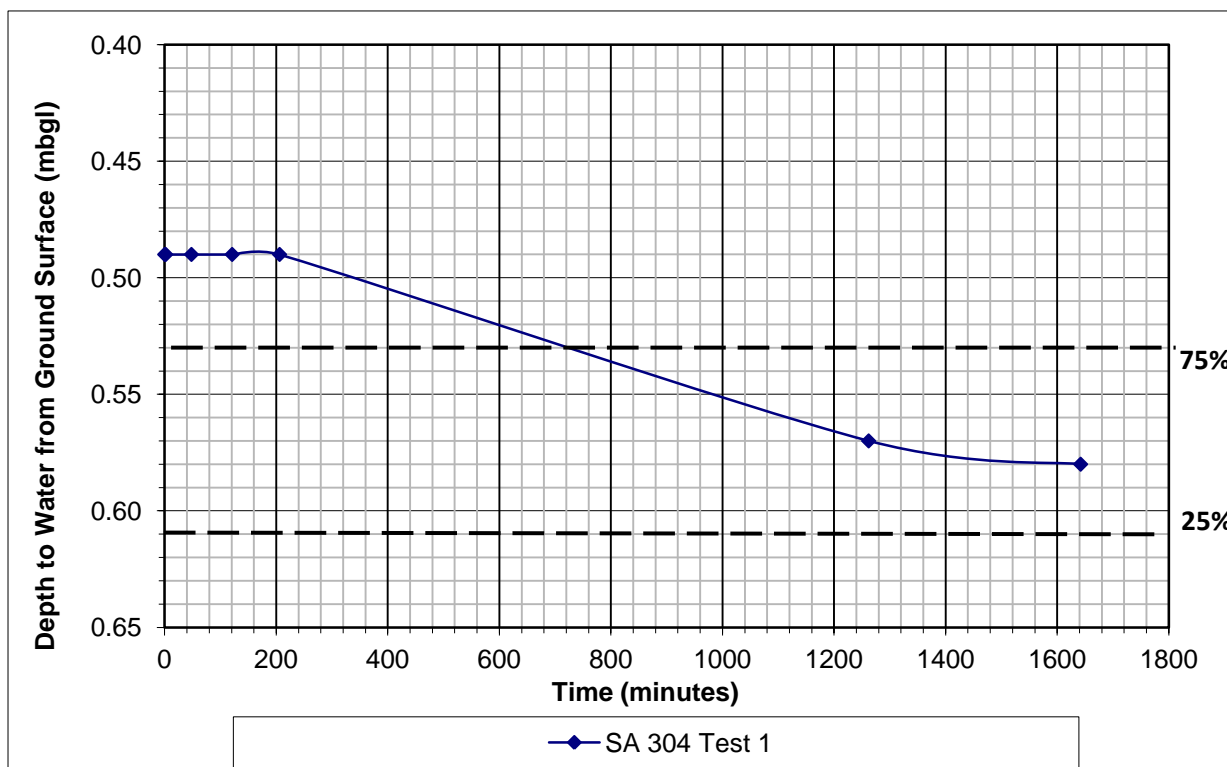
Trial Pit Infiltration Testing to BRE Digest 365

Client: A2 Dominion **Report No:** 19-12-10
Site: Elmsbrook Local Centre, OX27 8BA **Date Tested:** 07/01/20
Dimensions: 0.70m x 1.0m x 0.65m **Test Location:** SA 304
(width x length x depth)

Test Response Zone Description - : Alluvium

Unable To Calculate Average Soil Infiltration Rate
