Trenchard Circle, Upper Heyford
Phase 2 Environmental Risk Assessment

Report Ref. 163408/ERA/001

Job No. 163408

December 2016

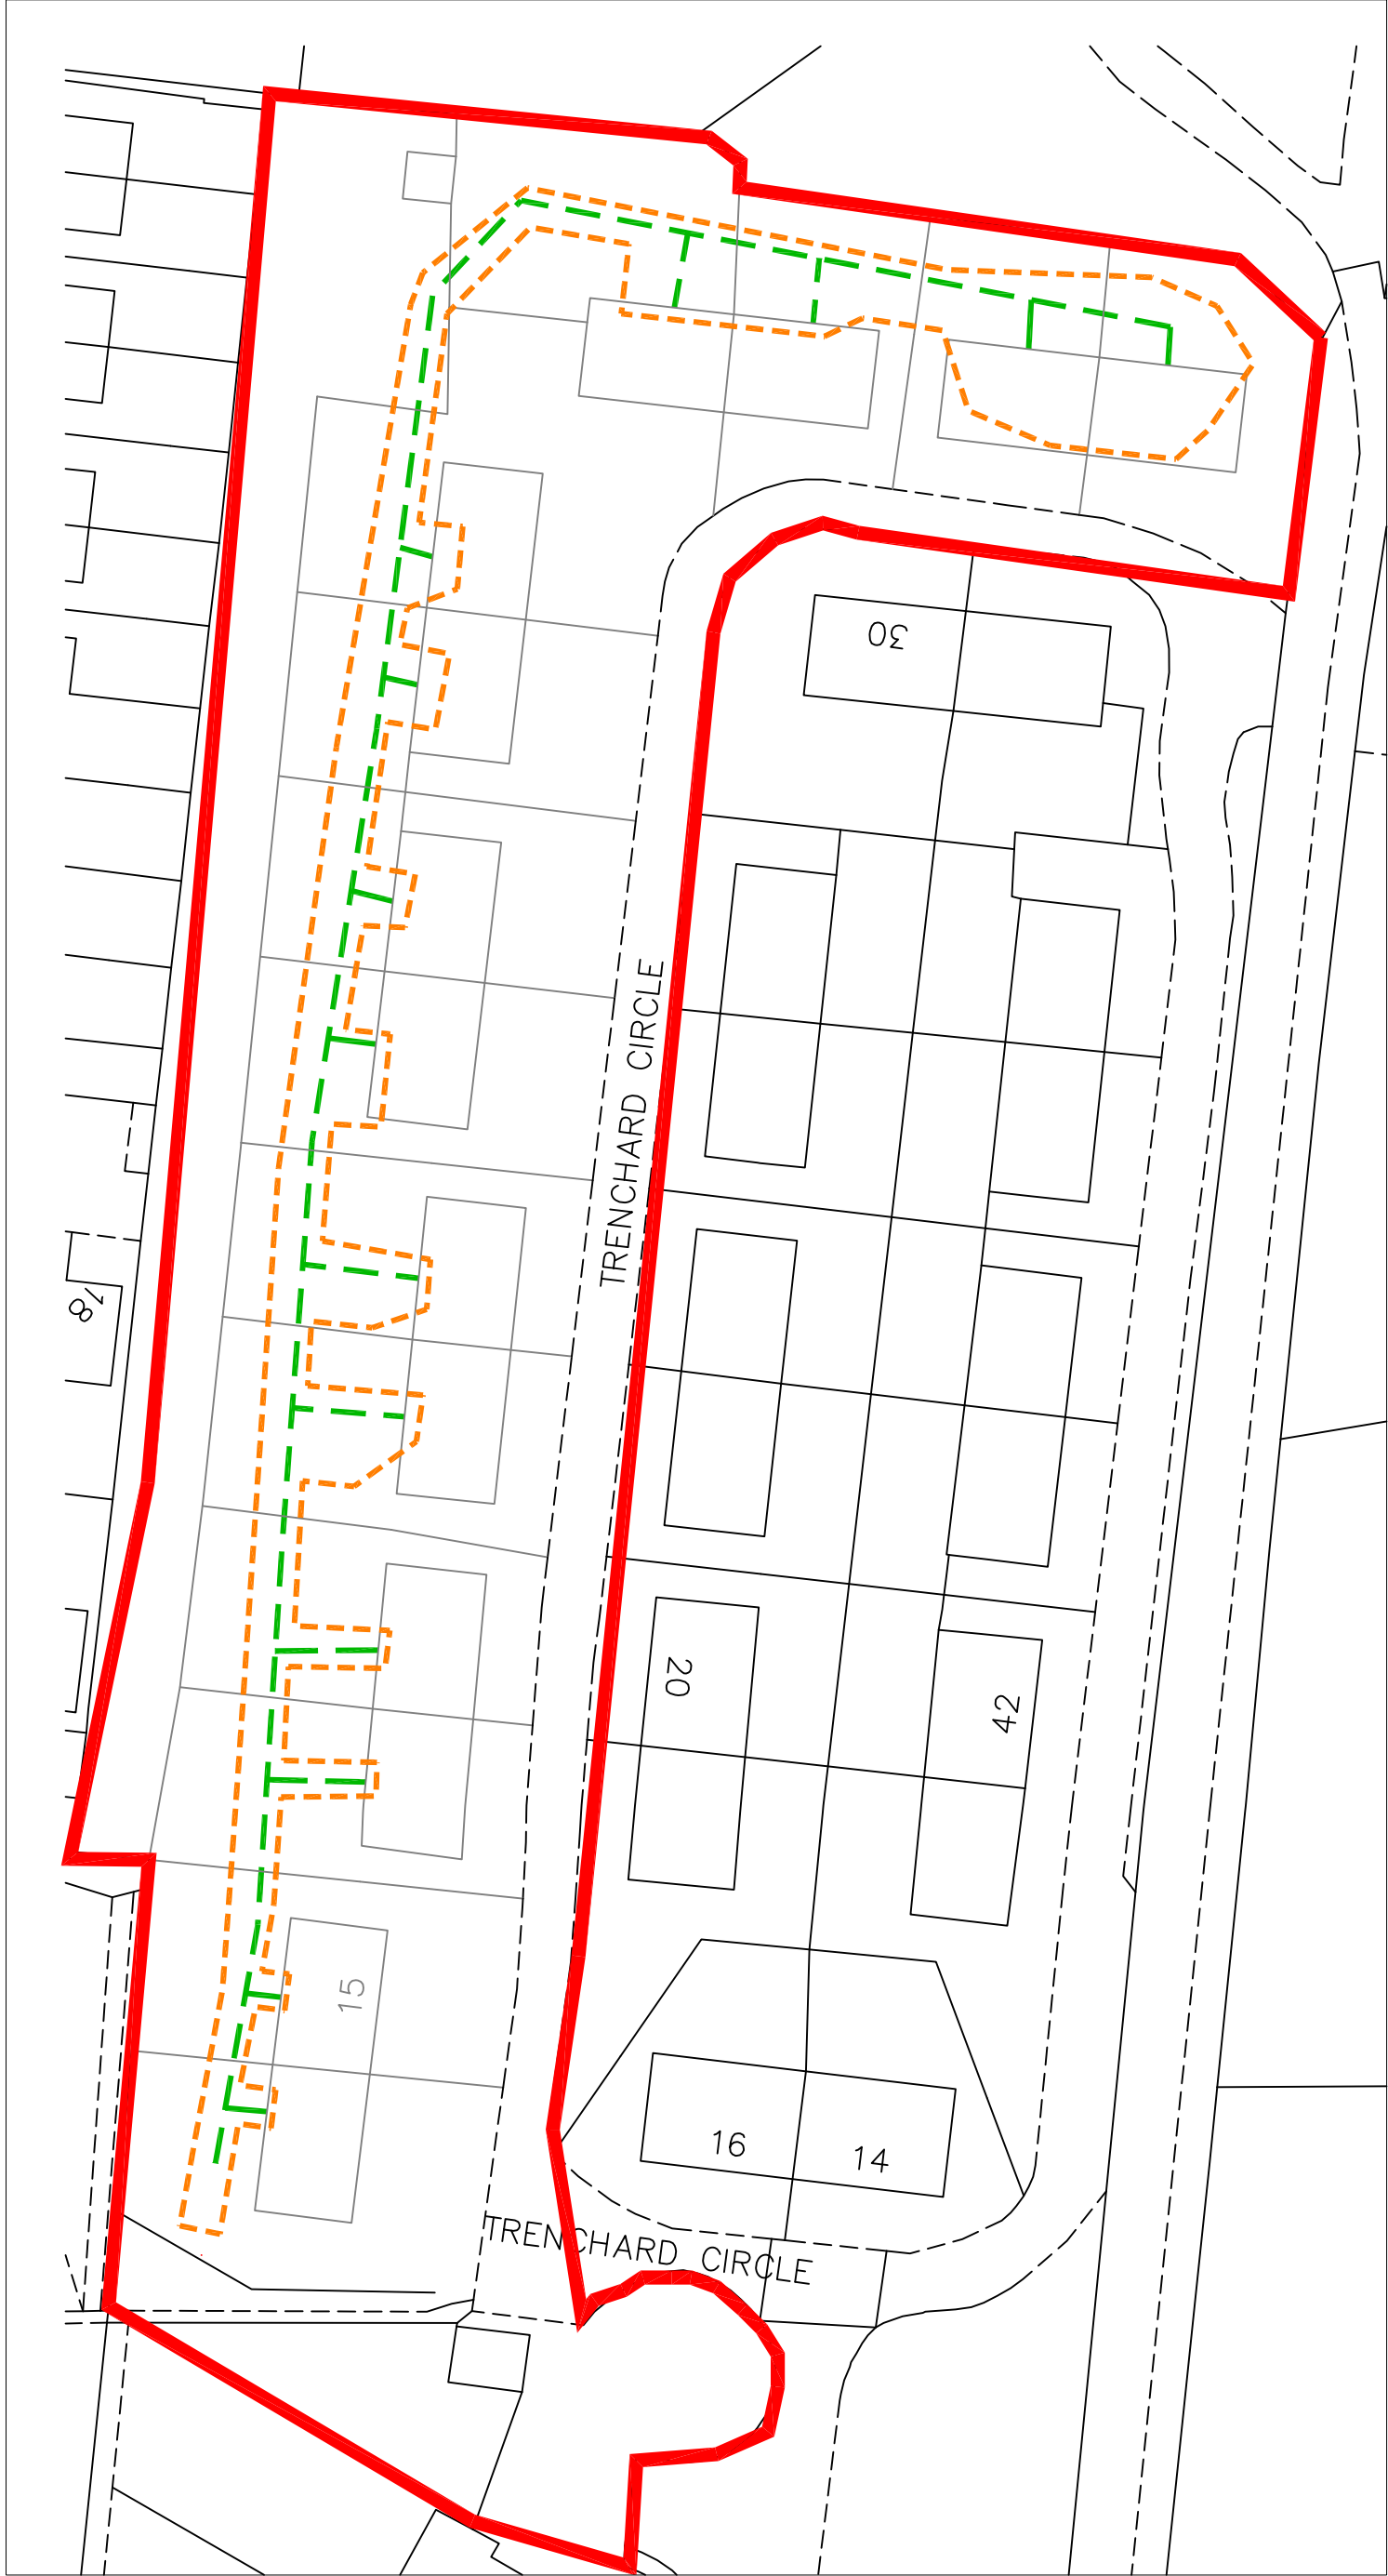
- Site Boundary
- - - Indicative position of below-ground oil pipes to be removed.
- - - Impacted soils around pipework to be segregated and treated/excavated. Validation testing of residual soils.

- 6.5 Table 6.1 presents a summary of the recommended further works, remediation and/or mitigation controls during the redevelopment. This should be read in conjunction with the Remedial Plan (Figure 4).
