**Trenchard Circle,  
Heyford Park  
Extended Phase I Habitat and  
Preliminary Bat Survey**

On Behalf of:  
The Dorchester Group

Issue No.	1
Issue Date	3/3/2016
Written By:	Mark Satinet
Checked By:	Paula Matthews

4 Acre Ecology Limited

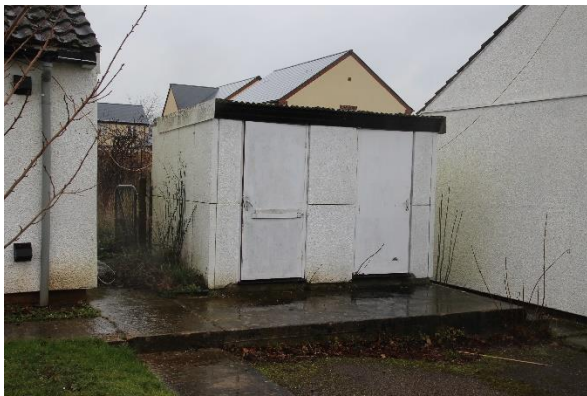
3. A double shed

5.10 The sheds have single skin prefabricated panel walls with single skin corrugated asbestos sheet mono-pitch roofs. Most of the sheds are paired, lying between the bungalow blocks, but there are some single ones. Internally the sheds are dark, but have no obvious crevices. They are individually 1.5m wide, 2m long and 2m high (See Figure 2).

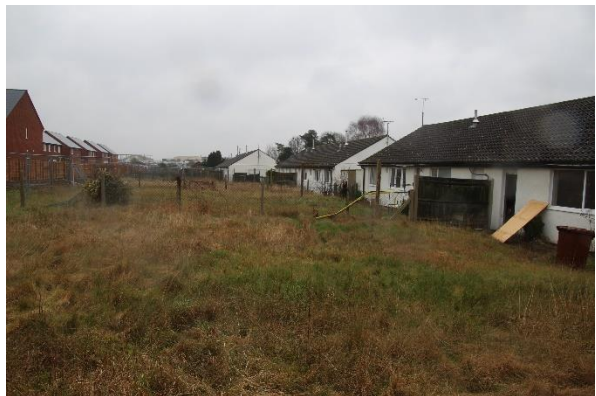
4. The rear gardens

- 5.18 This forms around 60.2% of the site, consisting of tightly mown and well maintained lawns to the front of all the buildings (roughly a third of this habitat), with similar lawn areas to the rear of all the buildings, but these appear not to have been managed for over a year and have mainly long grass in them (See Figure 2).

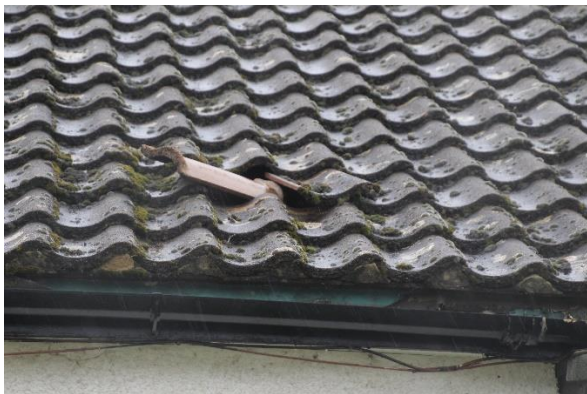
5.12 The roofs are covered by large interlocking concrete roof tiles with no chimneys, but they do have a flue in the rear of each dwelling, all well sealed, apart from a large hole around the flue of No. 37. The eaves are sealed by wooden barge boards, while the ends are sealed by the render, which rises to the tiles. The roofs are generally well-sealed, but there are some gaps where tiles have slipped or been damaged, such as the SE corner of No. 13, the lower east side of No. 19, the lower east side of 27, the lower northern side of No. 30 and the lower south side of No. 32.

5. Broken Tiles

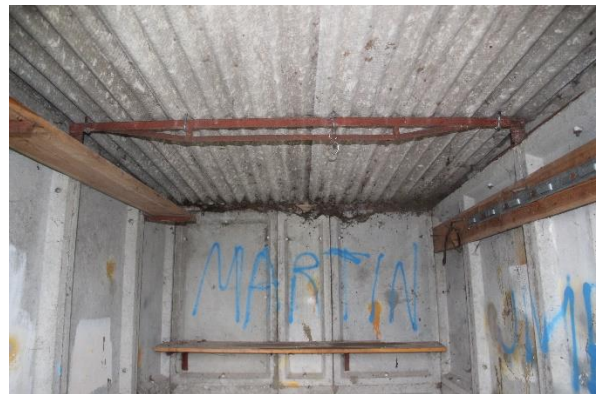
6. Interior of shed

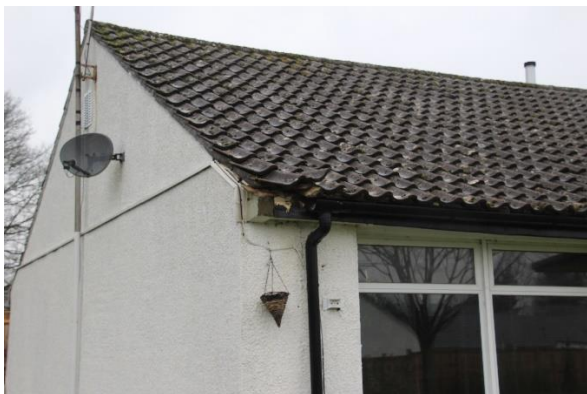
7. Gable end with grill above satellite dish

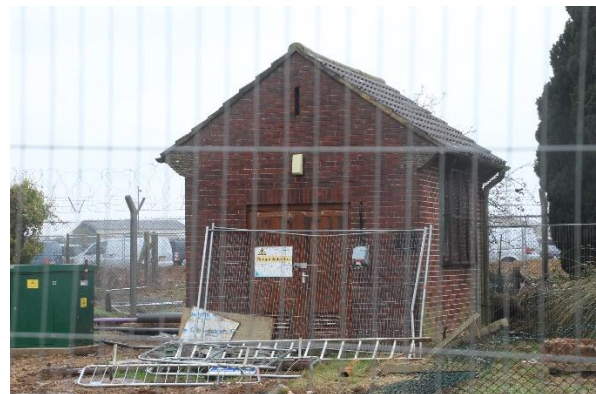
- 6.20 The sheds are all regarded as having negligible potential for roosting bats, but the remaining single storey brick building has low potential. Although the roof is well sealed and the tiles are all intact, the air hole in the southern gable provides access into the building, which was not surveyed internally. This should be surveyed internally and emergence surveys carried out if evidence of bats is found. If access is not gained then an emergence survey is required during the peak of the active season, which is late May to mid-August.

8. Detached single brick building with air hole

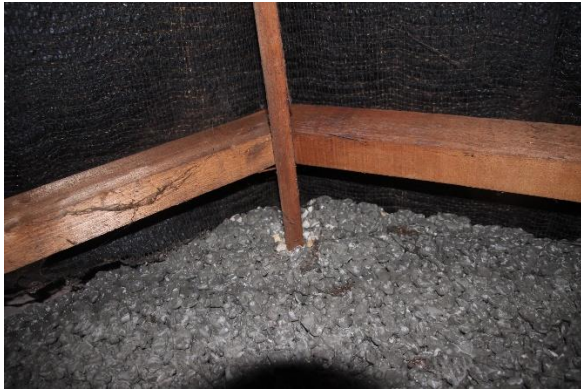
9. Ridge board under felt lining with sprayed concrete wall

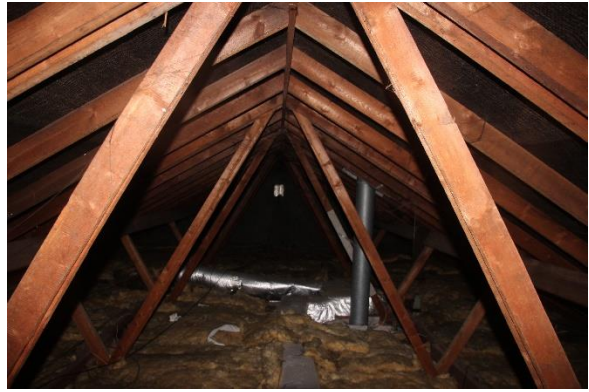
10. Collar roof space with well-spaced trusses

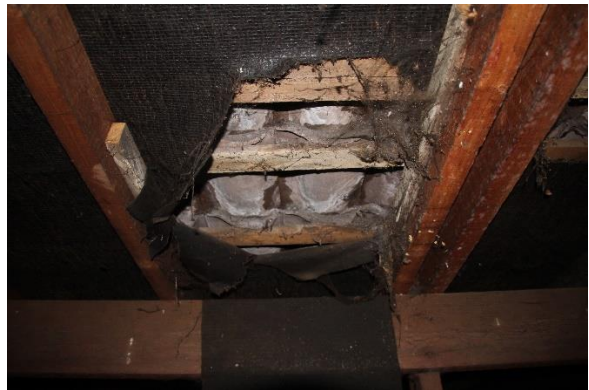
- 6.17 Crevice dwelling bats, such as Pipistrelles, could also be roosting in the buildings, their droppings, if present, being trapped by the felt lining (Jones and Racey, 2008). However, apart from the few tiles noted as missing, there is little potential for crevice dwelling bats to enter beneath the tiles and the eaves and gables are otherwise well sealed.

12. Cob-webbed gap showing tightly fitting tiles

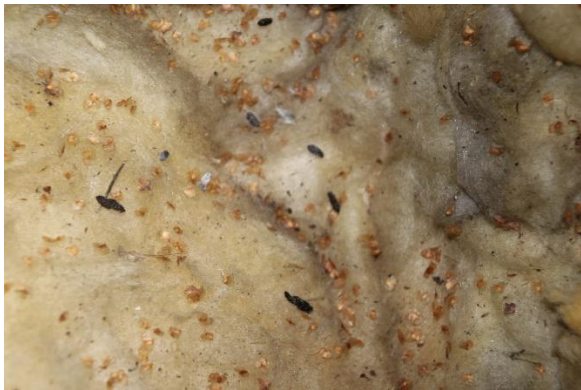
- 5.16 All the sheds had no evidence of bats in them and the majority of the bungalows had no signs either. However, a few scattered bat droppings were found in three of the roofs, all of a similar size and shape, being 8-10mm long, 2.0-2.5mm in diameter and coarse in texture. There were 11 found in No. 21, along with 3 moth wings, 6 in No.37 and 34 in No. 32, plus 10 yellow underwing moth wings and one set of tortoiseshell wing in the latter. The droppings were at the wall next to the loft hatch (open) in No. 21 and No. 37, but beneath the ridge board in No.32. In the latter there were two small concentrations of 10 droppings each at the western wall and in the middle of the roof, with a further group of 14 scattered towards the eastern end of the roof space.

- 6.14 The buildings on-site are all regarded as having low potential for roosting bats due to their construction and well-sealed roofs. However there are some places where the roofs have failed and evidence of bats was found in three buildings, numbers 21, 32 and 37, although this was a low level of droppings with only a few feeding signs.

13. Scattered bat droppings on insulation

- 7.17 Lights will be placed in the roof spaces where roosts are present a week before demolition begins, but outside the peak activity period, to deter their use by Brown Long-eared bats ahead of stripping the roofs. Before works commence the BLICL holder or Ecologist named on the EPS Licence will inspect the internal roof spaces as a final check for roosting bats, removing any found by hand and placing them in the bat boxes.

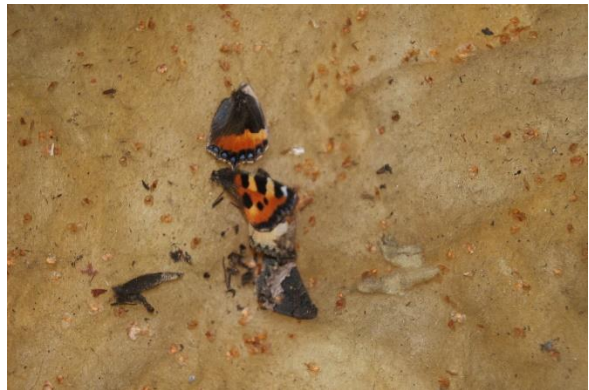
- 6.16 The fact that the doors into the loft hatch areas may have been open in the past, with the loft hatches all open, means that opportunist bats may have entered into No.s 21 and 37 and that these are not roosts. However with a hole in the roof of 32 and slightly higher numbers of bat droppings present this may be a night-time feeding roost, with a number of moth wings found with the droppings.

14. Butterfly wings

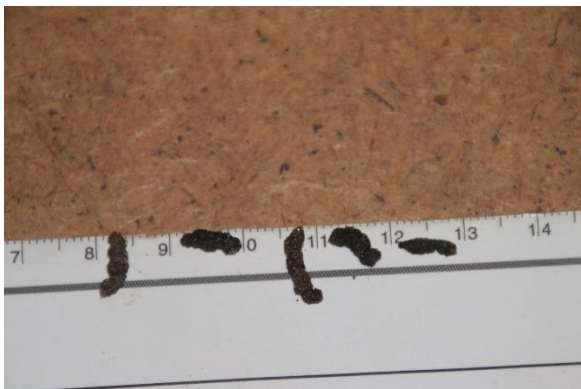
- 6.15 The bat droppings were 2.0-2.5mm diameter and 8-10mm length, which is indicative of Long-eared bats, thought to be Brown Long-eared bats as Grey Long-eared bats have not been found this far north in the country (Entwistle & Swift, 2008). These bats are light testing bats that fly within a roost before emerging. As there were mainly scattered droppings, with a small area only in numbers 21 and 37, and two small concentrations of 10 droppings each, plus 14 scattered droppings in number 32, this would indicate that the roof space is rarely used and possibly as a night-time feeding roost only, (JNCC, 2004).

15. Close-up of bat droppings

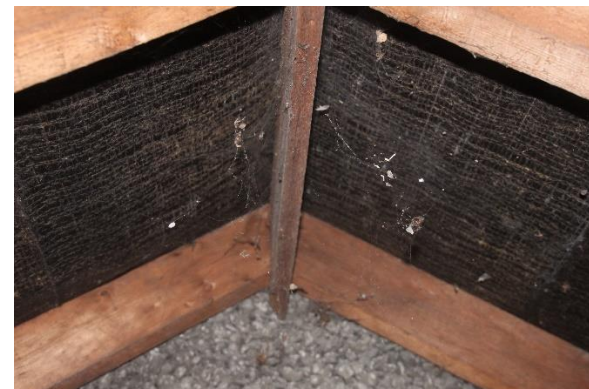
16. Cobwebs in ridge in most buildings
