**Phase 1a Section 2
Graven Hill, Bicester**

**Land Contamination Verification Report for Earthworks Fill
(to assist with discharging original Planning Condition
No 58)**

Report Ref: 173044/VR/002

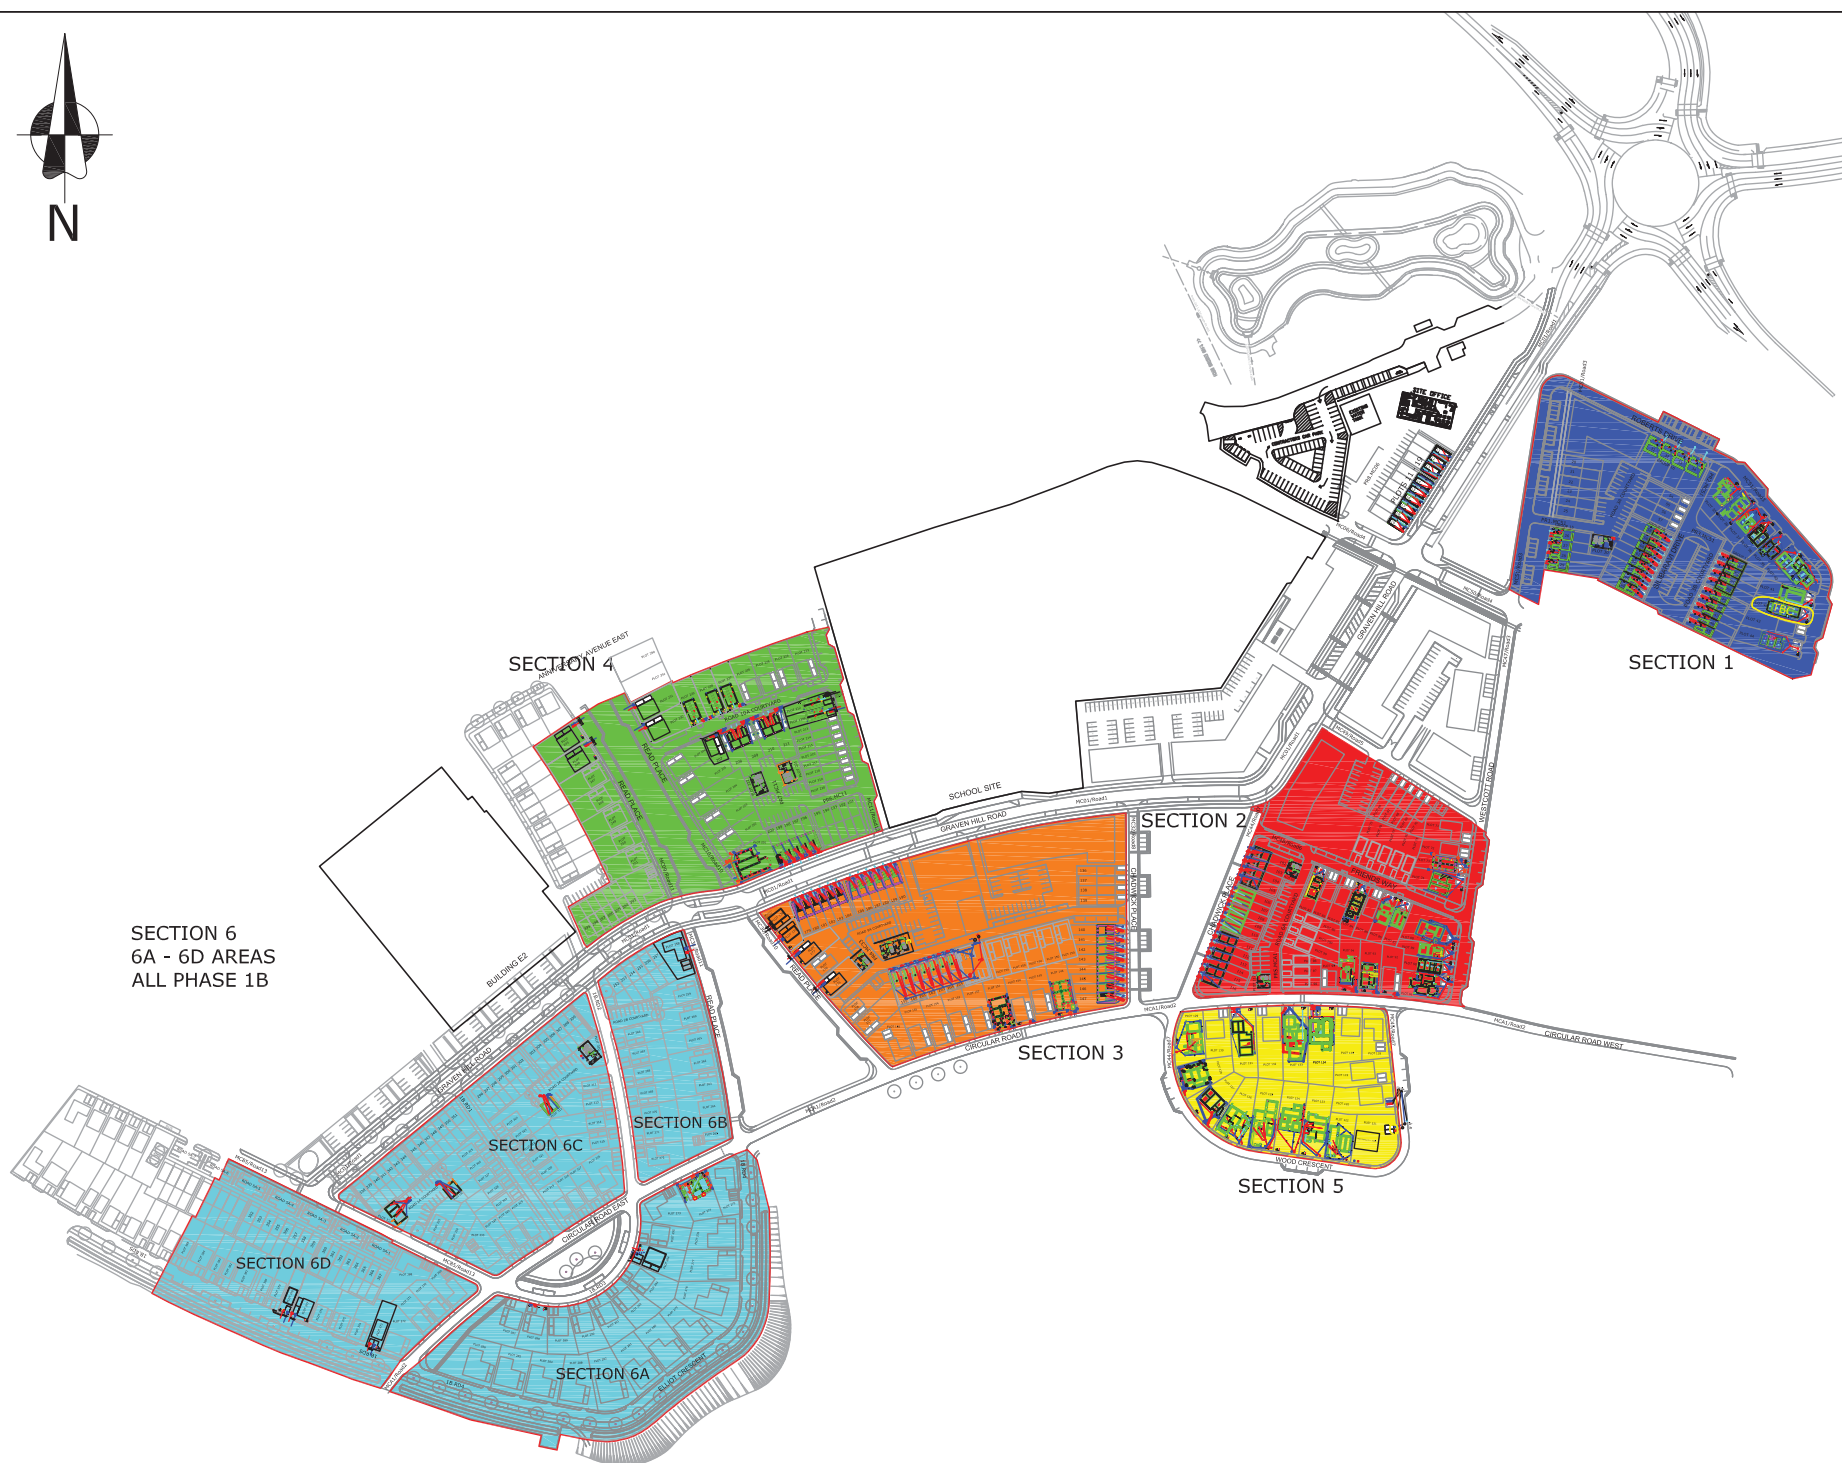
DRAWING TITLE:
SITE REMEDIATION
STRATEGY - WHOLE SITE,
ALL SECTIONS & AREAS FOR
VALIDATION WITH RED LINE
BOUNDARIES

- 1.4 The site is being developed in different sections, as presented on Figure 1 (Careys drawing 3252-PJC/AAe-00S00).

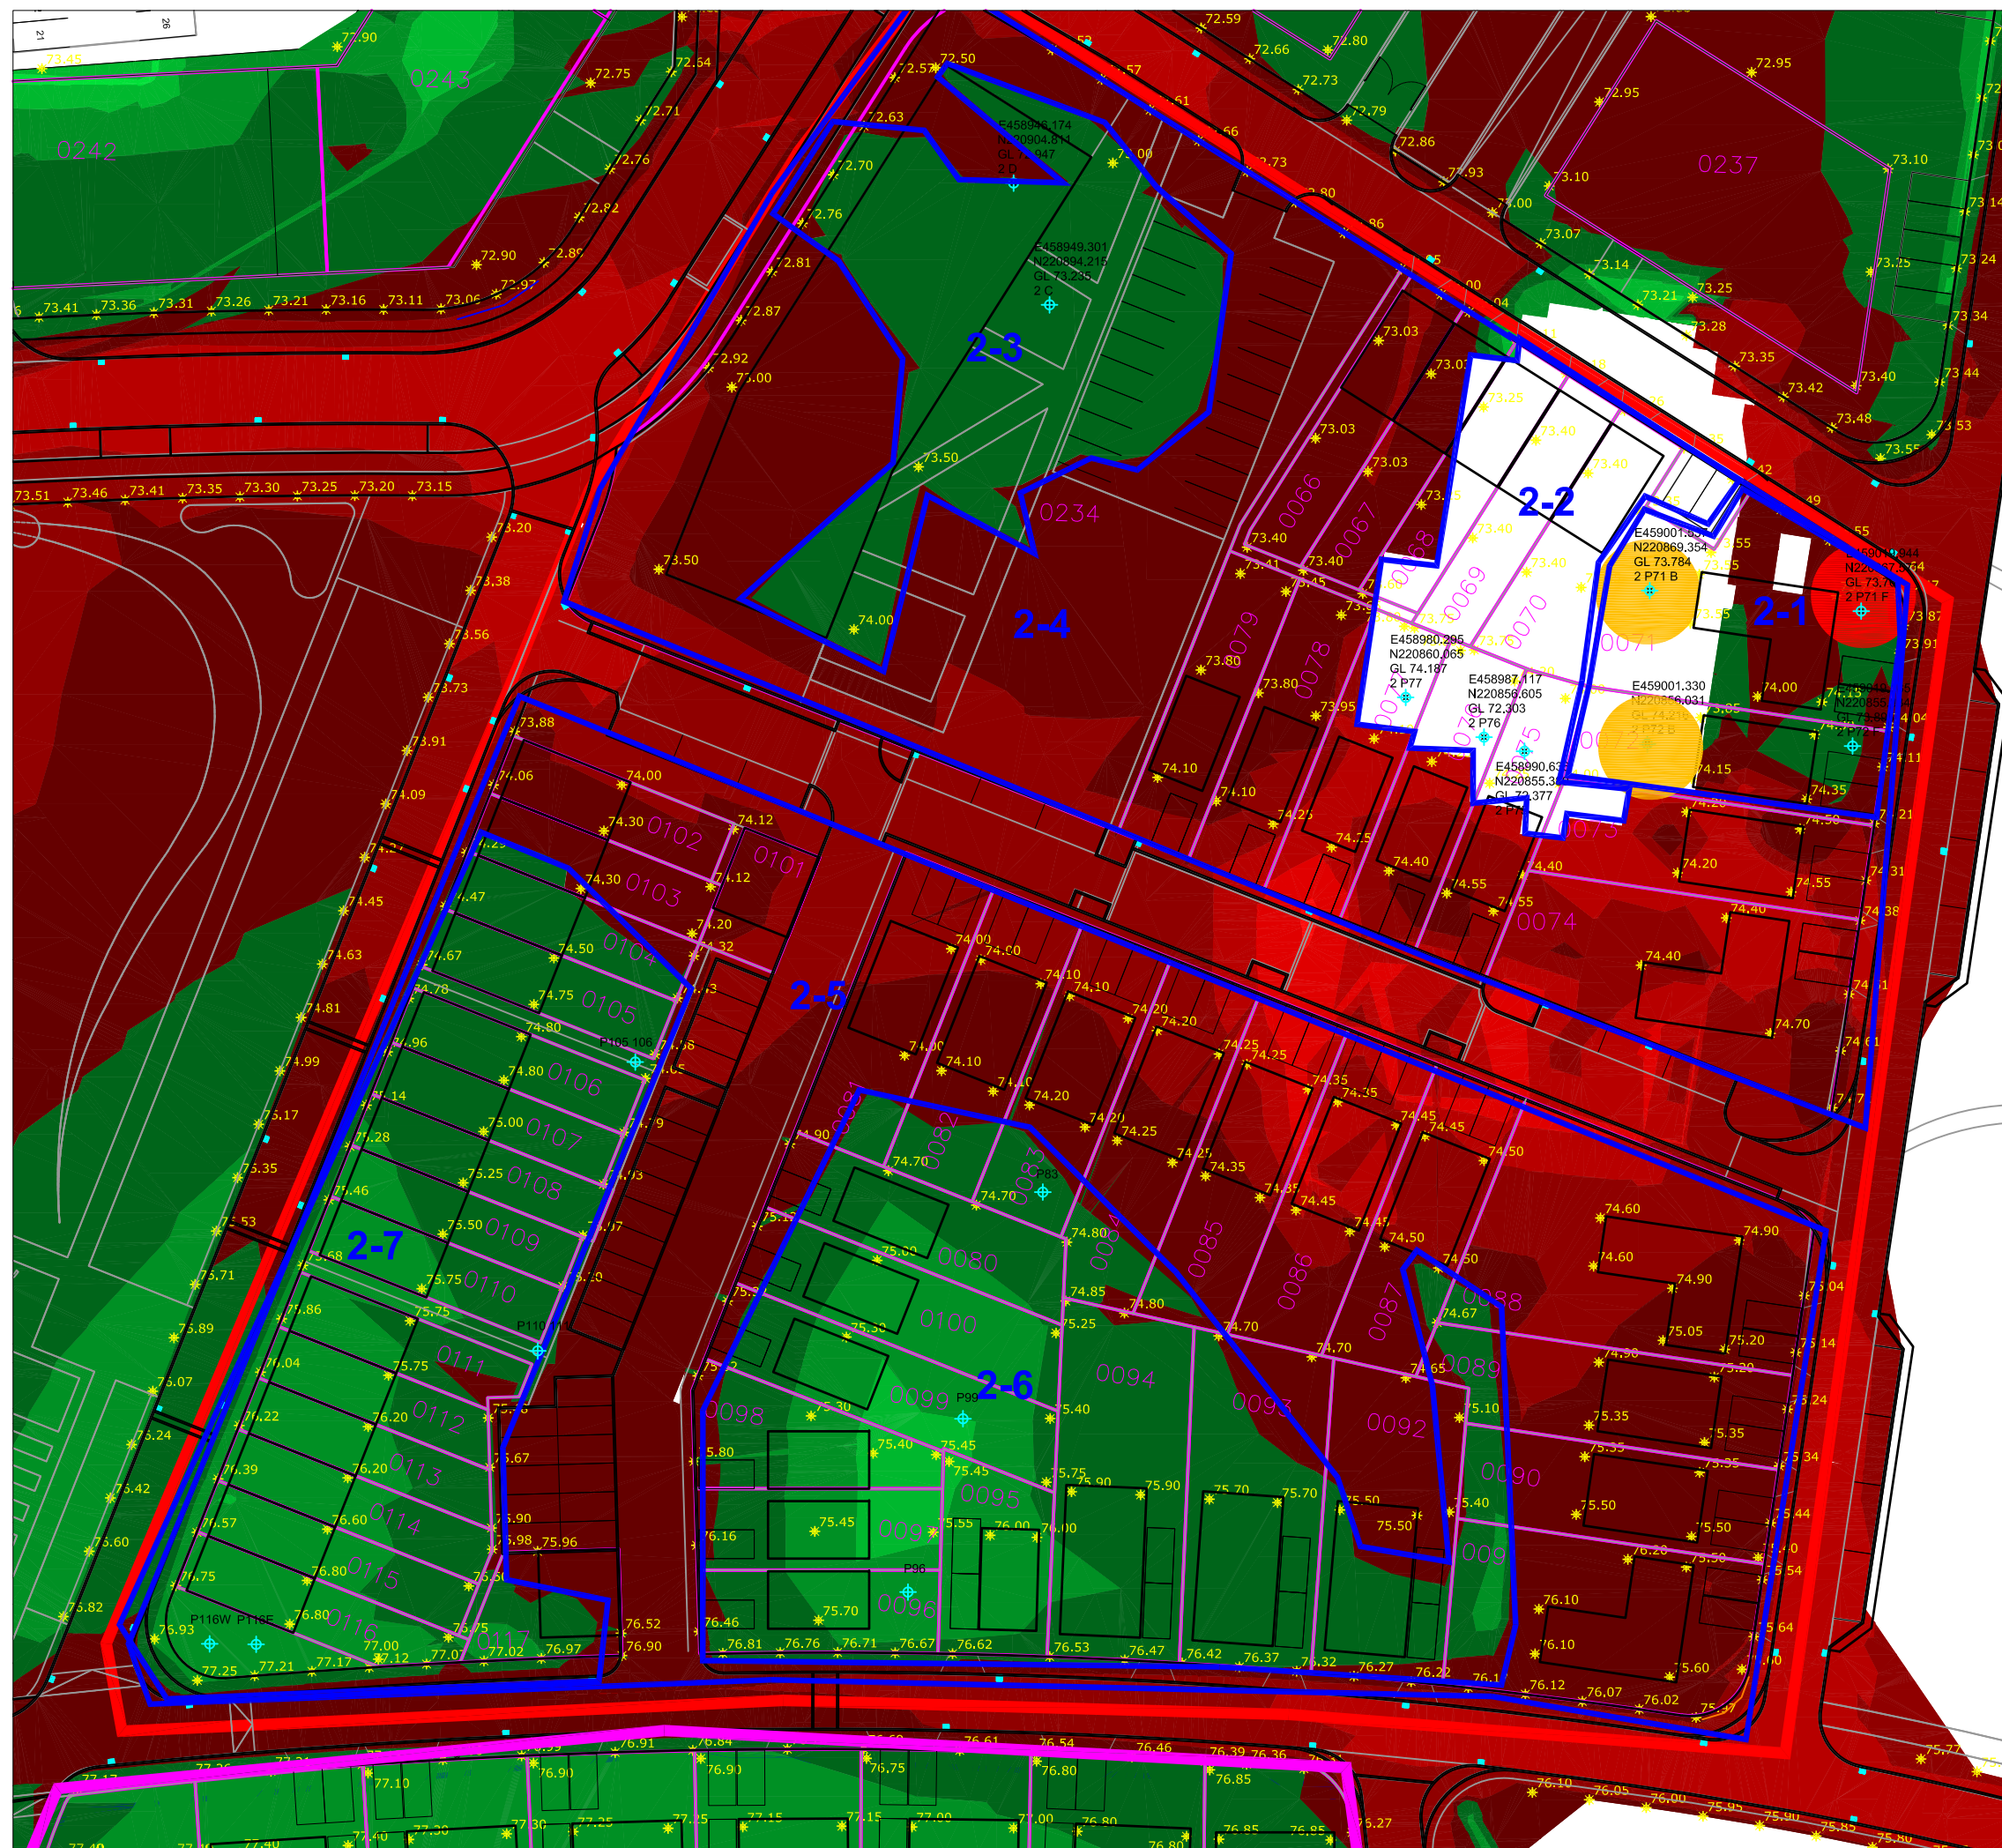
Rev.	Details	Drawn Chkd.	Date
Project 173044 Graven Hill, Bicester			
Title Earthworks Fill Verification Plan - Section 2			
<div>

- P71 F - Chrysotile Asbestos fibres/clumps 0.002%
- P71 B - Dibenz(a,h)Anthracene 0.64mg/kg versus 0.28mg/kg
- P72 B - Dibenz(a,h)Anthracene 0.39mg/kg versus 0.28mg/kg

- 2.1 The section has been sub-divided into areas of cut and fill, as presented on Figure 2. To verify the chemical quality of subsoil, trial pits were constructed at locations made available by Careys to be representative of earthworks fill. The trial pits were marked out by the Careys Site Engineer and the ground levels recorded.
- 2.2 Table 2.1 presents the calculated fill volume for the soft landscaping in each sub-area and the required number of tests against the frequency specified within the approved remedial strategy (1 test per 250 m³ site-won fill).

- 2.3 Trial pits were completed on 22nd January and 26th March 2019. The location of the trial pits is presented on Figure 2.
- 2.4 AAe inspected the trial pits for any visual or olfactory evidence of contamination and collected representative samples of the subsoil for laboratory testing analysis in accordance with quality control requirements.
- 2.5 Photo plates of the trial pits are presented in Appendix B.

- 2.8 The soil results have been consolidated and compared against the specification provided in the Waterman Remediation Strategy. The consolidated data is presented in Appendix D. Where the testing suite includes determinants for which limiting values for the protection of human health are not included in the Waterman Remediation Strategy, the Soil Guidance Values (SGVs) presented in Appendix G have been adopted. Non-compliances against the specification are summarised in Table 2.3 below and shown on Figure 2.

Table 2.3 Summary of non-compliance with specification	
Location	Non-Compliance
Plot 71 (Front)	Asbestos fibre 0.002%
Plot 71 (Rear)	PAH
Plot 72 (Rear)	PAH

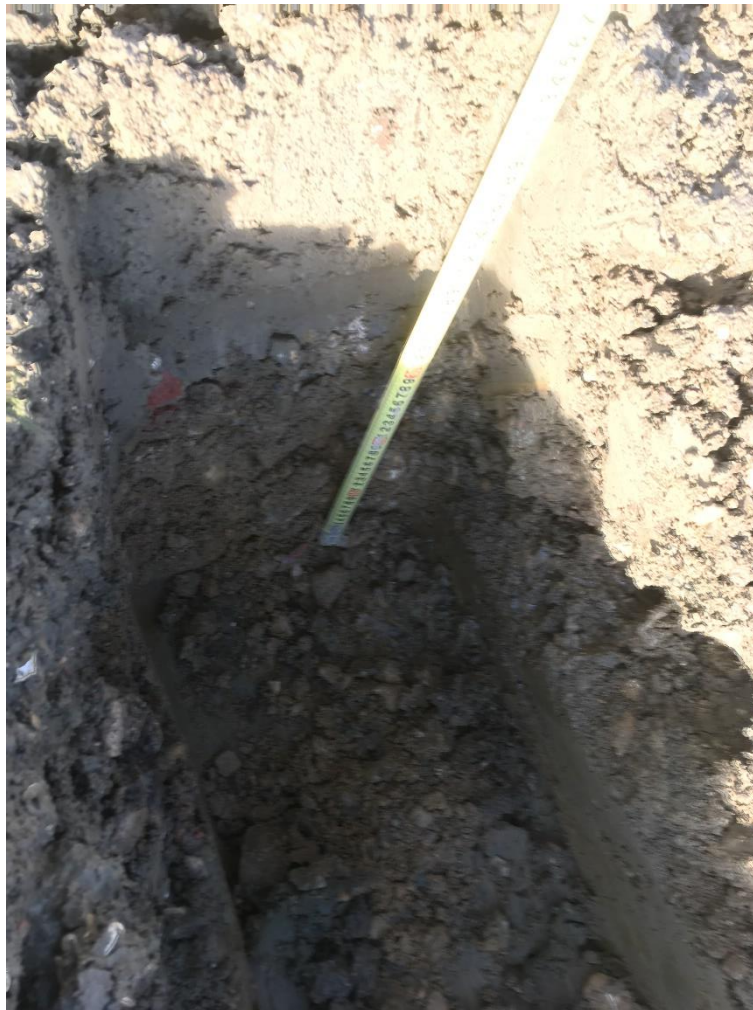
Comment	Project 173044
<u>Strata comprises:</u>	Reference 2 Plot 71 Back
0.00-0.40m Dark greyish brown sandy gravelly CLAY. Gravel is subangular fine of brick, concrete and hardcore. (MADE GROUND)	Date 22/01/19
0.40-0.605m: Dark greyish brown silty CLAY. (PETERBOROUGH MEMBER)	Originator Richard Heath
	<div>

- 3.1 The strategy for the remediation of non-conforming plots is set out in the 'Remedial Method Statement for Non-Conforming Works (RMS)' presented at Appendix A, and can be summarised as follows:
- Removal of impacted soils from non-conforming areas to 450 mm below finished formation level.
 - Placement of a permeable geotextile marker layer over the residual soils.
 - Reinstatement with acceptable soils from pre-approved stockpiles only.
 - Inspection of the non-conforming areas to verify that the reinstated soil has been constructed to a minimum depth of 450 mm above the geotextile marker layer.

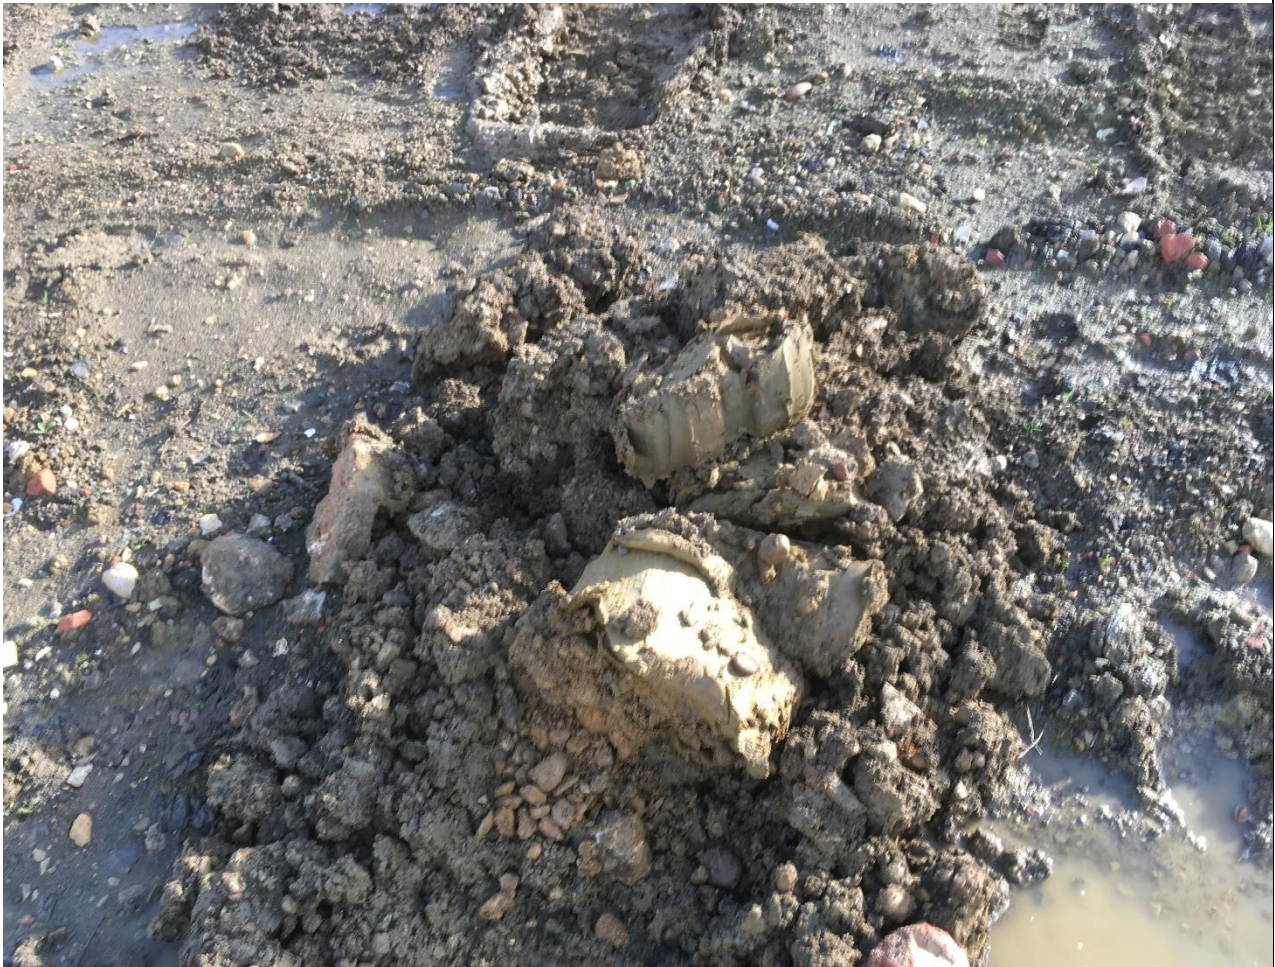
Comment	Project 173044
	Reference 2 Plot 71 Back Arisings
	Date 22/01/19
	Originator Richard Heath
	<div>

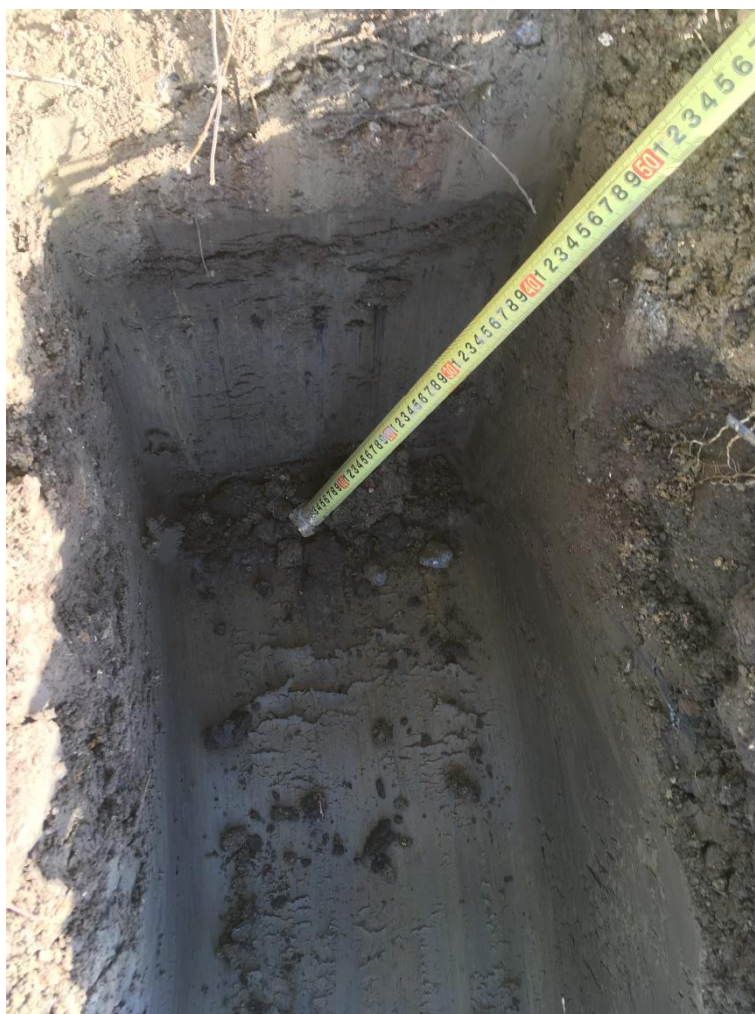
Comment	Project 173044
<u>Strata comprises:</u>	Reference 2 Plot 71 Front
0.00-0.20m Dark greyish brown sandy gravelly CLAY. Gravel is subangular fine of brick, concrete and hardcore. (MADE GROUND)	Date 22/01/19
0.20-0.50m: Dark greyish brown silty CLAY. (PETERBOROUGH MEMBER)	Originator Richard Heath
	<div>

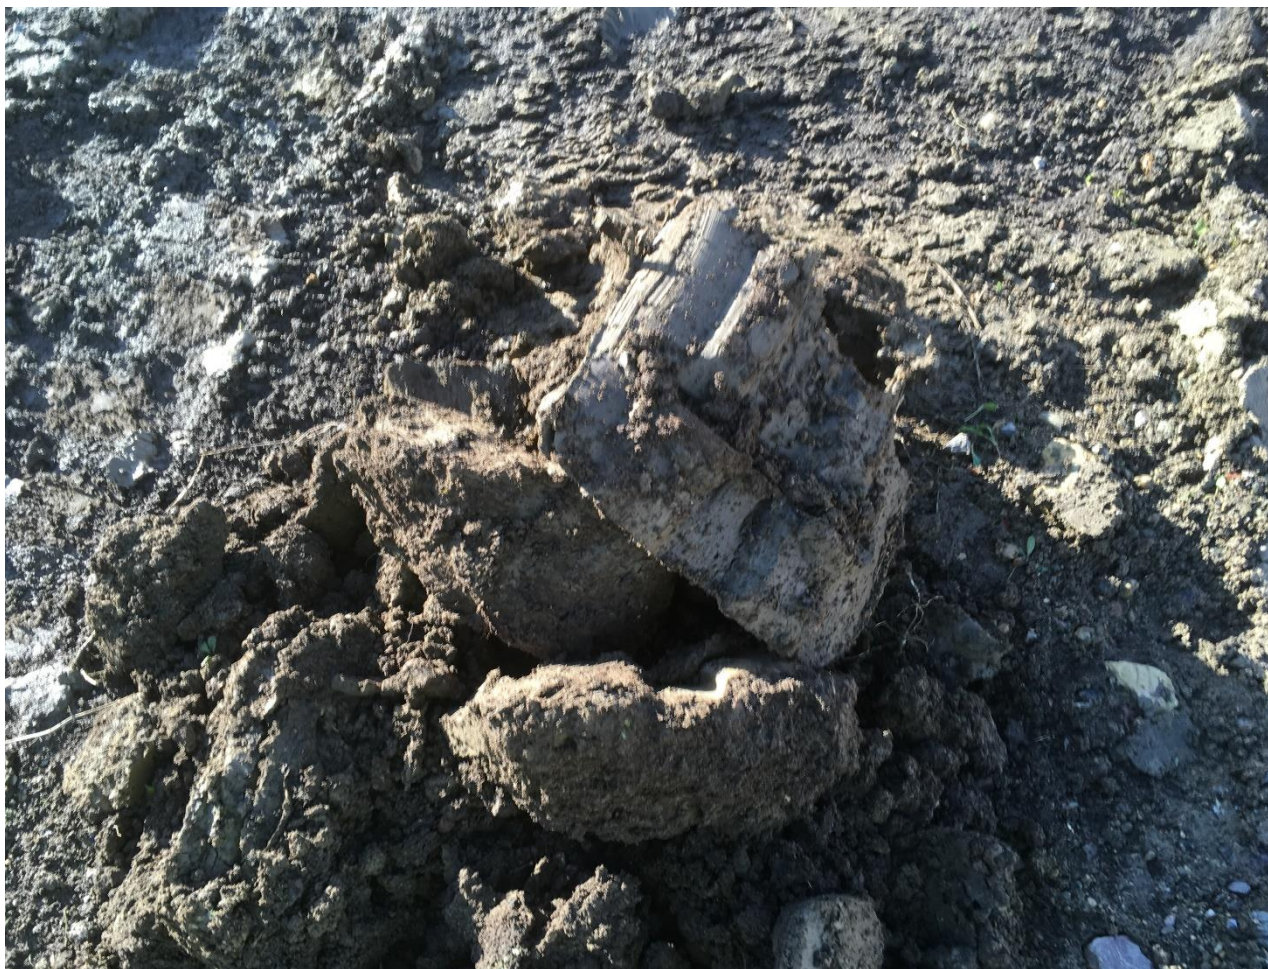
Comment	Project 173044
	Reference 2 Plot 71 Front Arisings
	Date 22/01/19
	Originator Richard Heath
	<div>

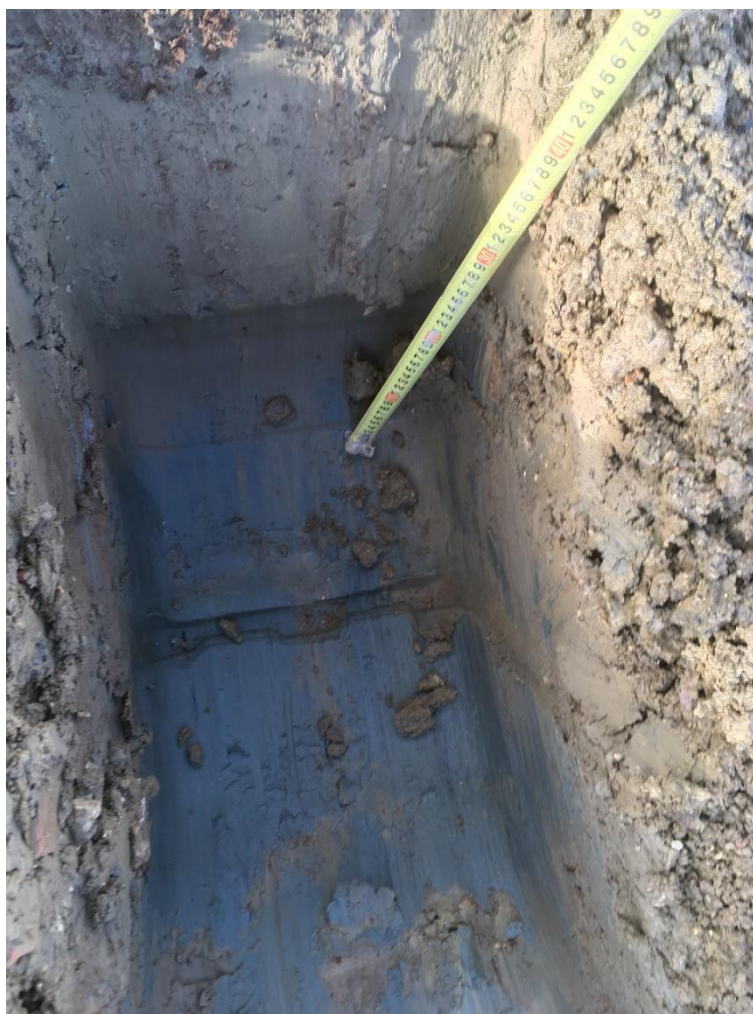
Comment <u>Strata comprises:</u> 0.0-0.45m: Dark greyish brown becoming dark grey silty CLAY. (PETERBOROUGH MEMBER)	Project 173044
	Reference 2 Plot 72 Back
	Date 22/01/19
	Originator Richard Heath
	<div data-bbox="667 1624 874 1794" data-label="Image"> </div> <div data-bbox="1145 1615 1431 1861" data-label="Text"> <p>AA Environmental Limited Units 4-8 Cholswell Court Shippon, Abingdon OX13 6HX T: (01235) 536042 F: (01235) 523849 info@aee-llp.com www.aee-llp.com</p> </div>

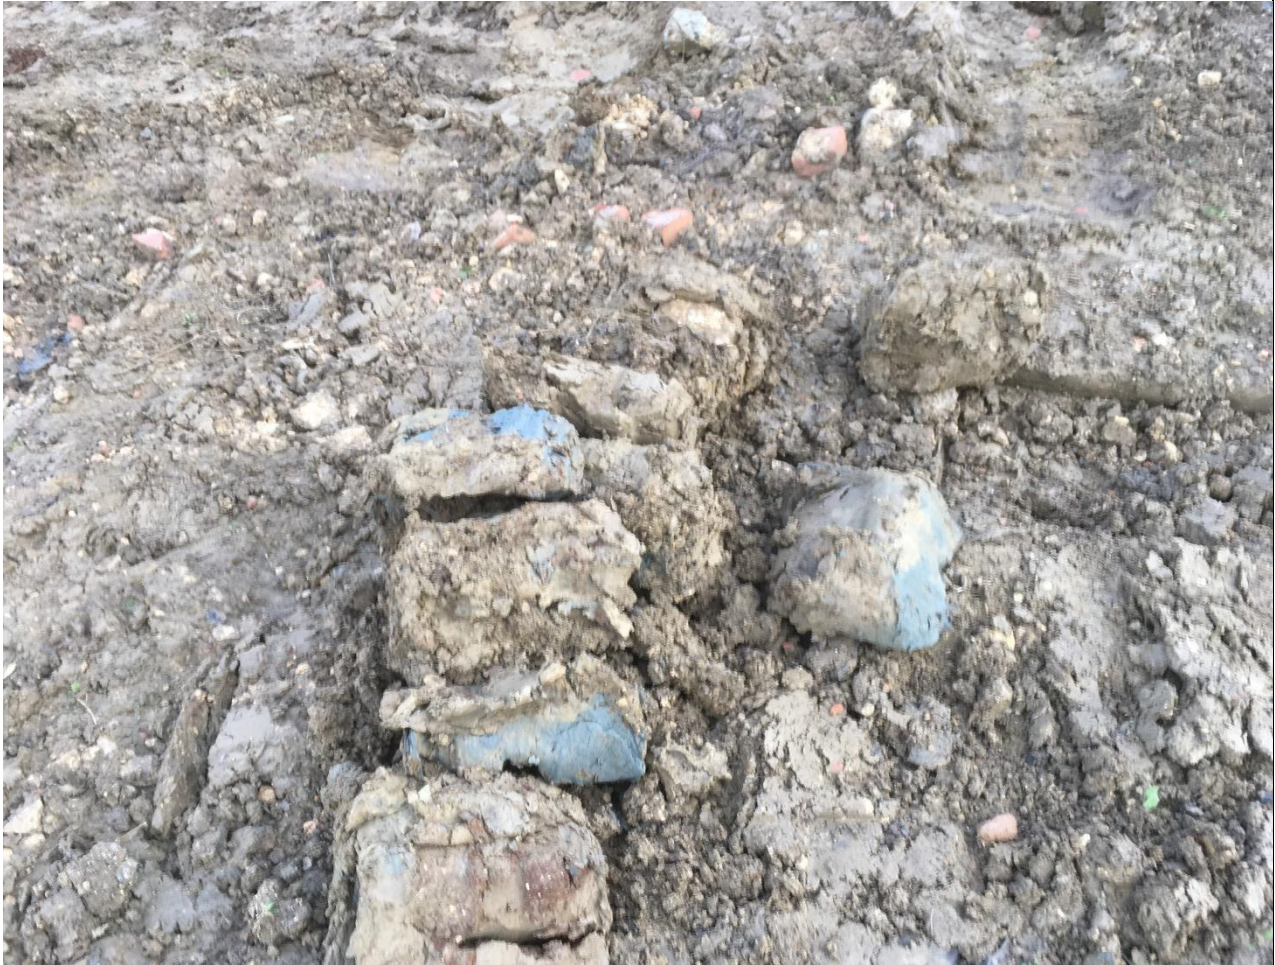
Comment	Project 173044
	Reference 2 Plot 72 Back Arisings
	Date 22/01/19
	Originator Richard Heath
	<div style="display: flex; justify-content: space-between; align-items: center;"> <div style="text-align: center;">

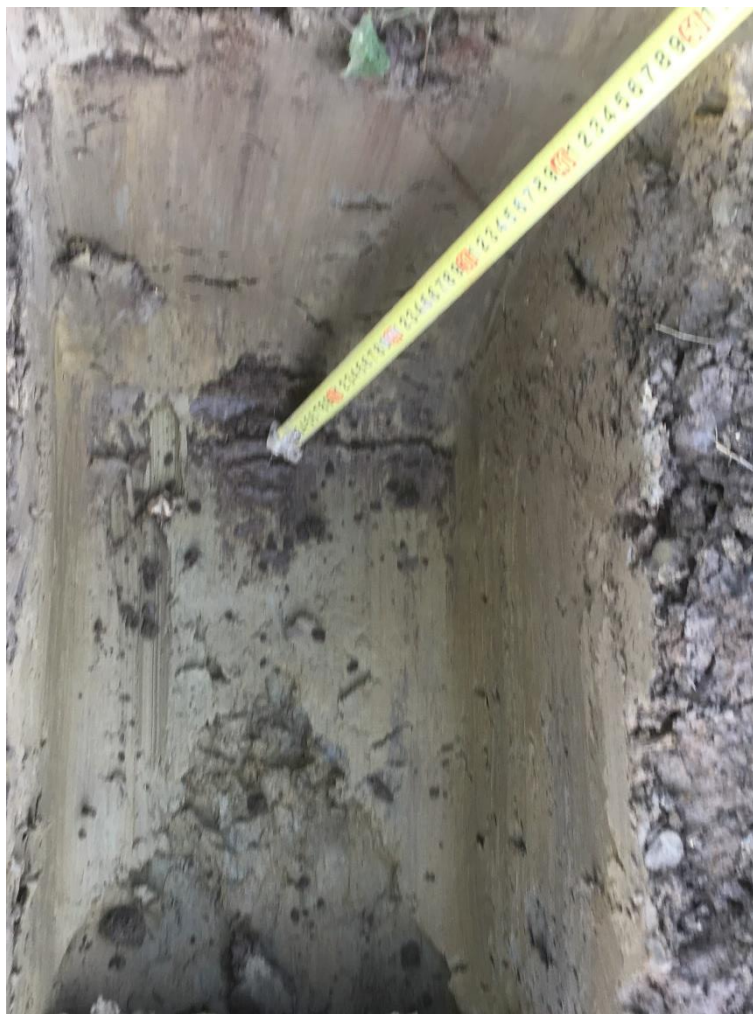
Comment	Project 173044
<u>Strata comprises:</u>	Reference 2 Plot 72 Front
0.0-0.45m: Dark greyish brown silty CLAY. (PETERBOROUGH MEMBER)	Date 22/01/19
	Originator Richard Heath
	<div>

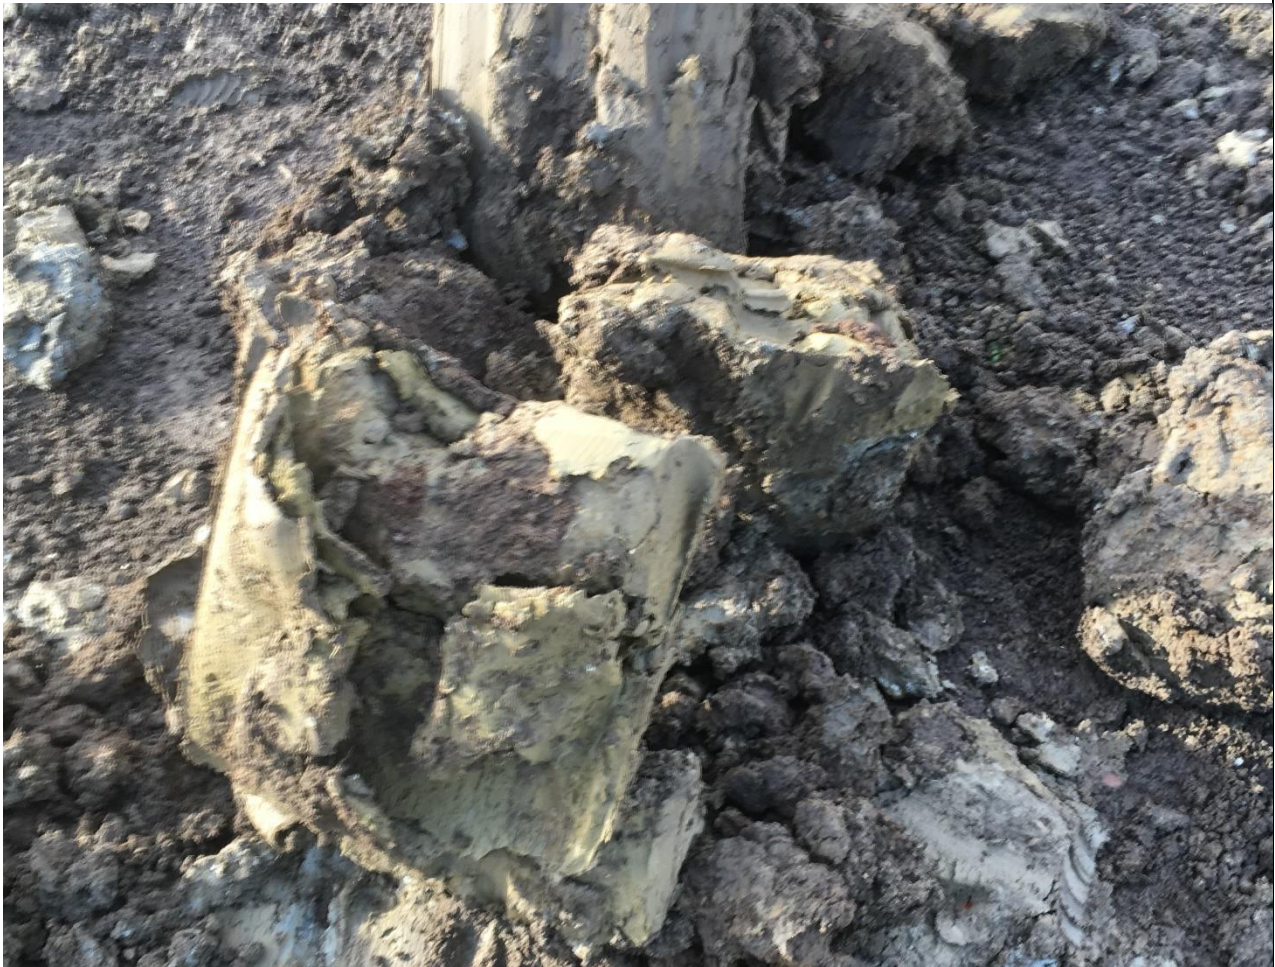
Comment	Project 173044
	Reference 2 Plot 72 Front Arisings
	Date 22/01/19
	Originator Richard Heath
	<div style="display: flex; justify-content: space-between; align-items: center;"> <div style="text-align: center;">
