**Phase 1a Section 6  
Graven Hill, Bicester**

**Land Contamination Verification Report for Earthworks Fill  
(to assist with discharging original Planning Condition  
No 58)**

**Job No:** 173044

**Report Ref:** 173044/VR/003

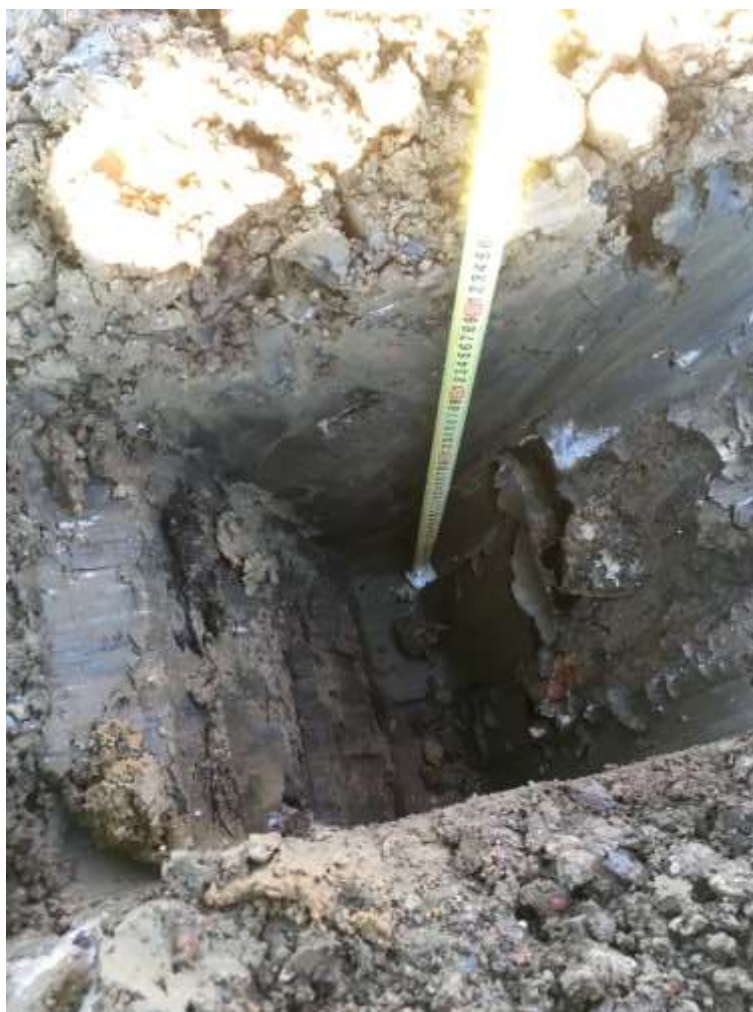
<table><tr> <td data-bbox="646 1379 1165 1451"> <p><b>Project</b> 173044</p> </td><td data-bbox="1165 1379 1444 1451"></td></tr><tr> <td data-bbox="646 1451 1165 1514"> <p><b>Reference</b> 6B Plot 254</p> </td><td data-bbox="1165 1451 1444 1514"></td></tr></table>

<p><b>Comment</b></p> <p><u>Strata comprises:</u></p> <p>0.00-0.40m Dark greyish brown sandy gravelly CLAY. Gravel is subangular fine of brick, concrete and hardcore. (MADE GROUND)</p> <p>0.20-0.60m: Dark brown silty CLAY. (PETERBOROUGH MEMBER)</p>

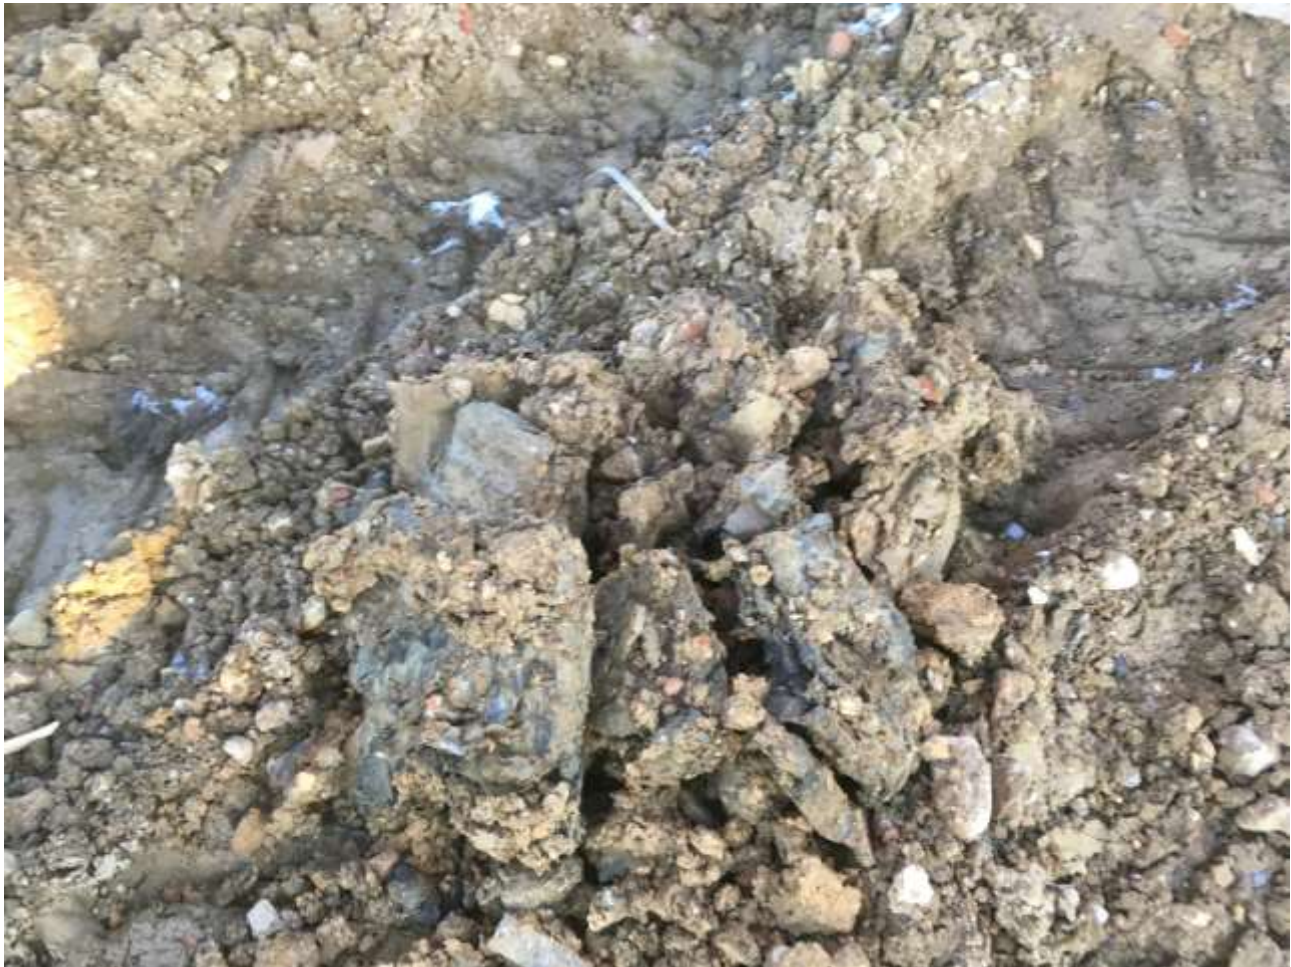
<b>Comment</b>	<b>Project</b> 173044
	<b>Reference</b> 6B Plot 254 Arisings
	<b>Date</b> 17/01/19
	<b>Originator</b> Richard Heath
	<div>

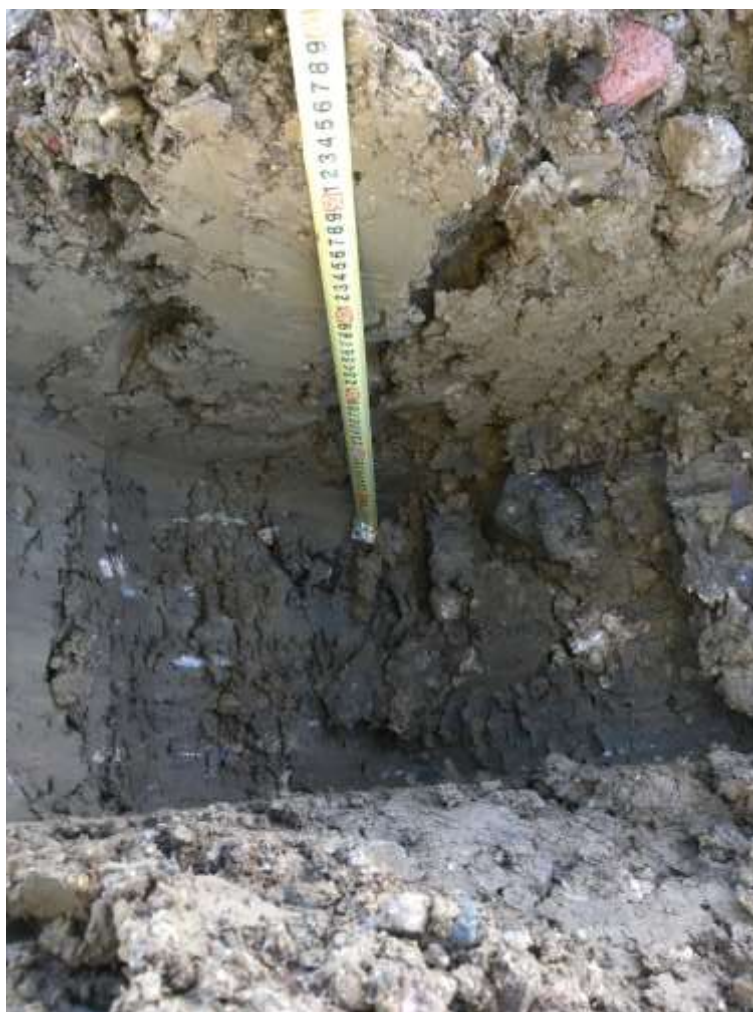
<b>Comment</b>  <u>Strata comprises:</u>  0.00-0.60m Dark greyish brown sandy gravelly CLAY. Gravel is subangular fine of brick, concrete and hardcore. Dark brown silty CLAY. (MADE GROUND)	<b>Project</b> 173044
	<b>Reference</b> 6B Plot 257
	<b>Date</b> 17/01/19
	<b>Originator</b> Richard Heath
	<div data-bbox="663 1619 1011 1789" data-label="Image"> </div> <div data-bbox="1160 1606 1444 1856" data-label="Text"> <p><b>AA Environmental Limited</b>  Units 4-8 Cholswell Court  Shippon, Abingdon  OX13 6HX  T: (01235) 536042  F: (01235) 523849  info@aae-llp.com  <a href="http://www.aae-llp.com">www.aae-llp.com</a></p> </div>

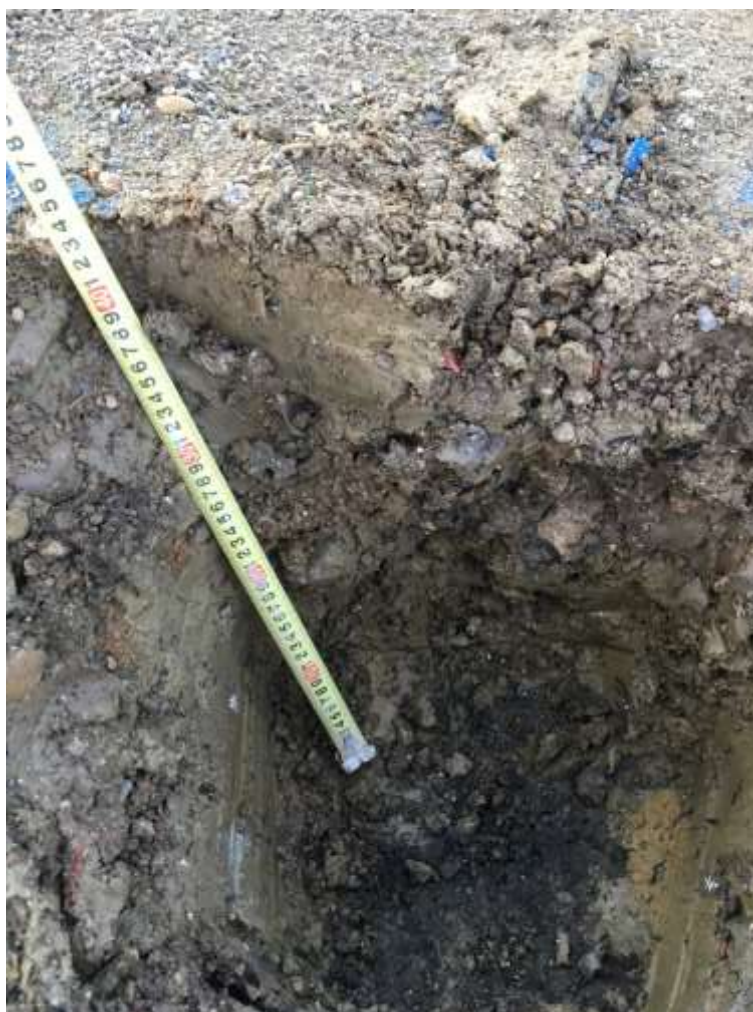
<p><b>Comment</b></p> <p><u>Strata comprises:</u></p> <p>0.00-0.30m Dark greyish brown sandy gravelly CLAY. Gravel is subangular fine of brick, concrete and hardcore. (MADE GROUND)</p> <p>0.30-0.45m Blackish brown silty CLAY. (PETERBOROUGH MEMBER)</p>	<p><b>Project</b> 173044</p>
	<p><b>Reference</b> 6D Plot 366</p>
	<p><b>Date</b> 15/01/19</p>
	<p><b>Originator</b> Richard Heath</p>
	<div data-bbox="667 1608 874 1776">
