East West Rail Phase 2

Compound A1: Land north east of Charbridge Lane

Environmental Appraisal Report

Appendix D – Arboricultural Impact Assessment

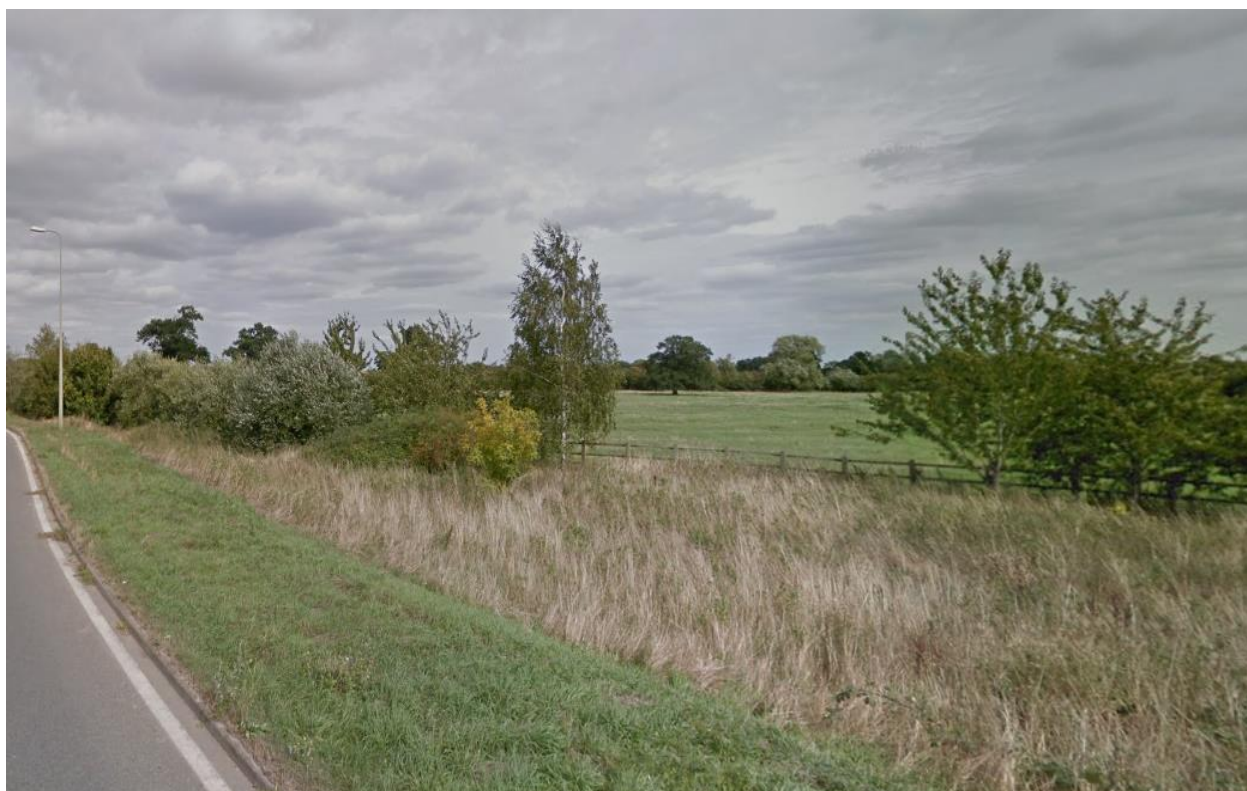
- 3.1.5 G478 lies to the east of Bicester road, and comprises a mixture of planted and self-sown stock. Given the limited size and age of the trees the group is of low quality. Insert 3.1 shows the group, at the point proposed for the access into the compound area.

Insert 3.1: tree group G478. This existing gap being for underground utilities.

4.2.1 The impacts of the work have been assessed, and at present the vegetation removal is limited to part of G351 and G478 to facilitate construction access into the compound and onto the railway corridor.

4.2.2 Tree T194 was identified for potential removal as part of the TWAO but can now be retained as part of the compound works. Similarly, all of tree group G478 was identified for removal as part of the TWAO but now only part removed as part of the compound application.

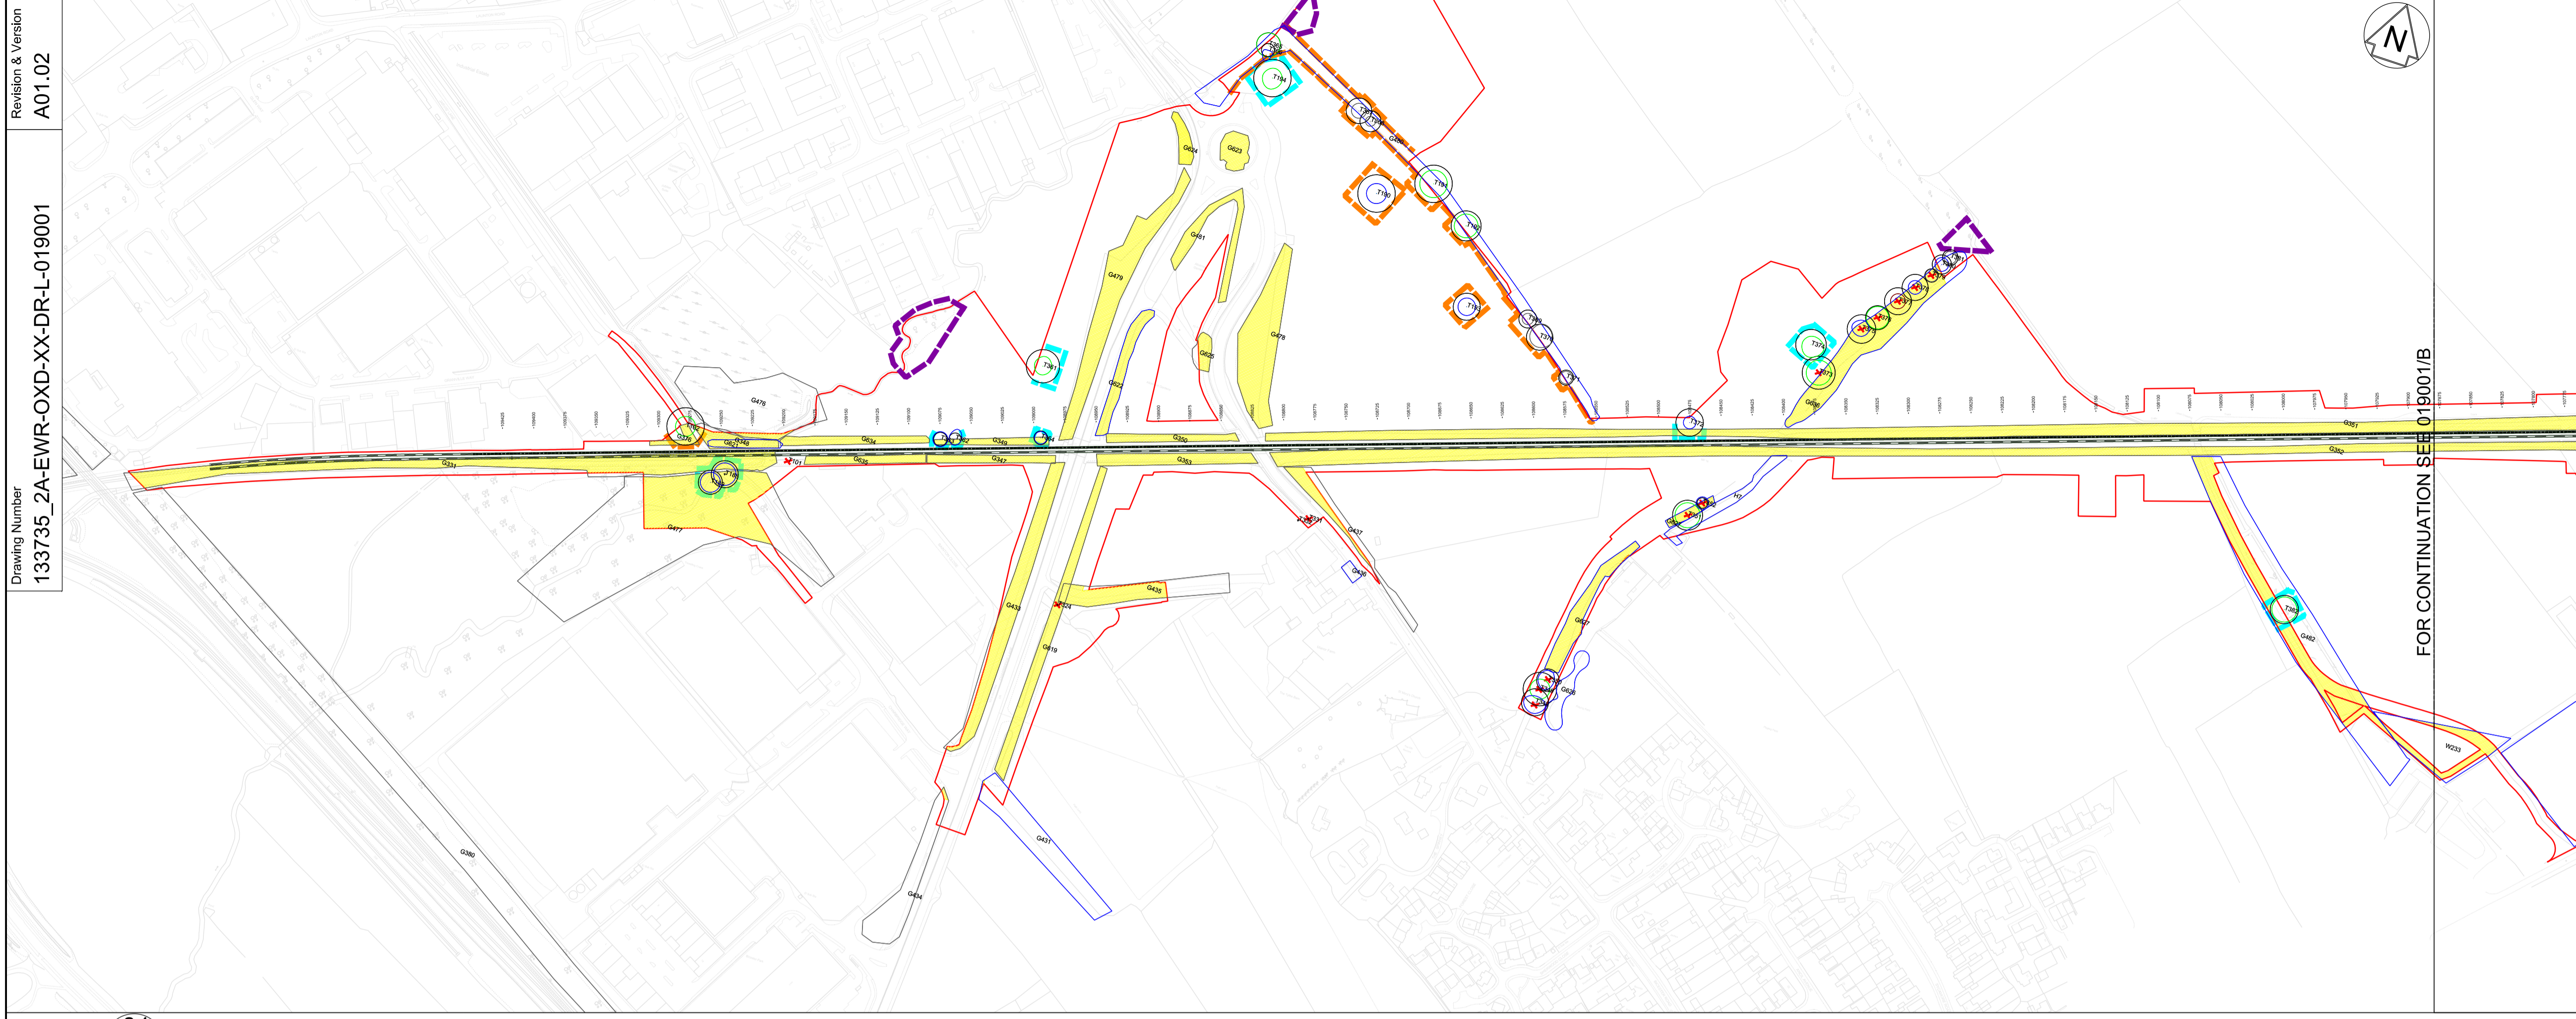
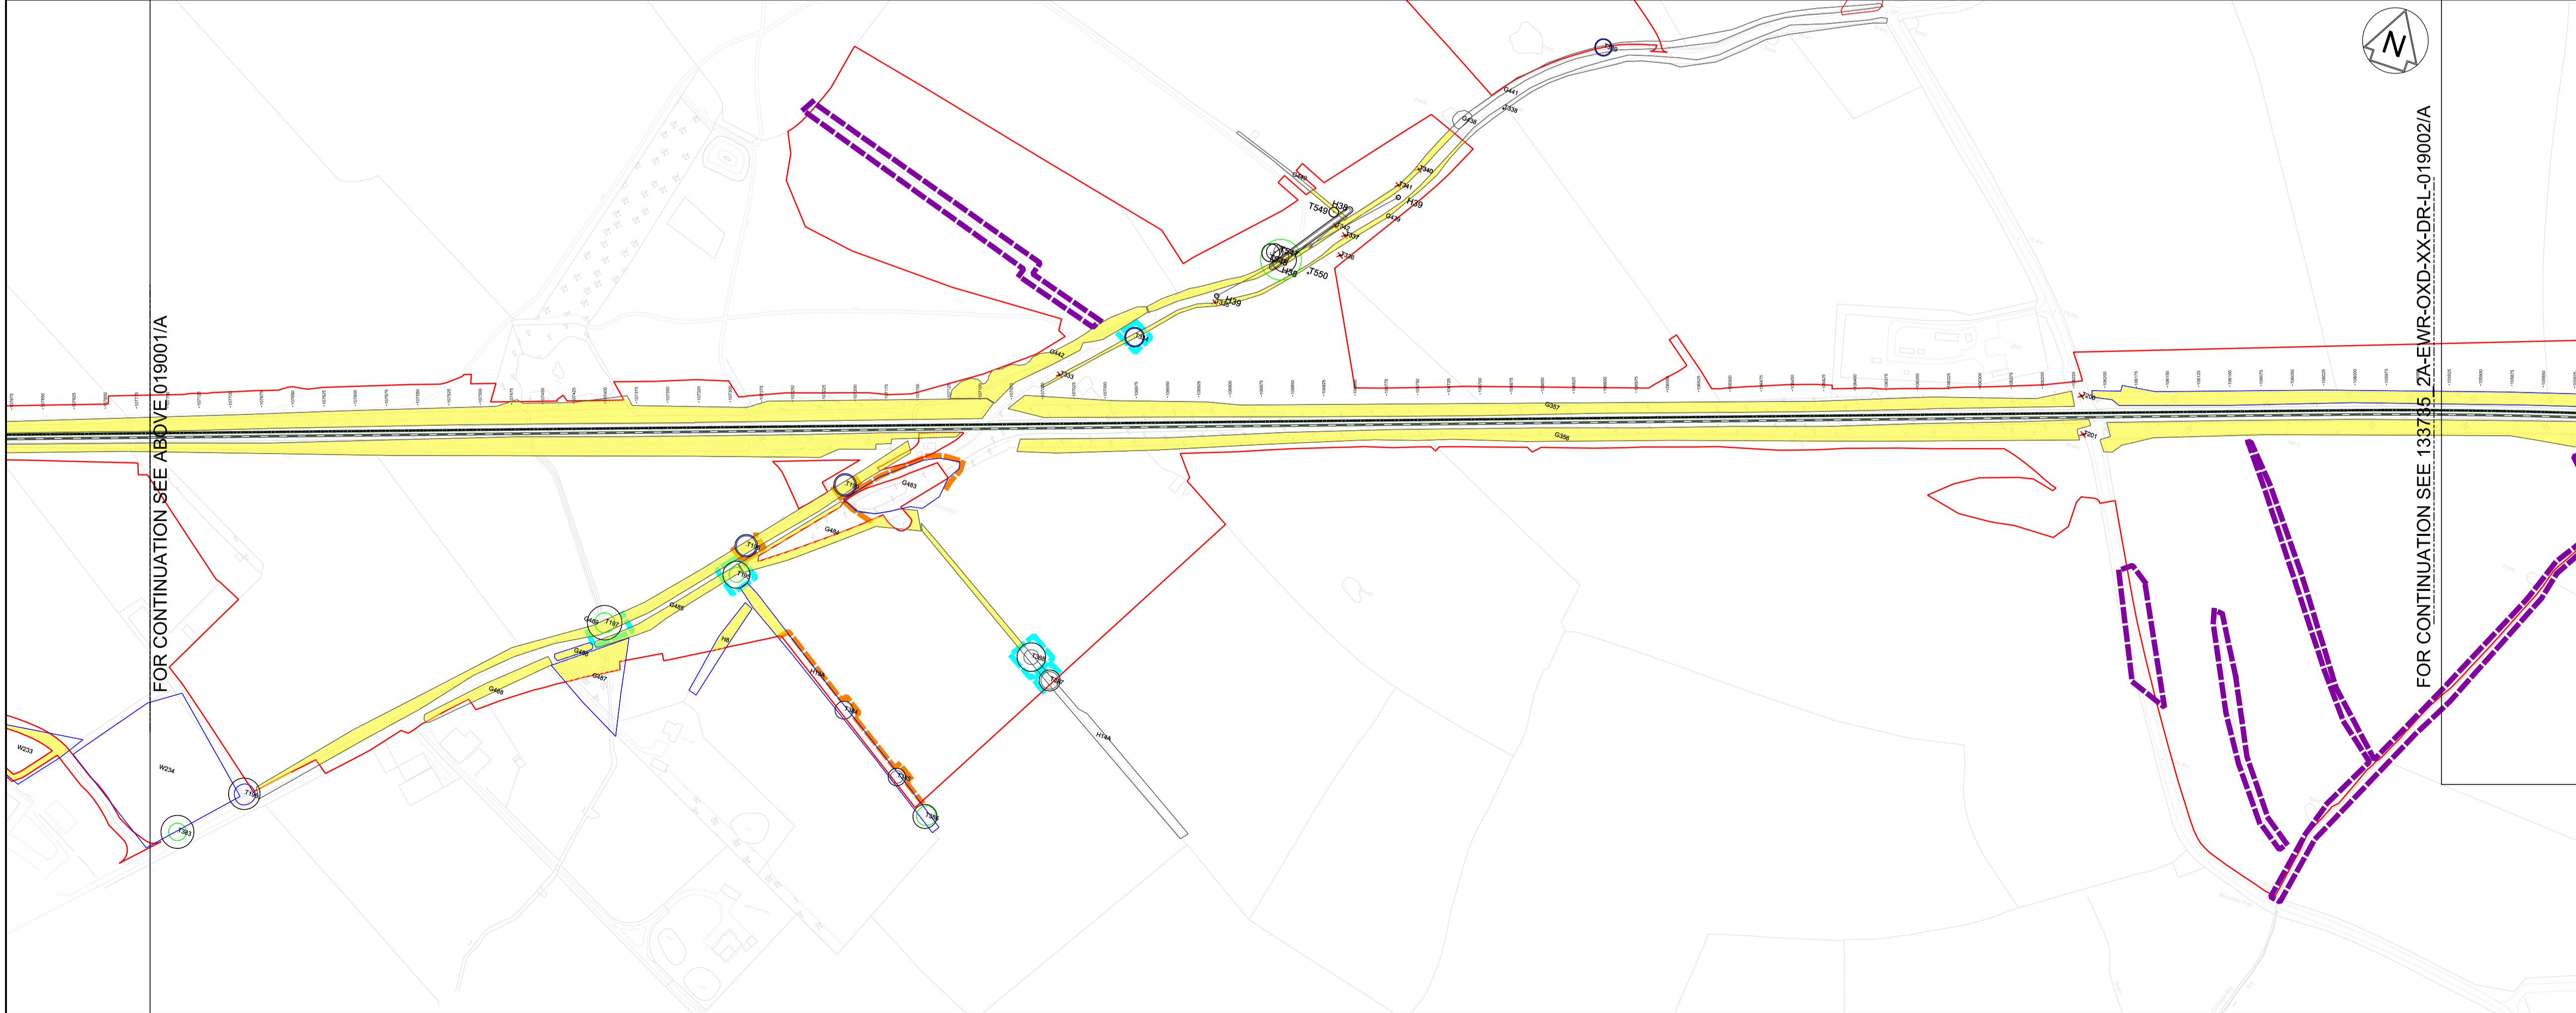
Drawing Title
**TREE PROTECTION PLAN
ROUTE SECTION 2A
SHEET 2**

Appendix C Tree Protection Plan ‘133735_2A-EWR-OXD-XX-DR-L-019001’

- 2.4.5 Where trees have been recorded individually as *BS5837:2012* category A, B or C trees, their crown spreads and root protection areas are illustrated on the accompanying TPP. For the tree groups, the outline of the groups has been plotted using available aerial imagery; however, their root protection areas are omitted. Except where individual trees are plotted as part of groups.

- 4.2.4 The RPAs of the recorded trees have been used to define the compound layout. These areas shall require protection during the works and the provision of site fencing and tree protection fencing will provide this protection.
- 4.2.5 The protection measures are limited at this time to the provision of protective barriers to define construction exclusion zones (CEZs) in the form of a 'heras' type fencing or similar. The location of protective fencing has been illustrated on the TPP. However, as the layout of the compound has been adapted to retain trees in the north and east of the site, the 'A1 Site Design' drawing illustrates the position of compound perimeter fencing and the location of internal fencing to protect those trees inside the compound facility. This plan shall be utilised to confirm the location of the fencing on site.
