# White Post Road, Banbury

Geotechnical and geoenvironmental site assessment

313498-01 (00)

FEBRUARY 2017

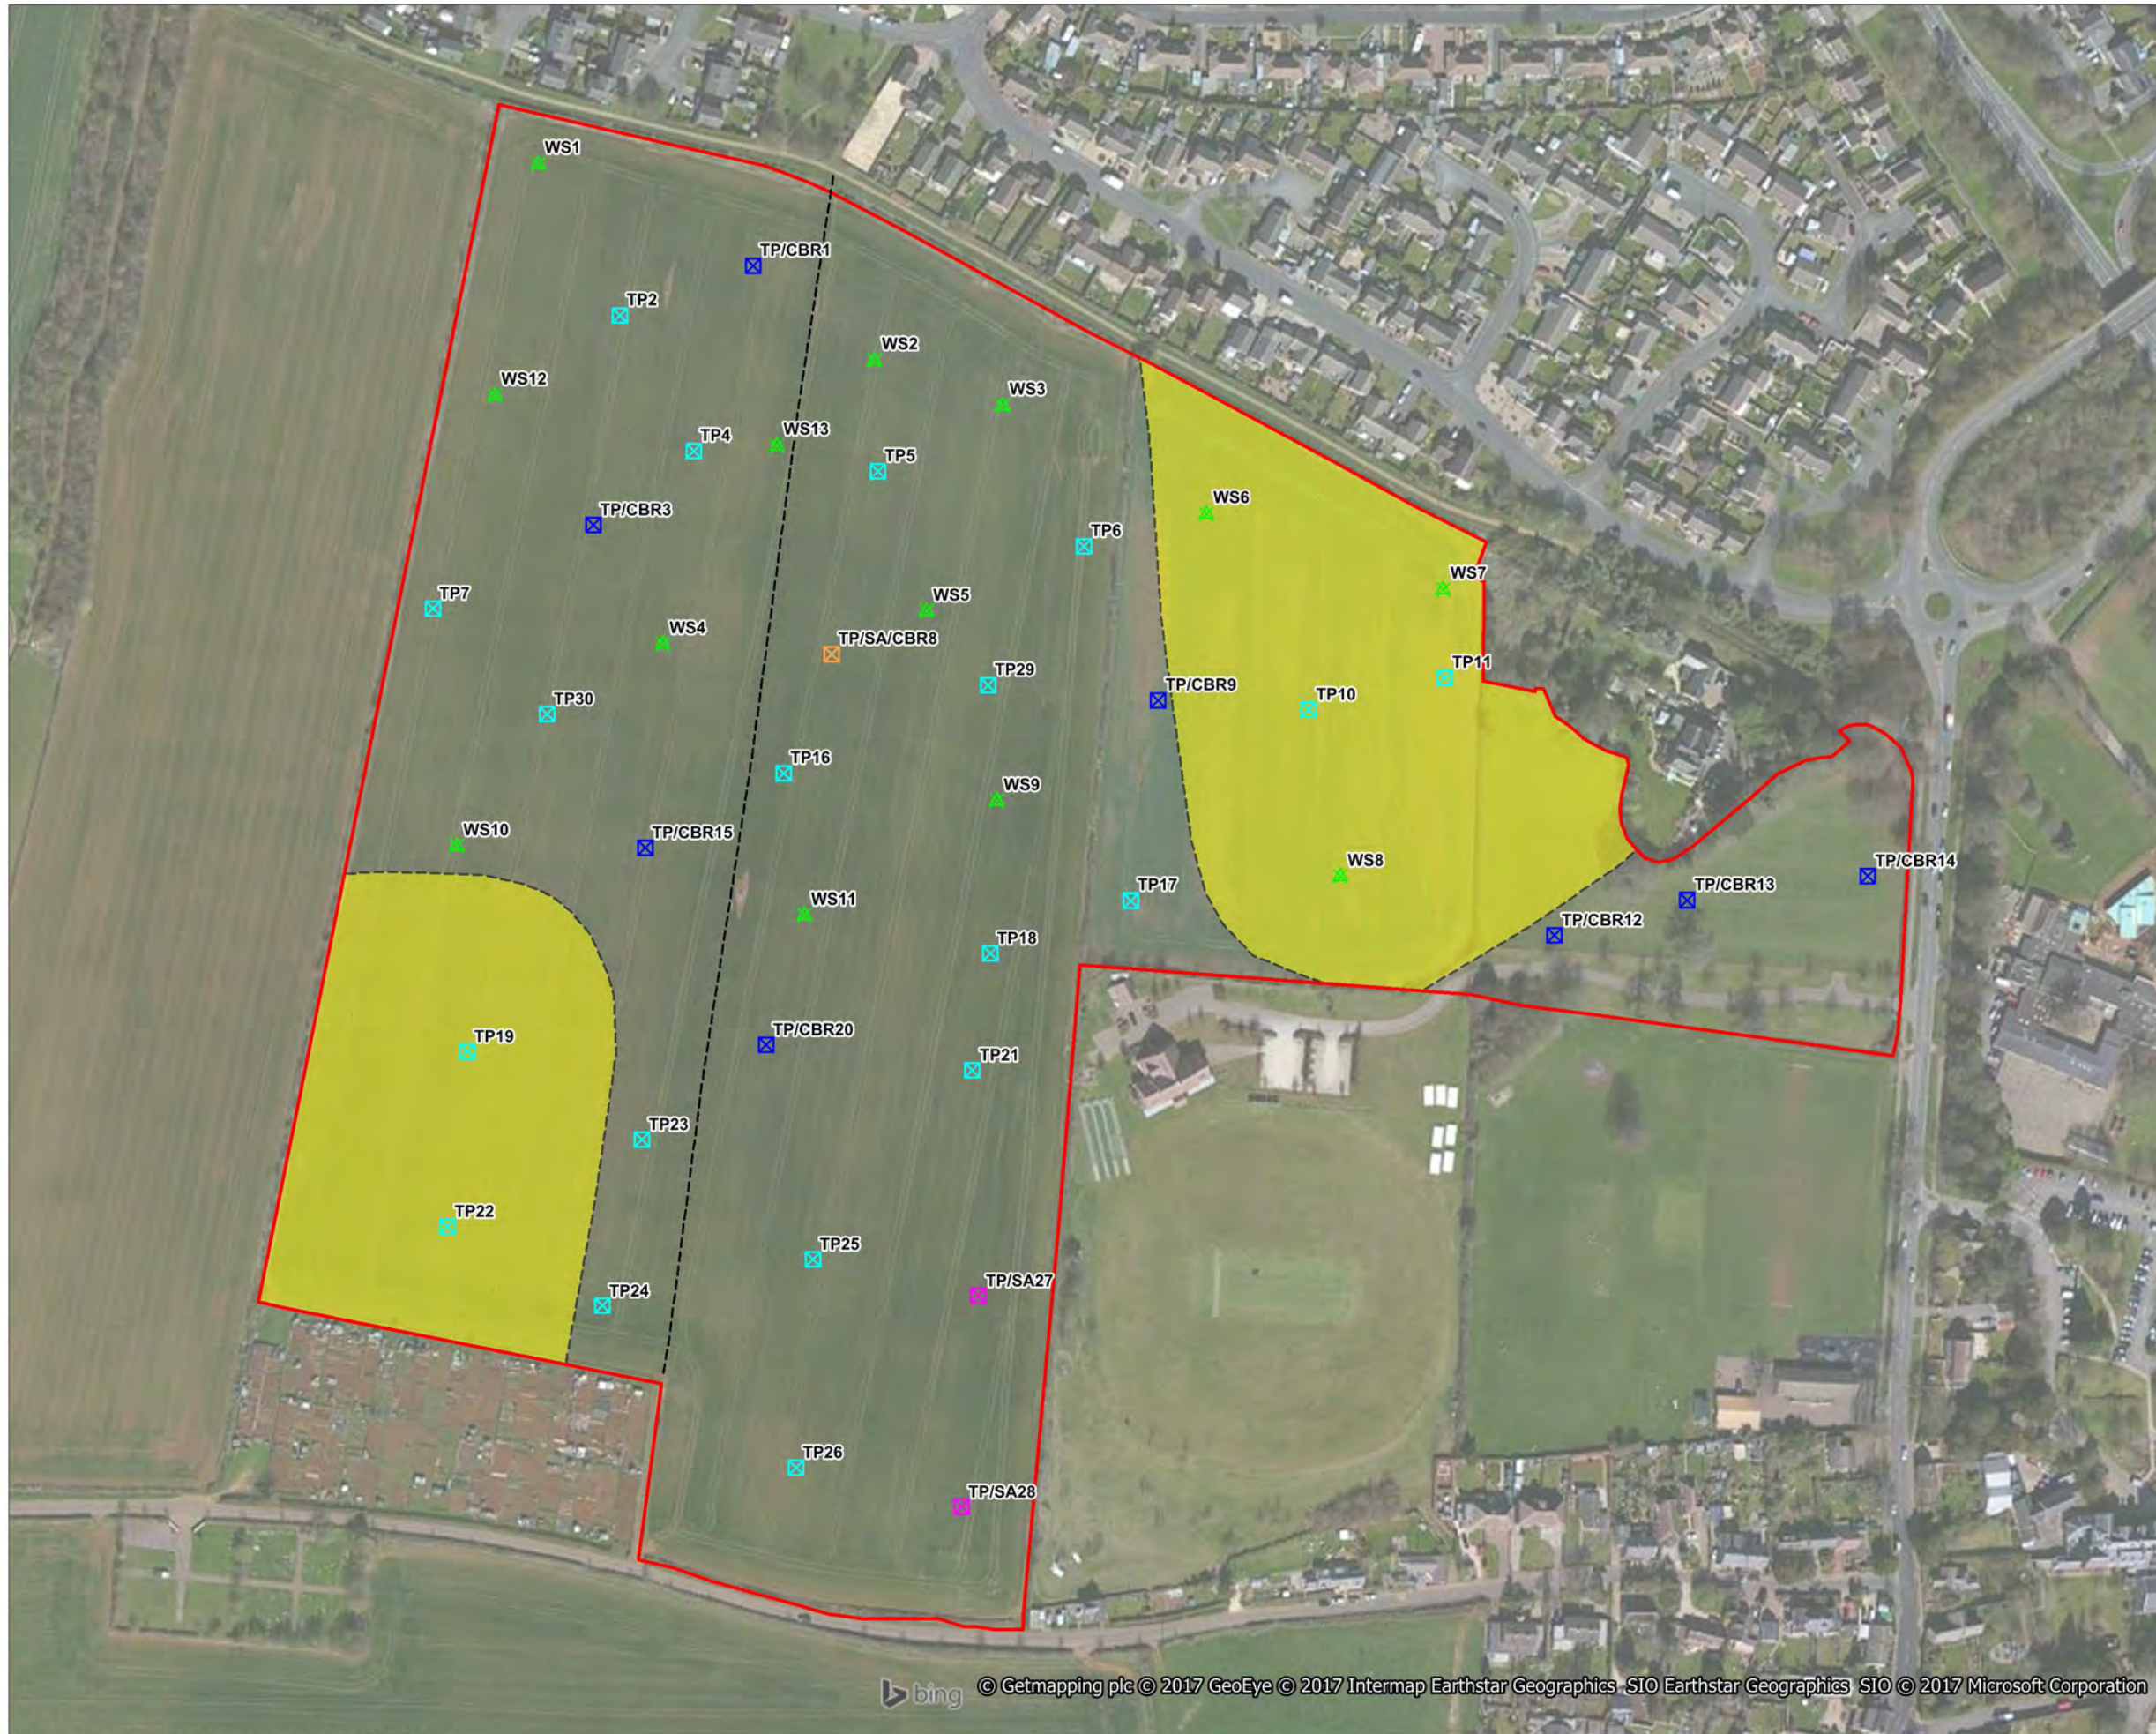
Figure 2  
Exploratory Borehole Plan

- Site boundary
- Window Sample (WS)
- Trial Pit (TP)
- Trial Pit / California Bearing Ratio (TP/CBR)
- Trial Pit / Shell and Auger (TP/SA)
- Trial Pit / Shell and Auger / California Bearing Ratio (TP/SA/CBR)
- Archaeologically Sensitive Area
- Footpath

Trial holes were used to accurately log the soils beneath the site, obtain representative samples for chemical and geotechnical laboratory testing, and to facilitate in-situ testing. Four of the trial pits were selected to undertake soakaway testing, in order to provide information on the infiltration characteristics of the shallow soils.
