Our Ref: 252380-L01 (00)

**RE: WYKHAM LANE, BODICOTE INFILTRATION TESTING**

Wykam Lane, Bodicote

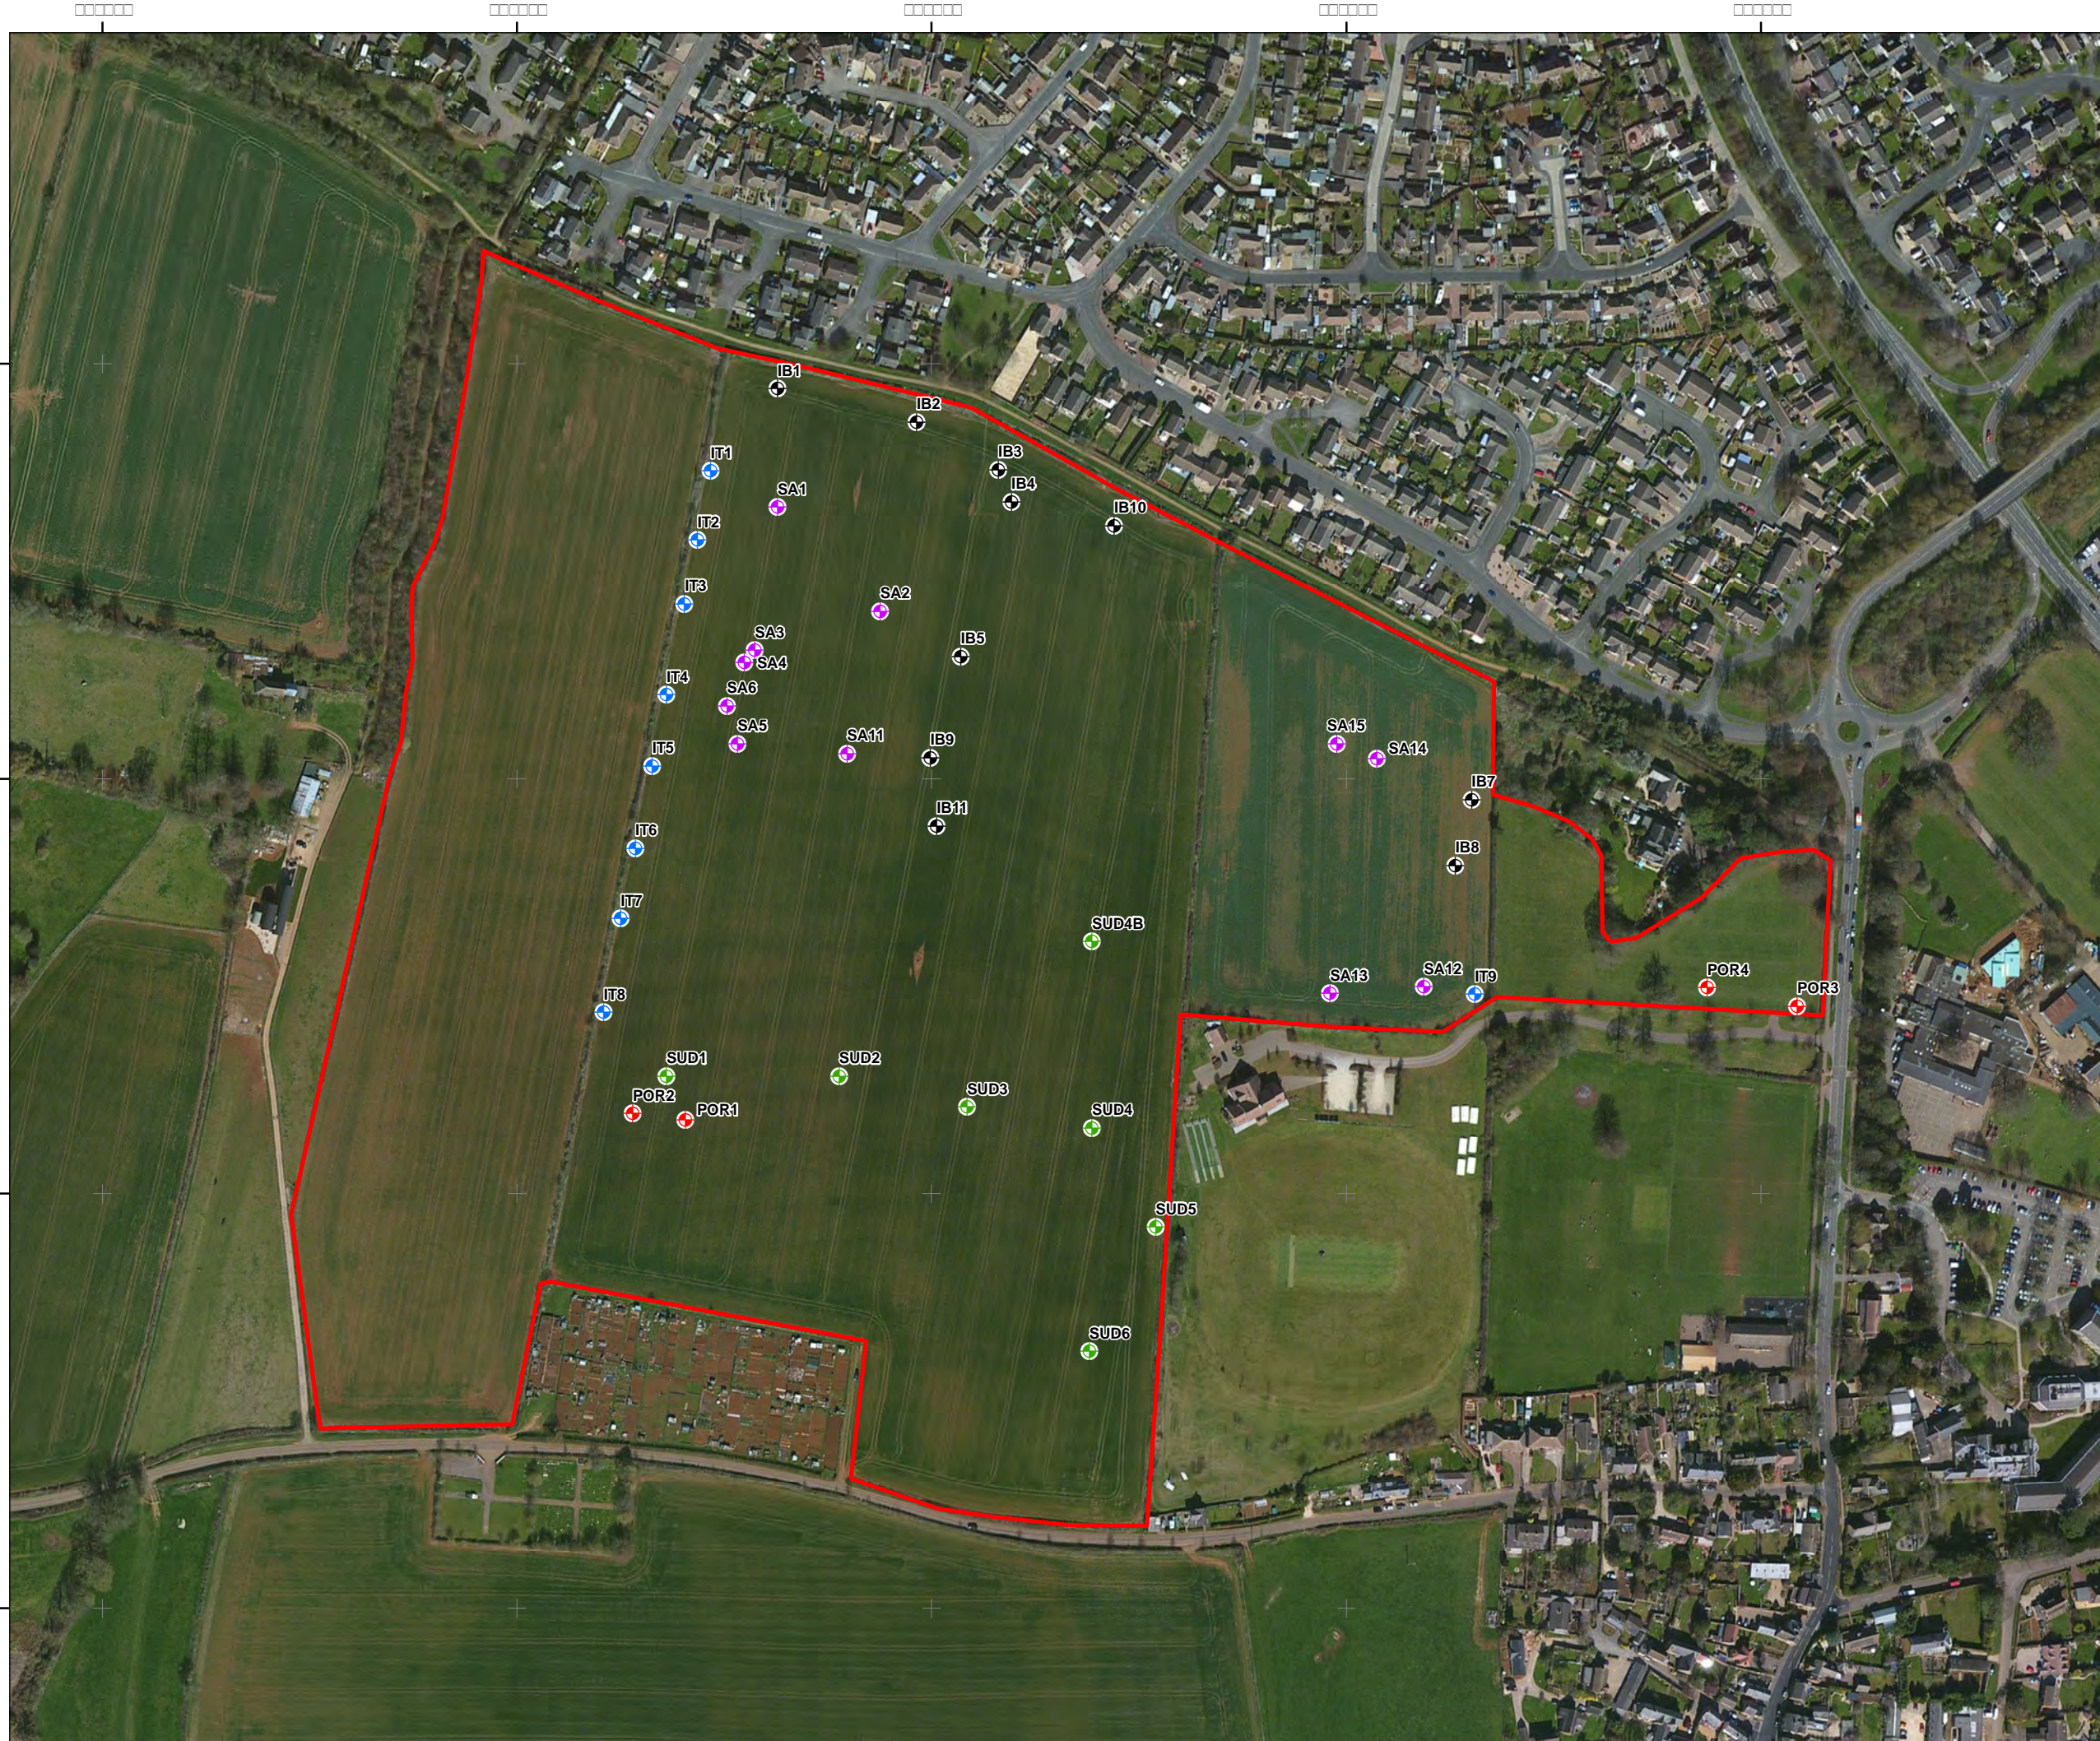
| Figure 2 | Soakaway test location plan |

A plan showing the test locations is presented as Figure 2.
