project: Cedar Lodge, North Side, Steeple Aston OX25 3SE
title: Proposed rebuilding of existing and failing free standing wall

first issue	31.01.2020	checked	djs
scale	various @ A3	drawn	TW
dwg. no.	2018-1014-PL30	rev.	-

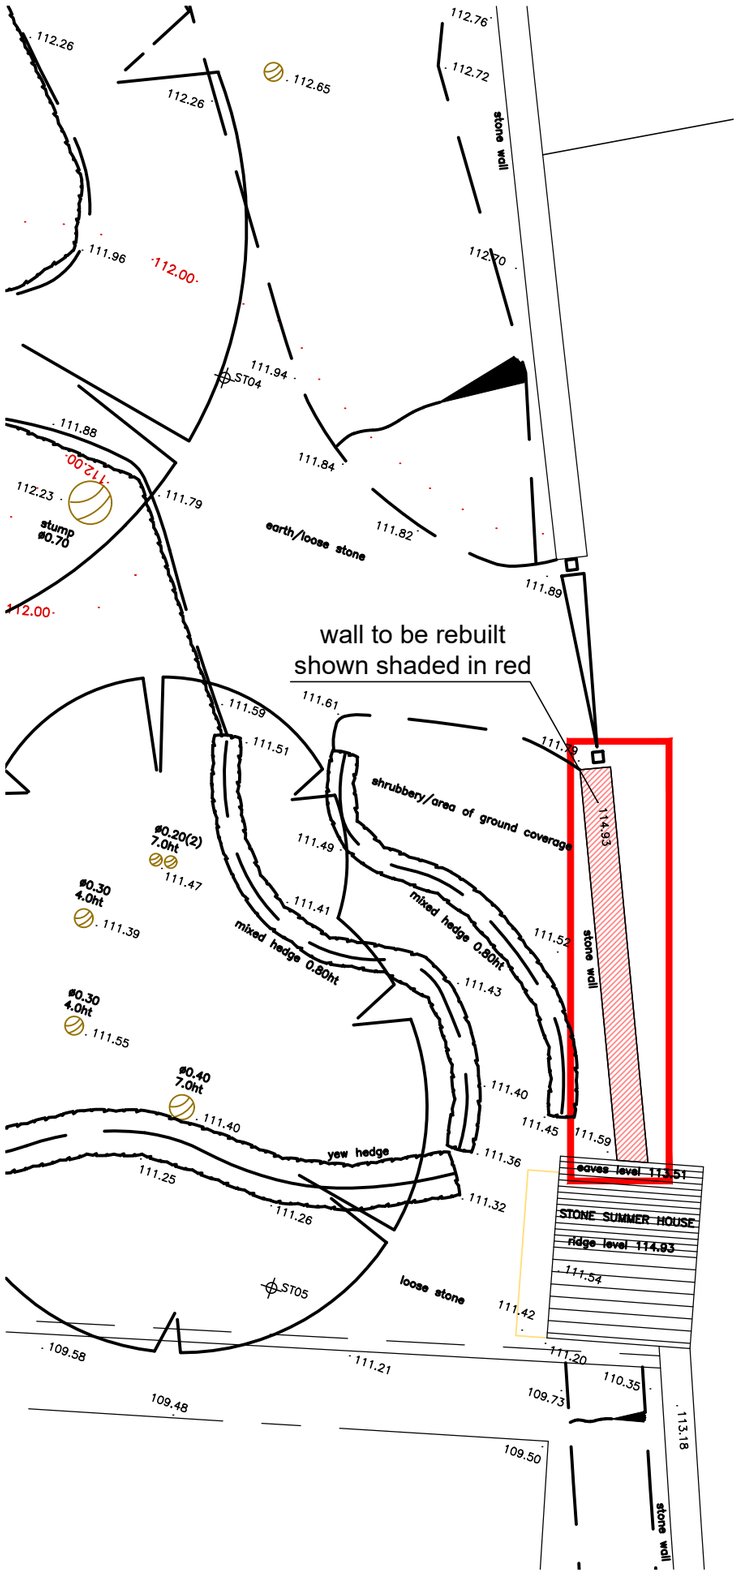
Part Site Survey Block Plan 1:100

Dangerous lean to wall

East face of wall

West face of wall showing failing junction with adjacent summer house

Existing wall to be carefully dismantled with all stone to be set aside for reuse.
New foundations to be formed
Wall rebuilt using set aside stone, slate copings and, lime mortar
