DETECTION SURVEY REPORT

SCALE	1:500 @ A1	DATE	AUGUST 2021
DRAWN	WHS	CHK	NC
DRAWING NO.	16871-7-872	REV	-

TITLE
AIRFIELD, CAMP ROAD
UPPER HEYFORD

DETAILS
PAS 128:2014 UTILITY SURVEY

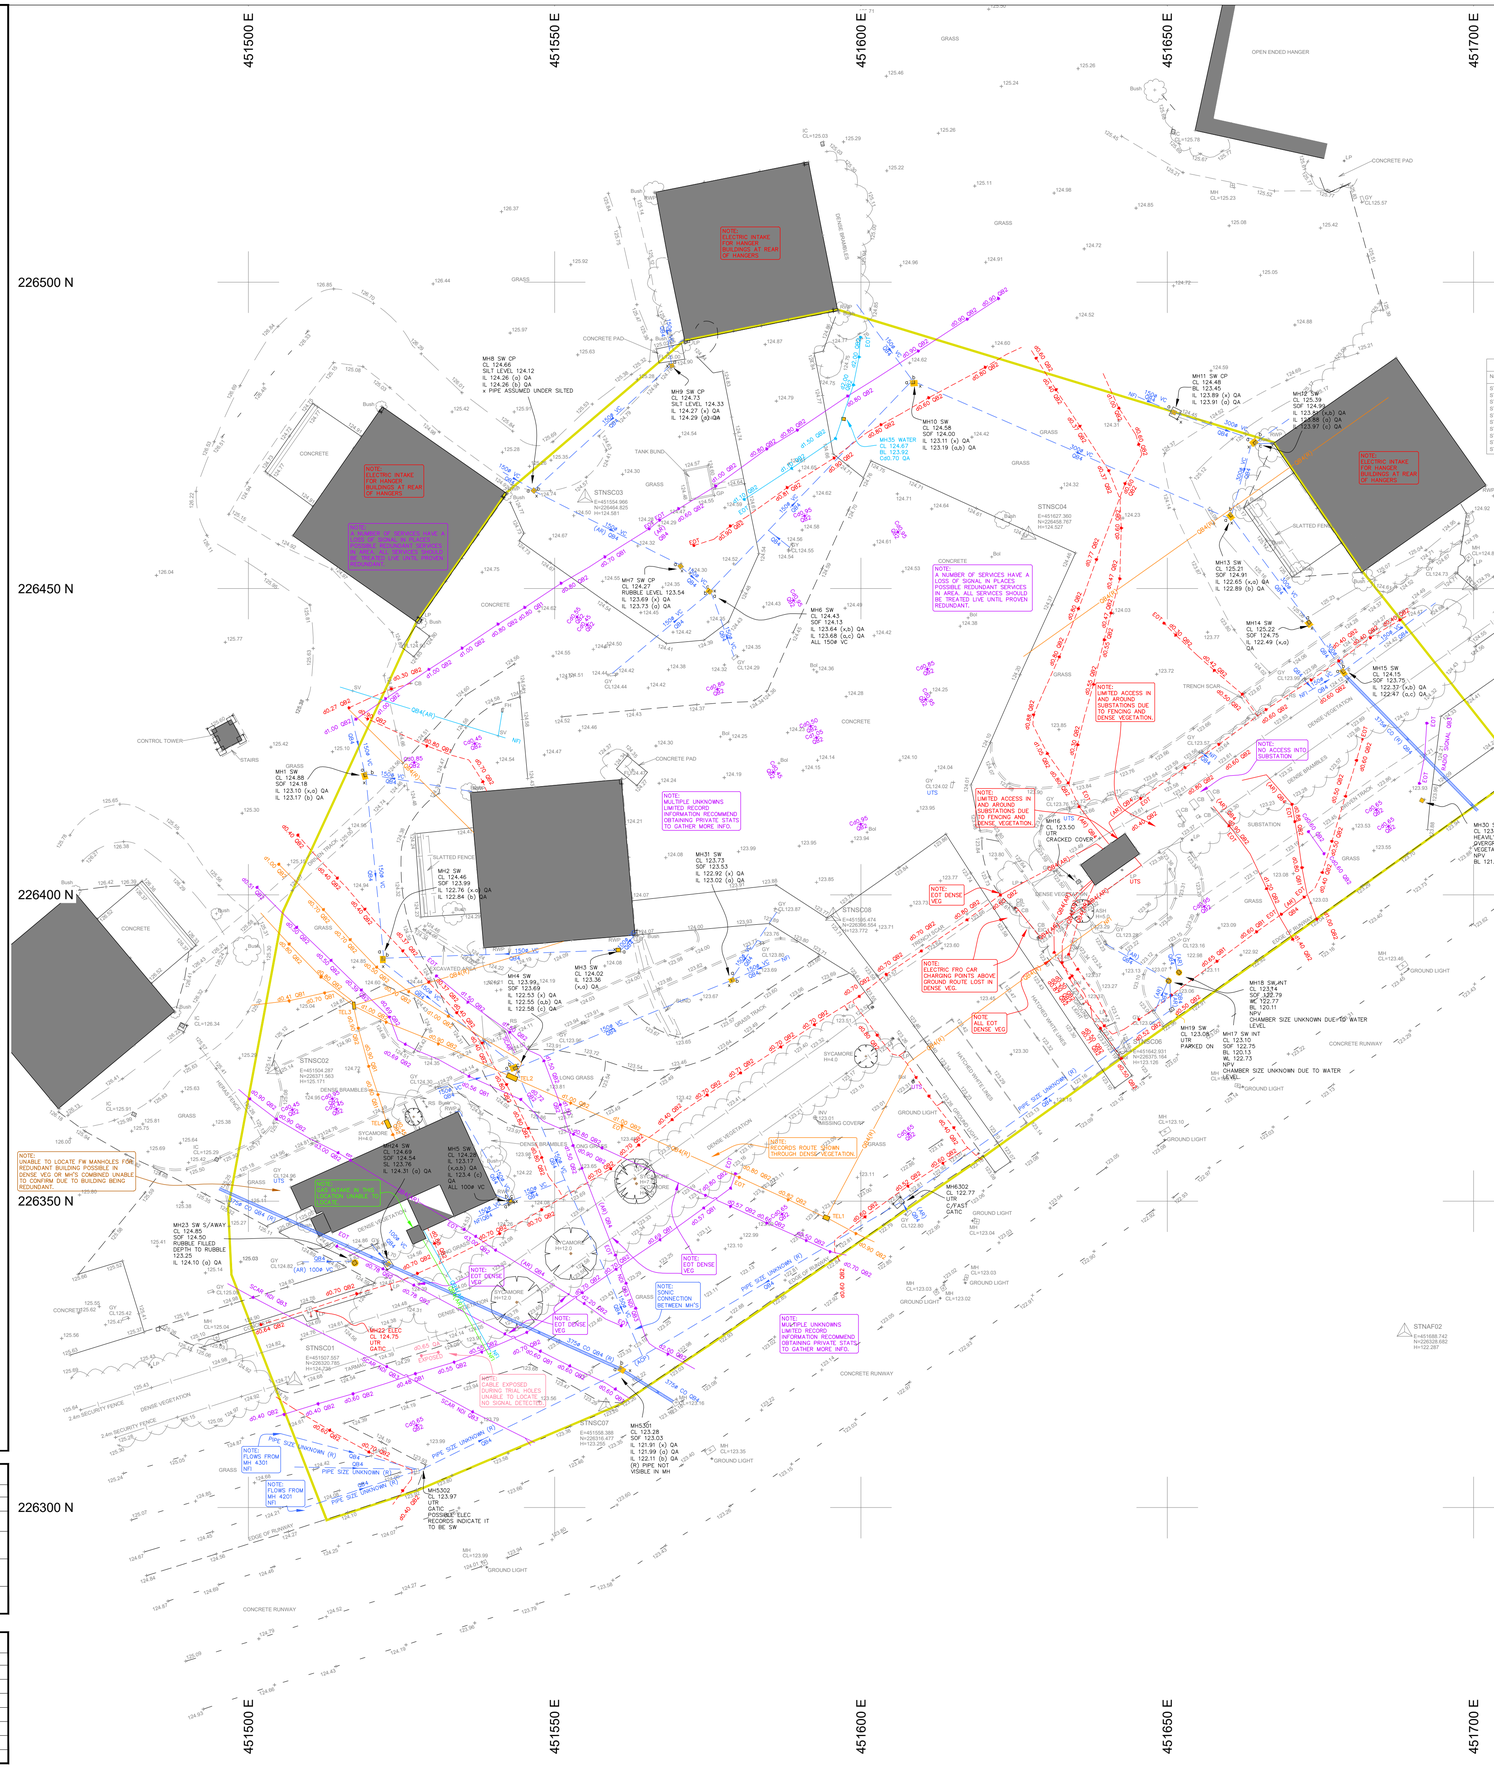
DETECTION SURVEY
DRAINAGE
Drainage was lifted with pipe sizes and invert levels recorded. Wherever possible the chamber sizes have been recorded and positioned on the drawing. All connections from gullies, external rainwater pipes and external soil stacks have been proven wherever possible into manholes and sewer runs by radio sonde location and/or GPR. Where a saddle connection is present the position is assumed only until proven to QB2 or above. In instances where other detection methods were unsuccessful connections between manholes have been assumed to be straight and labelled as QB4. All drainage should be cross checked in critical areas by CCTV survey or verification survey type A. Unable to lift some MH's due to c/fast,damaged or gatic.

WATER
Water utility has been located where possible using EML methods. Thames water records show no private services. Recommend obtaining private stat plans to gather more information on water pipes. Some unknown responses are possibly water services. Recommend trial excavations in critical areas to confirm position and depth of pipes.

GAS
No gas network located. Unable to locate gas for redundant building due to no EML signal and dense vegetation to conduct GPR scans. Gas records show no private gas pipes within survey area. Recommend obtaining private stat plans to gather more information. Some unknown responses are possibly gas services. Recommend trial excavations in critical areas around gas intake for building to confirm route of service.

ELECTRICITY
Electric cables have been located using EML methods with electronically derived depth recorded. Electric records show no private cables recommend obtaining private records to gather more information. HV and LV cables have been identified only from depth and route. Unable to confirm for certain which is HV and LV. Recommend trial excavations in critical areas to confirm position and depth of cables.

TELECOM
Telecom ducts have been traced with depths recorded. Due to laws protecting British Telecom apparatus all ducts have been located using remote detection techniques only and compared with record information. Chamber sizes have been recorded using GPR techniques wherever possible. For further information regarding BT apparatus please contact Openreach directly.

CATV
No CATV or communications ducts located within survey area recommend obtaining records to confirm this.

UNKNOWNS
Some unknown targets identified on the drawing using GPR are classified as "non-linear targets". These are not consistent with what we expect to see when identifying a buried utility, and appear on the drawing as single targets with depths (i.e. not linking two or more depth readings). This does not mean they are not utilities, we are just unable to positively identify them as a utility. We would strongly recommend that further verification surveys (PAS 128:2014 survey type A) are carried out to identify these targets in critical areas. Many unknowns located using EML methods recommend obtaining private stats to better identity services possible fuel lines in survey area.
