BS 5837:2012 Arboricultural Survey

Banbury 200, Southam Road, Banbury

Issued: January 2021

Delta-Simons Project No. 20-1787.01

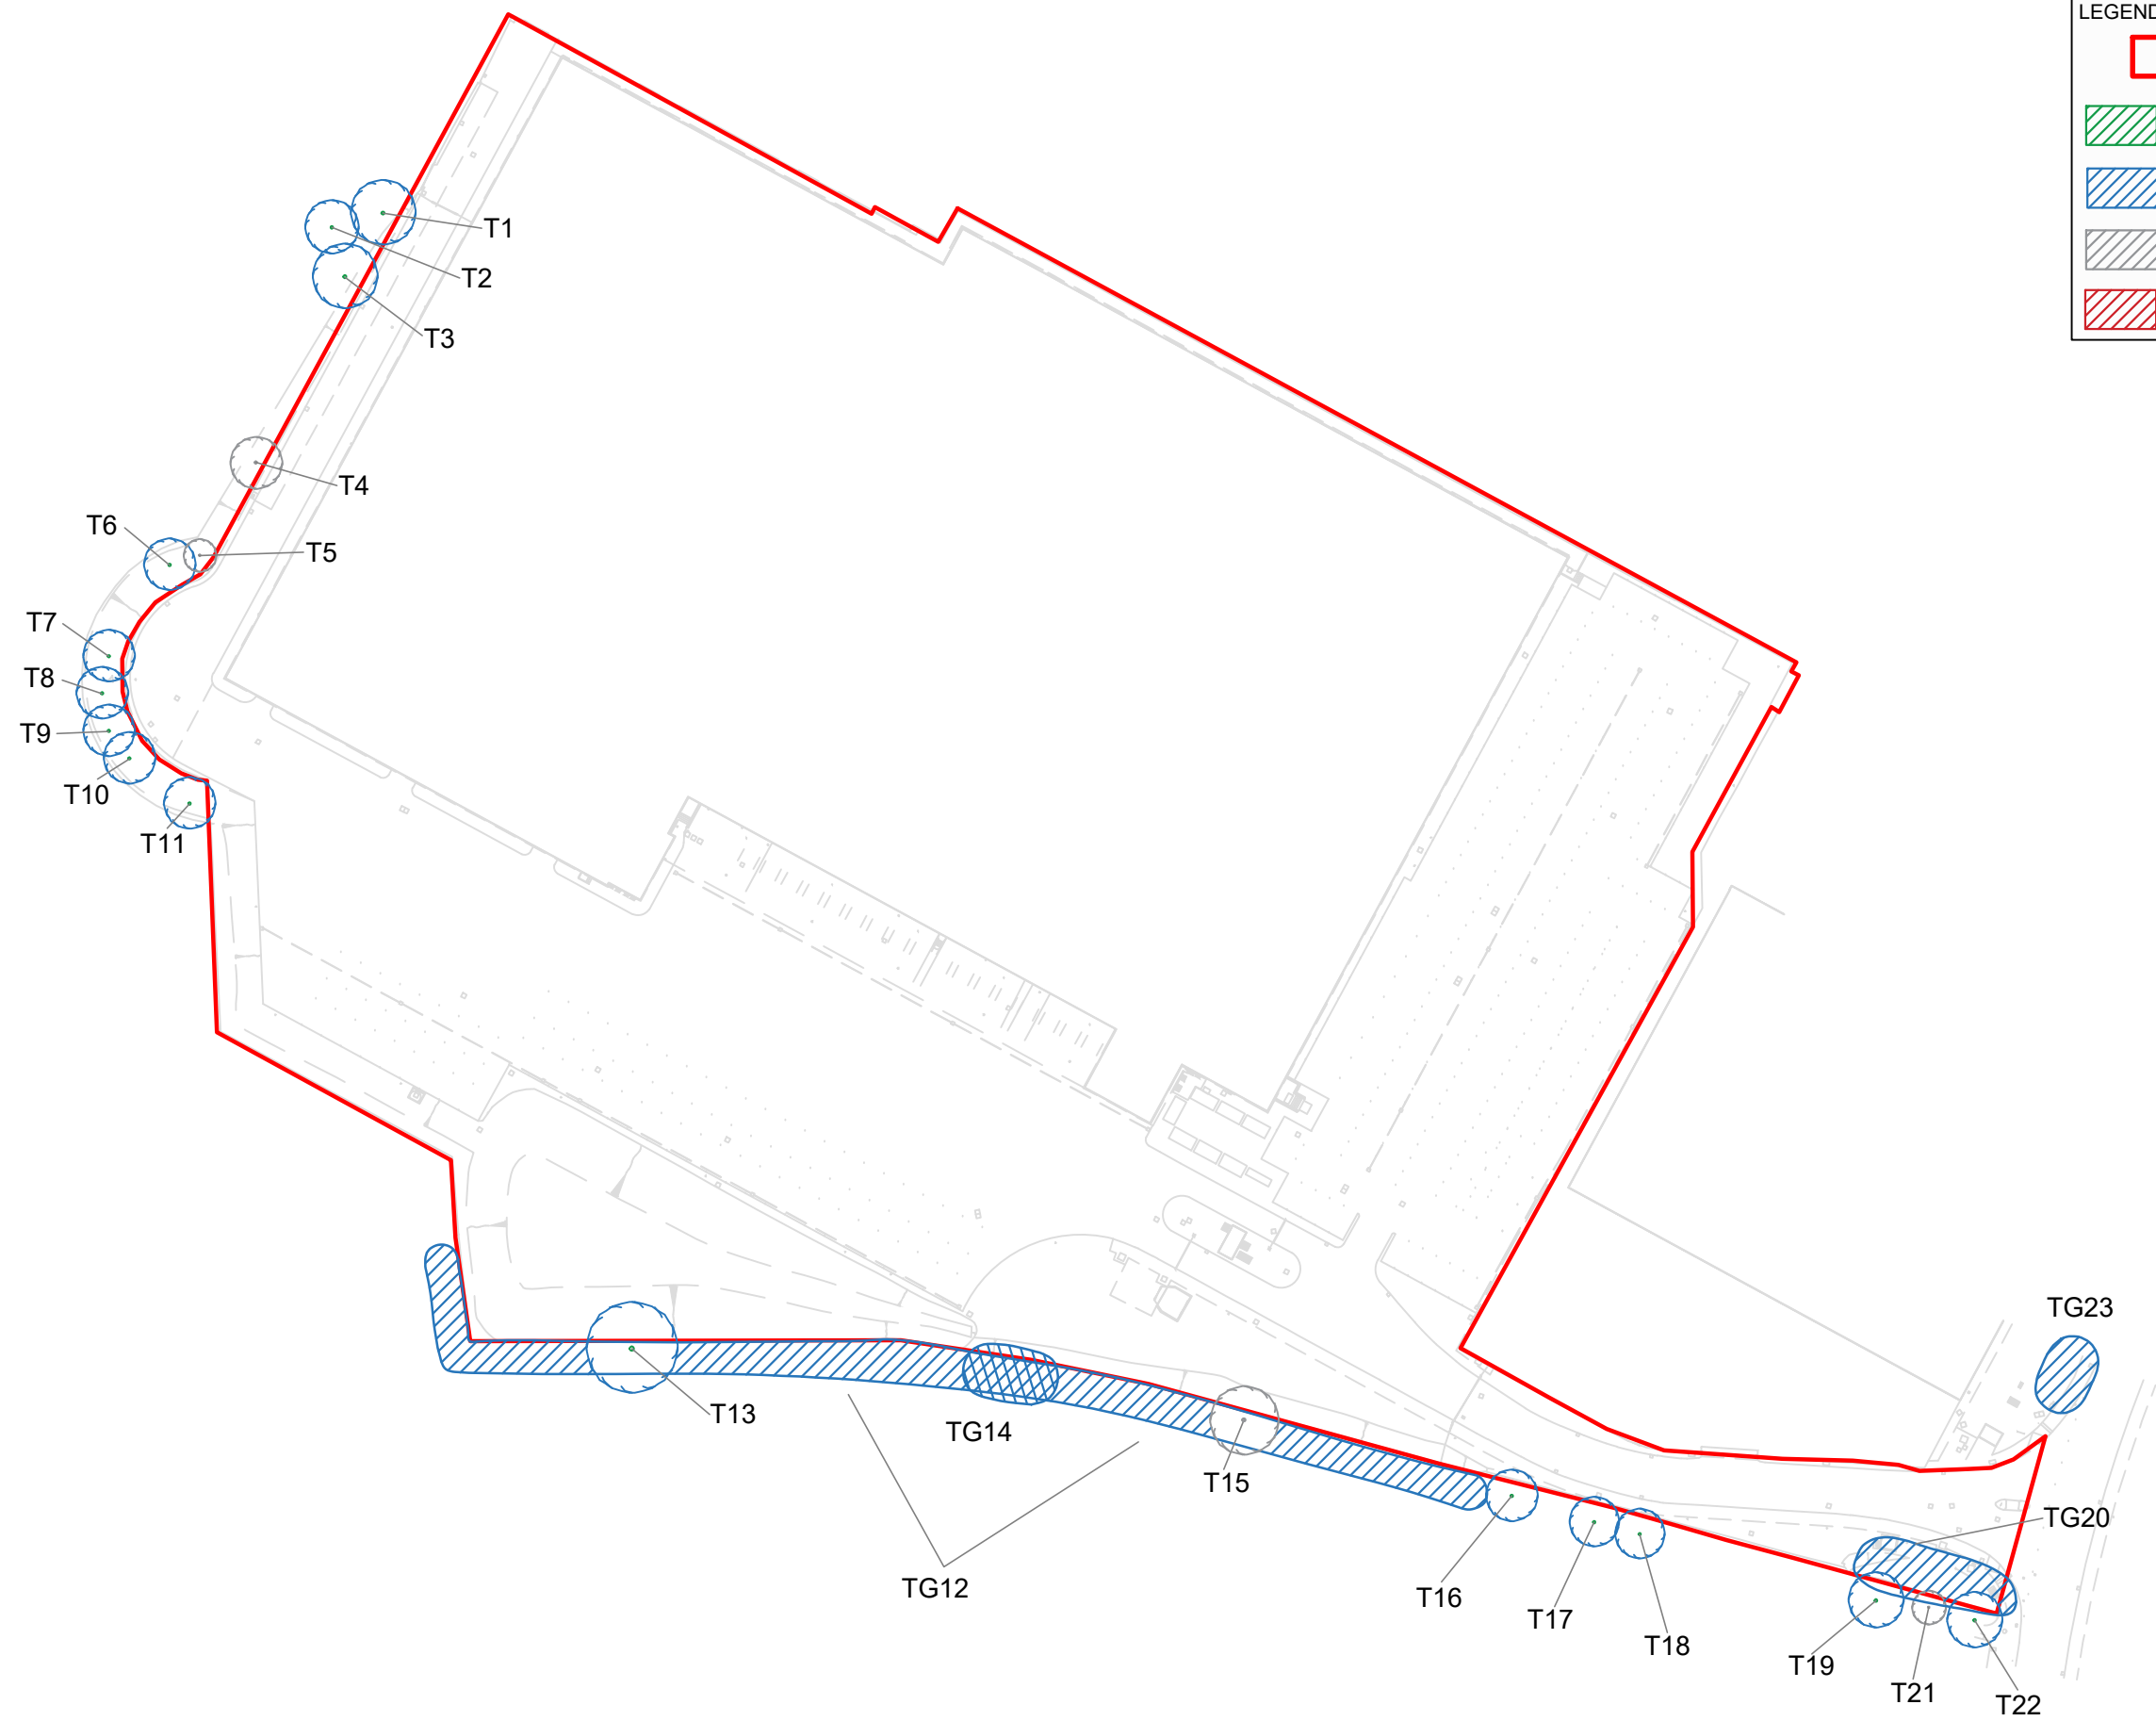
Figure 2 – Tree Survey

The extent and positions of significant individual trees or groups of trees close to the Site are shown on the Arboricultural Survey Plan (Figure 2). The Root Protection Areas (RPA) of the key trees of value identified for, or recommended for retention have been marked within the Constraints Plan (Figure 3) using the RPAs provided in the Tree Schedule within Table 1.

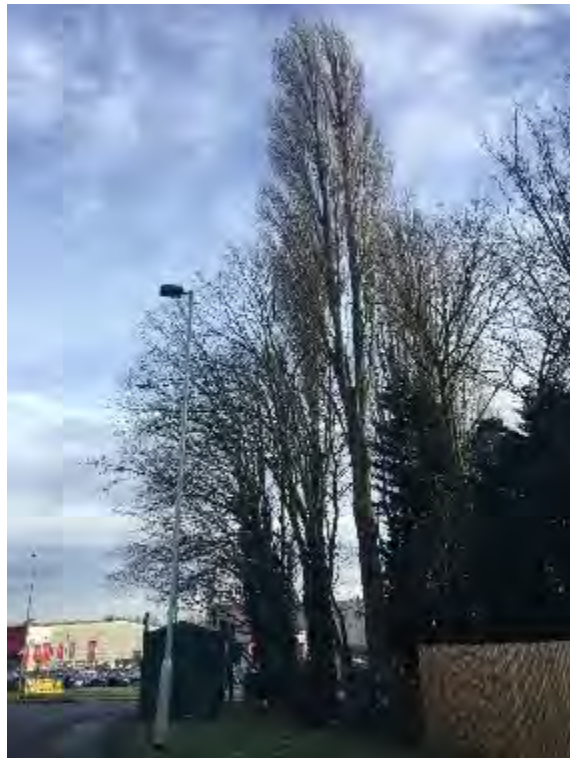
Photograph 178– TG20

It appears no management has taken place to the trees present on-Site, although, trees to the south have previously been crown lifted over the footpath and ivy has been severed on a small number of trees. Ivy is beginning to extend up the stems of TG20 and this should be controlled to prevent it taking over. To ensure that the root areas and canopy extremities of the individual trees and the tree groups that may be retained are not damaged, a Constraints Plan has been prepared to show the locations where protective fencing should be erected for any trees selected for retention (see Figure 3). Any tree surgery required is best carried out towards the conclusion of the development so that, if necessary, any known root damage can be corrected by the appropriate crown thinning to restore root /shoot balance.
