BS 5837:2012 Tree Survey

Banbury 200 Site, Southam Road, Banbury, OX16 3AE

Issued: October 2021

Delta-Simons Project No. 21-1553.02

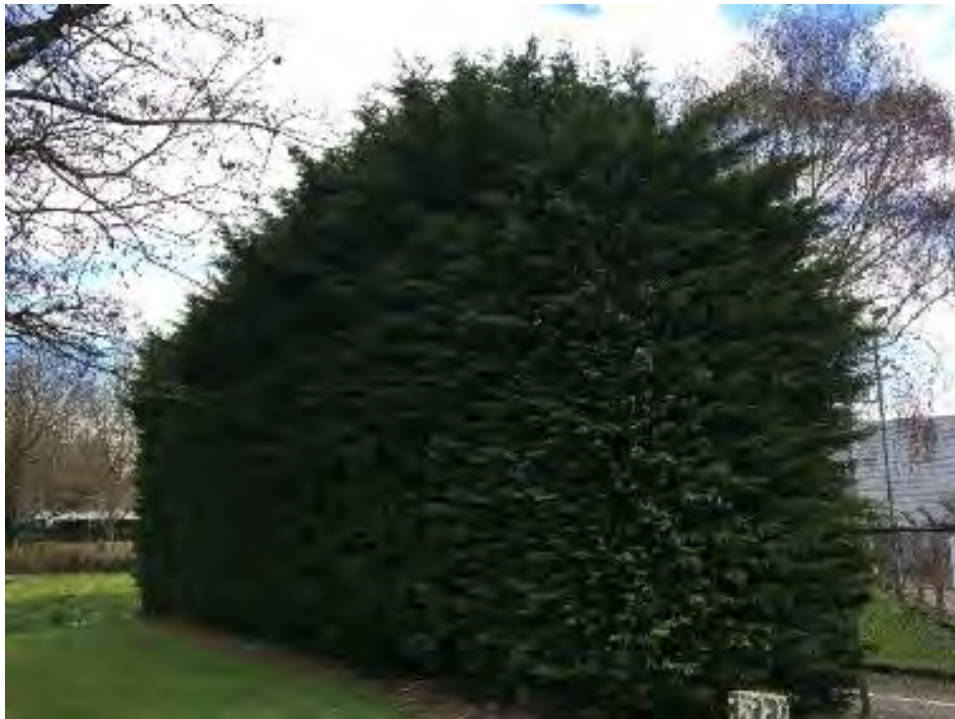
Photograph 26 – TG30

Previous tree management on-Site includes crown lifting to T36, T37, T22, T31, T32 and T33 to provide clearance beneath and also the cutting back of TG30 to prevent obstructing the footpath. Ivy is beginning to extend up the stems of TG2 and this should be controlled to prevent it taking over, whilst the fallen cherry in TG26 should be removed. To ensure that the root areas and canopy extremities of the individual trees and the tree groups that may be retained are not damaged, a Constraints Plan has been prepared to show the locations where protective fencing should be erected for any trees selected for retention (see Figure 3). Any tree surgery required is best carried out towards the conclusion of the development so that, if necessary, any known root damage can be corrected by the appropriate crown thinning to restore root / shoot balance.
