Report On Field visit to South West Bicester: Pingle Brook

Project No: 11011546

Date: June 23, 2006

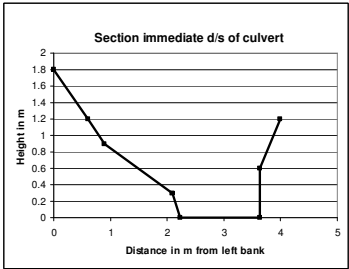
<p>Brook d/s of culvert (Looking u/s)</p>	<p>Brook d/s of Culvert on Oxford Road:</p> <ul style="list-style-type: none"> ○ Brook cross section downstream of the culvert on the Oxford Road is different than u/s. ○ Immediate d/s of the culvert the section is shown.
