Structural Report

Burdrop Farm House, Burdrop

Oxfordshire, OX15 5RN

October 2019

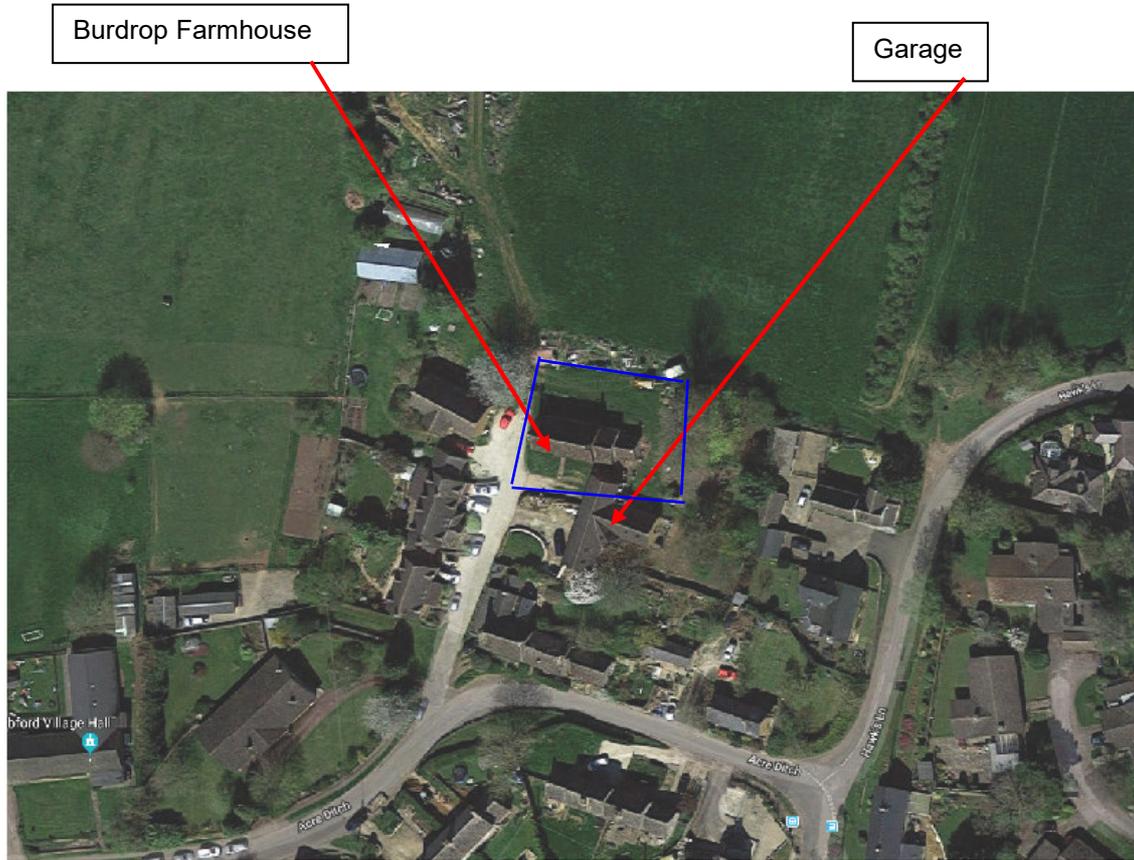
The property is sited towards the northern limit of Burdrop which is a small village contiguous with Sibford Ferris and Sibford Gower. There is open land to the rear (north) side but other buildings are located to the south

The main (part) three-storey building is indicated in the centre of the view above but its garage is part of a recently constructed new building to the south which also includes a separate house.

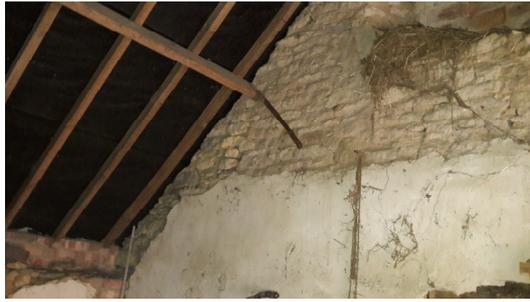
The intermediate height section was built with an externally accessed upper level via a short set of steps with an undercroft. The first floor is a recent replacement and the upper level is plastered to above eaves level, as shown below, suggesting a former ceiling at this level.

The original floor level is not known (probably lower) but it is quite likely that this space was used for storage possibly with animals kept below.

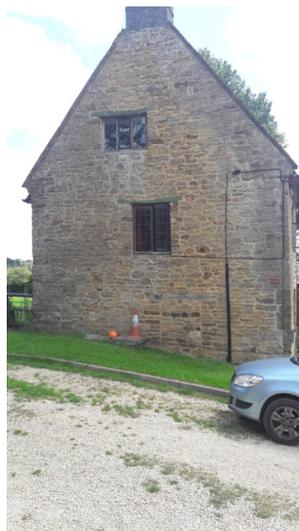
Many internal changes have been made to floors, partitions and stairs since this period. The current stair arrangement is clearly relatively modern and there must once have been two staircases to suit the two cottages. A former door opening can be seen in the west elevation as shown in the photograph below.

It is assumed that this dates from the use of the building as two cottages and that the ground level at this doorway was once lower. The raised ground at the western end is a potential source of dampness and this is discussed below.

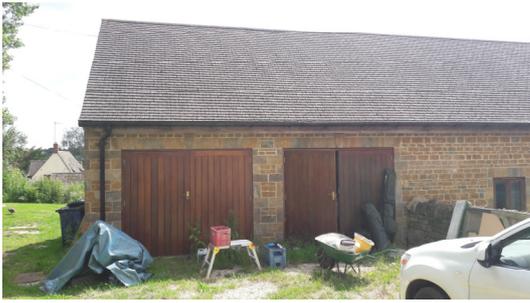
These garages are constructed with modern 'split and tumbled' ironstone facing, as shown above left and a concrete blockwork inner leaf as shown above right. The plain tile roof covering incorporates a modern breathable roof felt and is supported on a 'cut' timber roof of rafters and purlins.
