HIGHWAY CONDITION SURVEY, CAMP ROAD

20/02730//DISC-Heyford Park

Heyford Park, Camp Road, Upper Heyford, Bicester

Dorchester Living Limited

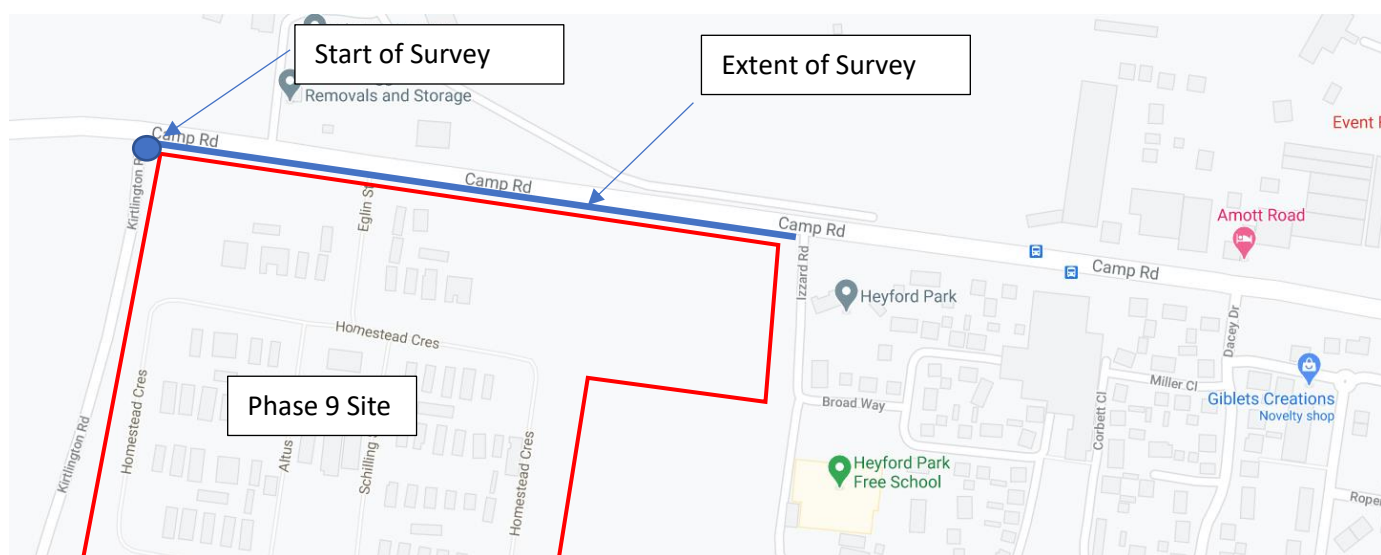
Figure 1

The start of the survey was from the junction between Kirtlington Road and Camp Road looking east and photographs were taken up to Izzard Road.
