PROJECT: BARTLETT COTTAGE, SIBFORD GOWERS, OS 15 5RY

## 4.0 Proposed Works

### 4.01 Restoration Works - Roof Works & Chimneys

With reference to Allcott Residential Building Survey (Level 3) conducted on 2 SEP 2020 and the accompanying plans.

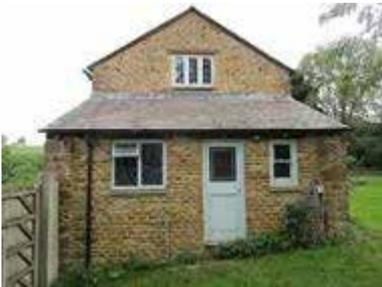
Existing South West Elevation

6 The timber window at first floor level is in a dilapidated state. The proposal is to replace with new double-glazed metal frame windows to match the existing with slim mullions and metal glazing bars, set in a fixed timber surround frame.

7 The ground floor windows are in a dilapidated state. The proposal is to replace with new double-glazed metal frame windows to match the existing with slim mullions and metal glazing bars, set in a fixed timber surround frame.

8 There is some slight cracking to the left and right hand sides of this elevation at the lowest point of the roof line most likely as result of light roof spread. As part of re-pointing works , crack stitching is proposed in order to tie the stone quoins to the main stone wall.

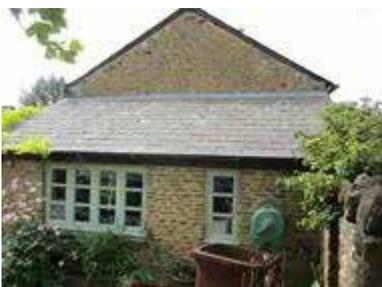
Existing North East Elevation

8 The windows are in a dilapidated state. The proposal is to replace with new double-glazed metal frame windows to match the existing with slim mullions and metal glazing bars, set in a fixed timber surround frame matching to existing.

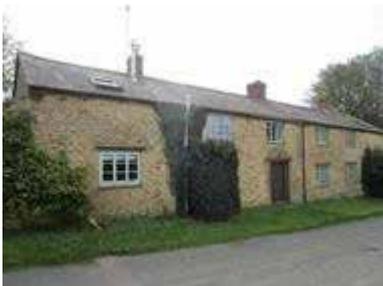
Existing North West Elevation

9 The timber window at ground and first floor level are in a dilapidated state. The proposal is to replace with new double-glazed metal frame windows to match the existing with slim mullions and metal glazing bars, set in a fixed timber surround frame.

10 The lintels above the first floor windows have clearly suffered with some decay and deterioration over the life of the building however in large part they appear original and at this stage no failure is noted. However where more significant deterioration is noted particularly to the right hand side of this elevation.
