## **Health Hub, Bicester**

### **Review of Walking & Cycling Routes in Bicester**

February 2021

**Client Name:** Apollo  
**Document Reference:** WIE16470-R-1-1-1-Walking & Cycling Routes  
**Project Number:** WIE16470

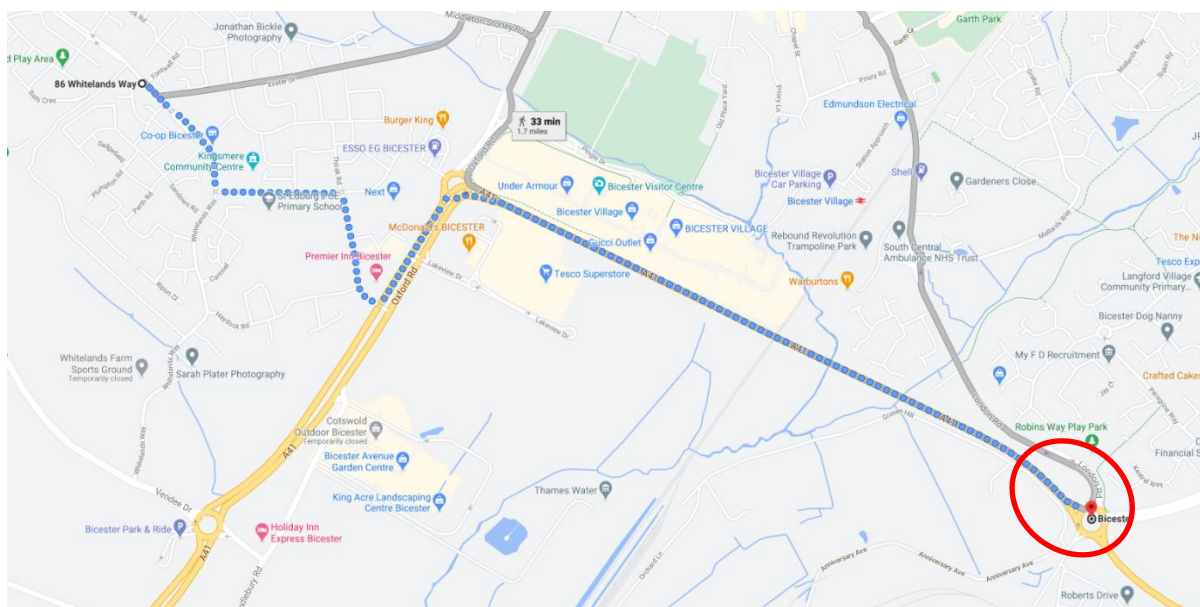
Figure 1: Route 1 - A41 Roundabout to 86 Whitelands Way (Proposed)

The area in **Figure 1**, highlighted by a red circle, was the only area that could be assessed. It should be noted that this area was of a good condition, with crossings available around the roundabout.

Along the section of the A41 that was assessed, there was a footway on the northern kerb only, no footpath was available on the southern kerb line.

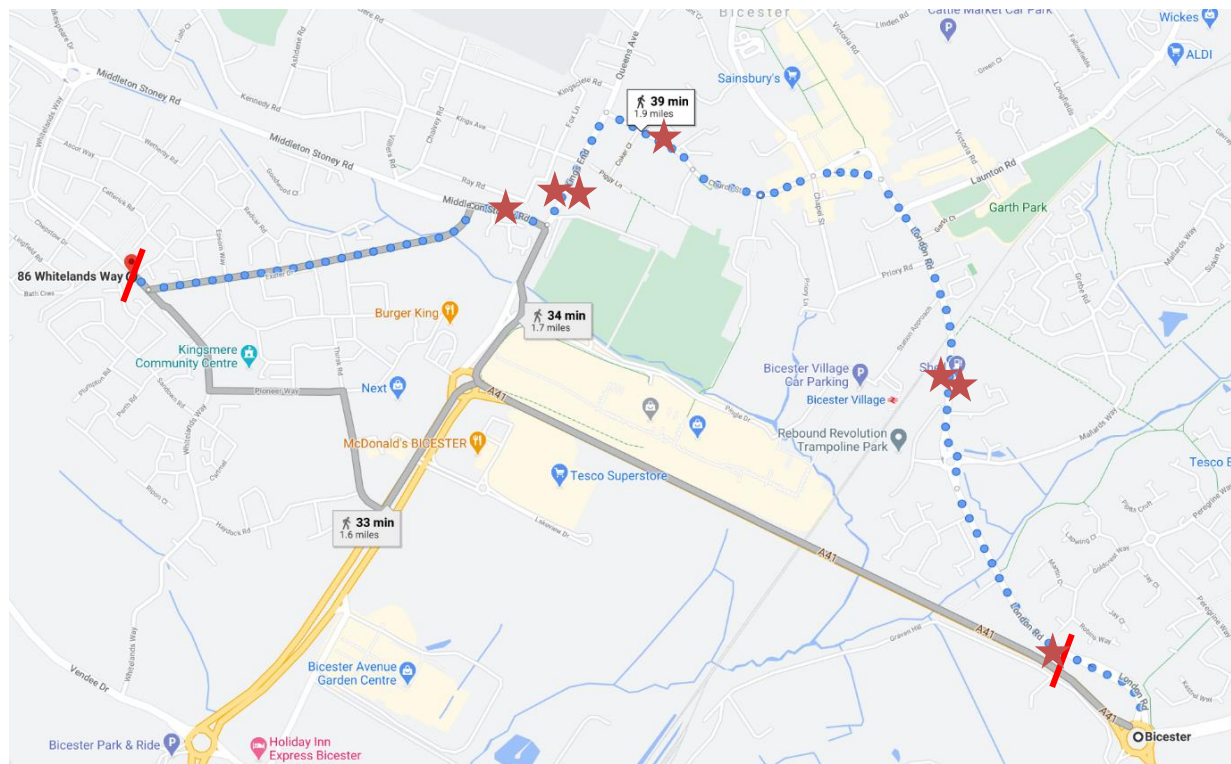
Figure 2: Route 1 - A41 Roundabout to 86 Whitelands Way (Undertaken)

The route shown within **Figure 2** was followed within the red line marks, the red line indicates the location of an unpaved footpath that takes pedestrians from the A41 footway onto London Road and vice versa.

The stars in **Figure 2** highlight bus stops that were identified when on site. The first stop that was identified, to the south of London Road, indicates the Bus stop that was found on site on the southern kerb line.

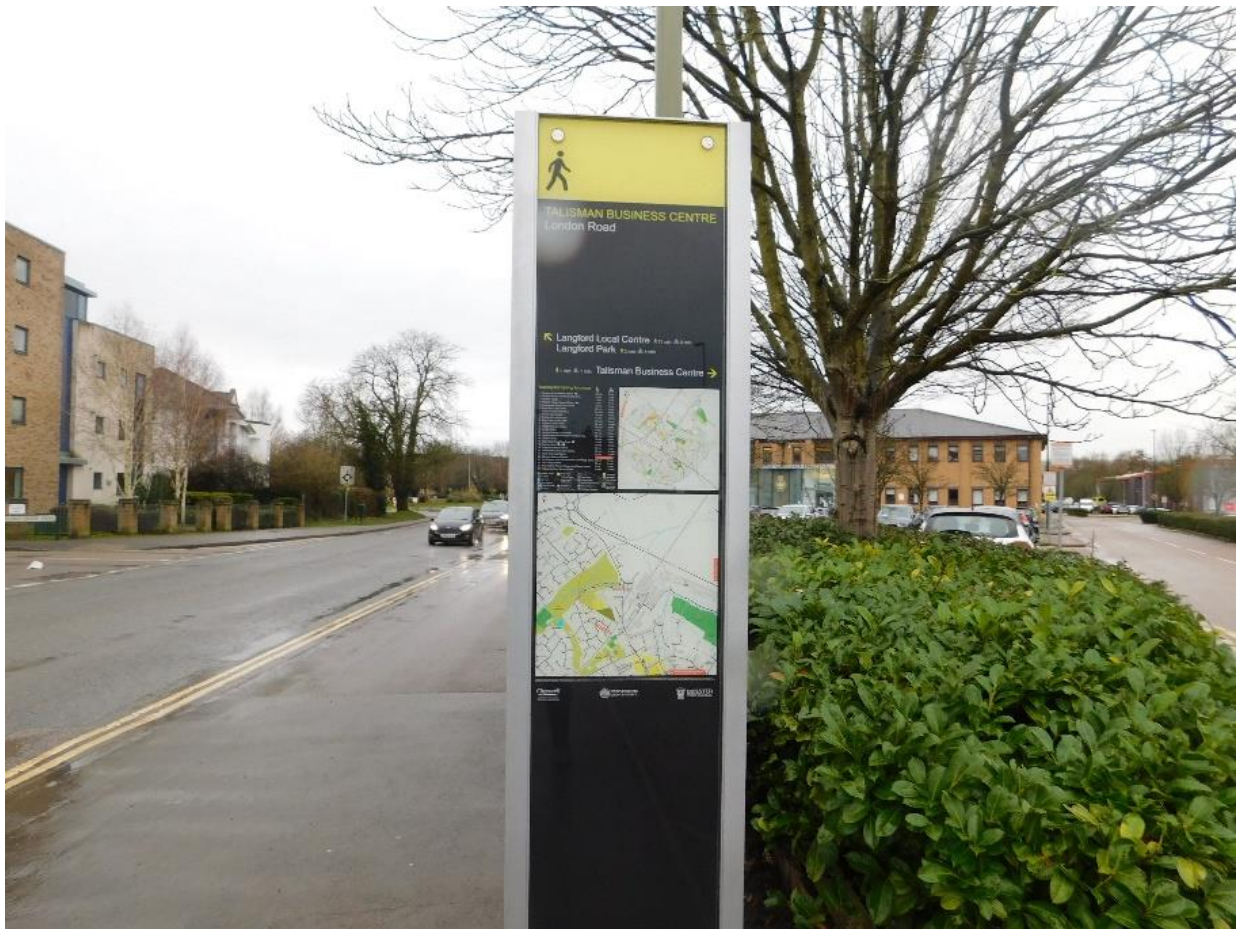
Figure 5: Notice Board Example

Near these bus stops an information sign was found, during the site visit several were seen on a number of other routes. These signs provide information on where you are located, direction of where key locations are and a map which provides insight into facilities and amenities surround within a 5min walking radius. An example of these is shown in **Figure 5** below.

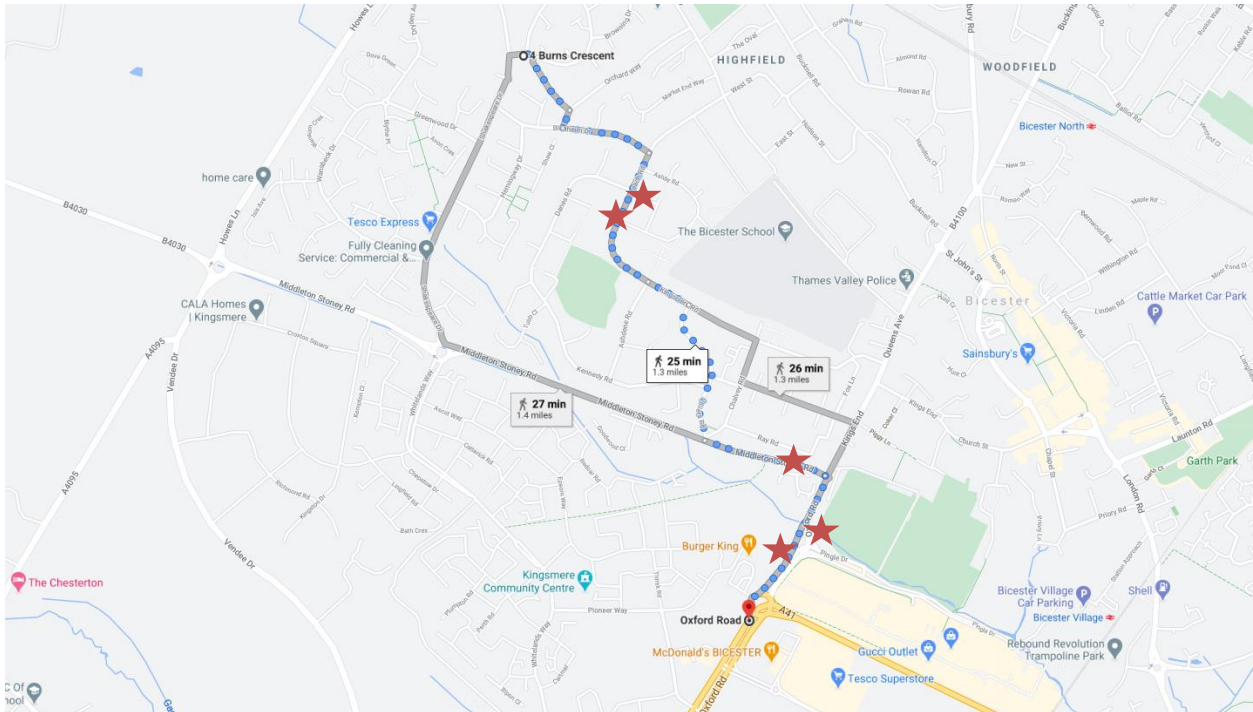
Figure 6: Route 2 - 4 Burns Crescent to Oxford Road Roundabout

From Burns Crescent the route travels south onto Meredith Close.

Meredith Close footways have a few minor concerns including cracking and uneven surface but these issues would not prevent the use of the footways. However, at the end of the footways on Meredith Close you have to use the end of the carriageway to access the footpath which leads onto Orchard Way, this is not ideal but the carriageway allows access to a small number of residential dwellings and is therefore has low traffic. This is shown in **Figure 7** below.

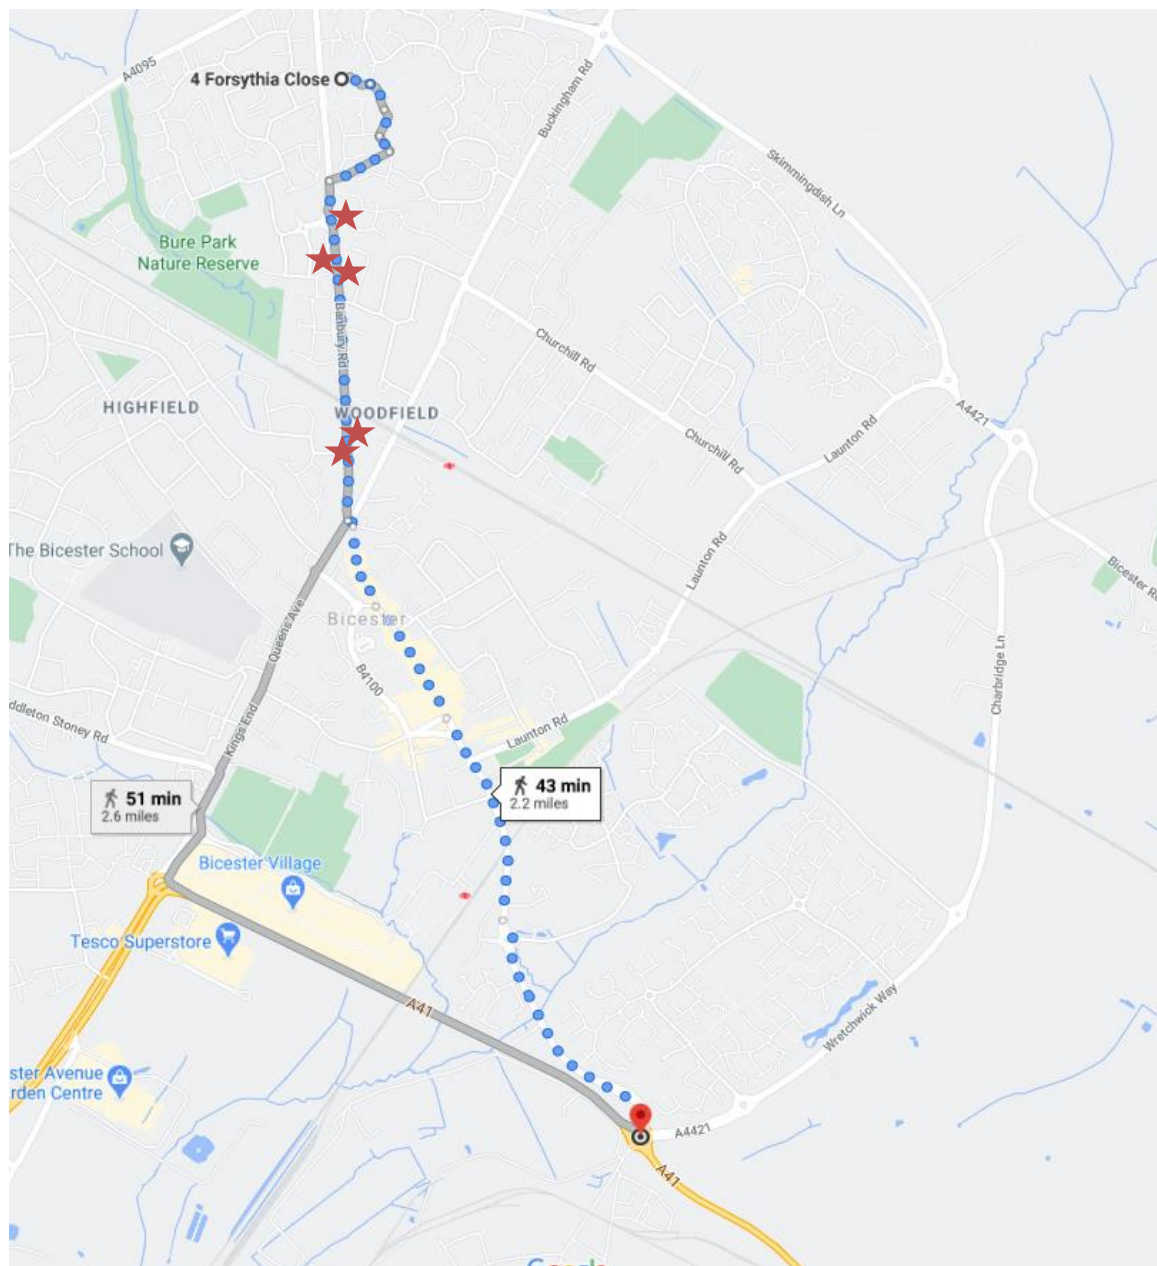
Figure 12: Route 3 - A41/A4421 Roundabout to 4 Forsythia Close

This route was followed from the A41 roundabout to Forsythia Close. However, the start of the route was covered in Route 1 therefore, this assessment begins from the junction of Market Square and Sheep Street in the town centre.

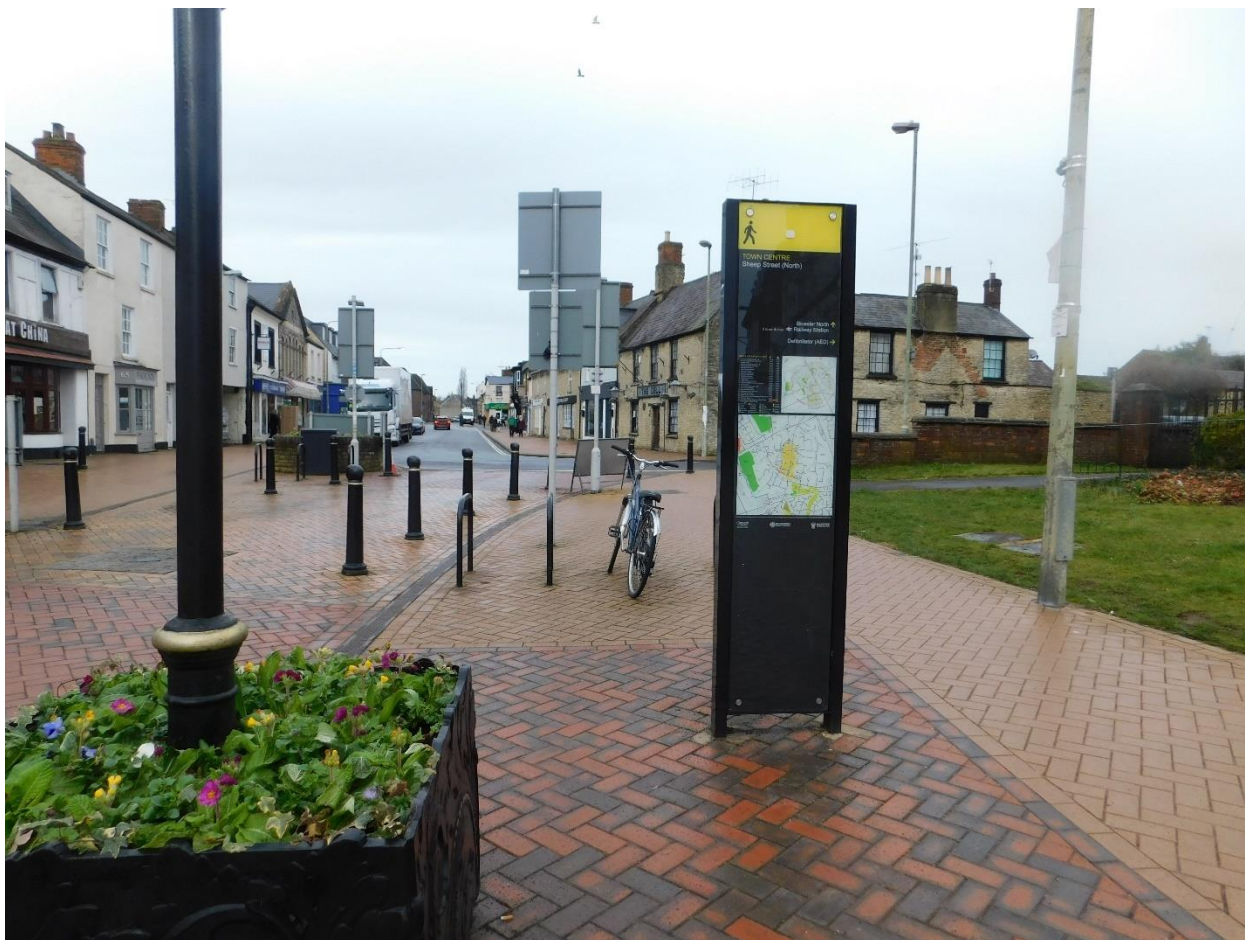
Figure 13: Route 3 - Corner of Sheep Street

Sheep Street is restricted to pedestrian and cyclists only in the south as it travels through the centre of the town. Sheep Street is of a great condition with a number of cycle stands and walking notice boards, as shown in Figure X below.

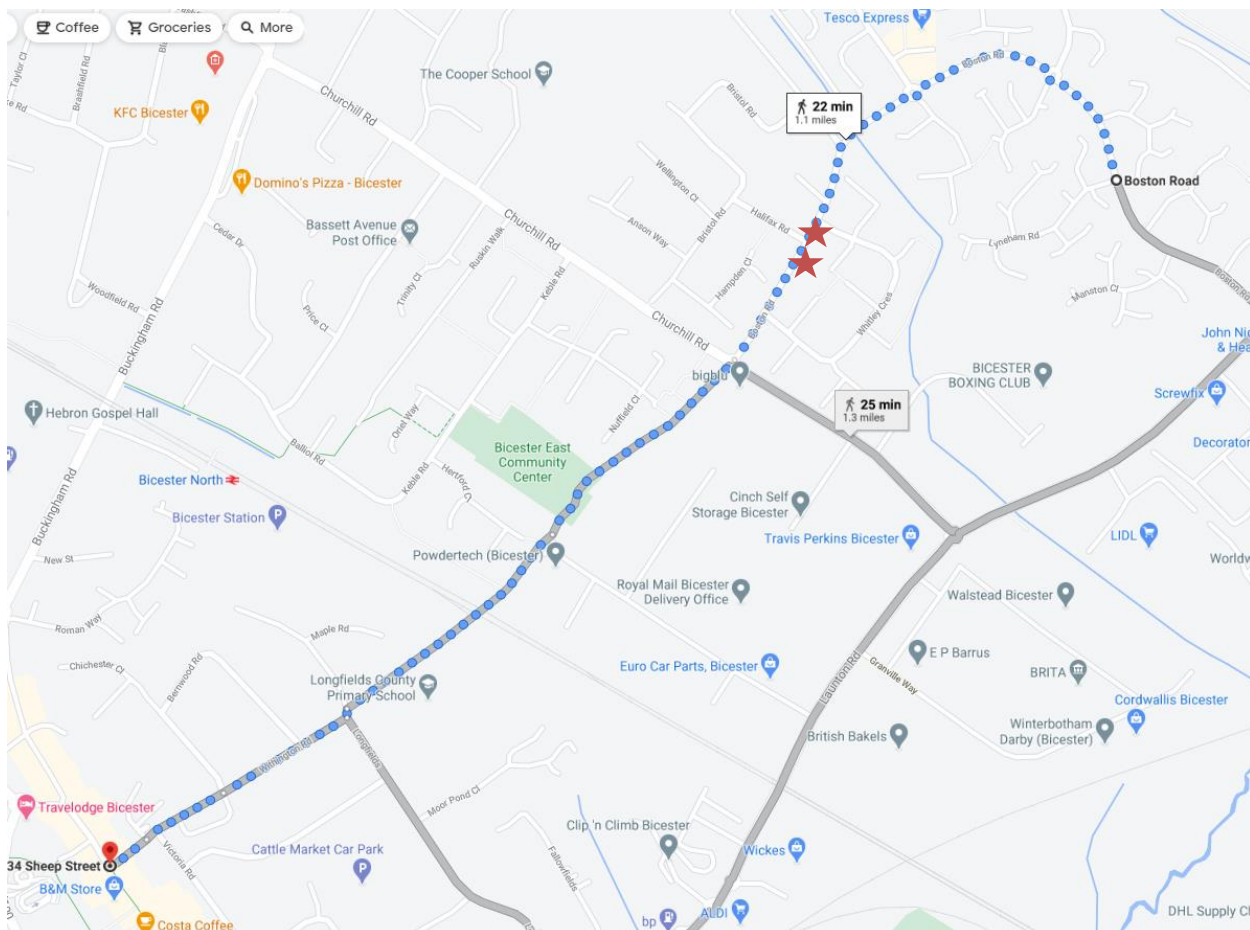
Figure 16: 1.5 Route 4 - Bell Lane / Sheep Street Junction to Boston Road

**Figure 16** below highlights route 4, that was assessed from Bell Lane / Sheep Street junction through to Boston Road.

At the beginning of the route, Bell Lane and Sheep Street, north kerb line is slightly narrow and at junction with Crumps Butts, there is no tactile paving at this junction and due to frequent vehicle use the carriageway is uneven and would be difficult to cross for vulnerable users. However, the southern kerb is more attractive as the footway is wider but there has been some damage to the tactile paving's. Crumps Butts junction and the damaged paving is shown in the figures below.

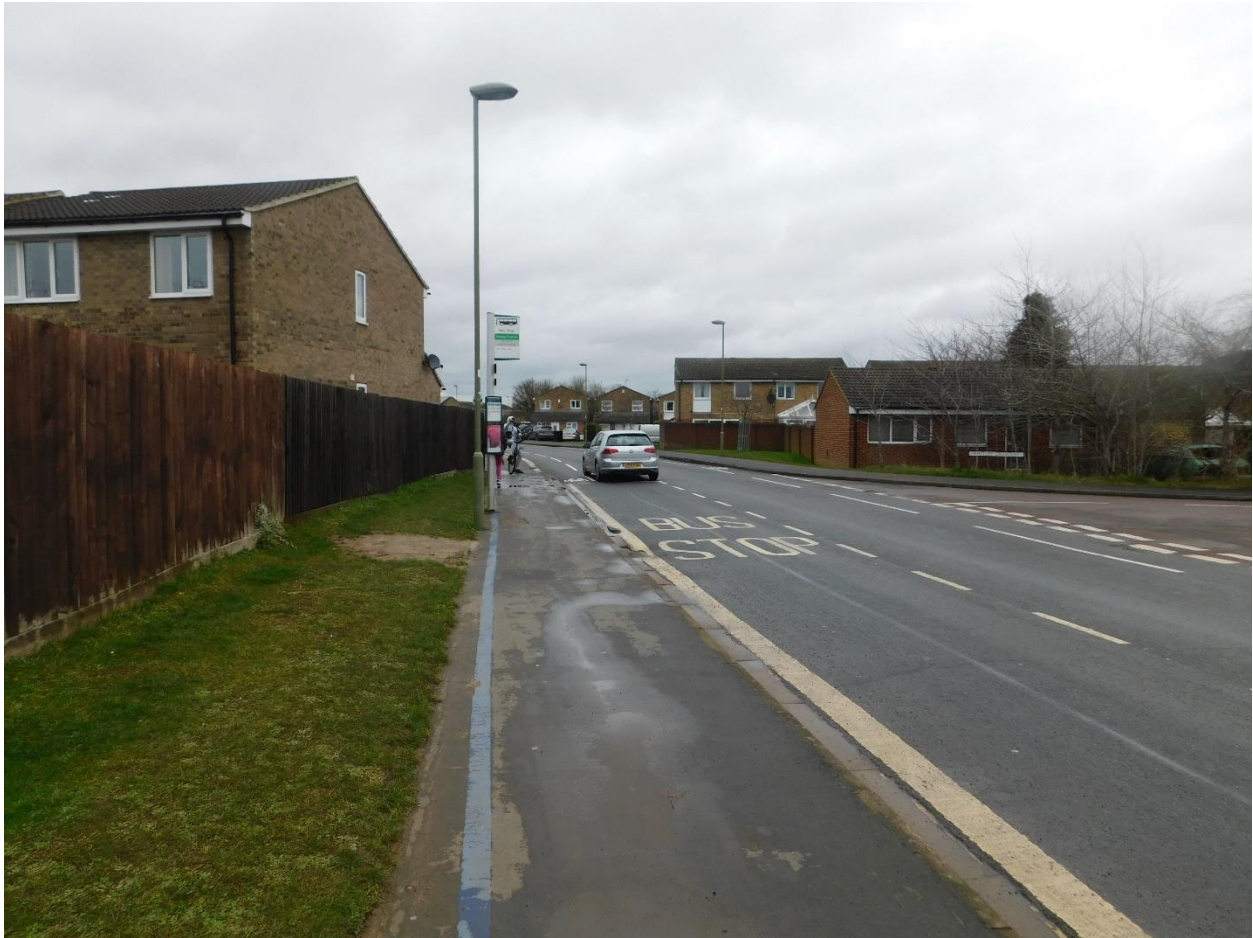
Figure 19: Route 4 - Bosotn Road Bus Stop

The route continues until the mini roundabout where most footpaths have tactile paving's for safer crossing. It should be noted that as you continue on Boston Road the footway stops on the southern kerb but one is still present on the northern kerb. Another flag and pole bus stop was also noted at the end of the route, all bus services along this route are numbers 16, 18 and S5.

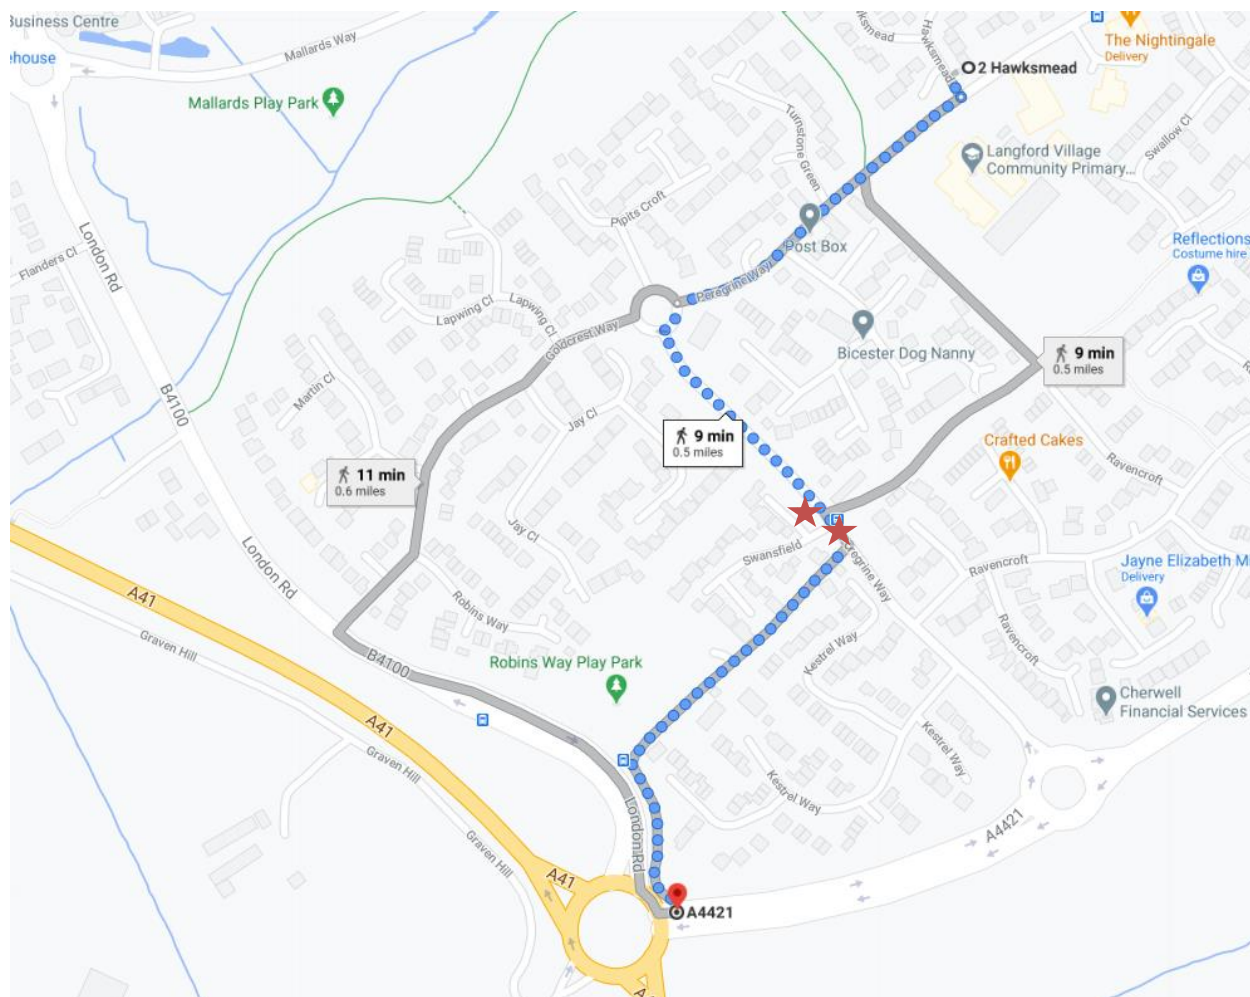
Figure 20: 1.6 Route 5 - 2 Hawksmead to A41/A4421 Roundabout

This route was walked from Hawksmead to the roundabout, Figure 20 below highlights the route.

At Hawksmead junction with Peregrine Way there are no tactile paving's but a dropped kerbs are present; this is the same for its junction with Turnstone Green and Kingfisher Way further along. There are a few minor issues including cracking and raised ironworks but overall conditions are good.

At the mini roundabout there continues to be no tactile paving's and as the route follows Peregrine Way past the roundabout there are further issues including surface uplift, cracking and the footpath has become smaller due to vegetation growing on the footpath. There is some concerns near the southwest kerb bus stop as there is more significant cracking.

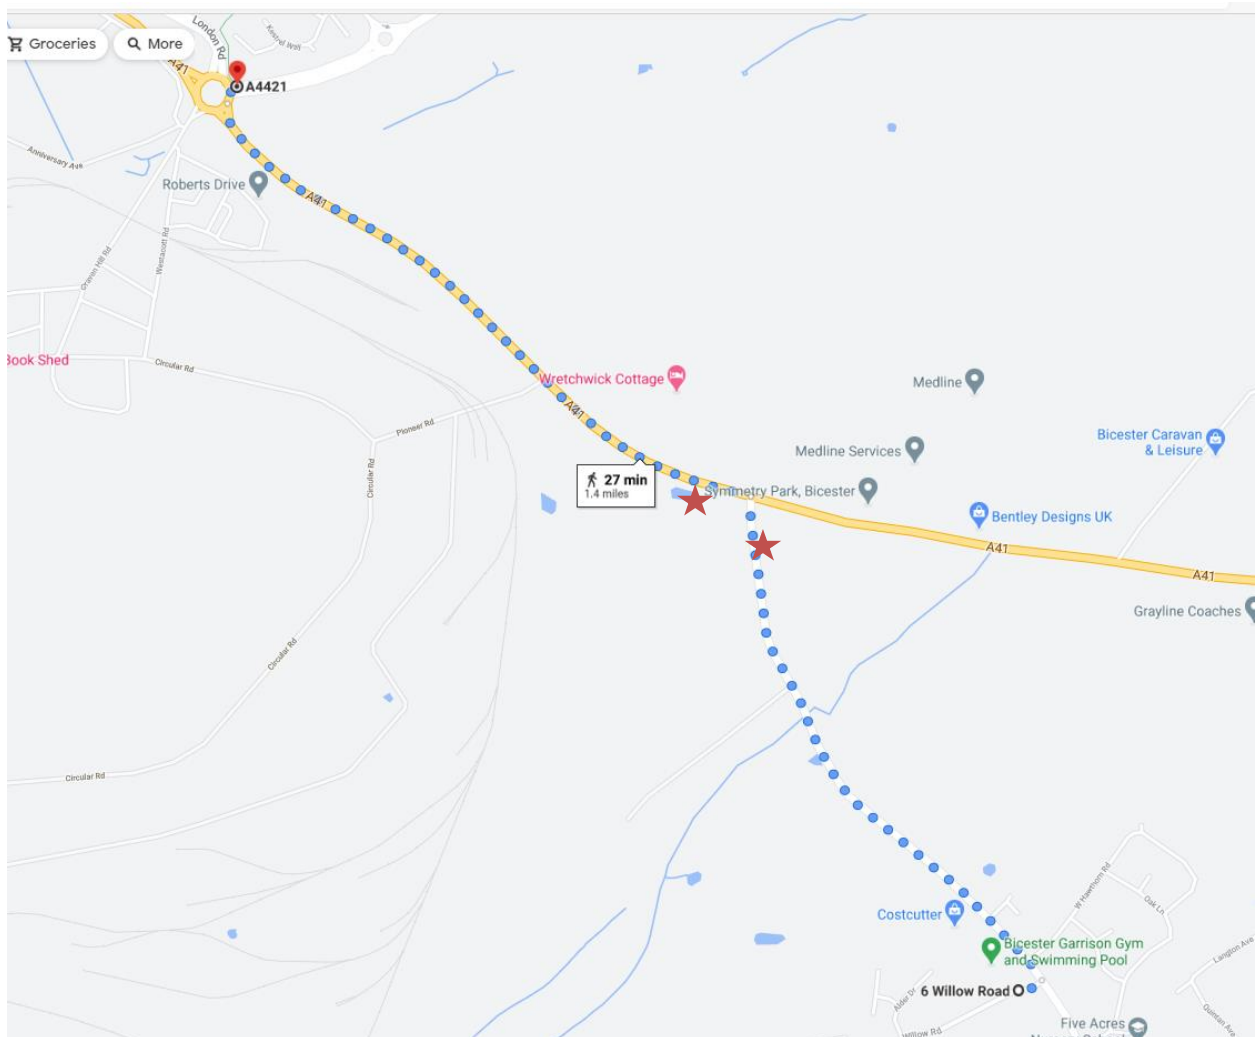
Figure 25: 1.7 Route 6 - 6 Willow Road to A41/A4421 Roundabout

This route was walked from the roundabout on the north and east kerb to Willow road and then back to the roundabout on the west and southern kerb. **Figure 25** highlights the route.

The route was started at the roundabout junction crossing along the A4421, at this pedestrian crossing there is a number of holes with sharp metal protruding, where metal poles were previously present.

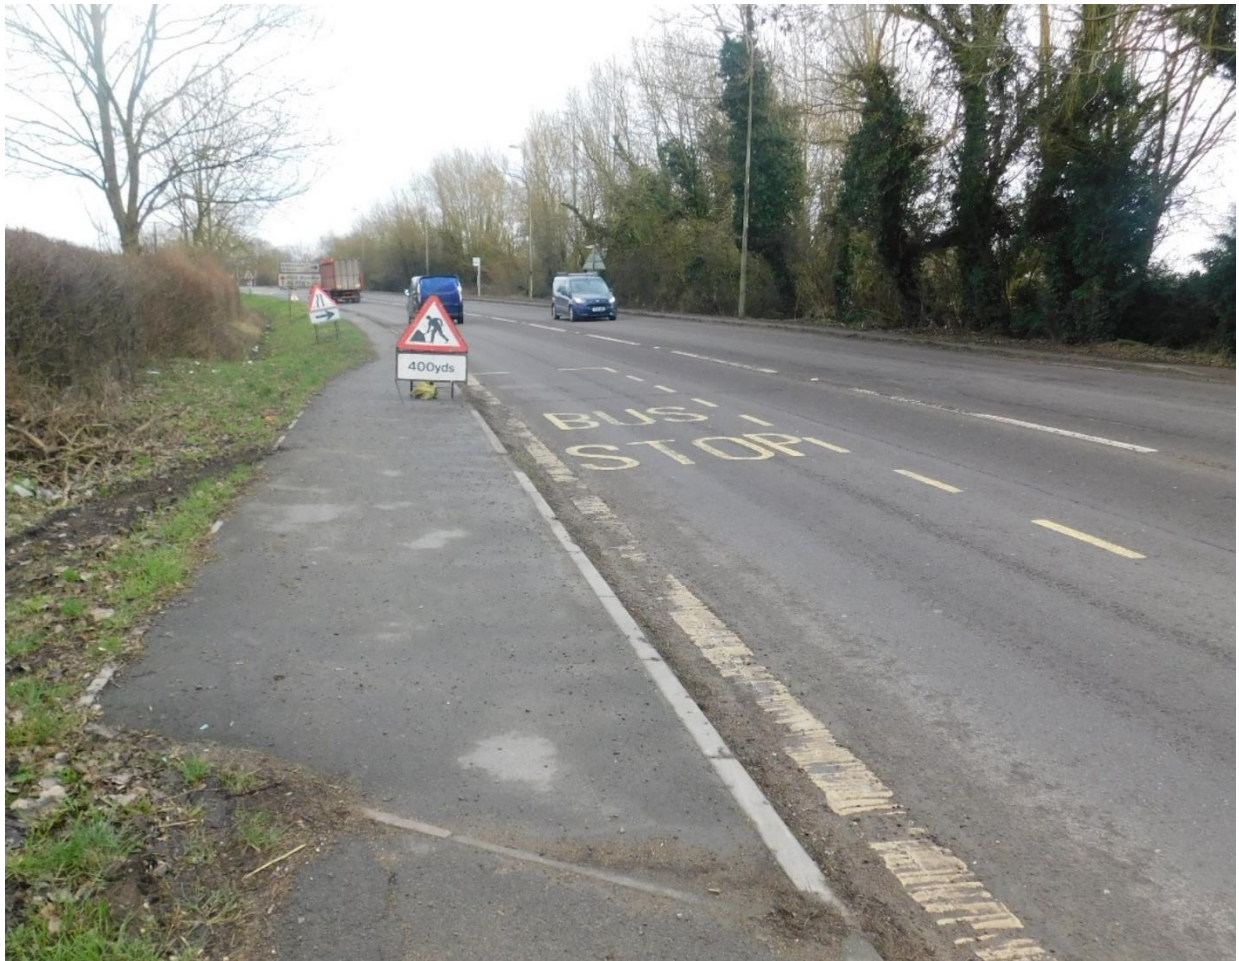
Figure 29: Route 6 - Bus Stop

There are dropped kerbs and tactile paving's for users to cross but on such a busy road a pelican would be preferable.

Flag and pole bus stop is available as you walk down Ploughley Road but no service information was present at the stop. Ploughley Road is also old surface as has cracking, is uneven and raised surface due to large tree roots.

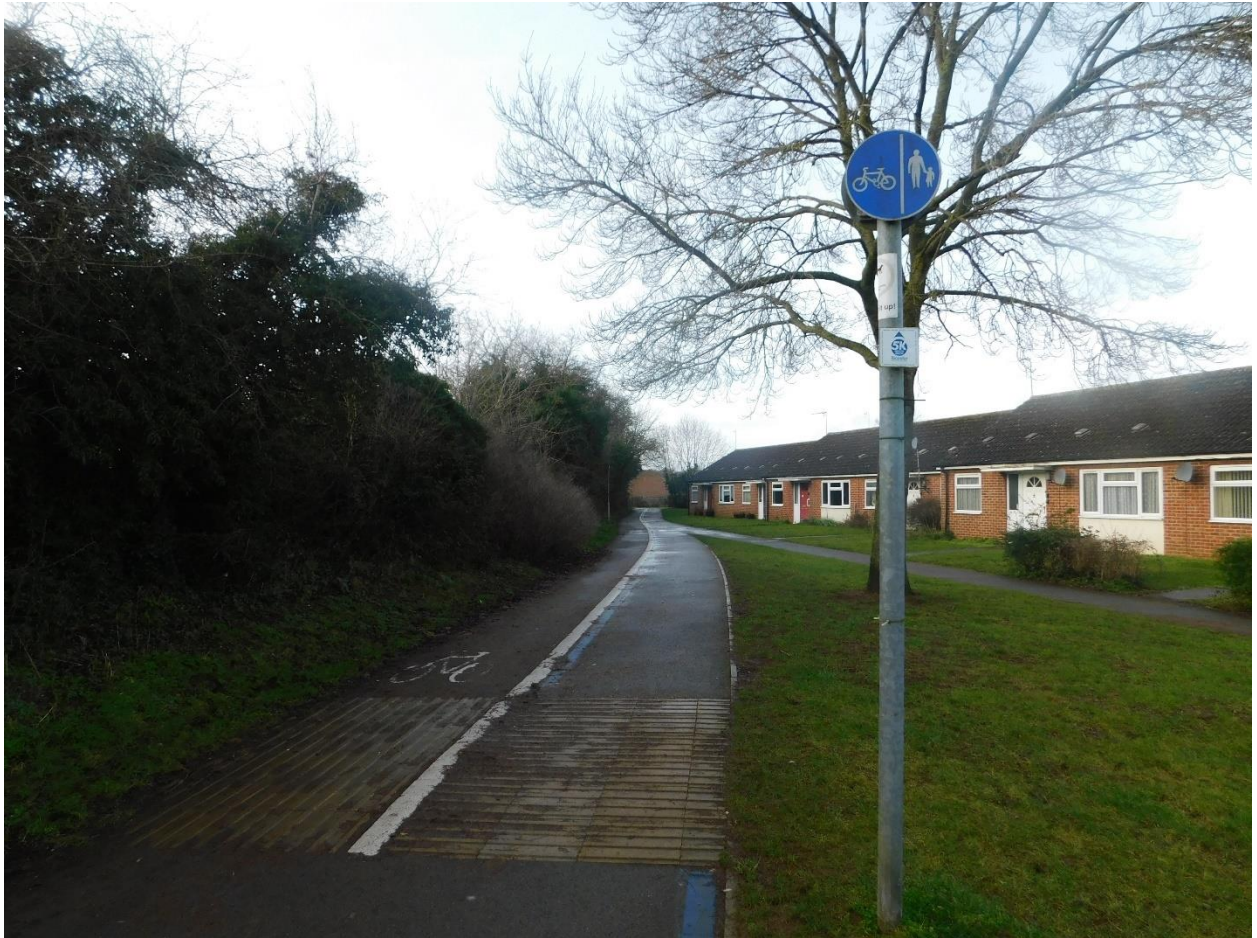
Figure 36: Route 2 - Town Walk

At the junction with Banbury Road there is lots of cycle signage, therefore if following a specific route it would be easy to get confused. There is a pelican crossing present for safe crossing as the cycle lane continues on the western kerb.

The cycle lane is of a good condition to the west of Banbury Road. If cyclists didn't want to continue up Banbury Road, due to the narrow footway this would be a great alternative until the mini roundabout junction with Lucerne Avenue. From there cyclists would have to use the road or the footway until the B4100/A4095 roundabout at the end of the route.

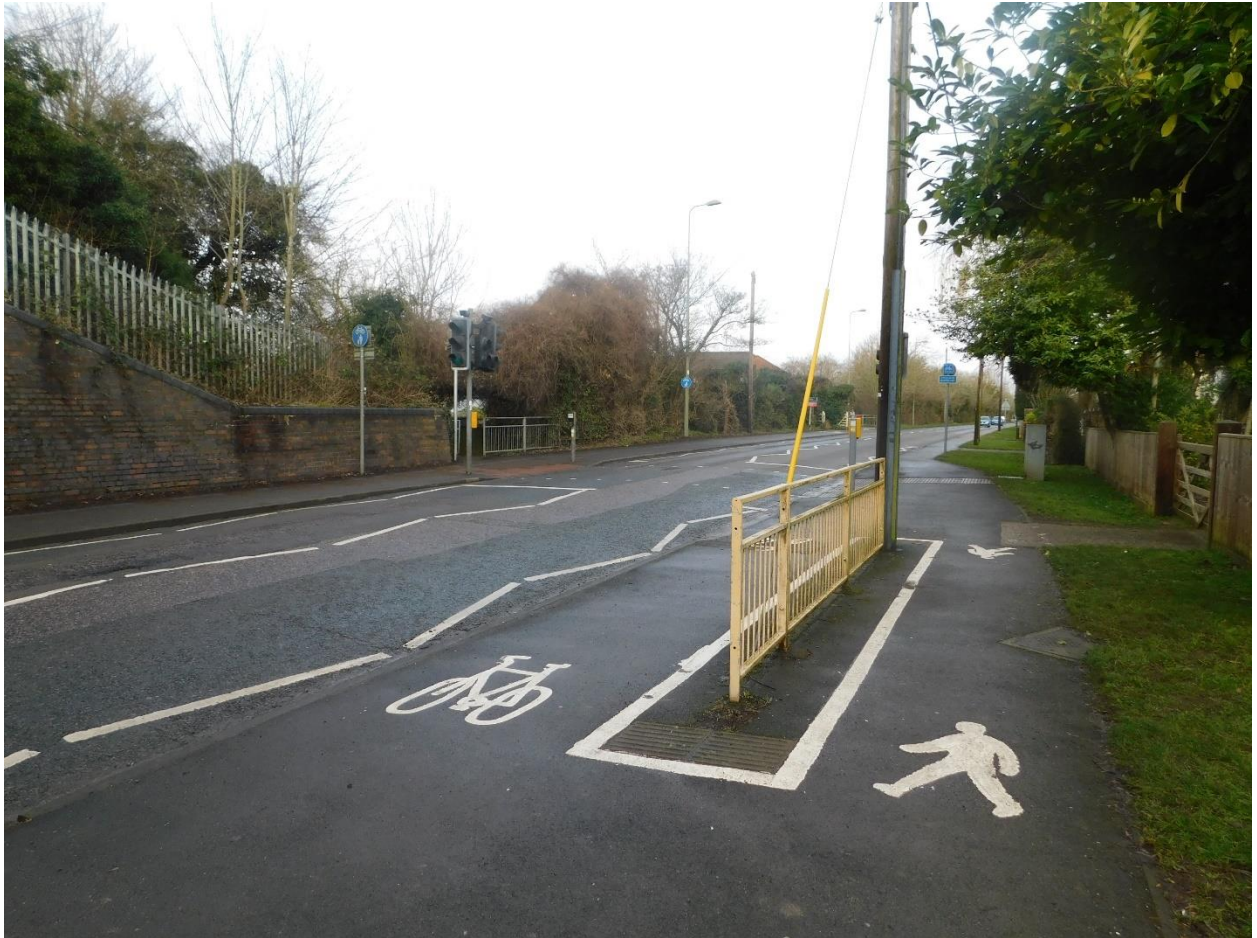
Figure 37: Route 3 - Banbury Road Crossing/Junction

As mentioned, there are a number of cycle path signs at the Banbury Road junction with the footpaths, this can be confusing to find the right direction as several cycle routes pass this junction. **Figure 37** below highlights this junction.

As you follow the footpath west it is unpaved and therefore not in good condition for cycling as whilst on site it was very muddy and wet with no lighting. There was stones sticking out the mud which could damage cycle tyres. There was also fallen vegetation on the path and it was very uneven and narrow.

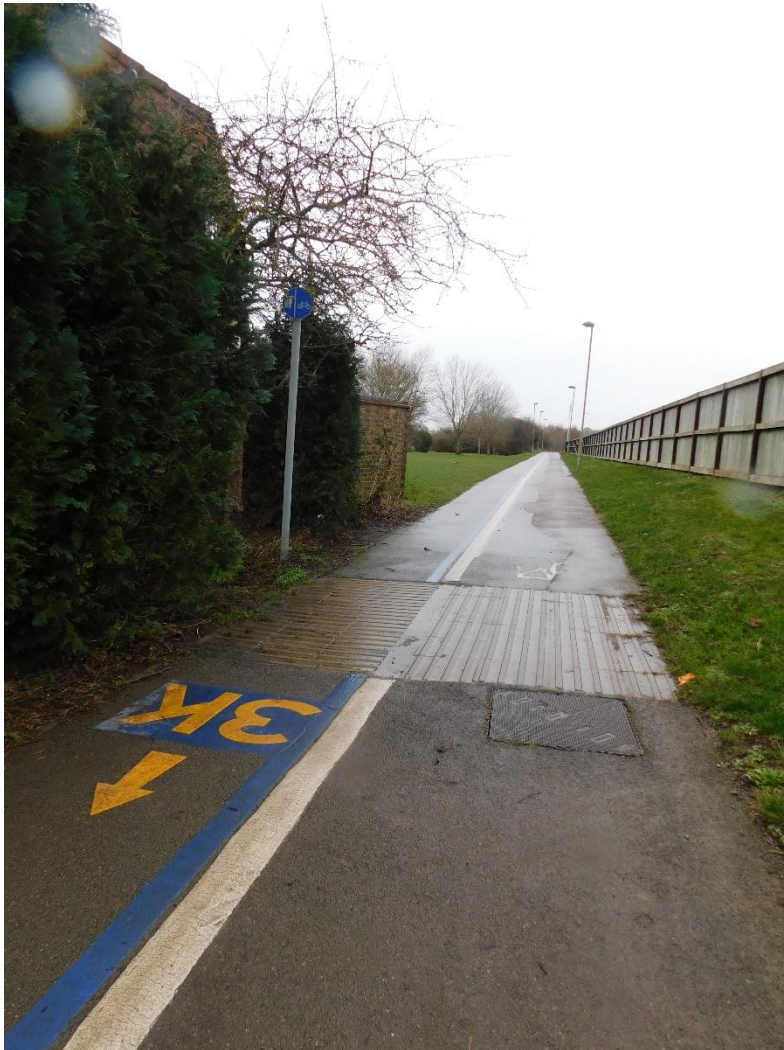
Figure 42: Route 4 - A4421 Cyclepath

The path continues with good conditions until the footpath along Bure Park Nature Reserve. This path was assessed in rote 3 and highlighted the poor unpaved conditions. The route conditions with great conditions for cycling back towards the town centre where footpaths become a little narrower but overall a very attractive route for cyclists.
