LAND AT NORTH WEST BICESTER

STAGE 1 RSA DESIGNER'S RESPONSE (A4095)

PROJECT NO. 4600/1100 DOC NO. D017

Stage 1 Road Safety Audit
Howes Lane junction with Bucknell Road, Bicester
Proposed Mini Roundabout

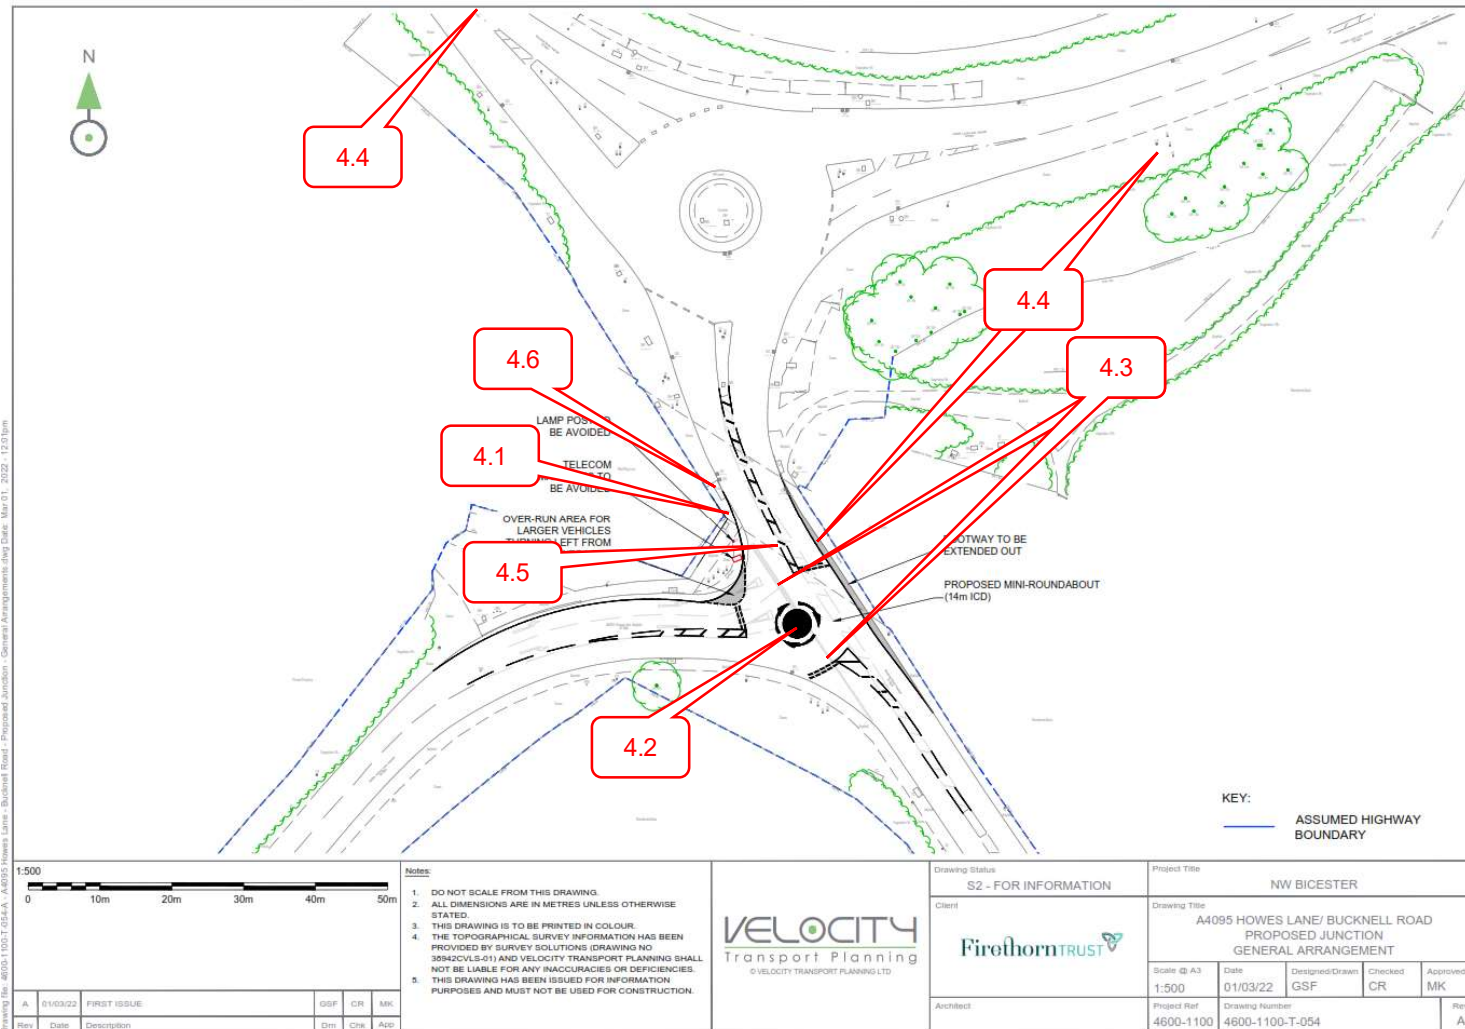
APPENDIX 2: Drawing Showing Problem Locations
Problem numbers shown on the attached drawing refer to Problem numbers within the report.

Item	Problem	Auditor's Recommendation	Designer's Response	OCC Response
4.1	<p>Location: On Bucknell Road – northern arm of the junction</p> <p>Summary: Reduced footway width may lead to pedestrian to vehicle collisions</p> <p>The realigned kerb of the northern exit arm of Bucknell Road, produces a reduced footway width on the western side of the road. The design sketch appears to show a footway width of approximately 1m. The reduced footway width may lead to pedestrians walking in the carriageway to pass others on the footway. This may lead to pedestrian to vehicle collisions. This may be exacerbated by the restricted inter-visibility between opposing pedestrians at this location, due to the railway bridge wing wall.</p> <p>The reduced footway width may bring pedestrians closer to the carriageway edge, and the wing mirrors of large vehicles may overhang the footway resulting in wing mirror strikes to pedestrians.</p>	<p>It is recommended that measures are introduced to provide a footway width that enables opposing users to pass without entering carriageway areas; measures may include the realignment of kerb lines.</p>	<p>The RSA comment on the footway amendment is noted but not accepted.</p> <p>The proposed kerbs have been aligned in order to allow for heavy goods vehicles (HGVs) and other vehicles to turn left from the A4095 Howes Lane onto Bucknell Road without incursion into the southbound lane of Bucknell Road.</p> <p>Whilst this change has reduced the effective footway width, it is noted that there is very little (if any) pedestrian demand in this location, with no pedestrians observed using this route within the traffic surveys undertaken 02/02/2022. On that basis, the likelihood of any conflict between pedestrians is minimal.</p> <p>It is also noted that the footway is reduced to a minimum of 1m for a very limited stretch, which still accords with the minimum requirements set out within Department for Transport (DfT) Inclusive Mobility Guidance (2002).</p> <p>In addition, the proposals improve the pedestrian footway provision along the eastern kerb of Bucknell</p>

4.2	<p>Location: At the mini roundabout, northbound travel through the junction</p> <p>Summary: Excessive entry path through the junction may lead to vehicle to vehicle collisions</p> <p>The offset central island location produces an excessive vehicle path through the junction for northbound users. This may lead to drivers failing to appropriately 'negotiate' the central island. Poor compliance with the circulatory requirements of the junction may lead to vehicle to vehicle collisions.</p>	<p>It is recommended that the size and location of the central island is amended to encourage appropriate circulatory movements for all turning manoeuvres. Measures may include a reduction in central island diameter, realignment of the eastern kerb realignment and a reduction of the circulatory carriageway width</p>	<p>The RSA comment on the alignment of the mini roundabout is noted but not accepted.</p> <p>The current location and arrangement of the central island is to allow for access through the mini roundabout for southbound HGVs turning right onto the A4095 Howes Lane. In addition, it is considered that with appropriate signage (details confirmed at the Detailed Design stage), drivers will be notified of the new junction layout.</p>

4.3	<p>Location: At the mini roundabout</p> <p>Summary: Construction joint issues may lead to loss of control type collisions</p> <p>The construction joint of the existing junction will fall within the circulatory carriageway area of the junction.</p>	<p>It is recommended that measures are introduced to ensure the integrity of the existing construction joint. Measures may include the resurfacing of the junction area to remove the construction joint</p>	<p>The RSA comment on the construction joint is noted and accepted.</p> <p>The details to ensure the integrity of the existing construction joint will be addressed at the Detailed Design</p>

<p>Large turning vehicles will increase stresses on the construction joint, which may lead to deterioration of the joint and pot holes within turning areas for vehicles. Poor carriageway surfaces within turning areas will increase the likelihood of loss of control type collisions, particularly for two-wheeled users.</p>	within likely stress areas	<p>stage.</p> <p>If it is considered necessary to resurface the junction area, this will be identified.</p>

4.4	<p>Location: At the mini roundabout – Bucknell Road Northern entry</p> <p>Summary: Late braking or failure to give way type collisions</p> <p>On the northern, Bucknell Road entry, drivers may fail to appreciate the presence of the mini roundabout, as siting of the diag 611.1 sign may be problematic and there may be reduced forward visibility to the sign. Poor perception of the change junction arrangements may lead to failure to give way or late braking shunt type collisions</p>	<p>It is recommended that forward visibility to the diag 611.1 sign is maximised to provide adequate warning of the junction type. Existing map type direction signs for the conventional roundabout on the A4095 (E) and Bucknell Road (N) approaches should be amended to clearly identify the new roundabout junction at Howes Lane</p>	<p>The RSA comment on signage is noted and accepted.</p> <p>The details of the signage strategy will be agreed at the Detailed Design stage.</p>
