**Arboricultural Impact Assessment:
Jacobs Douwe Egberts, Ruscote Avenue, Banbury – Site 2**

Document reference: 614-21, Revision 0

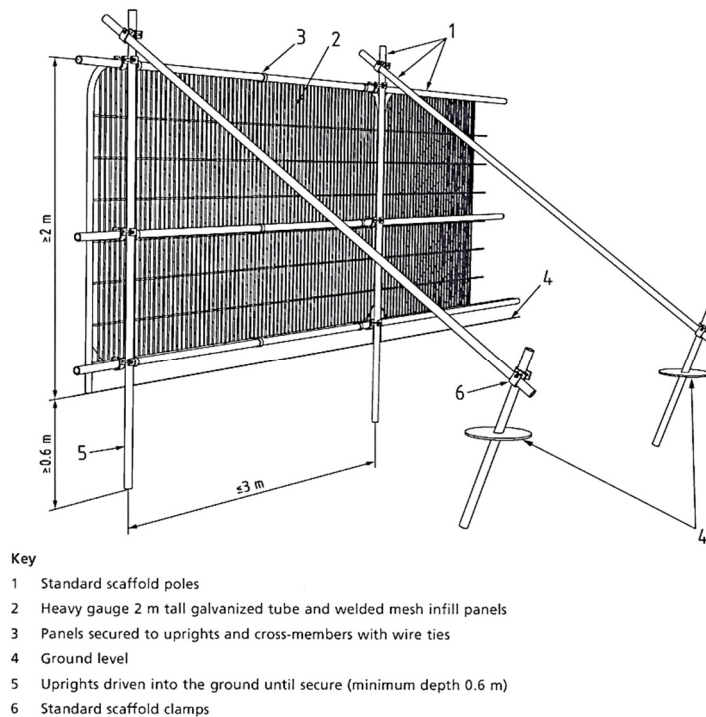
Extract from BS5837: 2012 *Trees in relation to design, demolition and construction – Recommendations*, Figure 2 Default specification of protective barrier

- 4.6 This robust protection barrier is based upon a scaffold framework with driven vertical posts and diagonal bracing where necessary to ensure the barrier remains fit for purpose throughout the duration of the construction period.
