Ref: LAS_368
Date: 04.05.2022

Site: POS Airfield Park, Phase 2, Heyford Park

Arboricultural Statement

Project:
Upper Heyford Phase 2 Open Space

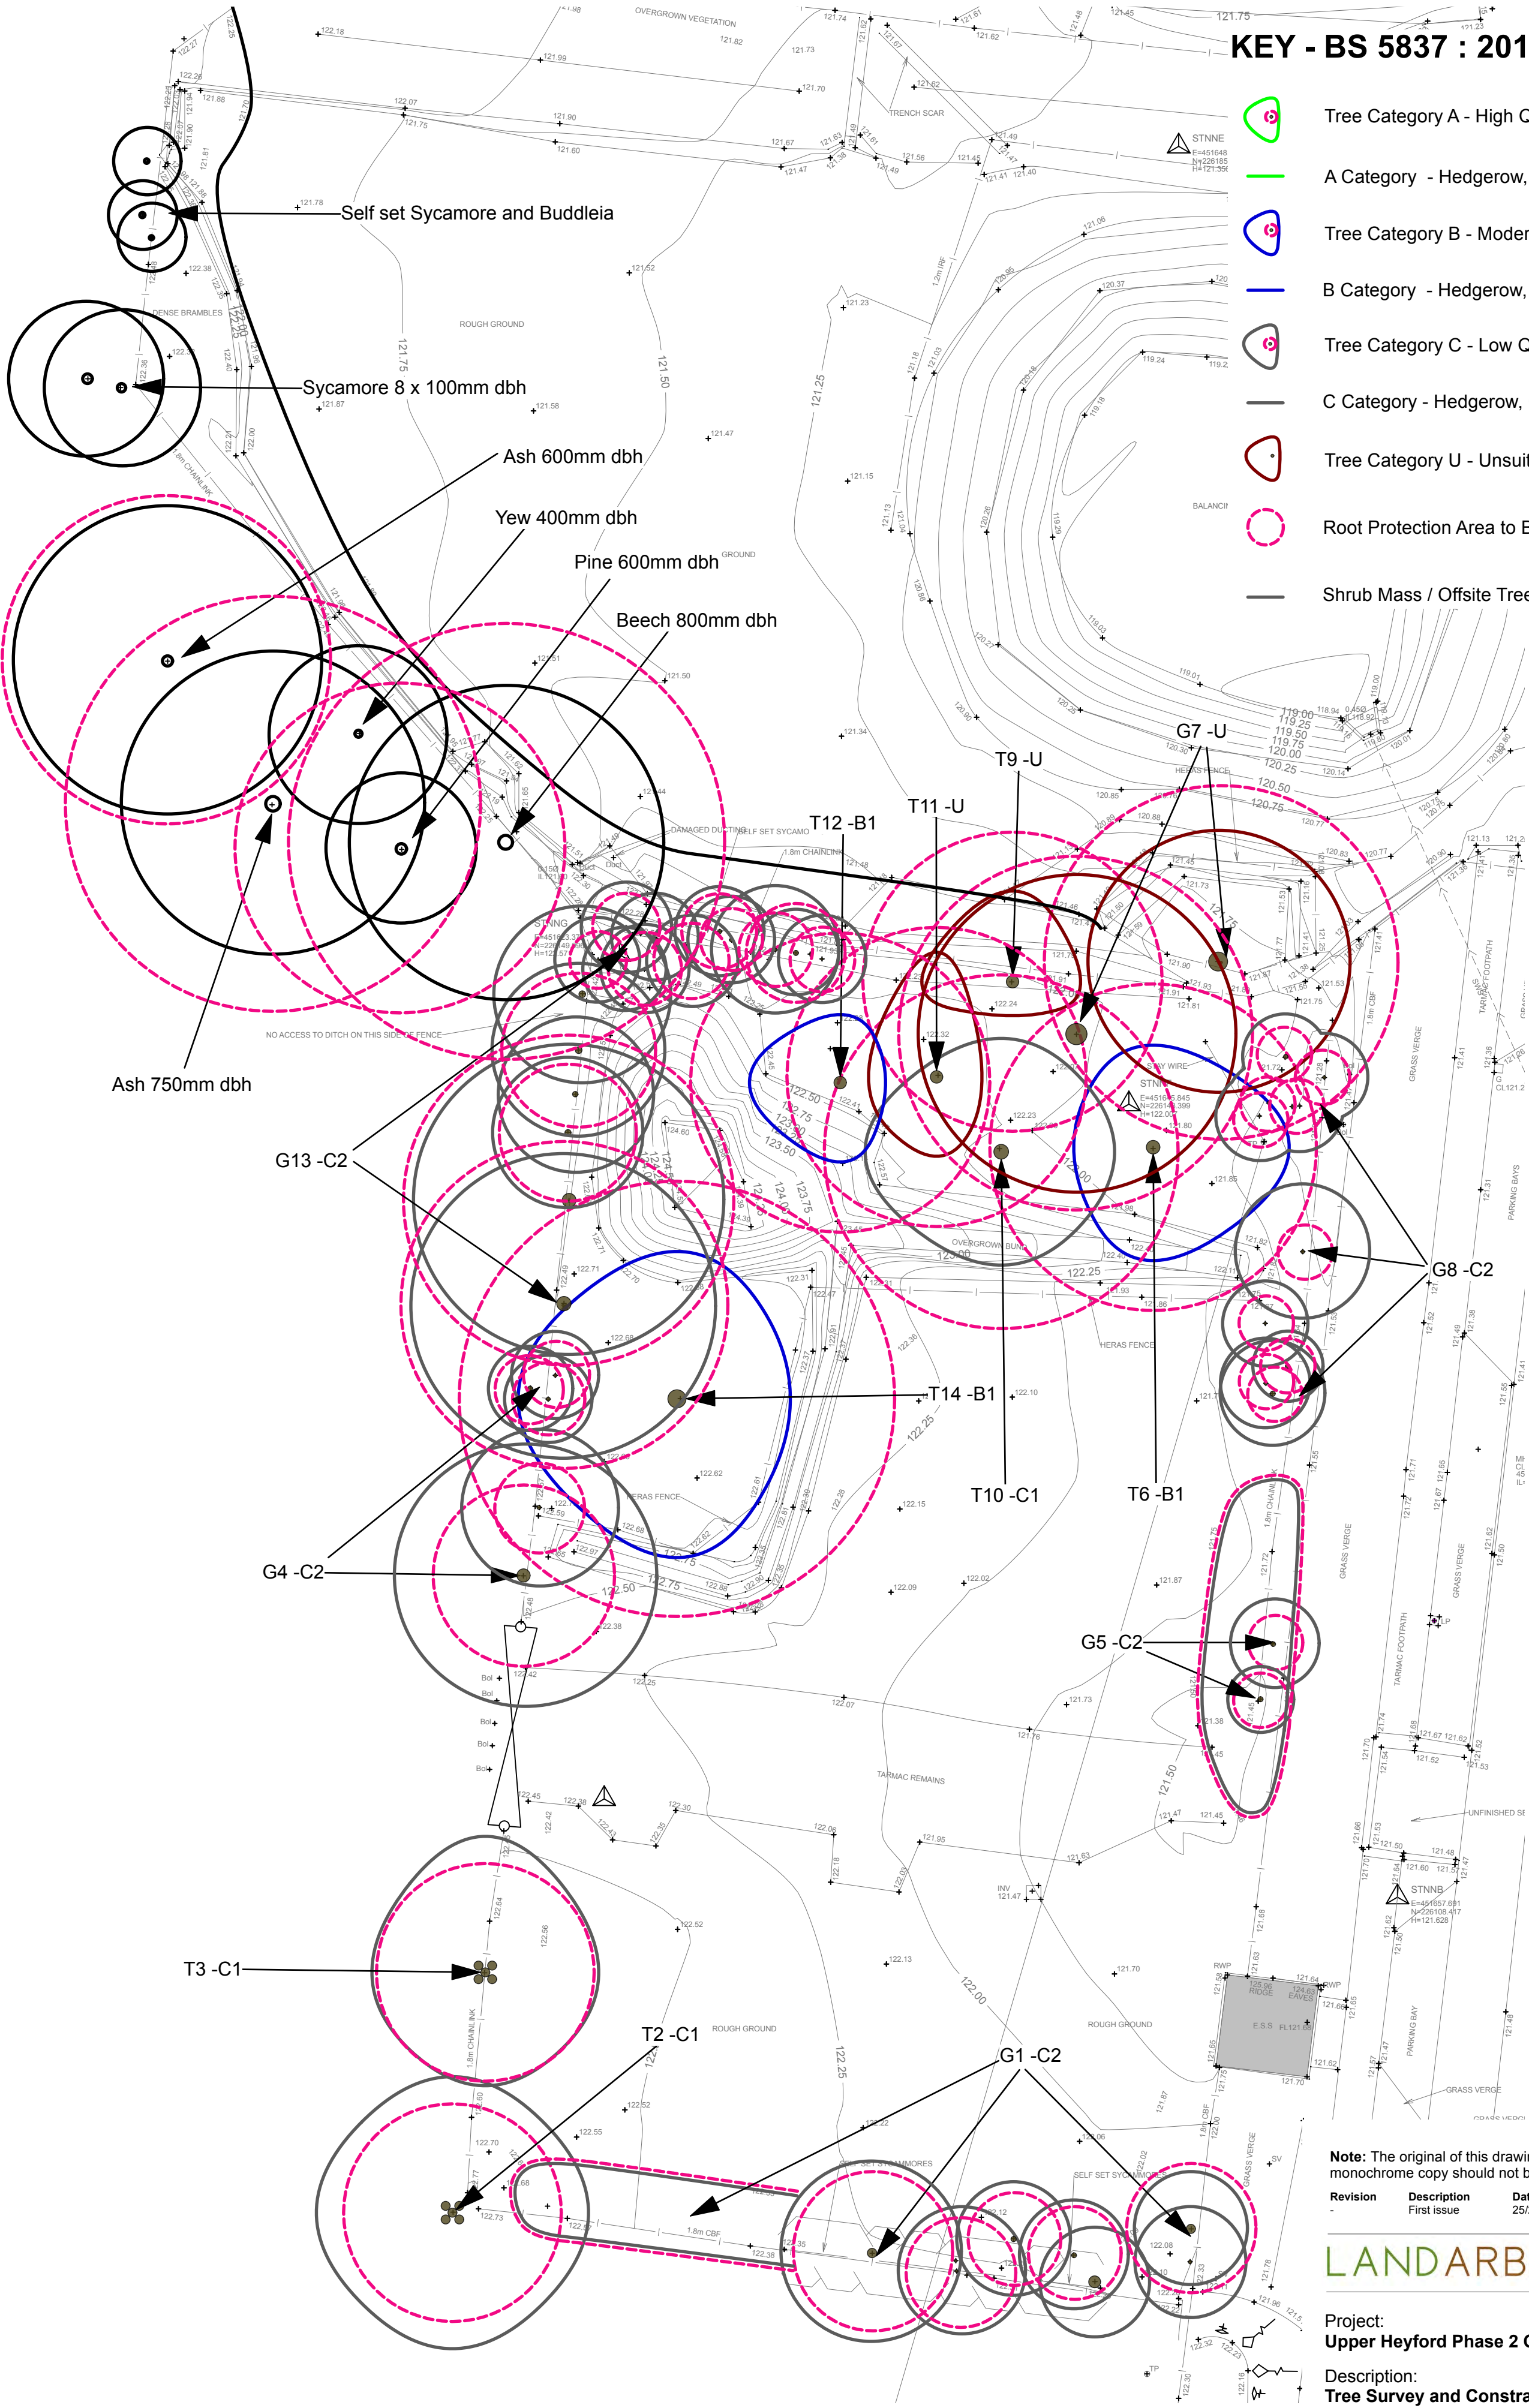
Description:
Tree Survey and Constraints Plan

Centrally to the site (south of attenuation basin) are several mature trees. There are two mature pine (T6 and T12), two dead pine trees (G7, two ash trees (T9 and T11) which appear to be in poor condition and a mature sycamore (T10) again which appears low quality.

In terms of impact of the loss of T6, G7, T9, T10, T11 and T12 it is important to note the current condition of these trees. G7 comprises two pine trees, both of which are dead therefore removal would be recommended regardless of proposals. T9 and T11 are both mature ash trees with very thin crowns, poor structural condition and appear to be in irreversible decline. These again would be recommended for removal regardless of development. T10 is a heavily ivy clad sycamore with thinning crown. It is assessed as low quality therefore should not be viewed as a constraint to development. Given its condition, it is considered that it could be replaced with new tree planting. T6 and T12 are mature pine that are assessed as moderate quality and generally should be retained. However, notwithstanding a requirement to remove contaminated soil from site, it is noted that the proposed drainage of the sports pitch to the existing attenuation pond passes next to the stem therefore the tree would need to be removed for this. In any case even if no development was proposed/approved, if the other trees are removed due to condition, the loss of companion shelter may reduce their long term retention value by an increased risk of storm damage and windthrow. T6 and T12 could only be retained if existing ground levels can be retained, which as discussed above it has been advised that the levels cannot be retained due to requirement to remove contaminated soil from site.

T11	Ash	15.5	1	550	6.6	137	U	5.5	2.0	3.5	3.0	0.0	-	-	2.0	M	<10	Poor	Poor	Dense ivy on stem and into crown, poor canopy shape and structure, thin leaf bearing structure, appears in sever decline.
T12	Pine	15.5	1	550	6.6	137	B1	3.0	2.0	3.5	4.0	0.0	-	-	5.0	M	10+	Good	Fair	Dense ivy on lower stem obscuring view. Some deadwood. Reasonably dense needle coverage.
G13	Ash, sycamore	8.0	5+	100	1.2	5	C2	As on plan				0.0	-	-	0.0	EM	10+	Fair	Poor	Self set ash and sycamore stems along boundary either side of chain link fence. Small trees, drawn up, dense ivy on most.
T14	Pine	15.5	1	800	9.6	290	B1	6.5	5.0	7.0	7.0	0.0	-	-	3.0	M	20+	Good	Fair	Large pine, spreading canopy. Dense ivy on stem obscuring view, pruned in padt, som deadwoid, dense crown, some past branch loss.

T14 will need to be removed due to its location in the footprint to the 5 aside pitch. It is also noted that the previously approved POS plan (see appendix 1) does not show T14 as a retained tree. But due to its location in the footprint to the 5 aside pitch as well as the alignment of the proposed drainage run, T14 would need to be removed if implementing the previously approved plans.
