the **play inspection** company

Post Installation Report

Blossom Field

Inspection Ref: 1667769

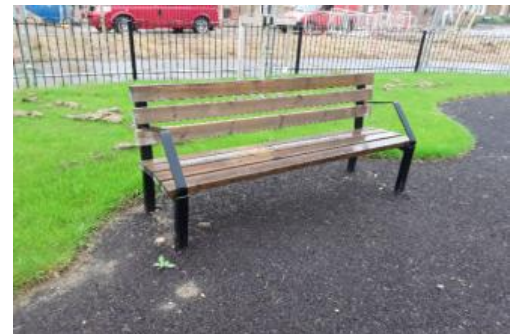
i 4 - Very Low Risk

Item: Bench
Manufacturer: Not Identified
Surface Type: Bonded Rubber Mulch
Item Quantity: 2
Equipment Compliance: N/A
Surface Area Compliance: N/A

Total Findings: 1

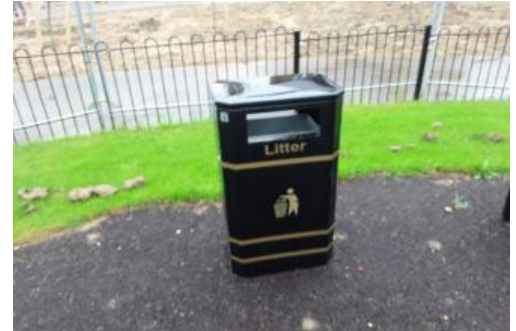
i 4 - Very Low Risk

Item: Litter Bin
Manufacturer: Broxap
Surface Type: Bonded Rubber Mulch
Item Quantity: 2
Equipment Compliance: N/A
Surface Area Compliance: N/A

Total Findings: 1

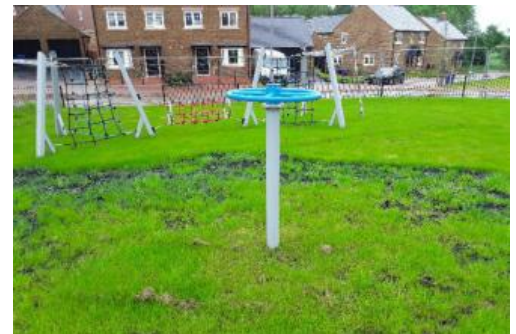
i 4 - Very Low Risk

Item: Overhead Rotator
Manufacturer: Vinci Play
Surface Type: Grass Matrix Tiles
Item Quantity: 1
Equipment Compliance: Yes
Surface Area Compliance: Yes

Total Findings: 1
