PROJECT Stratfield Farm
OX5 1DL Kidlington

DWG TITLE Block G and H
Existing Plans

JOB/DWG No. 219-116

1.0 Existing Ground Floor Plan Showing Demolition

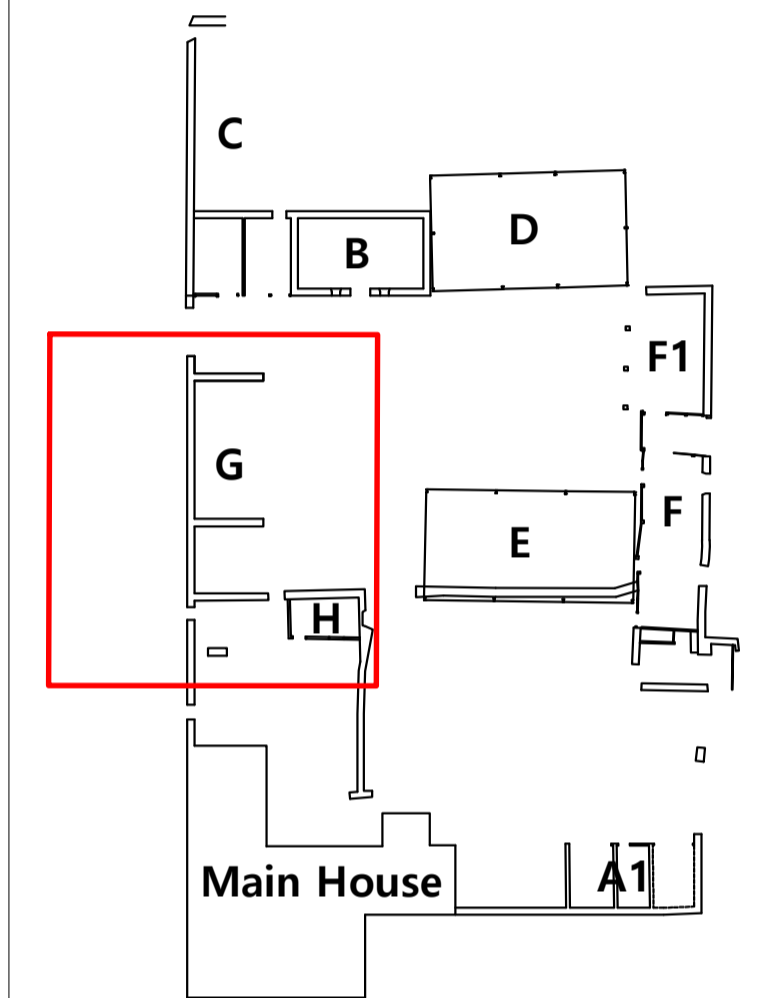
North gable wall largely intact coursed rubble limestone wall. Likely that the core of the wall has been washed away and that climbing plants have compromised the structure
Take down to ground level and rebuild like for like.

West wall. Coursed rubble limestone wall in largely ruinous state. Southwest section to the corner is intact but the remainder has missing sections.
Take down to ground level and rebuild like for like.

South wall. Coursed rubble limestone wall has been compromised by water ingress into the core of the wall. Visible structural movement.
Take down to ground level and rebuild like for like.

Interior overgrown. Fragments of possibly stone floor towards the southwest end, between the external wall and internal bay wall. Retain stone for reuse in repairs.

There is a low internal stone wall with cement pointing and badly rebuilt top section, with substantial root growth from the north side. Take down to ground level and rebuild like for like.

Small section of wall to be taken down to ground level and rebuilt like for like.

To be repaired and repointed
