# JAMES MACKINTOSH ARCHITECTS

## CONDITION SURVEY

Stratfield Farm Outbuildings, Kidlington, Oxford, OX5 1DL

May 2022

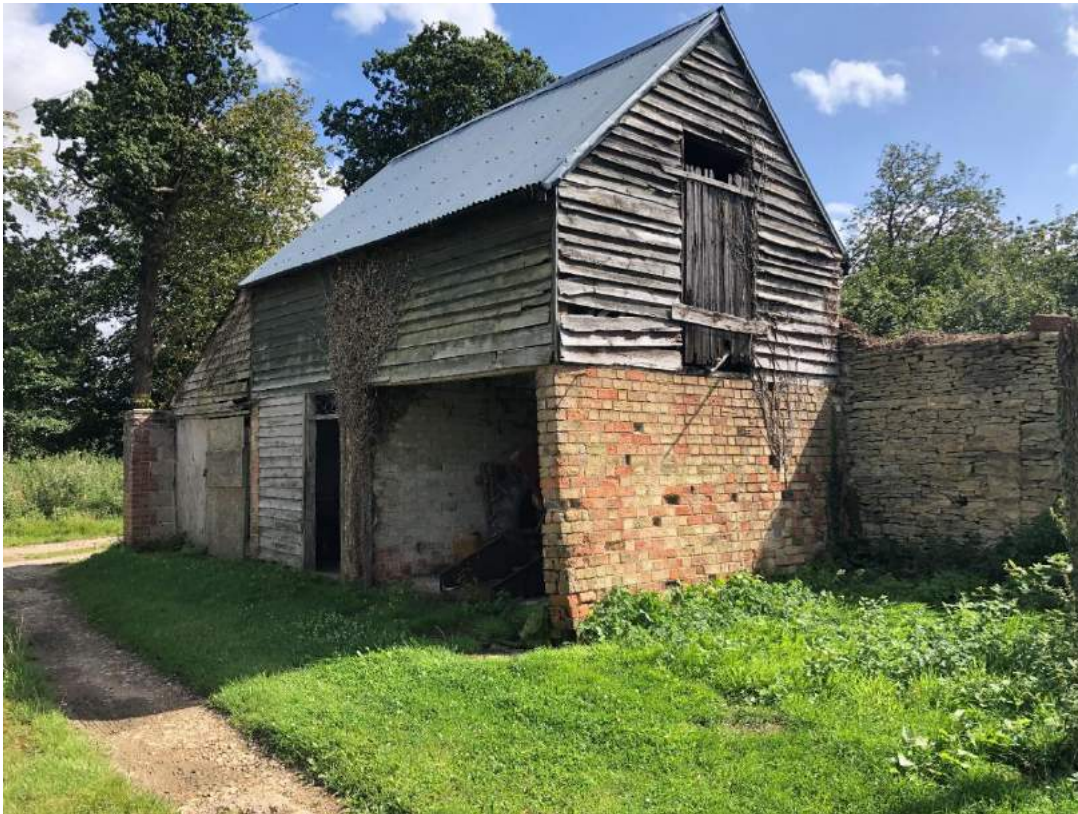
#### 6.2.1 Exterior

Block A1 is the most preserved out of all outbuildings. It is a 2 bay, single pile cart shed of masonry construction with a corrugated roof with a lean-to extension with timber panels to the front, built against a drystone garden wall to the rear.

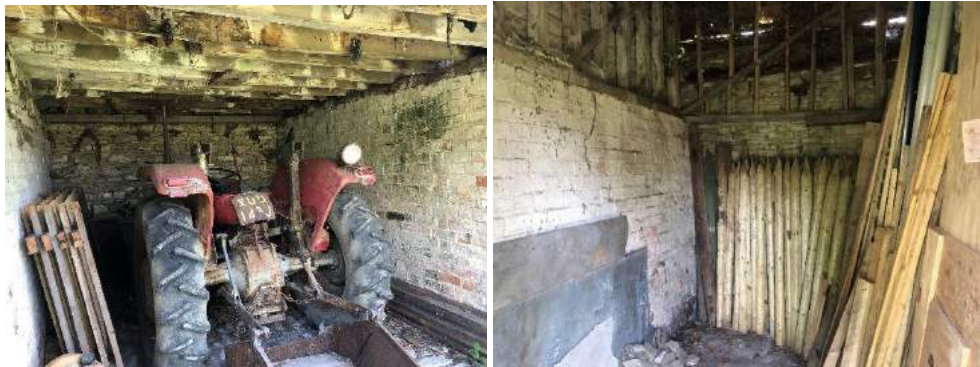
- b. Floor. Ground floor is from concrete and in fair condition, with the exception of west bay, which is cobbled with some concreted poured over the top. Good cobble stones should be reused and relaid. Mezzanine floor joists are in overall poor condition, with 3 towards the south end requiring replacing, as well as one fractured joists towards the north end (4<sup>th</sup> from opening). The floorboards have been saturated with water coming in from the high level door opening and potentially prior to the roof being replaced. They have decayed and will require replacing.

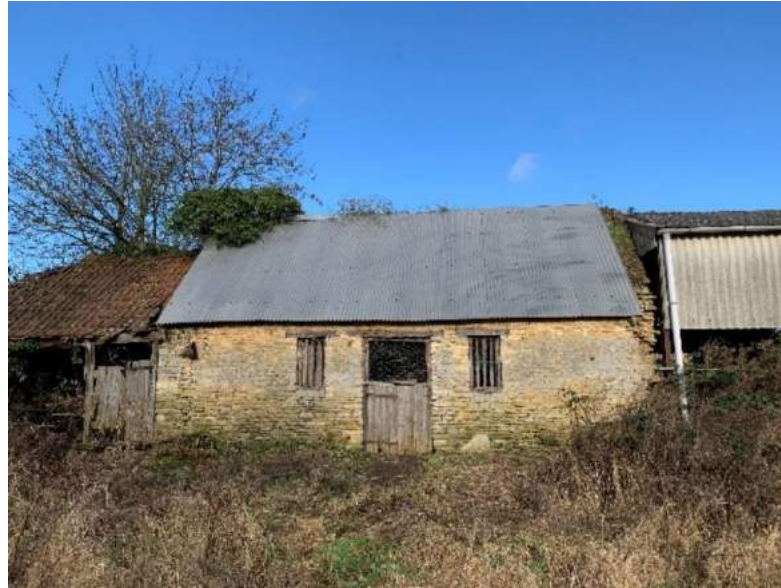
Single pile, single storey cottage, contemporary with the Farmhouse, with load bearing rubble stone walling and metal corrugated roof. According to the heritage statement the use of the building was likely a cowhouse rather than a stable. There are 2 window openings either side of a stable entrance

door with timber lintels. Stone slates around the building suggest that it was a stone slate roof in the past. Some of the timber frame is preserved.

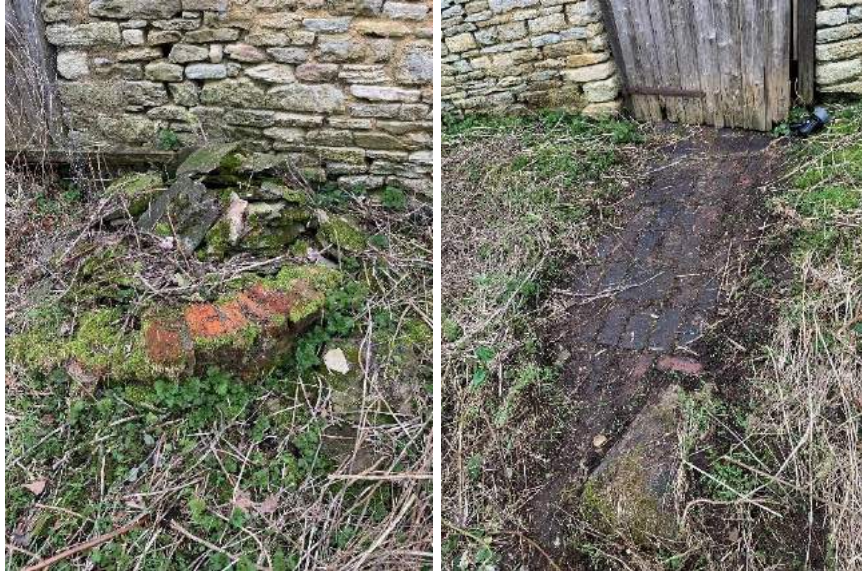
### 6.3.7 External finishes

Uneven brick paving outside the front stable door in fair condition. To the west there is a well with a brick opening.

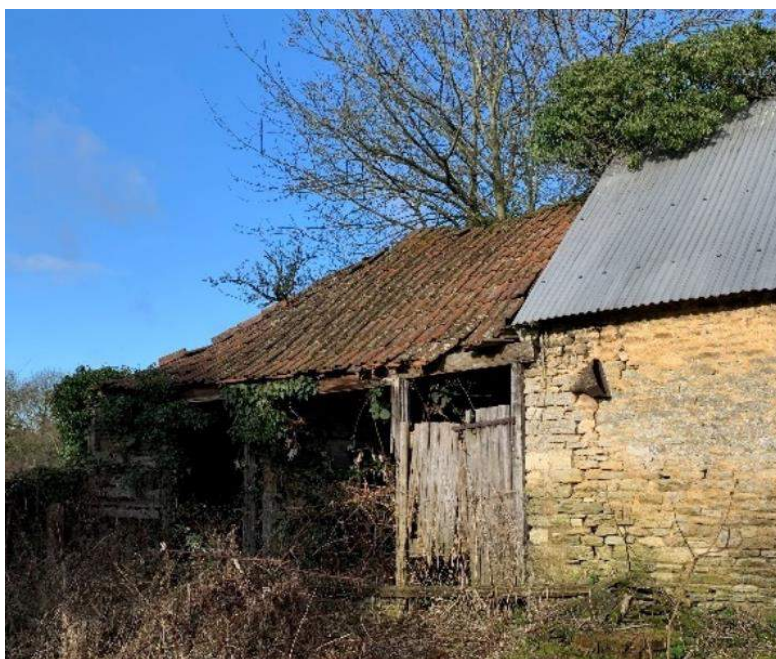
## 6.4 Block B1, west of Block B

The range runs east-west as an extension to Block B. It is in ruinous condition and unsafe to access. The hipped roof facing west has collapsed. The structure is defined by stone walls to the west, north and east elevations and would have been open to the south with some timber weatherboarding.

- 5.1.1 Carry out enabling works to Block B1. Carefully remove dangerous elements of roof structure in Block B1. Remove existing tree growing internally, under guidance of an arboriculturist. The existing timber truss should be secured to structure to avoid damage during demolition works.

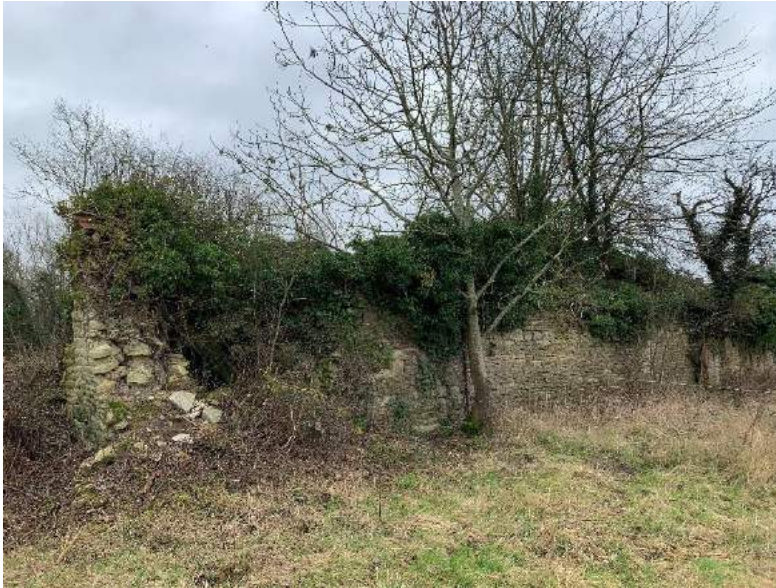
### 6.5.1 Exterior

Block C is in a ruinous condition, all that remains is a gable wall on the south end, a west boundary wall and a small section of north gable wall. The remaining walls are coursed rubble limestone.

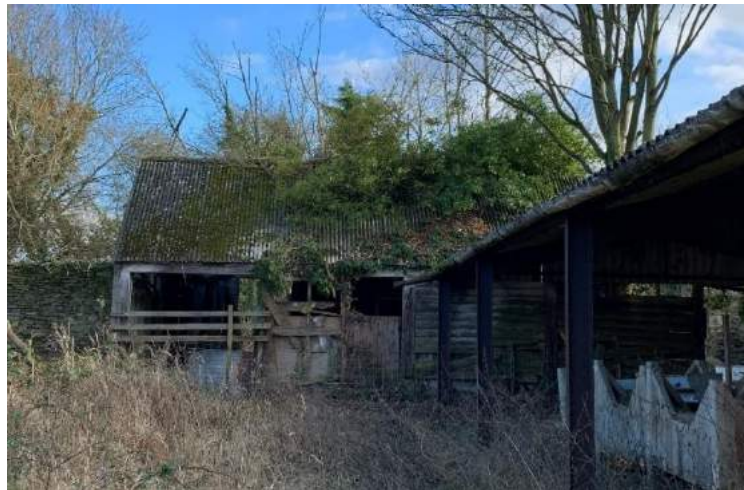
#### 6.6.1 Exterior

Single pile, 6 bay timber framed stable block with a masonry wall to the east side and a brick and stone extension to the south, with metal corrugated roof and partially collapsed to the south side. The whole of Block F appears to be raking towards to east.

- 5.1.4 Seek advice from structural engineer on repairs to the roof structure of Block F.
- 5.1.5 Carry out reroofing to Block B, as well as crack repairs and rebuilding of the south east corner to stop further water ingress, and the dormer window to the north.

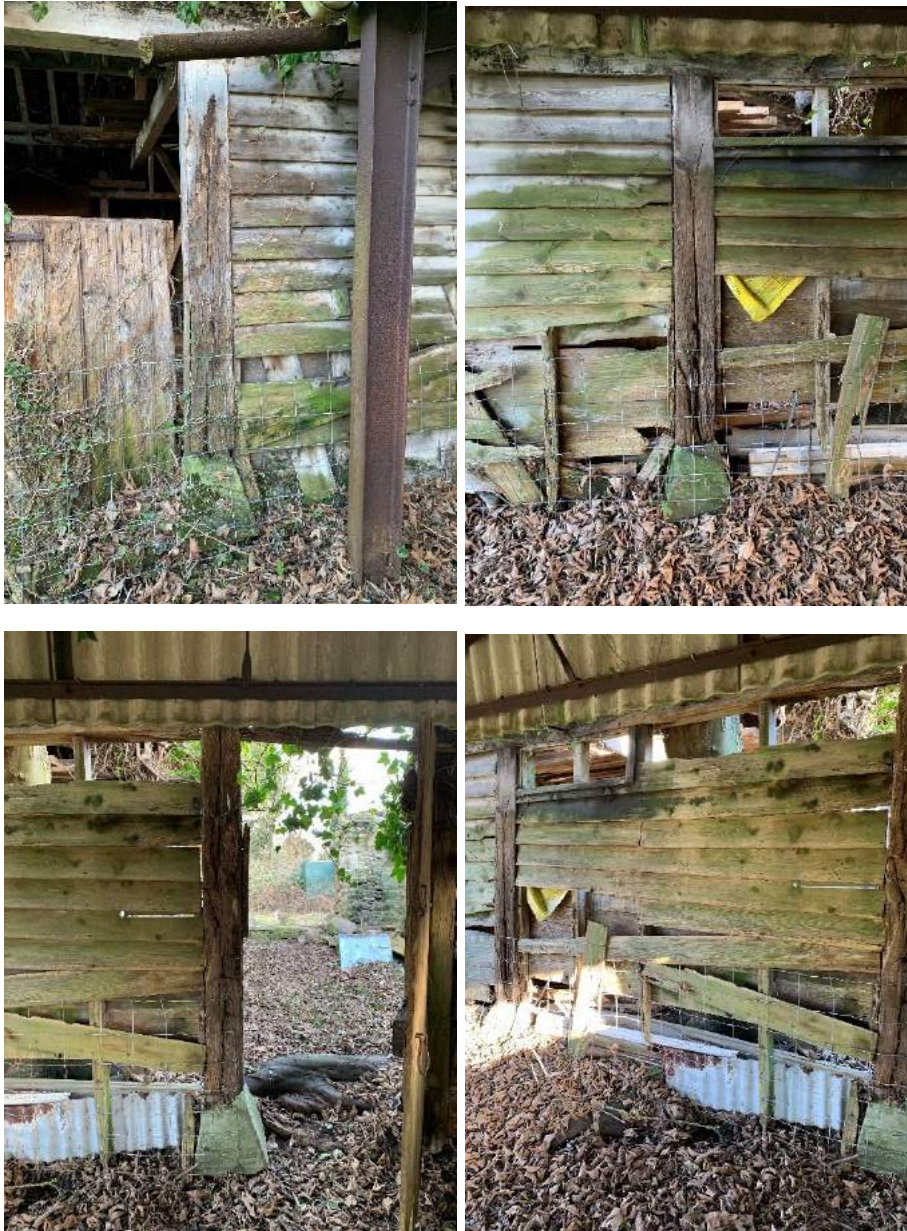
Weatherboarding/ panels;

- Between posts 1 and 2. Open bay.

- Between posts 2 and 3. The door jamb, has significantly decayed and cracked. The lower section of the door is intact, but the top section is missing. Small amounts of weatherboarding remain, but these have cracked and are dislocated.

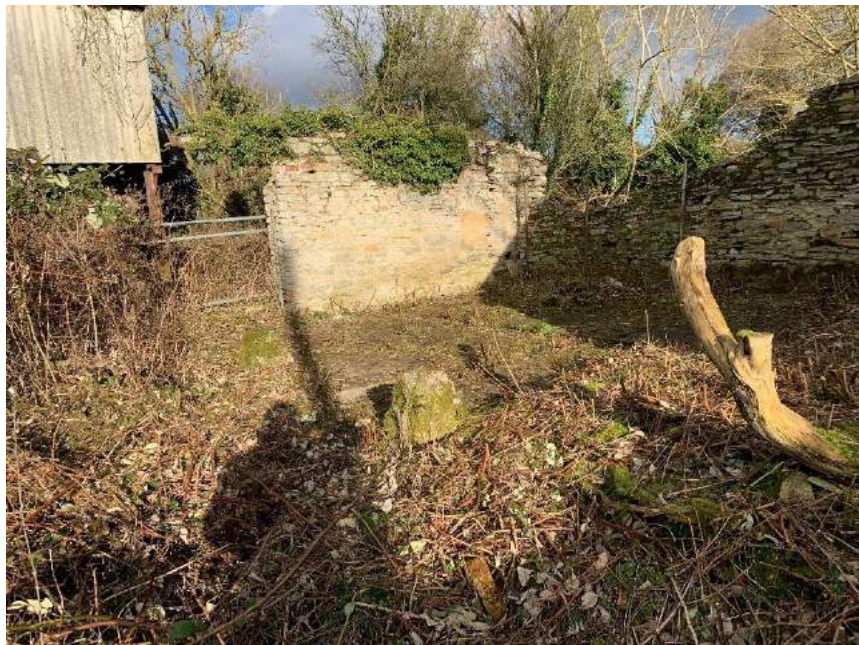
### 6.7.1 Exterior

In a ruinous condition. From remains it appears to have been a timber framed 3 bay structure, which projects slightly forward from Block F and is enclosed on 3 sides. North and East sides are masonry walls and south side is a timber wall connecting through to Block F with a door.

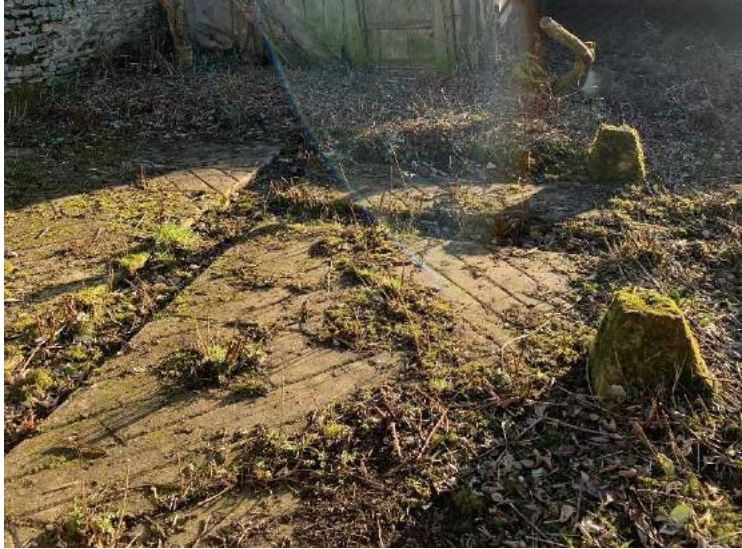
- a. Walls. The remaining stone walls are covered in moss and require rebuilding. In the southeast corner of Block F1 there is a tree that will require grubbing out.
- b. Floor. Concrete floor with drainage channels in fair condition.

- 5.1.9 Remove loose stone on the south wall of Block F south extension.
- 5.1.10 Remove a tree growing within the footprint of Block F1.

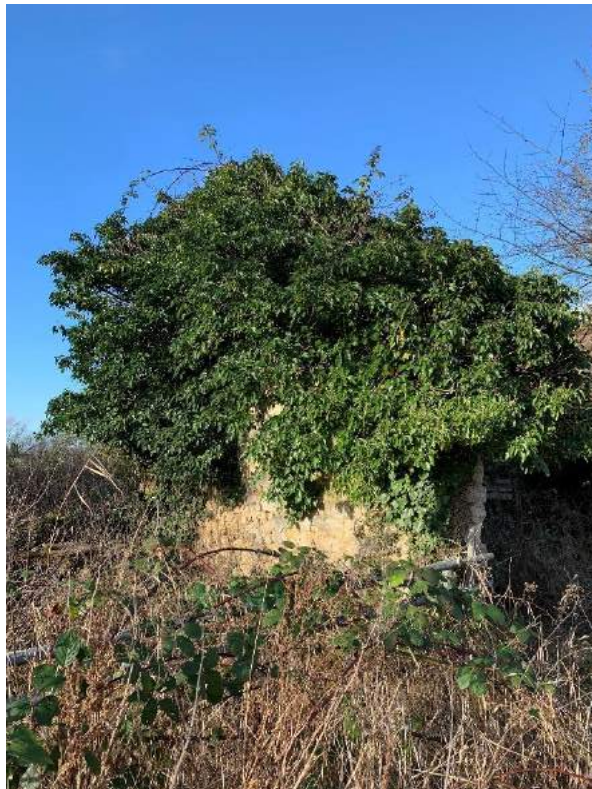
#### 6.8.1 Exterior

Block G is in a ruinous condition, with only the north gable wall largely intact and small sections of remaining external stone walls.

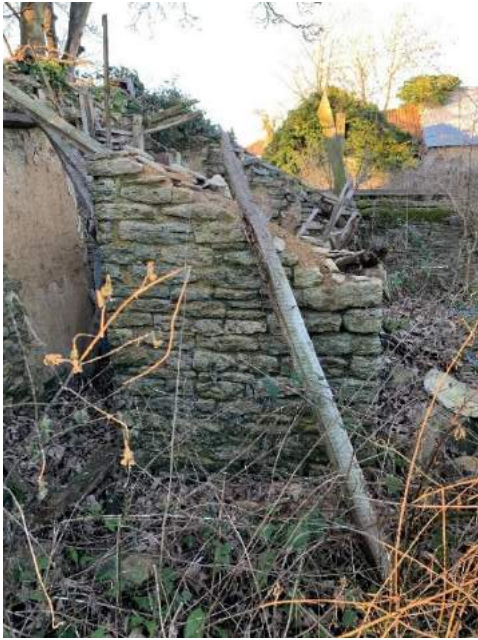
The roof has collapsed, but remains of a verge rafter and a wall plate suggest the shape of the roof. The west wall is unstable and leaning outwards towards the west by about 200mm. Small section of south wall, next to an old opening appears to be in fair condition. The door has collapsed and is rotten.

The structure requires rebuilding.

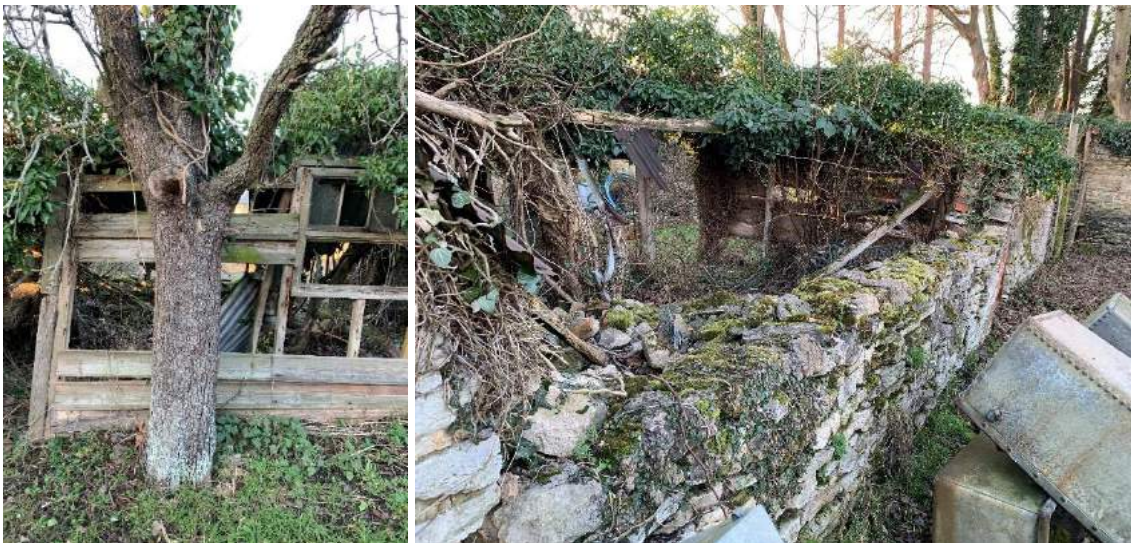
### 6.9.1 Exterior

Lean to shed abutting the garden wall to the north side. Two rubble stone walls and two timber wall with a metal corrugated roof. Simple metal roof structure with purlins, no rafters.

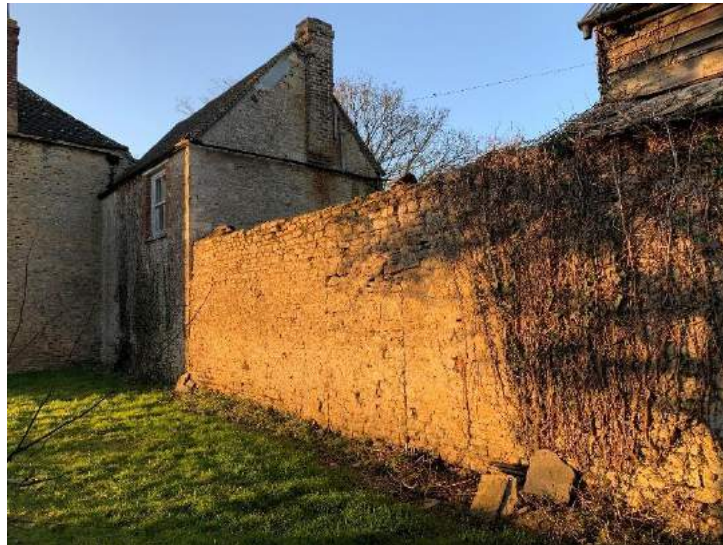
#### 6.10.1 Garden wall between main Farmhouse and Block A1

Course rubble limestone wall. The top of the wall does not have any capping, which has caused the mortar to be partly washed away. The wall will require repointing and a new capping, potentially stone slates continued from behind Block A1.

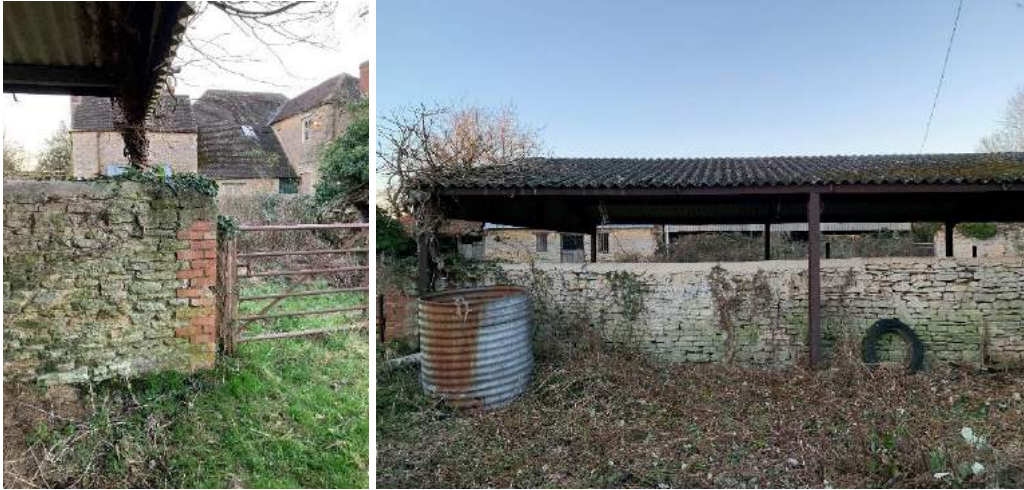
#### 6.10.2 Boundary wall 1 - Boundary wall within Block E

Drystone wall. Section of wall, approx. 3m from Block F curves to the east and is unstable. A small section of the top of the wall in the central bay of Block E will need gapping and a mortar capping. The wall has been badly infilled in small sections and pointed in some areas. There is an opening with a gate and brick quoins. It is recommended to relay the whole wall, reusing the existing stone.

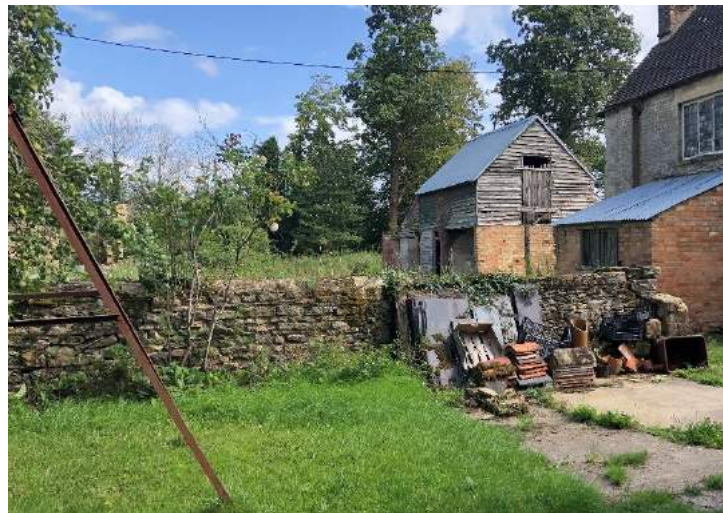
### 6.10.3 Boundary wall 2 - Boundary wall abutting Block H

Drystone wall abutting Block H on north end. The wall is unstable with a large crack and leaning towards the east side. The remains of the wall have been pointed. The wall should be re-laid reusing the existing stone work without any pointing.

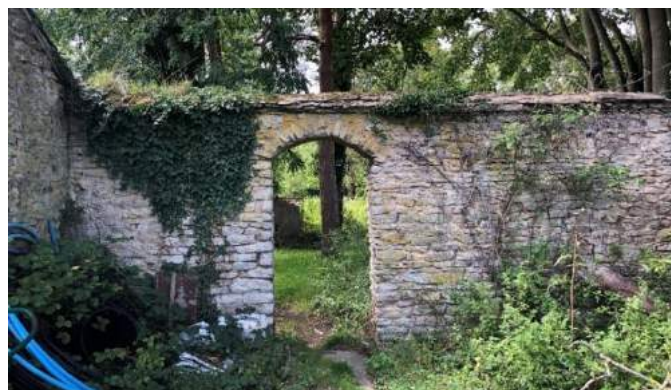
### 6.10.4 Boundary wall 3 - Boundary wall between Farmhouse and Block G

Coursed rubble stone wall. The wall is in fair condition with an archway to the orchard beyond. The wall requires removal of vegetation and repointing.

- 5.3.1 Carry out repairs to existing cracks in Boundary wall 3, which later becomes an external wall of Block G. The wall requires removal of vegetation and repointing.
- 5.3.2 Replace lintel and repair section of wall above the lintel in the south gable wall of Block C, following assessment by a structural engineer.
- 5.3.3 Take down unstable north gable wall of Block C and to Block G.
- 5.3.4 Carry out replacement of a left-hand jamb in the north wall of Block A1.
- 5.3.5 Carry out repairs of all lead flashings and horizontal timber boarding, as well as relaying of stone slates on the south wall of Block A1.
- 5.3.6 Tie in brick quoins to stone wall on east wall of Block A1.
- 5.3.7 Replace fractured joists and saturated timber boards of the mezzanine level in Block A1.

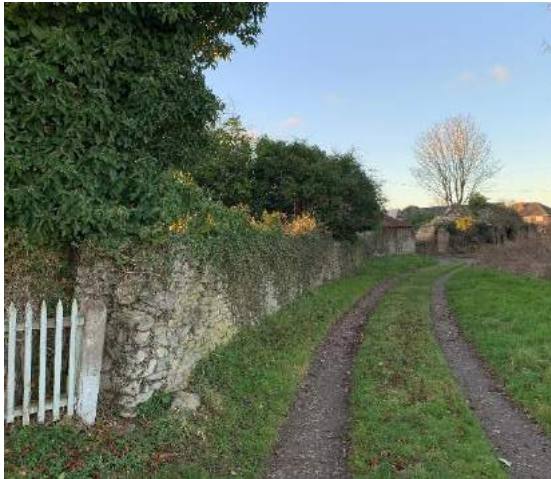
Drystone wall with mortar capping. The wall is generally in fair condition with the exception of 3 locations, which have been compromised by trees in close proximity. These are;

- At the gate at the front edge, compromised by the hedge
- At the centre of the wall, compromised by a large tree
- Where the wall meets with Block A1. There is a large crack potentially caused by movement from the wall of Block A1, which caused stones to become dislodged. This section of wall should be rebuilt with a separation to allow for future movement between the garden wall and Block A1.
