Ref: LAS_242_C
Date:23.01.2023

Site: Phase 10, Heyford Park Developments Ltd, Camp Road, Heyford Park

Arboricultural Impact Statement

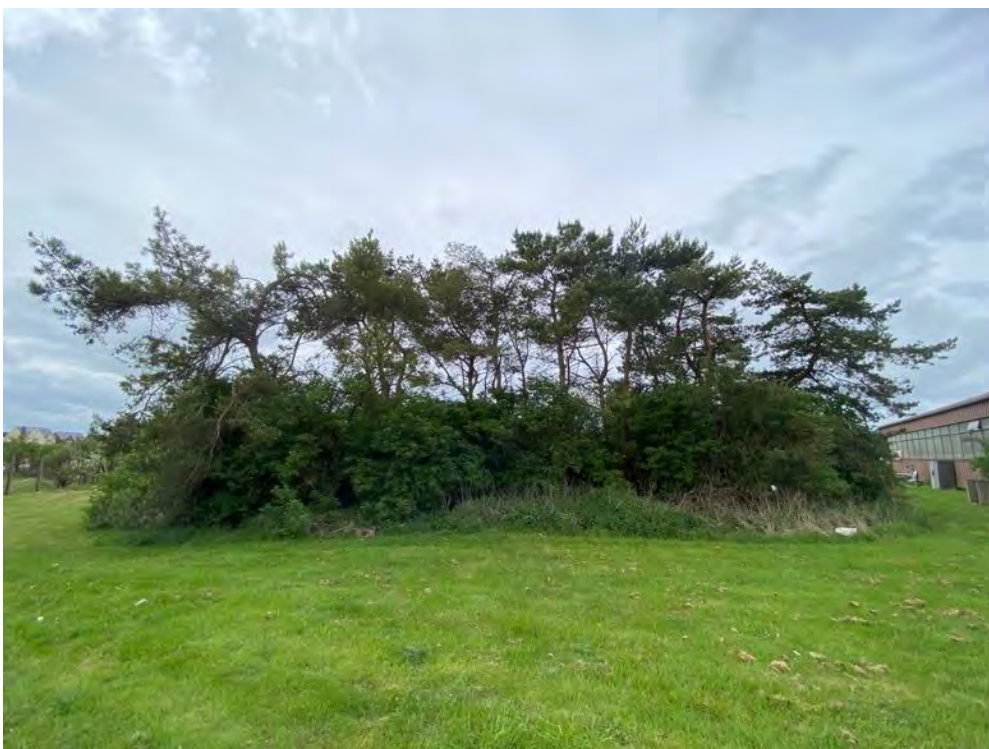
Photo 14: view south-west towards G1013.

With regard to G1013, this group will need to be removed to enable new parking and a dwelling to be constructed. Following pre-application feedback, this group was resurveyed to assess trees on an individual basis to see if any would justify a higher categorisation. All trees except T1013d are considered to be low quality due to structural condition and poor form. Many have suffered failures and or have poor form. Given many have already had branch failures and suffered storm damage, it is considered none except T1013d could realistically be retained on individual merit. Having grown as a group none appear to have a form or structural condition that would allow safe retention on an individual basis. The group would need to be either retained together or removed together. Given all but 1 of the trees are assessed individual as Category C and as a group Category C, these should not be viewed as a constraint to development.
