# ARBORICULTURAL REPORT

**Sibford Park, Sibford Gower, OX15 5RY**

Arboricultural Impact Assessment  
Date: October 2022

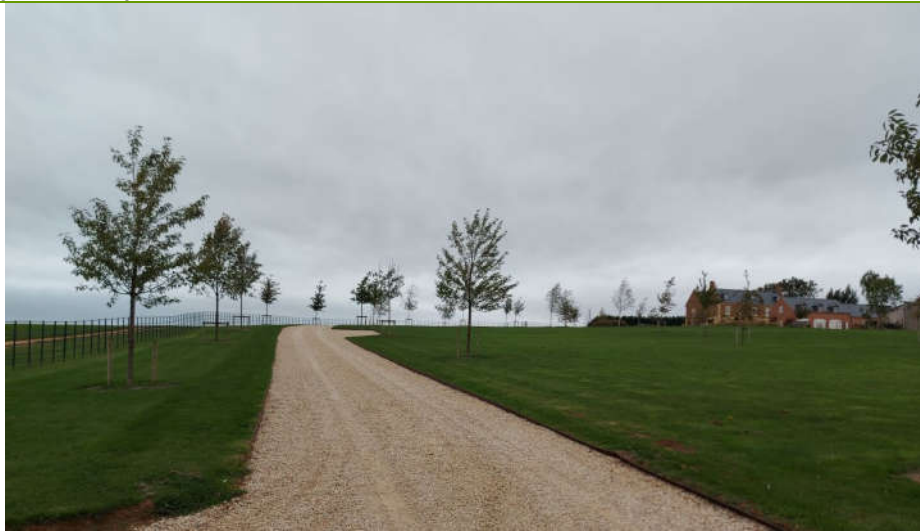
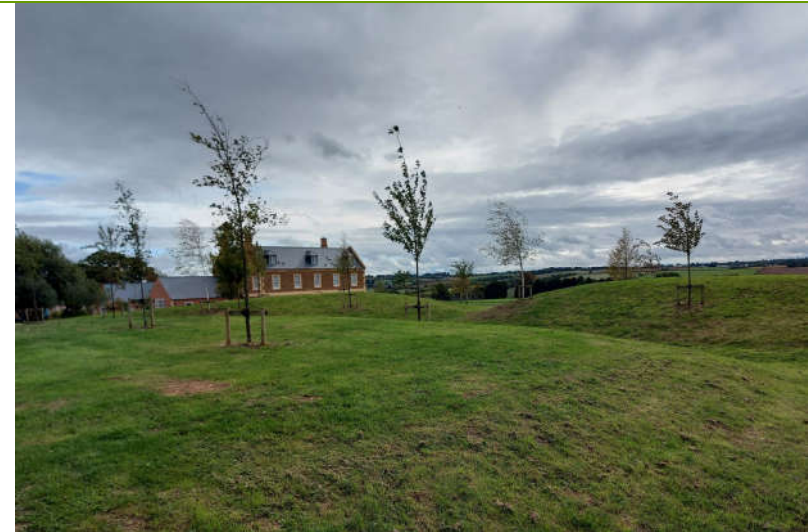
**P11 and P12. Extensive planting of large tree stock is associated with the development of Sibford Park manor house and further planting is ongoing.**
