MERSEYSIDE
FIRE & RESCUE
SERVICE

SIGNIFICANT INCIDENT REPORT

Incident: 018965 - 15092020

Address: Orsted BESS, Carnegie Road, Liverpool, L137HY

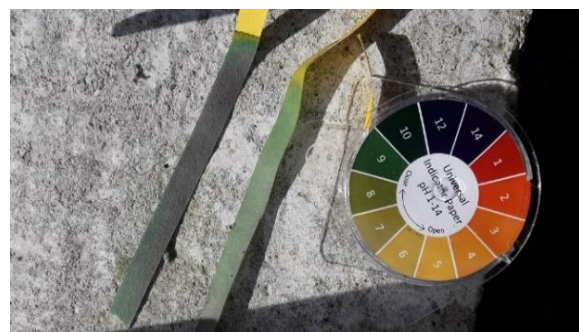
Observation: Final pH readings confirm neutral readings outside of the unit and a high alkaline content within, (pH of 14) consistent with the base metals used in Li-Ion cells. These metals include cobalt, nickel or manganese ions which are alkaline in nature. It is unconfirmed which metal, if not all, were present within the unit.

Action: Identified installations within station areas have revisited Site Specific Risk Information (SSRI) to include health, chemical and environmental hazards underpinned by informed data. This information has been gathered by operational crews in line with existing procedures for familiarisation of local risks.

Action: The SSRI refresh considered combined chemical and health hazards within typical units and should be clearly identifiable to MFRS personnel accessing the risk information for any future incidents at BESS sites. This information should be present and easily obtainable on site.

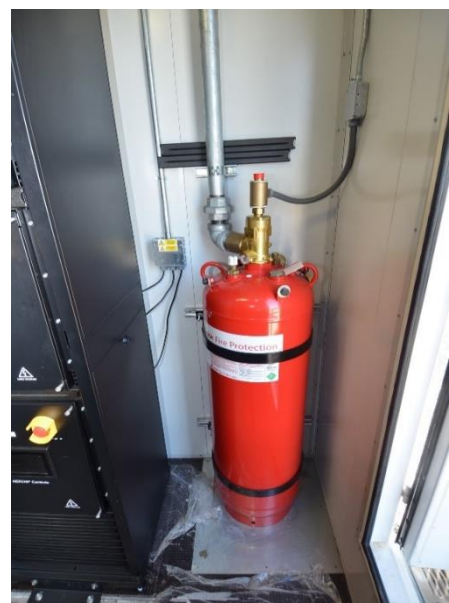
NOVEC 1230, the extinguishing agent fixed to the Orsted unit, is the latter type of agent, an aerosol of fluorinated ketones. The installation is pressurised with nitrogen, and is released on detection of fire conditions within the unit. NOVEC 1230 is stored as a liquid but discharges as an aerosol, evaporating 50 times quicker than water, absorbing heat and smothering any fire progression.
