PROJECT: BARTLETT COTTAGE  
SIBFORD COWLEY, OX15 5RY

## 4.0 Proposed Works

### 4.01 Restoration Works - Roof Works & Chimneys

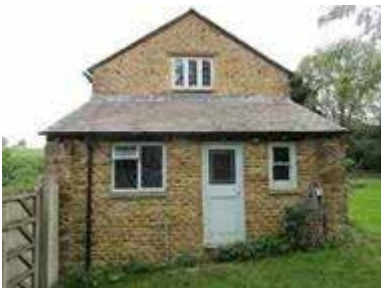
Existing South West Elevation

4 Timber windows to the right hand side of the entrance porch both at ground and first floor levels are in a dilapidated state. The proposal is to replace with new double-glazed metal frame windows to match the existing with slim mullions and metal glazing bars, set in a fixed timber surround frame.

5 Timber windows to the left hand side of the entrance porch are in a substantially dilapidated state and will benefit from replacement. There is some cracking above the ground floor window to the left hand side of the entrance porch. The lintel above the first floor window to the left hand side of the entrance porch is in a dilapidated state. The proposal is to replace with new double-glazed metal frame windows to match the existing with slim mullions and metal glazing bars, set in a fixed timber surround frame. The proposal is to replace the existing timber lintels with matching new timber lintels. A structural engineer will be appointed to size and propose the specification.

5 Timber windows to either side of door of the entrance porch are in a poor state. The proposal is to replace with new double-glazed metal frame windows to match the existing with slim mullions and metal glazing bars, set in a fixed timber surround frame.

6 The timber window at first floor level is in a dilapidated state. The proposal is to replace with new double-glazed metal frame windows to match the existing with slim mullions and metal glazing bars, set in a fixed timber surround frame.

7 The ground floor windows are in a dilapidated state. The proposal is to replace with new double-glazed metal frame windows to match the existing with slim mullions and metal glazing bars, set in a fixed timber surround frame.

8 There is some slight cracking to the left and right hand sides of this elevation at the lowest point of the roof line most likely as result of light roof spread. As part of re-pointing works , crack stitching is proposed in order to tie the stone quoins to the main stone wall.

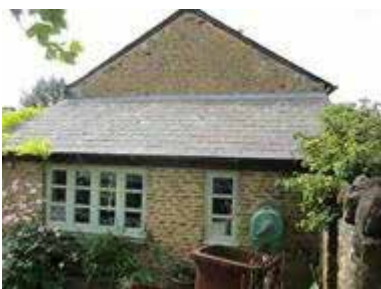
Existing North East Elevation

8 The windows are in a dilapidated state. The proposal is to replace with new double-glazed metal frame windows to match the existing with slim mullions and metal glazing bars, set in a fixed timber surround frame matching to existing.

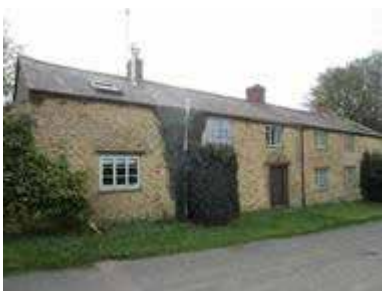
Existing North West Elevation

9 The timber window at ground and first floor level are in a dilapidated state. The proposal is to replace with new double-glazed metal frame windows to match the existing with slim mullions and metal glazing bars, set in a fixed timber surround frame.

10 The lintels above the first floor windows have clearly suffered with some decay and deterioration over the life of the building however in large part they appear original and at this stage no failure is noted. However where more significant deterioration is noted particularly to the right hand side of this elevation.

12 The existing 2nos roof lights are of some age, and the proposal is to replace them with new "conservation" roof lights ( double glazed ) to fit into the existing openings.
