**North Arms House, Wroxton – Schedule of Windows existing & proposed.**

In support of the application, the following schedule of existing and proposed window joinery is submitted.

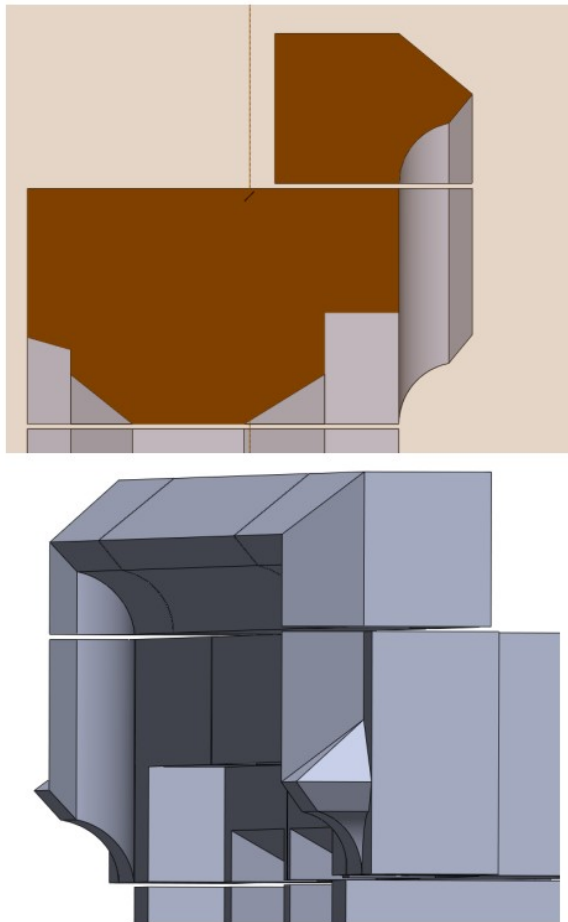
Fig.11 - GFW 11 Stone mullioned widow – proposed head moulding

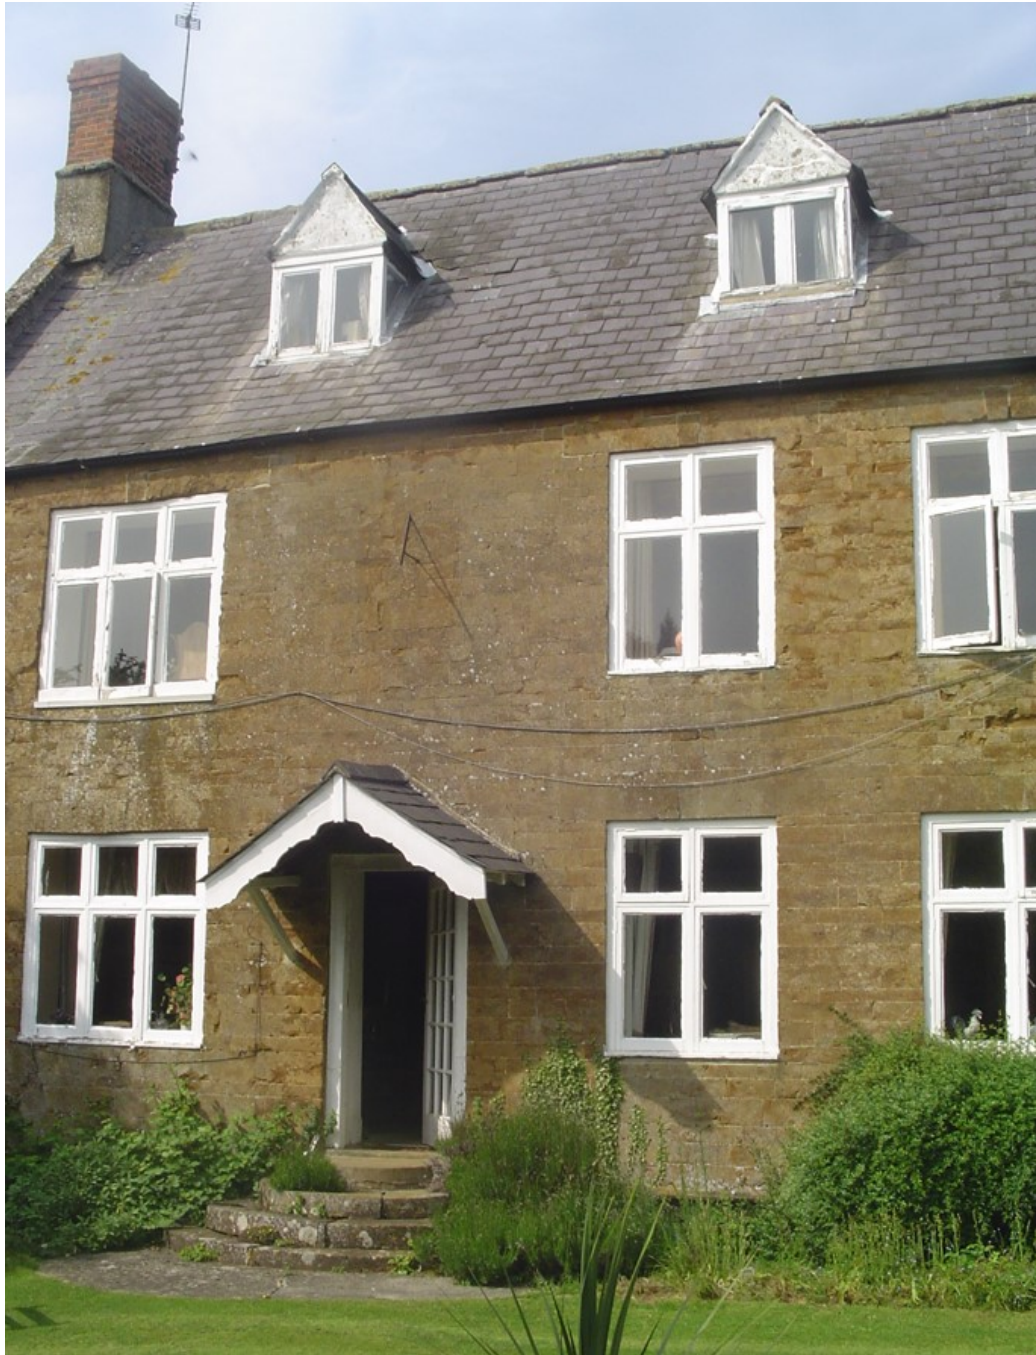
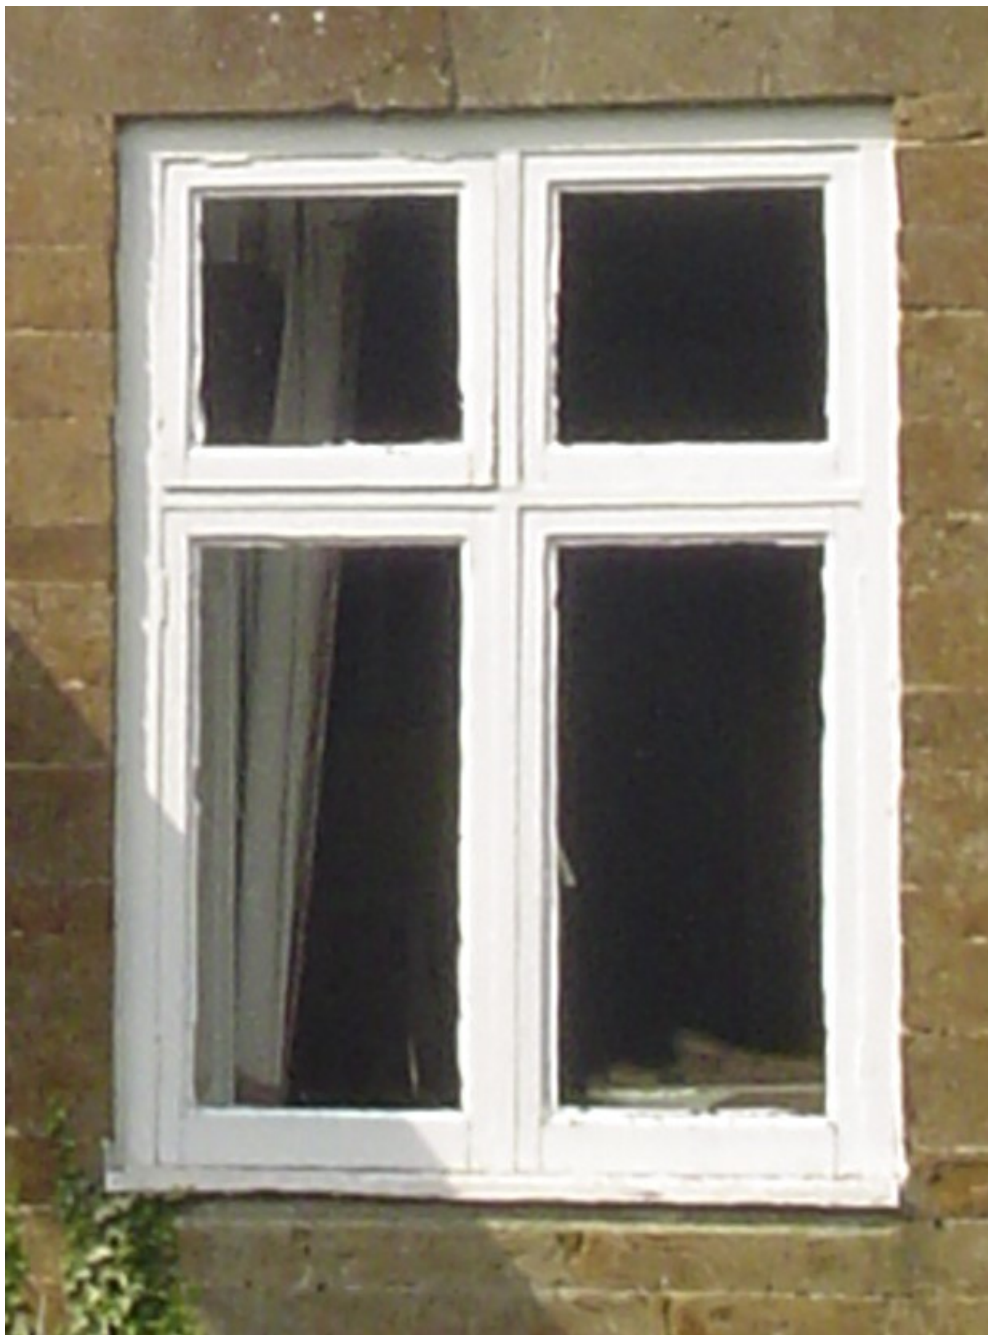
*Fig. Ax 1 –Raydon Hill House (c. 2006)*

The identical windows at Raydon Hill House, Mills Lane (35metres North Esat of North Arms House) had retained their opening side hung casements and top hung vents into early C21
