heyford park

BUILDING APPRAISAL

ROGER EVANS ASSOCIATES LTD FOR NORTH OXFORDSHIRE CONSORTIUM LTD

Issued : July 2006

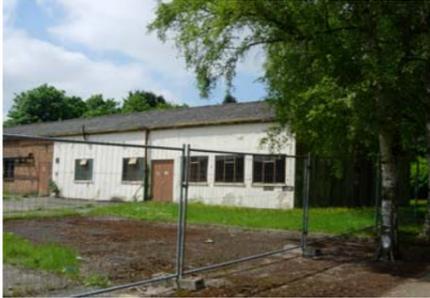
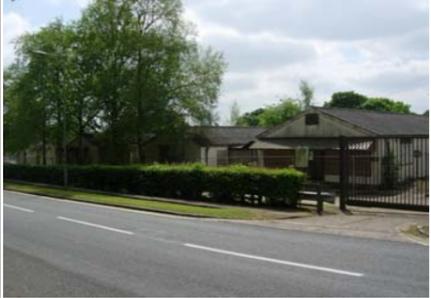
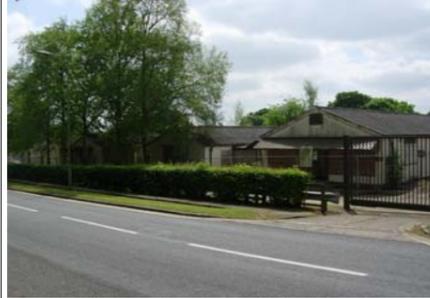
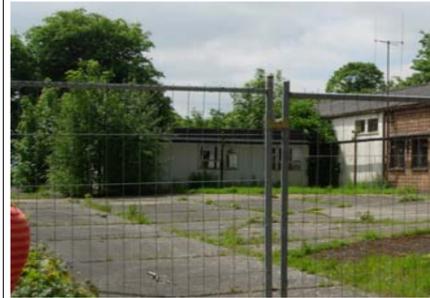
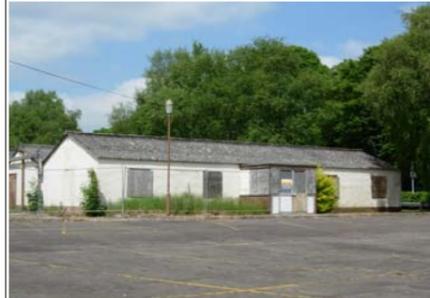
Area 1

Building No.	400	401	402	403	404
Current Use	Disused - former office	Disused - former office	Disused - former office	Disused - former office	Disused - former office
Date of Construction (NB: info from asset register)	1939	1939	1939		1939
Floor Area/Volume m ² /m ³ (NB: info from asset register)	797	334	361		361
Number of Floors	1	1	1	1	1
Building Height (Eaves, Ridge) m, estimated	3.5, 5	2.5, 4	2.5, 4	3	2.5, 4
Construction/Structure	Part clad in concrete panels, part brick & rendered brick walls with corrugated, pitched asbestos roof.	Pre-fabricated unit on concrete plinth, asbestos roof, boarded up timber windows.	Brick & render with corrugated, pitched asbestos roof.	Portakabin linked to rear of unit 400.	Rendered brick walls with corrugated, asbestos pitched roof. Boarded up windows.
Building/Setting Features & Characteristics of Note	Metal clad single storey building with shallow pitched roof to one side.

Potential Uses					
Status/Condition	4 poor	4 poor	4 poor	4 poor	4 poor

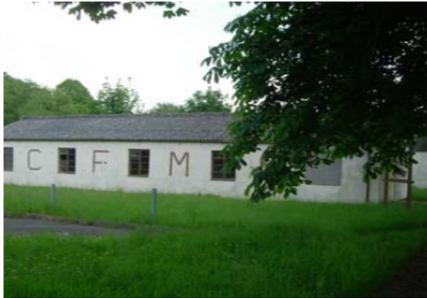
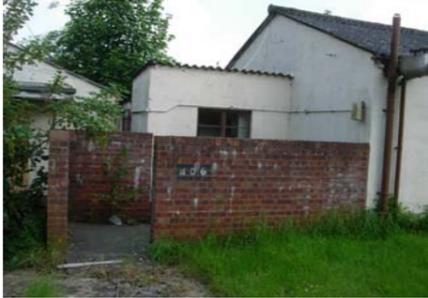
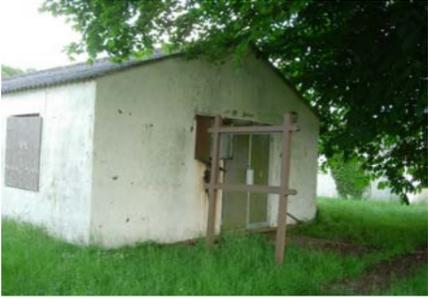
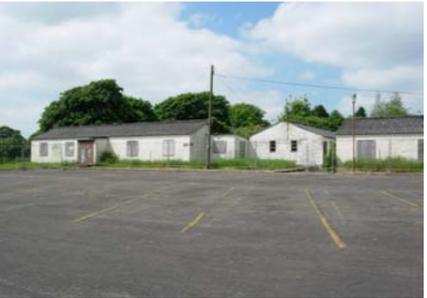
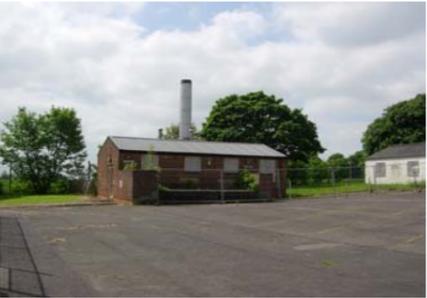
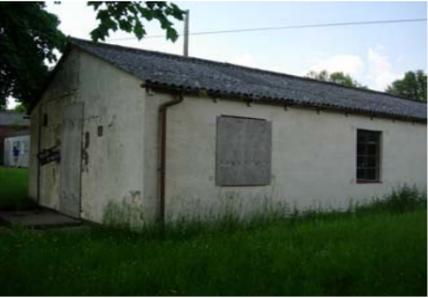
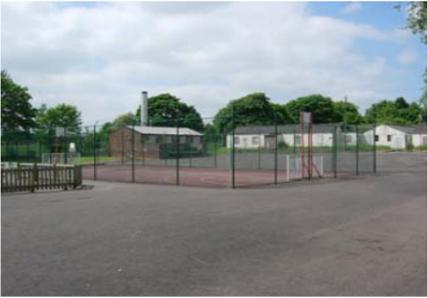
Area 1

Building No.	405	406	407	409	410
Current Use	Disused - former office	Disused - incinerator?	Disused - former leisure/office?	Disused - former office	Disused - former boiler house
Date of Construction (NB: info from asset register)	1939	1982	1939	1939	1939
Floor Area/Volume m ² /m ³ (NB: info from asset register)	119	10	119	146	91
Number of Floors	1		1	1	1
Building Height (Eaves, Ridge) m, estimated	2.5, 4	1.5	2.5, 4	2.5, 4	3, 4.2
Construction/Structure	Rendered brick walls with corrugated, asbestos pitched roof	concrete slab, 1.5 m high brick wall enclosure	Rendered brick walls with corrugated, asbestos pitched roof. Boarded up windows.	Rendered brick walls with corrugated, asbestos pitched roof. Boarded up windows.	Brick walls with sheet metal roof. Boarded up windows at high level. Large chimney & flues.
Building/Setting Features & Characteristics of Note					Basketball pitch and play area adjacent boiler house in reasonable condition.

Potential Uses					
Status/Condition	4 poor	4 poor	4 poor	4 poor	4 poor

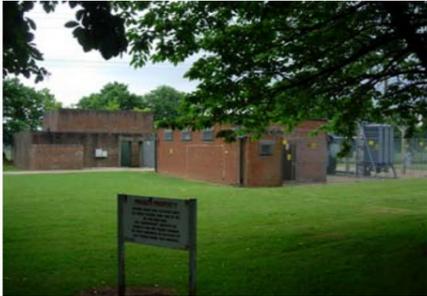
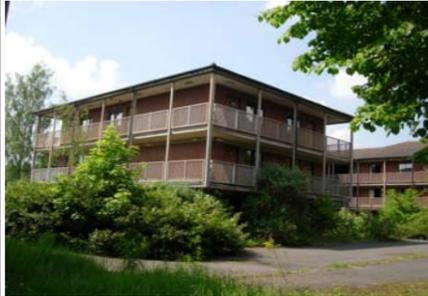
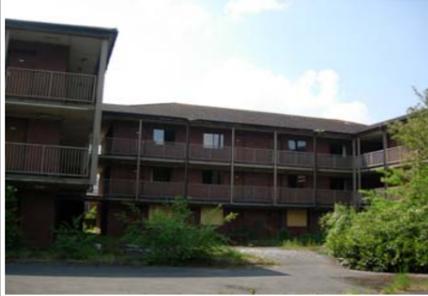
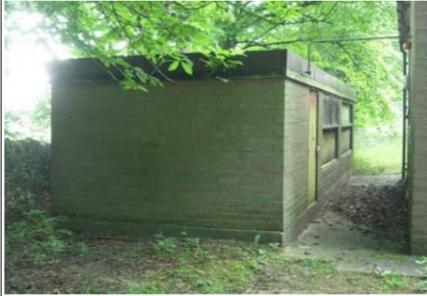
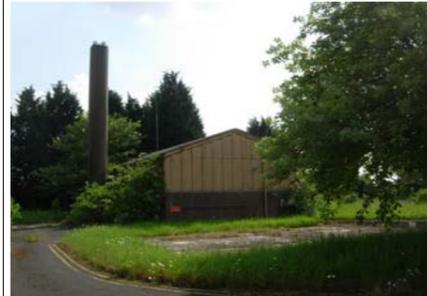
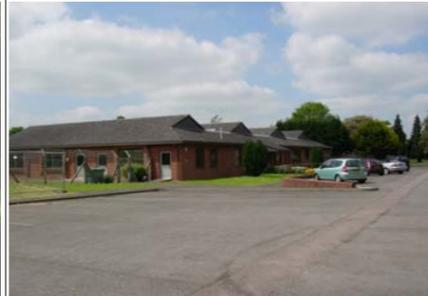
Area 1

Building No.	425	440	440B	441	442
Current Use	Electric sub-station	Disused - former dormitory	Disused - former boiler room	Disused - former boiler house	Child Care Centre
Date of Construction (NB: info from asset register)	1952	1984		1970	1984
Floor Area/Volume m²/m³ (NB: info from asset register)	103	4109		104	975
Number of Floors	1 & 1.5 equivalent	3	1	1.5 equivalent	1
Building Height (Eaves, Ridge) m, estimated	3 & 4	8, 10.5	2.5	4, 5.5	2.5, 5
Construction/Structure	Brick walls with metal vents and metal doors. Wire mesh fence enclosure supported by concrete posts. Barbed wire to top.	Red, brindled brick with red coloured mortar, concrete floors and timber, pitched, tiled roof. Large overhang to roof covering external concrete & steel access balconies to dormitory rooms. Metal windows with timber sub-frame.	Brick on concrete plinth with flat roof. Metal fascia. Timber windows.	Brown brick walls - partially metal clad. Pitched timber roof with corrugated asbestos covering. Large metal chimney.	Red/orange brick walls with timber, tiled roof.

Building/Setting Features & Characteristics of Note	Prominent location on Camp Road.	Building formed from large blocks linked together by stair towers and arranged to create courtyards. Some blocks sit at a lower level than surrounding parking & access roads which are retained by a low level brick wall (approx. 750mm high). Significant number of boarded and vandalised windows.	Located behind unit 440.		Deep plan building with multiple pitches to roof with half gable ends and roof lights in valleys between pitches. Metal windows. Fenced off play area to rear.
Potential Uses	Still in use.	Hotel accommodation			Still in use.
Status/Condition	2 good	3 fair	3 fair	3 fair	2 good

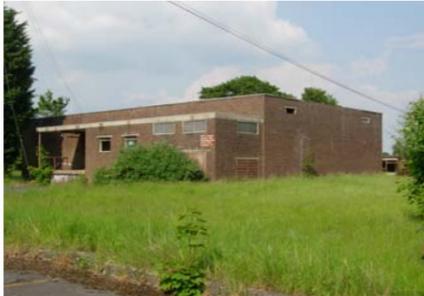
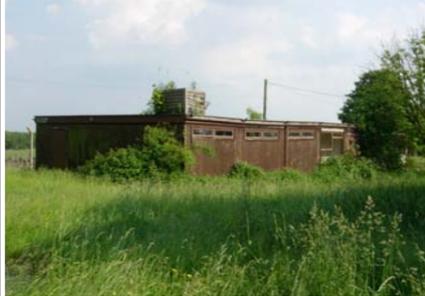
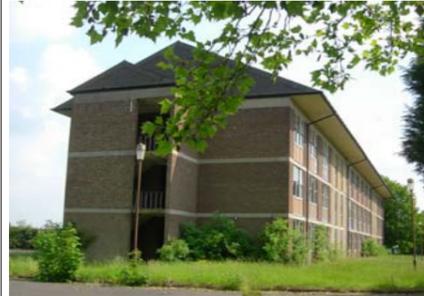
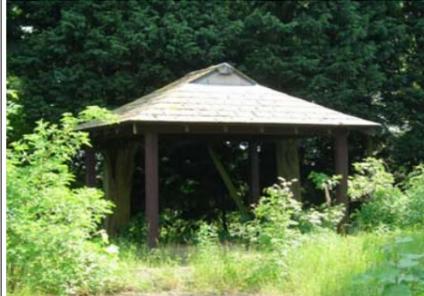
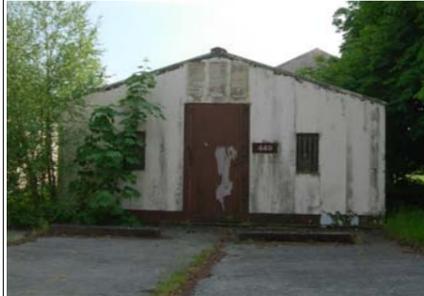
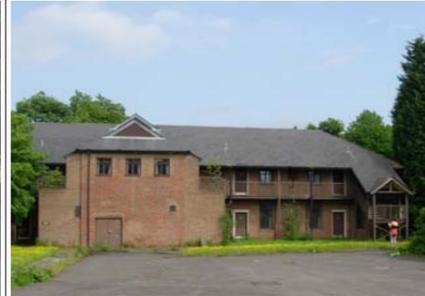
Area 1

Building No.	443	444	445, 446	449	450
Current Use	Disused - former store	Disused	Disused - former barracks blocks	Disused	Disused - former barracks blocks
Date of Construction (NB: info from asset register)	1971	1982	1970	1940	1925
Floor Area/Volume m²/m³ (NB: info from asset register)	376	159	2132	89	642
Number of Floors	1 & 1.5 equivalent	1	3	1	2
Building Height (Eaves, Ridge) m, estimated	3, 4.5	2.8	8, 11	2.1, 3	5.5, 8.5
Construction/Structure	Brown brick with flat roof. Loading bay to front with concrete flat roof. No windows to principal store volume. Large metal door to entry.	Pre-fabricated timber unit with metal clad plinth and flat asphalt roof. Timber windows.	Brown brick with concrete floor slabs. Pitched, timber, tiled roof with deep overhang. Metal windows in pre-fabricated timber infill panels. Some pebble-dash infill panels.	Metal cladding to walls over possible timber construction. Metal windows with timber cills and metal bars over internally. Timber door.	Red-brown, brindled brick with concrete floors and timber, pitched, tiled roof. Large overhang to roof covering external concrete & steel access balconies to dormitory rooms. Metal windows with timber sub-frame.

Building/Setting Features & Characteristics of Note	Asbestos present.	Roof collapsed and timber panels & windows rotten.	Asbestos present. External stairs at either end of building. Internal corridor feeds accommodation. Free-standing timber canopy with pitched roof adjacent.		Tall windows and high ceilings to ground floor. Suspended ceiling hangs lower than window soffit. Prominent laundry block to front of building. Modular rooms accessed off external balconies.
Potential Uses			Hostel, residential accommodation.		Hostel, residential accommodation.
Status/Condition	3 fair	4 poor	3 fair	4 poor	3 fair

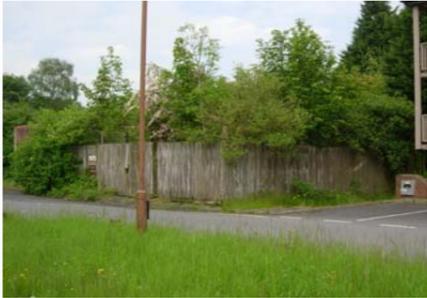
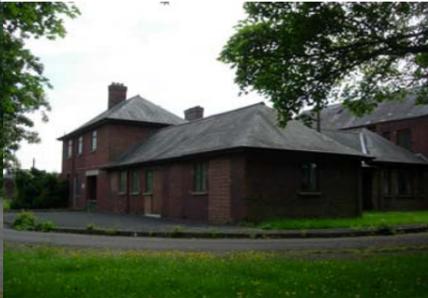
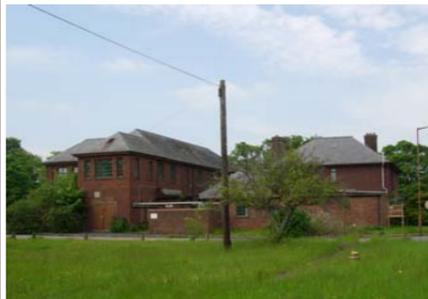
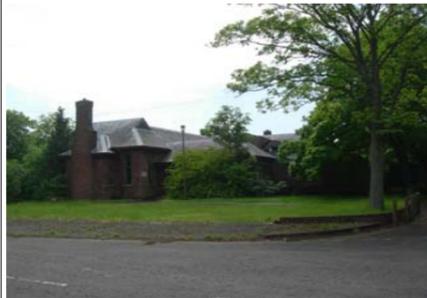
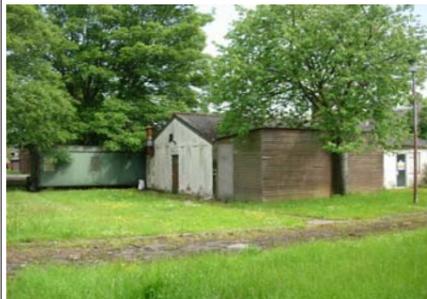
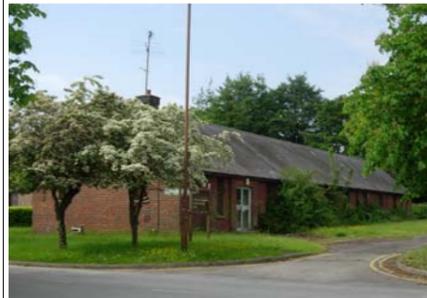
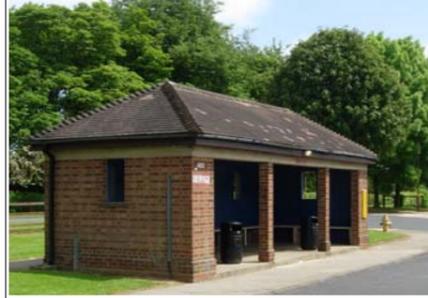
Area 1

Building No.	454	455	457	459	460
Current Use	Water tank	Disused - former offices	Disused - former offices	Disused - former day care centre	Bus shelter
Date of Construction (NB: info from asset register)	1950	1925	1925	1925	1939
Floor Area/Volume m ² /m ³ (NB: info from asset register)		1177	616	270	34
Number of Floors	1	1 & 2	1 & 1.5 equivalent	1	1
Building Height (Eaves, Ridge) m, estimated	1.8	2.5, 5 & 5, 7.5	2.5, 5 & 4, 6.5	2.5, 5	2.4, 3.5
Construction/Structure	1 No. timber fence enclosure, 1.8m high with barbed wire to top. Adjacent to 454.	Red, brindled brick with timber, pitched, tiled roof. Timber sub-frame to metal windows.	Principal block constructed from red, brindled brick with timber, pitched, tiled roof. Timber sub-frame to metal windows. Several extensions: timber clad lean to; rendered brick with pitched roof; metal clad; portakabin	Red, brindled brick with timber, pitched, tiled roof. Timber sub-frame to metal windows.	Brick with pitched, tiled roof.

Building/Setting Features & Characteristics of Note		Several single storey extensions to principal 2 storey volume, detrimental to overall appearance. Extensive bricking in of openings. Complicated floor plan potentially difficult to sub divide. Damp internally.	Asbestos present. Large HVAC system to rear of building. Extensions severely detrimental to overall character of building.	Simple single storey, volume with no extensions.	
Potential Uses		Offices	Offices	Small office units.	Still in use.
Status/Condition	4 poor	3 fair	3 fair	3 fair	2 good

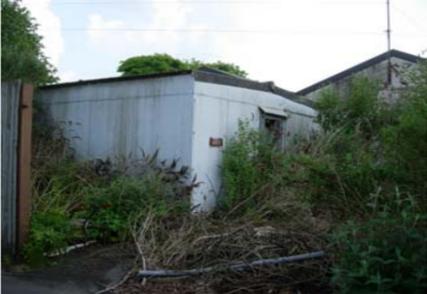
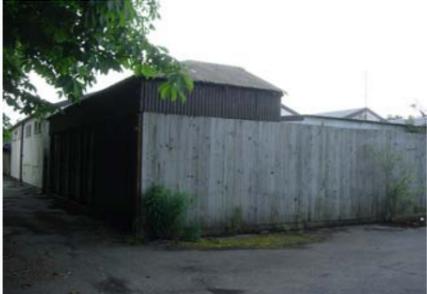
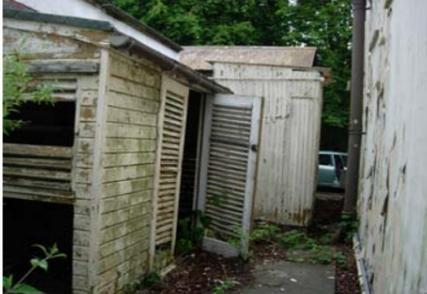
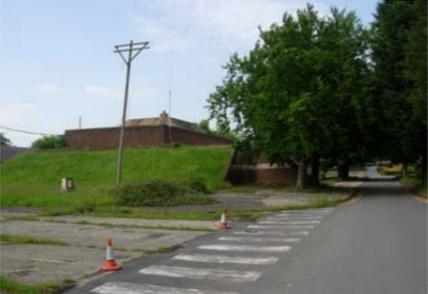
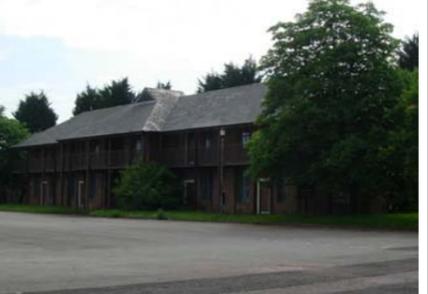
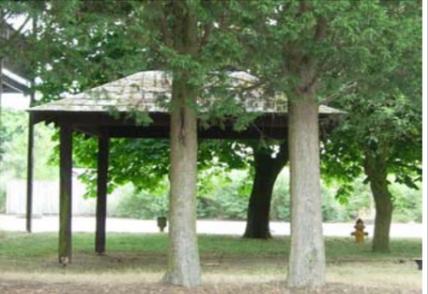
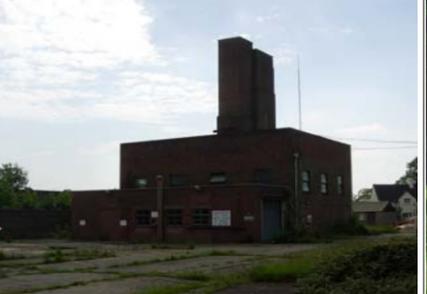
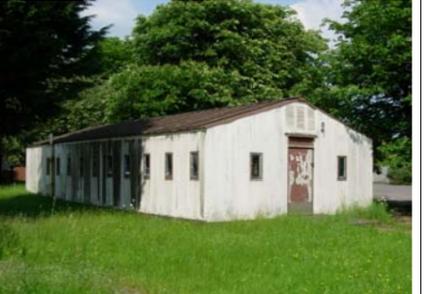
Building No.	461	465	466, 471, 480, 483	467	468
Current Use	Disused - pre-fabricated cabin & metal sheds	Disused - bunker	Disused - former barracks blocks (As 450)	Disused - former boiler house	Disused - former office/store
Date of Construction (NB: info from asset register)		1935	1925	1925	1940
Floor Area/Volume m²/m³ (NB: info from asset register)		216	642	264	94
Number of Floors	1 & 1.5 equivalent	1.5 equivalent	2	1 & 2 equivalent	1
Building Height (Eaves, Ridge) m, estimated	3 & 4	4	5.5, 8.5	3 & 6 & 12	3, 4.2
Construction/Structure	Concrete plinth, metal clad walls (painted), possible corrugated asbestos clad roof. 1 No. doorway, no visible windows. Lean-to white painted corrugated metal structure to rear. Metal container to rear, large metal doors, corrugated metal roof over supported by metal posts.	Brick and concrete with grassed earth mounded over lower level walls. Flat roof.	Red-brown, brindled brick with concrete floors and timber, pitched, tiled roof. Large overhang to roof covering external concrete & steel access balconies to dormitory rooms. Metal windows with timber sub-frame.	Red brick with flat concrete roof. 1 no. large brick chimney and 1 no. stair tower to rear. Asbestos present. Metal windows glazed with georgian wired glass.	Prefabricated unit with painted, metal clad walls and low pitched, metal roof. Rotten timber windows.

Building/Setting Features & Characteristics of Note	Structures surrounded by 1.8m high timber fence with metal and concrete support posts.		Tall windows and high ceilings to ground floor. Suspended ceiling hangs lower than window soffit. Prominent laundry block to front of building. Modular rooms accessed off external balconies. Metal & timber canopy adjacent with pitched tiled roof. (2.5, 3)	Concrete forecourt with holding tanks below. Some of removable slabs breaking up.	
Potential Uses		Secure storage.	Hostel, residential accommodation.		
Status/Condition	4 poor	3 fair	3 fair	4 poor	4 poor

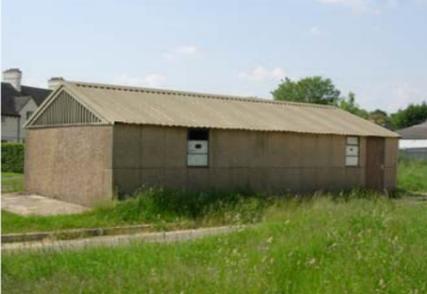
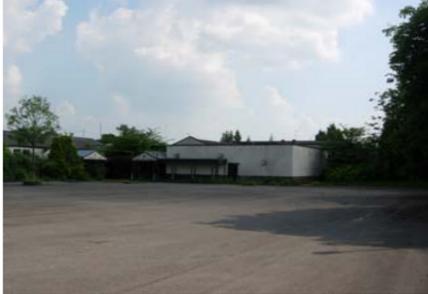
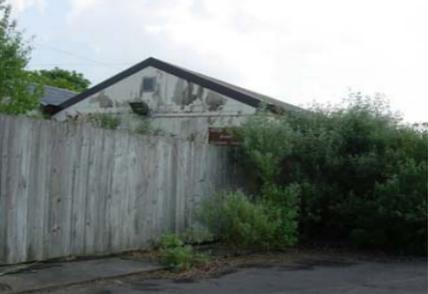
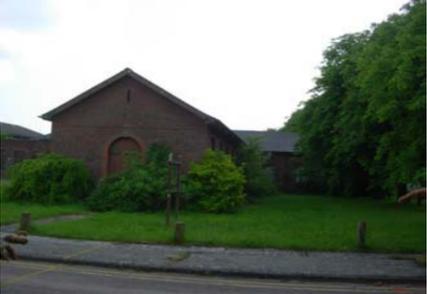
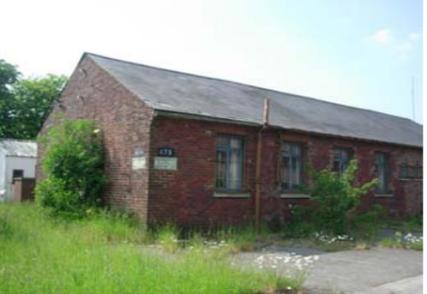
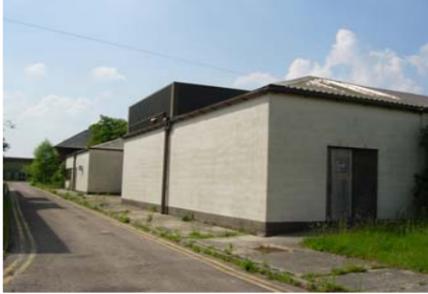
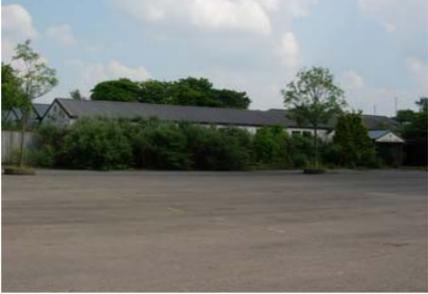
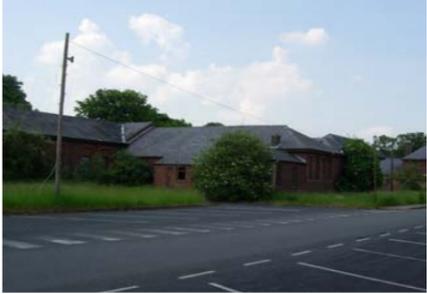
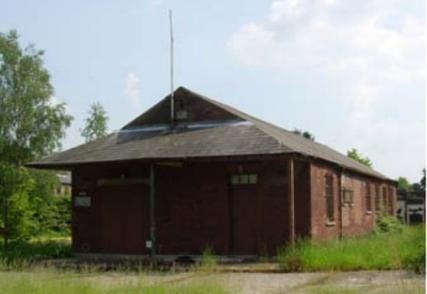
Building No.	470	472A	472B	474	475
Current Use	Disused	Disused - former mess complex	Disused - former recreation centre	Disused - former offices	Disused - former offices
Date of Construction (NB: info from asset register)	1977	1939	1939	1925	1925
Floor Area/Volume m ² /m ³ (NB: info from asset register)	60	3126 (total with 472B)	3126 (total with 472A)	650	161
Number of Floors	1	1.5 & 2 equivalent	1.5 equivalent	1 & 1.5 equivalent	1
Building Height (Eaves, Ridge) m, estimated	2.1, 3.5	4 & 6	3.5, 5	3, 5.5 & 4, 6.5	2.6, 4.6
Construction/Structure	Precast concrete panel walls with shallow pitched metal roof. Metal windows.	Painted concrete block walls with metal doors and windows. Flat roof to main block. Pitched metal roofs to single storey, blockwork rear extensions. Double height, corrugated, metal clad space to rear.	Concrete plinth with painted panel cladding to walls. Metal & glazed doors in timber subframe. Brick infill around entrance doors. Metal windows. Some portions with pitched metal clad roofs, others with flat asphalt roofs.	Red brindled brick walls with pitched tiled roof. Some flat & pitched roofed extensions. Timber doors. Metal windows with concrete cills.	Red brindled brick walls with black mortar & pitched tiled roof. Timber doors & porch at front entry. Metal windows with external metal bars over. Brick store adjacent.

Building/Setting Features & Characteristics of Note	U11 adjacent	Coffered ceiling to main internal space - large open plan area.	Several extensions to side of building.	Some feature soldier and arched brickwork courses over windows and doors. Rainwater goods & fascia rotten. Mould to internal walls.	Exposed rafters at eaves, brickwork patchy around windows. Brick corbels to eaves at gable ends.
Potential Uses				Offices	Small office units.
Status/Condition	4 poor	3 fair	3 fair	3 fair	3 fair

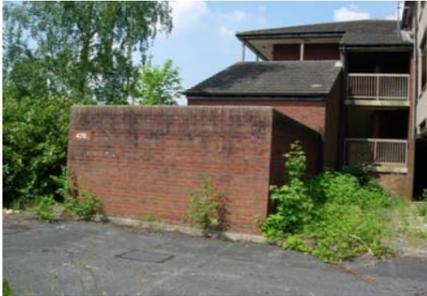
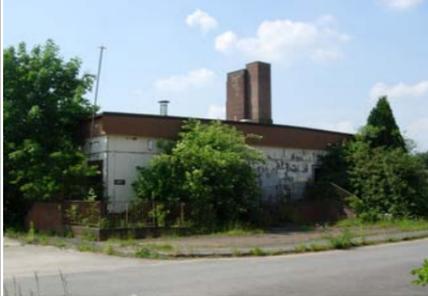
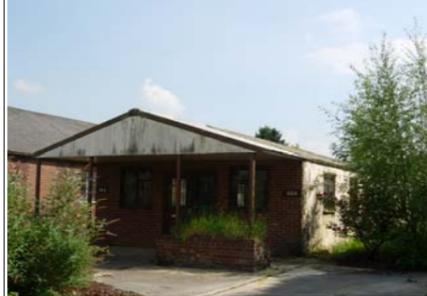
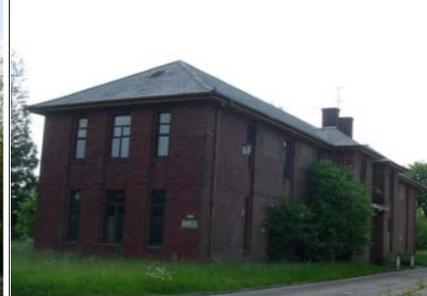
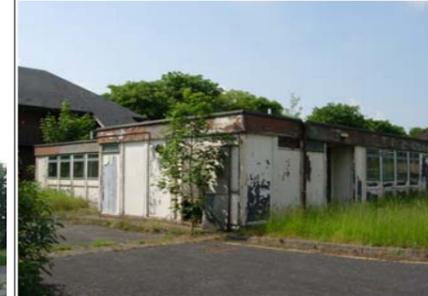
Building No.	476	481	484	485	486
Current Use	Electric sub-station	Disused - former store/shop	Disused	Disused	Disused - former offices
Date of Construction (NB: info from asset register)	1950	1973	1940	1925	1976
Floor Area/Volume m²/m³ (NB: info from asset register)		776	89	595	279
Number of Floors	1	1.5 equivalent	1	2 (2.5 equivalent)	1
Building Height (Eaves, Ridge) m, estimated	2.4	4.5	2.4, 3.4	6.5, 9	2.6
Construction/Structure	2.4m high red brindled brick enclosure.	Timber cladding panels to walls. Deep timber fascia. Flat roof. Asbestos present.	Concrete plinth, brick end wall, sides metal clad with pitched corrugated roof panels to front porch (possibly asbestos). Pitched metal roof panels to main building. Timber door and window cills. Porch supported by metal frame on brick piers.	Red, brindled brick walls with black mortar & pitched, tiled roof. Concrete frame & porch to entrance. Metal windows with quarry tile cills.	Timber pre-fabricated unit on concrete plinth with metal windows and doors. Misc. infill panels. Flat asphalt roof with deep timber fascia.

Building/Setting Features & Characteristics of Note		Concrete ramped access to side adjacent street..		Tall narrow window to front in recessed alcoves. Some openings boarded up. Obscured glazing to lower level window lights on both floors. Approx. 400mm overhang to roof.	Rotting timber panels and fascia.
Potential Uses				Offices	
Status/Condition	3 fair	4 poor	4 poor	3 fair	4 poor

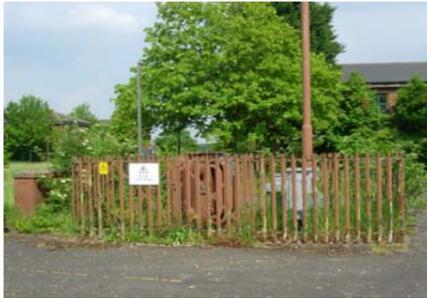
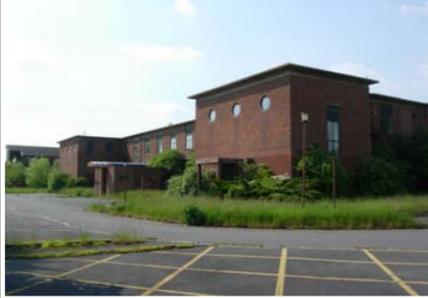
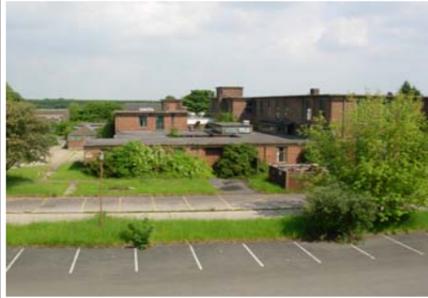
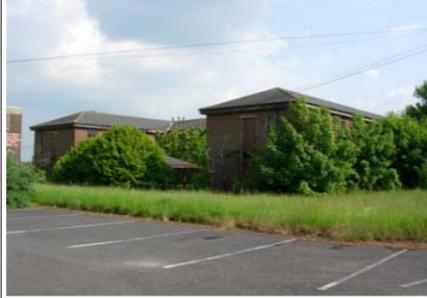
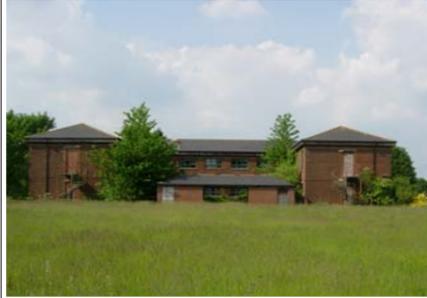
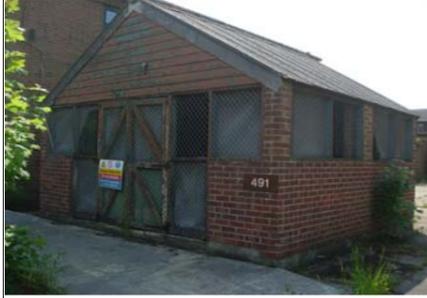
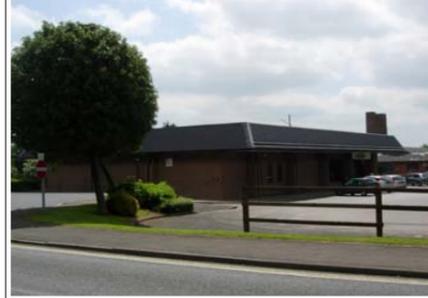
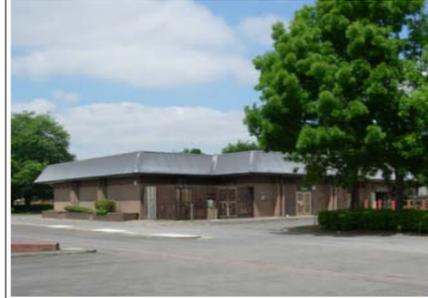
Building No.	487	488	489, 498, 500	491	492
Current Use	Electric sub-station	Disused - former lamplighter inn/dining facility	Disused - former barracks blocks	Store	Shop
Date of Construction (NB: info from asset register)	1940	1935	1926	1935	1985
Floor Area/Volume m ² /m ³ (NB: info from asset register)		2973	1259	26	616
Number of Floors		1 & 2 (1.5 & 3 equivalent)	2	1	1
Building Height (Eaves, Ridge) m, estimated	1.5	3 & 6	5, 7	2.1, 3.5	4
Construction/Structure	Painted metal fence to enclosure approx. 1.5m high.	Red brindled brick walls with flat concrete roof. Concrete entrance canopies. Metal windows in timber sub-frames.	Red, brindled brick with pitched, tiled roof. Metal windows in timber sub-frames. Curved concrete blocks frame entrance with shallow concrete canopy over.	Brown brick walls on concrete plinth with timber clad gables. Corrugated asbestos cladding on timber pitched roof. Timber open frame doors with metal mesh over.	Brown brick walls. Flat metal roof with deep angled fascia.

Building/Setting Features & Characteristics of Note		Tall windows to ceiling height, blacked out/infilled at high level. Multiple building volumes linked together. Electric sub-station adjacent in timber fence.	H-block arrangement. Entrance corridor runs front to back with brick BBQ and canopy to one end and brick stores to the other. Deep timber fascia to roof. External spiral escape stairs.	No glazing to window openings - perforated metal mesh with chicken wire over.	Deep plan creates dark interior - poor artificial lighting
Potential Uses					Still in use.
Status/Condition	3 fair	3 fair	3 fair	4 poor	2 good

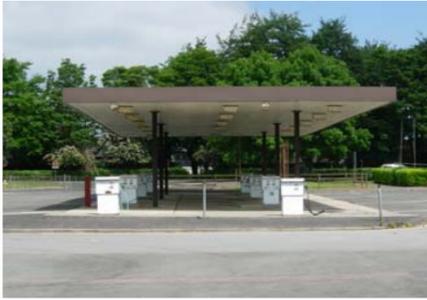
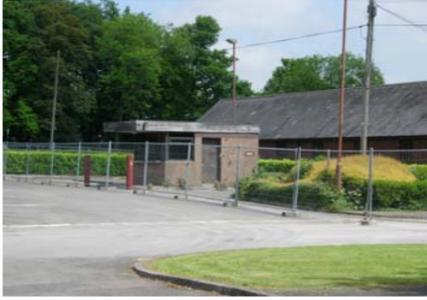
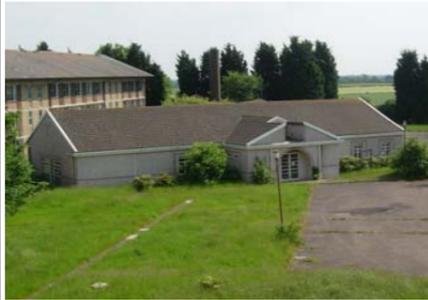
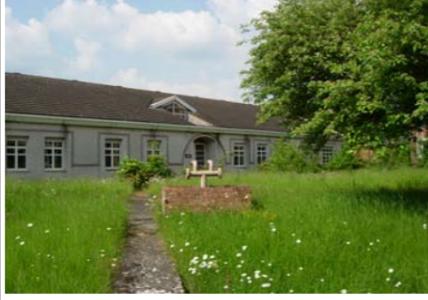
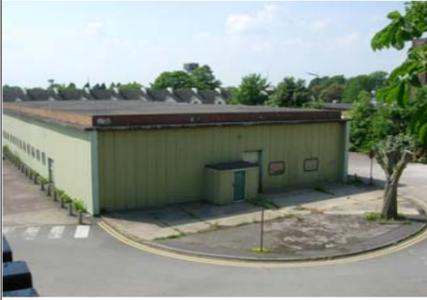
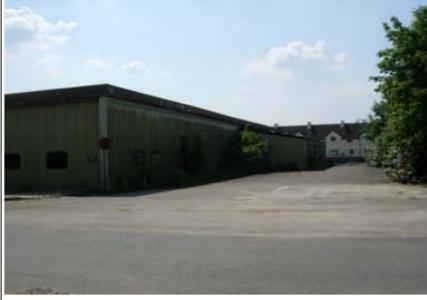
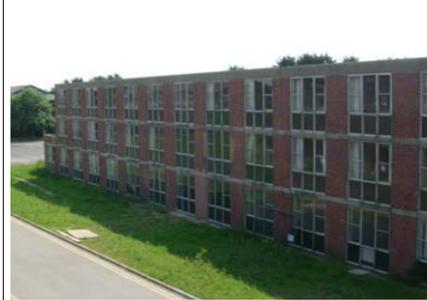
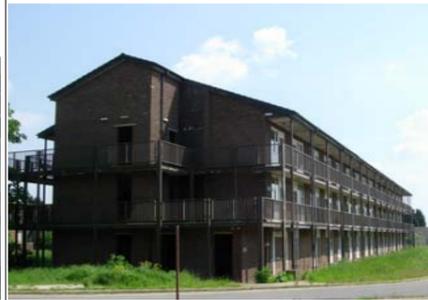
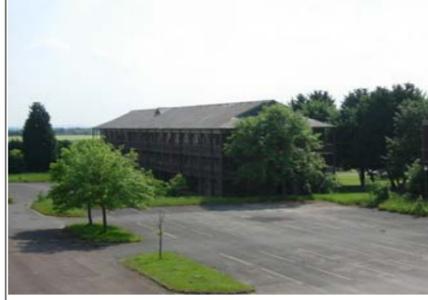
Building No.	493	502	529	593, 594	596, 598
Current Use	Disused - former petrol station	Disused - former offices	Disused - former leisure unit	Disused - former barracks blocks	Disused - former barracks blocks
Date of Construction (NB: info from asset register)	1985	1939	1935	1972	1972
Floor Area/Volume m²/m³ (NB: info from asset register)	10	402	1126	2140	2786
Number of Floors	1 & 2 equivalent	1	1 & 2 equivalent	3	3
Building Height (Eaves, Ridge) m, estimated	4 & 2.4	2.5, 5	3 & 5	8	8, 11
Construction/Structure	Metal canopy over forecourt. Brick booth with asphalt roof and timber fascia.	Building clad externally with clay-chip type rendered panels. Structure below not evident. Interlocking concrete tiles to roof. Plastic fascia and guttering. UPVC windows.	Green painted metal clad walls. Concrete flat roof with asphalt covering. Metal prot-hole type windows.	Red brick (with pink mortar) & blockwork walls with concrete floors (exposed slab edges). Flat roof. Some panels of reconstituted stone/concrete blocks. Floor to ceiling metal window panels with infill material to lower panel.	Brown brick walls with brown mortar. Concrete floors extend beyond external wall to form access balconies to dorm rooms. Pitched, tiled roof overhanging full extent of balconies. Metal balcony structure & windows.

Building/Setting Features & Characteristics of Note		Inverted dormer to rear of roof. Entrance porch. Main corridor runs from front to rear of building. Feature decorative line in panelling runs around building.	Entry porch and lean-to with mono-pitch roof to one side of building.	Appearance of 1960s prefabricated school blocks. Asbestos present. Concrete access stairs to either end of block. Central corridor gives access to dorm rooms.	Concrete access stairs to either end of block.
Potential Uses		Offices	Storage unit.	Hostel, residential accommodation.	Hostel, residential accommodation.
Status/Condition	4 poor	3 fair	3 fair	3 fair	3 fair

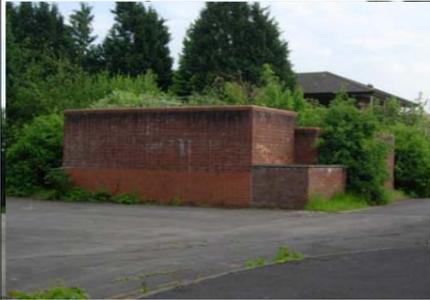
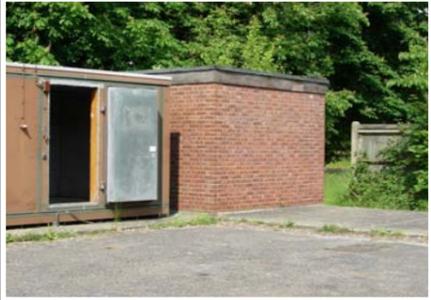
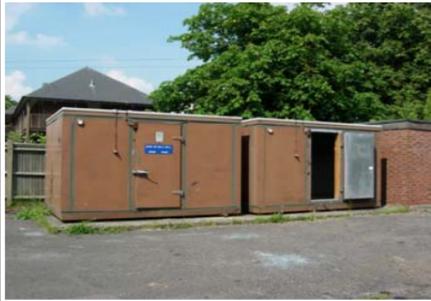
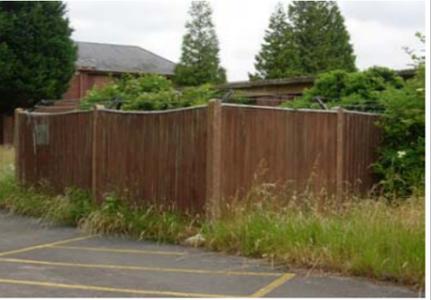
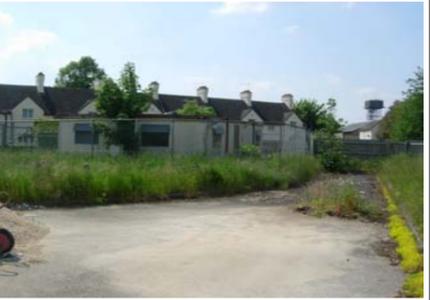
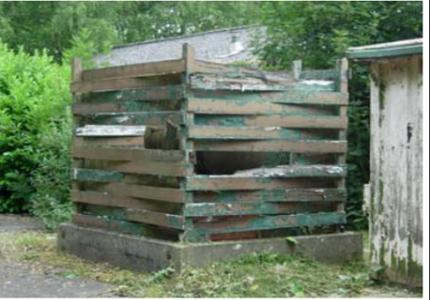
Building No.	UH8	UH9	UH10	UH11	UH12
Current Use	Disused	Disused - generator	Sub-station	Disused - Portakabin	Tank
Date of Construction (NB: info from asset register)					
Floor Area/Volume m²/m³ (NB: info from asset register)					
Number of Floors	1	1	1	1	
Building Height (Eaves, Ridge) m, estimated	3 & 1.8	2.2	1.8	2.8	2
Construction/Structure	Mixed brick construction with flat roof and varied volume heights.	Brick walls, flat asphalt roof, timber fascia and louvred timber doors. Two large prefabricated metal fridges to one side.	1.8m high timber fence panels supported by concrete posts. Barbed wire on top.	Disused Portakabin adjacent to building 470 surrounded by chicken wire fencing.	Metal tank on concrete plinth surrounded by timber boards & chicken wire
Building/Setting Features & Characteristics of Note					
Potential Uses					
Status/Condition	4 poor	3 fair	3 fair	4 poor	4 poor

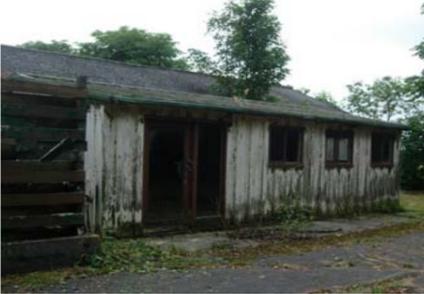
Building No.	UH13
Current Use	Disused - office
Date of Construction (NB: info from asset register)	
Floor Area/Volume m²/m³ (NB: info from asset register)	
Number of Floors	1
Building Height (Eaves, Ridge) m, estimated	2.4, 3
Construction/Structure	Corrugated metal clad walls on concrete plinth. Pitched metal roof. Metal windows.
Building/Setting Features & Characteristics of Note	
Potential Uses	
Status/Condition	4 poor

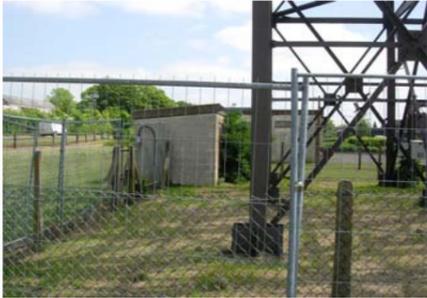
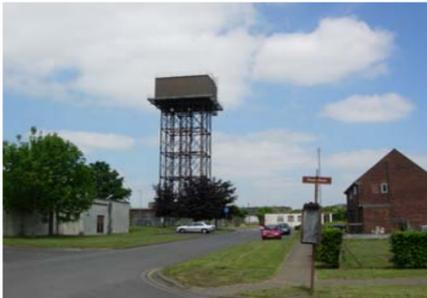
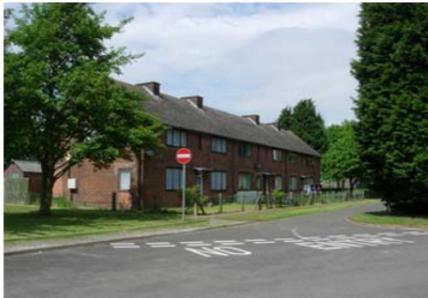
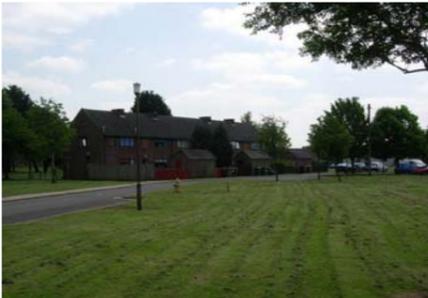
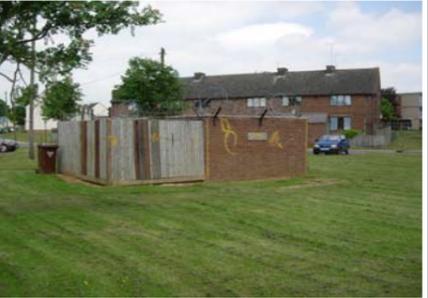
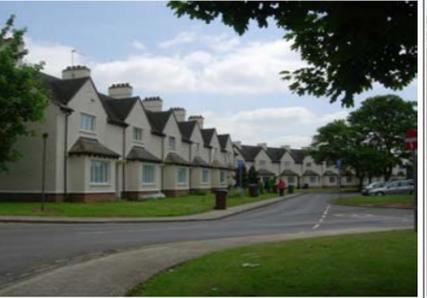
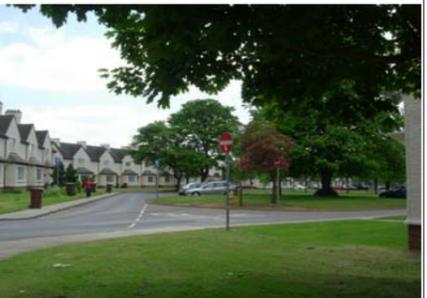
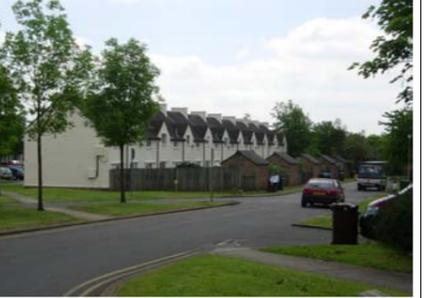
Building No.	291	530, 531, 533, 534	532	535, 536, 539, 540,	537, 538
Current Use	Water Tower	Housing	Electric Sub-Station	Housing	Housing
Date of Construction (NB: info from asset register)	1972	1925	1949	1925	1925
Floor Area/Volume m²/m³ (NB: info from asset register)		480 (3 no. units)		(3 No. units)	(5 No. units)
Number of Floors	10 equivalent	2	1	2	2
Building Height (Eaves, Ridge) m, estimated	25	4.5, 6.5	1.8	4.5, 6.5	4.5, 6.5
Construction/Structure	Metal frame supporting metal tank. Small blockwork shed with monopitch, asphalt roof in corner of compound. 2m high.	Terraced units of red, brindled brick construction with timber, pitched, tiled roofs. Each current family unit consists of 2 no. smaller units which have been knocked together with one entry door replaced by a window. Mix of timber and UPVC windows.	Surround to sub-station part brick, part timber panel with concrete post supports. Barbed wire to top of enclosure. Some graffiti damage.	Terraced units of rendered brick construction with timber, pitched, tiled roofs. Plinth at building base of unrendered brick approx. 7 no. courses. Exposed rafters at eaves and white UPVC windows. Each current family unit consists of 2 no. smaller units which have been knocked together with one entry door replaced by a window.	Terraced units of rendered brick construction with timber, pitched, tiled roofs. Plinth at building base of unrendered brick approx. 7 no. courses. Exposed rafters at eaves and white UPVC windows. Each current family unit consists of 2 no. smaller units which have been knocked together with one entry door replaced by a window.

Building/Setting Features & Characteristics of Note	Prominent feature on site. Functional design.	Buildings' surroundings are well maintained and located in an attractive setting around an oval green, though their rear gardens and sheds face onto the green.		Buildings appear to have been recently renovated and both they and their surroundings are well maintained and located in an attractive setting around an oval green.	Buildings appear to have been recently renovated and both they and their surroundings are well maintained and located in an attractive setting around an oval green.
Potential Uses	Observation tower landmark	Housing	Existing use only	Housing	Housing
Status/Condition	3 fair	3 fair	4 poor	1 excellent	1 excellent

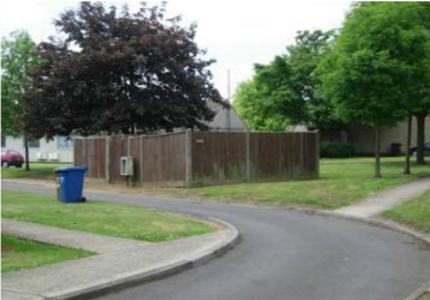
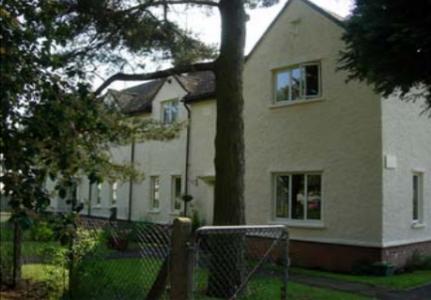
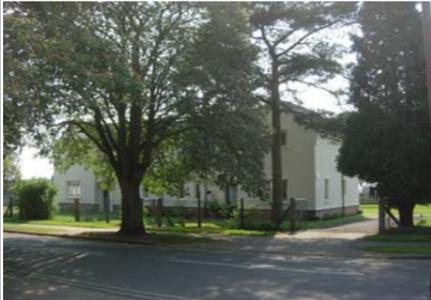
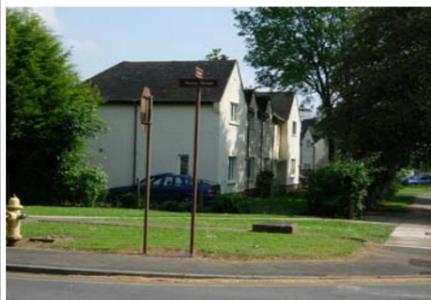
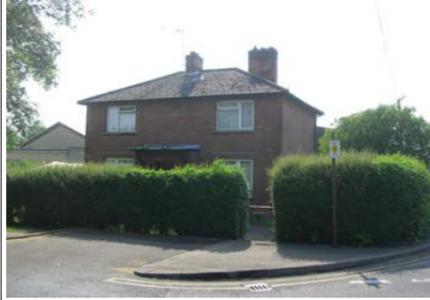
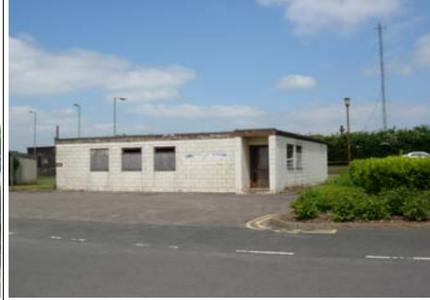
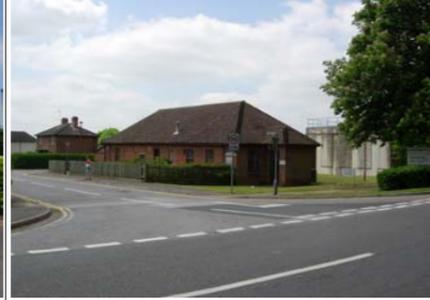
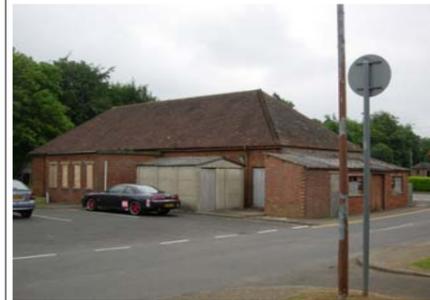
Building No.	542	543, 544	546X	546	547
Current Use	Electric Sub Station	Housing	Housing	Disused - former credit union	Disused - former launderette/store
Date of Construction (NB: info from asset register)	1940	1925	1930	1977	1935
Floor Area/Volume m ² /m ³ (NB: info from asset register)		253		140	228
Number of Floors	1	2	2	1	1
Building Height (Eaves, Ridge) m, estimated	1.8	4.5, 6.5	4.5, 6.5	2.5	2.3, 4.5
Construction/Structure	Enclosure to sub-station constructed from 1.8m high stained timber fence panels supported by concrete posts.	500mm brick plinth & rendered brick walls. Pitched, tiled roof with corbel to eaves. UPVC windows. Surrounded by chicken wire fence supported by concrete posts.	Brindled red brick walls with pitched, tiled roof. Brick/timber porch over entry with lead roof. UPVC windows with concrete cills.	Painted concrete blockwork walls. Flat asphalt roof. Timber windows & fascia.	Brindled red brick with timber, tiled, pitched roof. Internal metal bars over timber sashed windows. Single storey brick lean-to and prefabricated concrete shed to rear.

Building/Setting Features & Characteristics of Note			2 chimneys	Building in poor state of repair with boarded & broken windows & doors. Timber rotting.	Many windows broken and boarded over. Evidence of previous adaptation work i.e. infilled windows/doors. Entry door adjacent Camp Road in porch structure.
Potential Uses	Existing use only	Currently in use	Currently in use	Small office	Housing
Status/Condition	3 fair	2 good	2 good	4 poor	3 fair

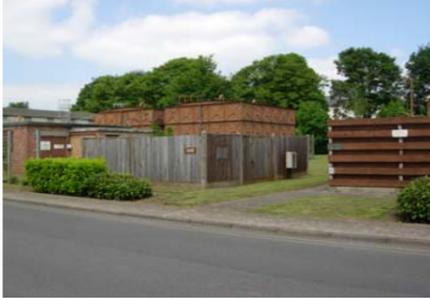
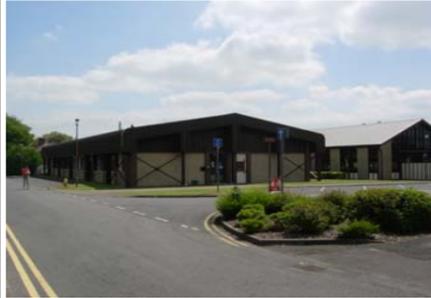
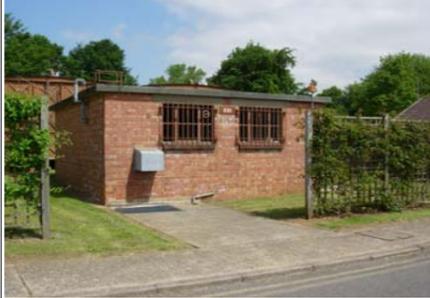
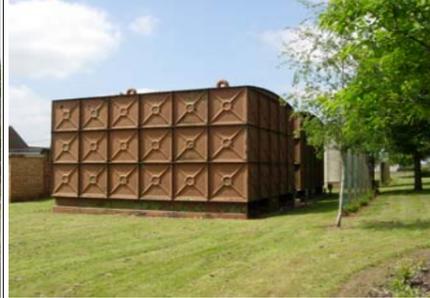
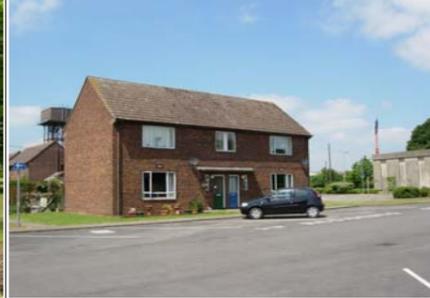
Building No.	548	549	551	552	553
Current Use	Electric Sub-Station	Community Centre	Water Pump	Water Tanks (2 No.)	Housing
Date of Construction (NB: info from asset register)	1940	1945	1935	1952	1953
Floor Area/Volume m²/m³ (NB: info from asset register)		580	50		196 (2 no. units)
Number of Floors	1	1	1	1.5 equivalent	2
Building Height (Eaves, Ridge) m, estimated	1.8	4.5, 6	2.4	3.5	4.5, 6.5
Construction/Structure	Enclosure to sub-station constructed from 1.8m high stained timber fence panels supported by concrete posts.	External steel frame with brick piers and pebble dash infill external walls. Deep span metal clad roof and gable ends. Metal windows.	Brindled, orange/red brick construction with flat asphalt roof. Metal windows with metal security bars mounted externally.	Metal containers with brick plinth.	Brown brindled brick with timber, tiled pitched roof. White UPVC windows. Minimal flat roofed porch over entrance doors.

Building/Setting Features & Characteristics of Note					Semi-detached housing units and surrounds appear to be well maintained.
Potential Uses	Existing use only	Office / warehouse	Existing use only	Storage / re-use panels as feature	Housing
Status/Condition	2 good	2 good	2 good	2 good	2 good

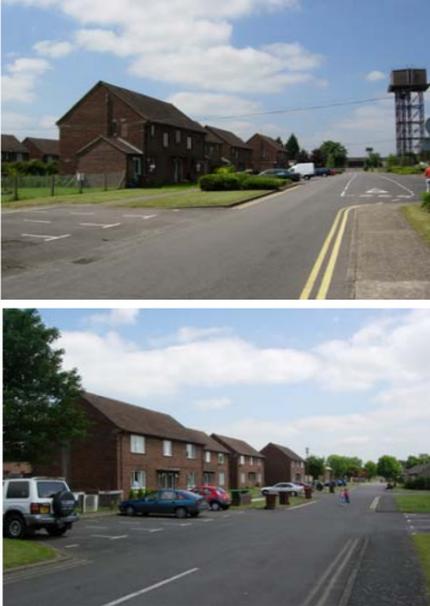
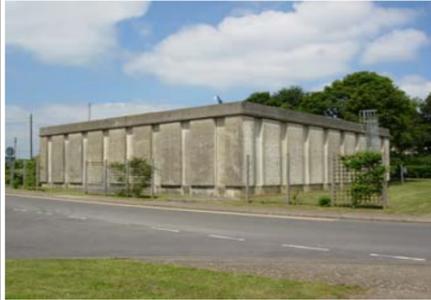
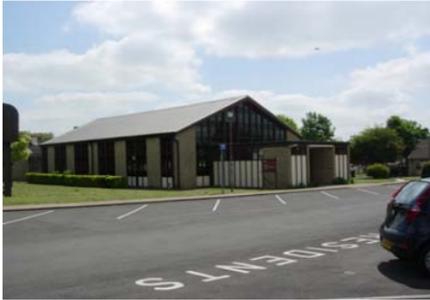
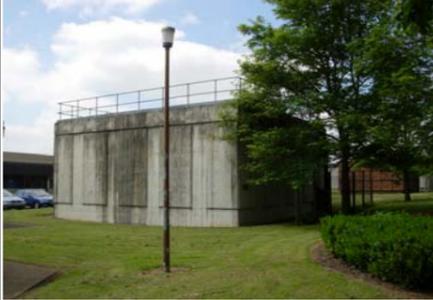
Building No.	554-562	565	568	572	573
Current Use	Housing	Water Tank	Disused - former waste disposal	Chapel	Water tank
Date of Construction (NB: info from asset register)	1953	1979	1945	1961	1987
Floor Area/Volume m²/m³ (NB: info from asset register)	9 no. semi-detached units as Building No. 553 with single storey extensions built onto end gables.			680	
Number of Floors	2 & 1	1.5 equivalent		1 & 2 equivalent	1.5 equivalent
Building Height (Eaves, Ridge) m, estimated	4.5, 6.5	3		4, 6	3.5
Construction/Structure	Construction as 553 but not all windows renovated to white UPVC.	Poured concrete construction with some textured concrete panels to walls. Flat roof with concrete parapet and ladder access.	Poured concrete pits with standing water connected to drainage pipe. Surrounded by timber panel fence, 1.8m high with concrete post supports & barbed wire to top.	Single storey entrance foyer with flat asphalt roof. Beige, brindled brick walls with timber & glazed infill panels. Double height larger hall space timber protal framed with brick & timber cladding panels to match entrance. Flat roofed brick extension to rear. Sheet metal roof.	Poured concrete construction with some textured concrete panels to walls. Flat roof with maetal railings around perimeter and ladder access.

Building/Setting Features & Characteristics of Note	Semi-detached housing units and surrounds appear to be well maintained.			Well maintained building & surrounds.	
Potential Uses	Housing	Warehouse / store	Existing use only	Office / existing use	Recycling / equipment store
Status/Condition	2 good	2 good	3 fair	2 good	2 good

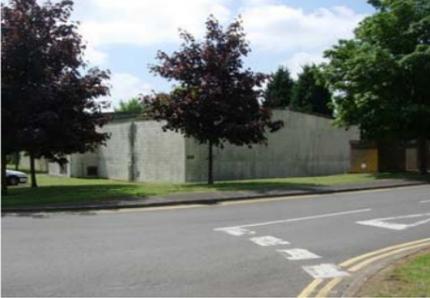
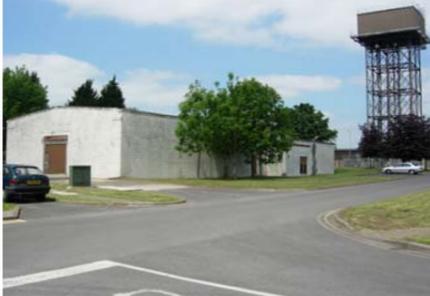
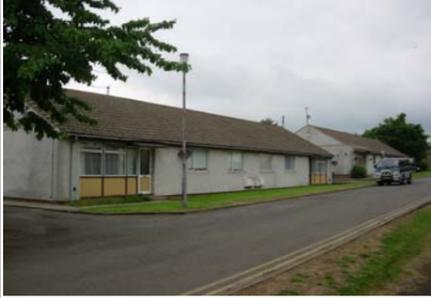
Building No.	588	640 (additional numbers below)	642 (additional numbers below)	646 (additional numbers below)	673
Current Use	Store	Housing	Housing	Housing	Electric Sub-Station
Date of Construction (NB: info from asset register)	1975	1957	1957	1957	1950
Floor Area/Volume m ² /m ³ (NB: info from asset register)	579	231 (1 No. 2 bed, 1 No. 4 bed)	231 (2 No. 3 bed)	194 (2 No. 2 bed)	
Number of Floors	1.5-2 equivalent	1	1	1	
Building Height (Eaves, Ridge) m, estimated	4	2.2, 4	2.2, 4	2.2, 4	1.8
Construction/Structure	Painted concrete blockwork walls with shallow pitched asbestos roof. Timber fascia board. Minimal openings. Large shuttered door to one end.	Pre-cast concrete panel wall construction on brick plinth (2 no. courses). Tiled roof. Small flat roofed porch over entrance door. Coloured timber infill panel & glazing adjacent front door.	Pre-cast concrete panel wall construction on brick plinth (2 no. courses). Tiled roof. Small flat roofed porch over entrance door. Coloured timber infill panel & glazing adjacent front door.	Pre-cast concrete panel wall construction on brick plinth (2 no. courses). Tiled roof. Small flat roofed porch over entrance door. Coloured timber infill panel & glazing adjacent front door.	Enclosure to sub-station constructed from 1.8m high stained timber fence panels supported by concrete posts. Barbed wire to top of fence.

Building/Setting Features & Characteristics of Note	Plants growing on roof and in gutters.	Semi-detached pre-fabricated family single storey units with associated sheds. Bland facades with no architectural features of note.	Semi-detached pre-fabricated family single storey units with associated sheds. Bland facades with no architectural features of note.	Semi-detached pre-fabricated family single storey units with associated sheds. Bland facades with no architectural features of note.	
Potential Uses	Warehouse / store				Existing use only
Status/Condition	3 fair	3 fair	3 fair	3 fair	3 fair

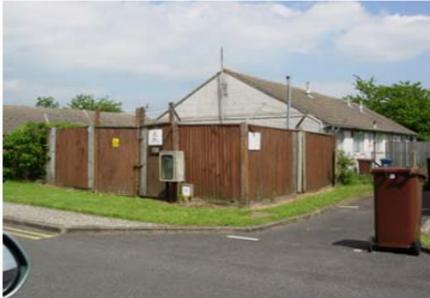
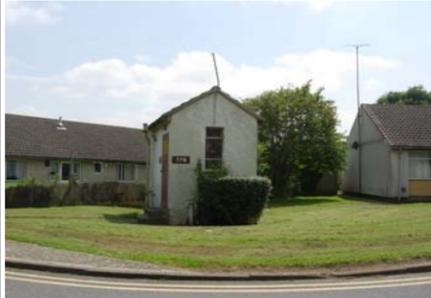
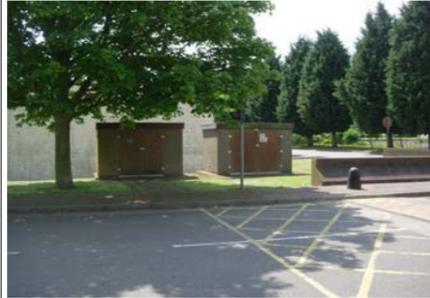
Building No.	738	779	UH2
Current Use	Electric Sub-Station	Sewage Pump	Sub-stations
Date of Construction (NB: info from asset register)	1950	1989	
Floor Area/Volume m ² /m ³ (NB: info from asset register)		11	
Number of Floors		1	
Building Height (Eaves, Ridge) m, estimated	1.8	2.5, 3	1.8
Construction/Structure	Enclosure to sub-station constructed from 1.8m high stained timber fence panels supported by concrete posts. Barbed wire to top of fence.	Rendered brick with timber, tiled roof.	2 no. structures. Both with buff brick walls with flat asphalt roof and timber doors.
Building/Setting Features & Characteristics of Note			Adjacent to 588
Potential Uses	Existing use only	Existing use only	Existing use only
Status/Condition	3 fair	3 fair	2 good

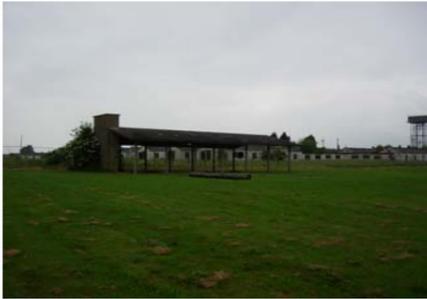
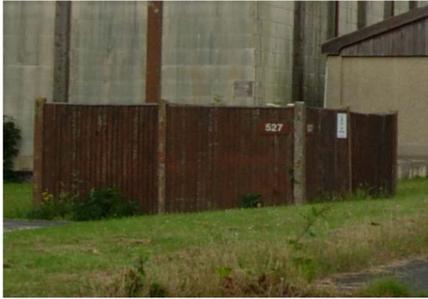
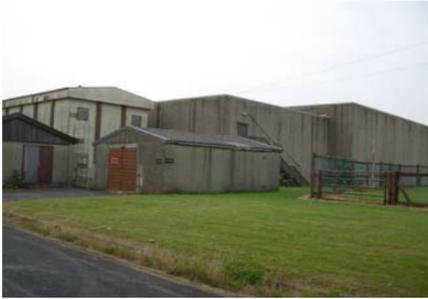
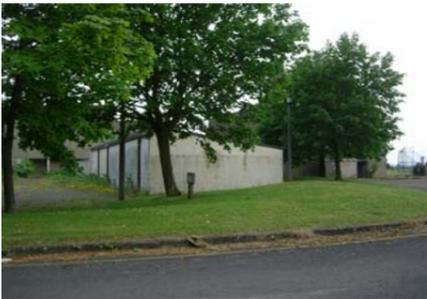
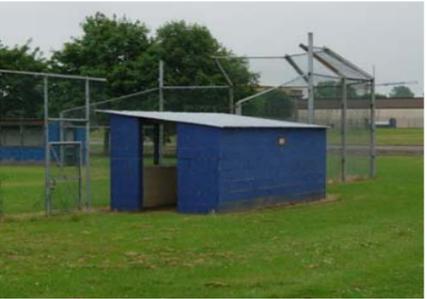
Building No.	515	527	528	566	567
Current Use	Disused - former leisure	Electrical sub station	Store	Disused - former store	Disused - baseball dugouts
Date of Construction (NB: info from asset register)	1983	1976	1982	1989	
Floor Area/Volume m²/m³ (NB: info from asset register)	145		33	143	
Number of Floors	1	1	1	1	1
Building Height (Eaves, Ridge) m, estimated	2.4, 4	1.8	2.2, 3	2.4, 3	2.2, 2.4
Construction/Structure	Timber frame with walls removed. Large brick chimney clad in concrete bricks. Curved composite rafters with asphalt tiles on roof - some missing. Timber roof boards expressed internally.	Enclosure of 1.8m timber panels supported by concrete posts.	Concrete plinth & structure with pebble dashed walls. Possible corrugated asbestos roof. Large timber garage door at front.	Blockwork walls with metal monopitch roof supported by metal columns. No windows.	Blockwork walls with metal monopitch roof. Timber frames to openings covered by chicken wire.

Building/Setting Features & Characteristics of Note					Adjacent to baseball field.
Potential Uses					
Status/Condition	4 poor	3 fair	3 fair	3 fair	3 fair
