heyford park

BUILDING APPRAISAL

ROGER EVANS ASSOCIATES LTD FOR NORTH OXFORDSHIRE CONSORTIUM LTD

Issued : July 2006

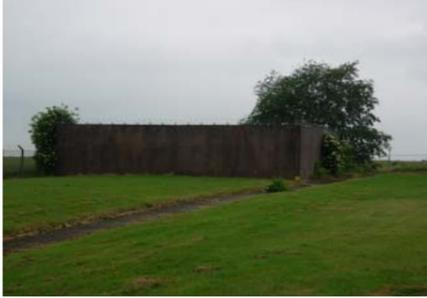
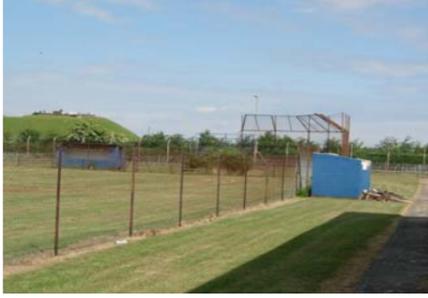
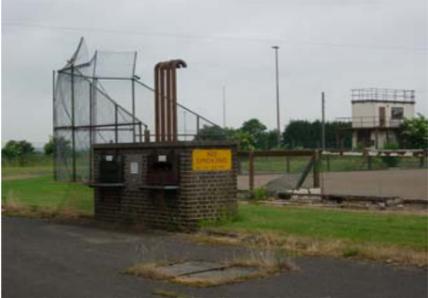
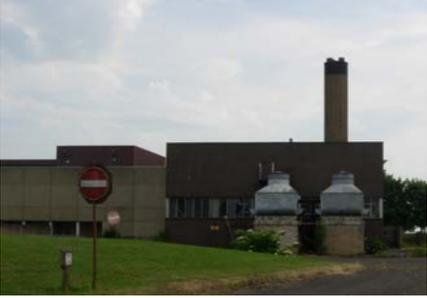
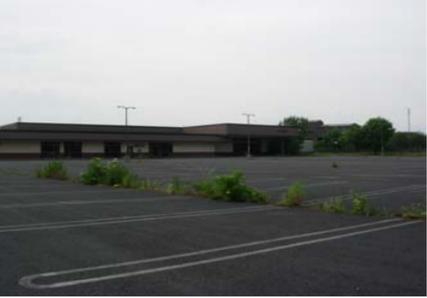
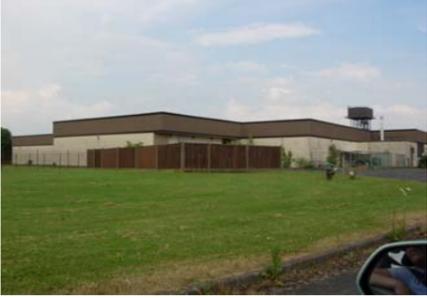
Building No.	570	577	578	579	581
Current Use	Disused - former store	Disused - baseball dugouts	Disused - fuel inlet	Disused - boiler house	Disused - former supermarket
Date of Construction (NB: info from asset register)	1987			1980	1975
Floor Area/Volume m ² /m ³ (NB: info from asset register)	23			304	3522
Number of Floors	1	1			1
Building Height (Eaves, Ridge) m, estimated	5	2.2, 2.4	1.8	8	4 & 6
Construction/Structure	Concrete plinth. Unidentified panelling to walls with barbed wire on top.	Blockwork walls with metal monopitch roof. Timber frames to openings covered by chicken wire.	Brick with concrete roof.	Steel frame, metal cladding to walls. Large concrete chimney - approx. 18m	Blockwork walls on brick plinth. Flat roof with parapet. Metal clad deep roof fascia.
Building/Setting Features & Characteristics of Note		Adjacent to baseball field.			
Potential Uses					
Status/Condition	4 poor	4 poor	3 fair	2 good	3 fair

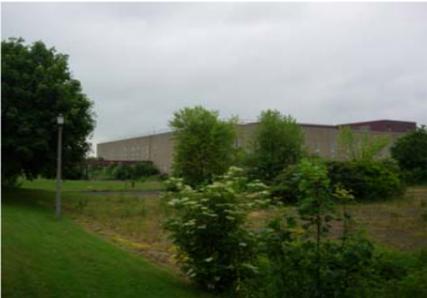
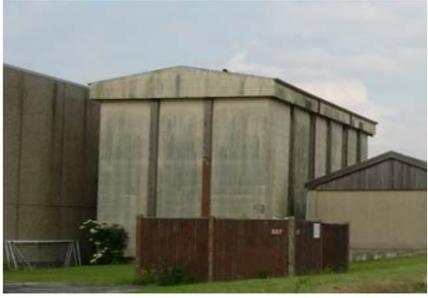
Building No.	582	583	584	590	595
Current Use	Disused - former hospital (60 bed)	Gymnasium	Store	Waste disposal pit	Disused - baseball dugouts
Date of Construction (NB: info from asset register)	1982	1976	1982	1940	
Floor Area/Volume m ² /m ³ (NB: info from asset register)	9042	2302	116		
Number of Floors	2	1	1		1
Building Height (Eaves, Ridge) m, estimated	9	8; 4.5; 7, 7.5	2.4, 4	1.8	2.2, 2.4
Construction/Structure	Concrete precast pebble dash panel walls. Flat roof with metal capping. Metal windows. Large metal plant housings on roof.	Pebble dash concrete walls to main volume (8m high) with flat roof and metal capping. Concrete base to lower entrance volume (4.5m high) with plastic weather boarding to walls. Metal windows & doors with timber subframes. 2 No. volumes (7.5m high) adjacent gym clad with timber shingles on plywood background. Timber boxing forms piers on walls. Shallow pitch roof with metal flashing. Boiler-house to rear has rendered walls with flat roof (4.5m high).	Concrete plinth & structure with pebble dashed walls. Timber weather boarding to gable ends. Metal windows behind wire mesh with timber cills. Possible corrugated asbestos roof with plastic fascia. Plastic roof to porch. Asbestos internal walls.	Pit surrounded by 1.8m high timber fence panels supported by concrete posts.	Blockwork walls with metal monopitch roof. Timber frames to openings covered by chicken wire.

Building/Setting Features & Characteristics of Note					Adjacent to baseball field.
Potential Uses		Still in use			
Status/Condition	3 fair	3 fair	3 fair	2 good	4 poor

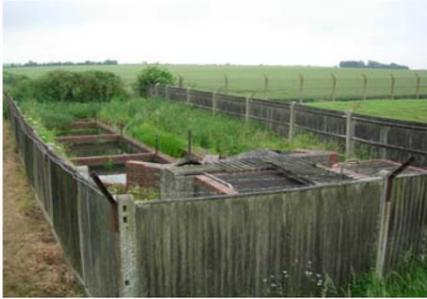
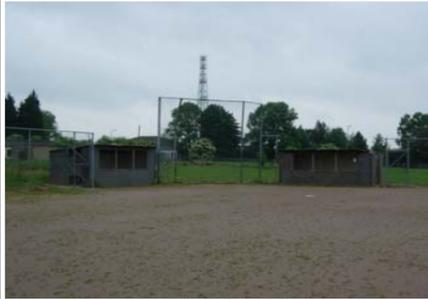
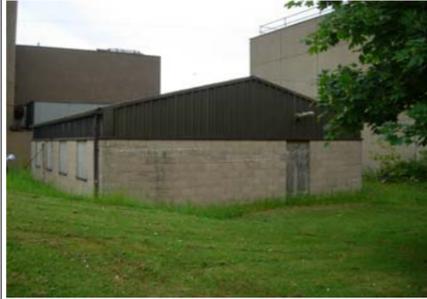
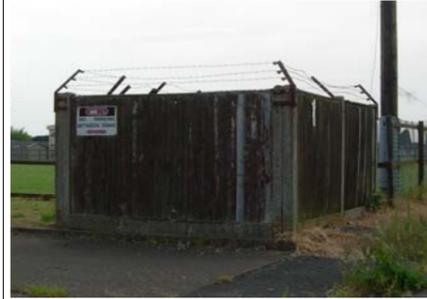
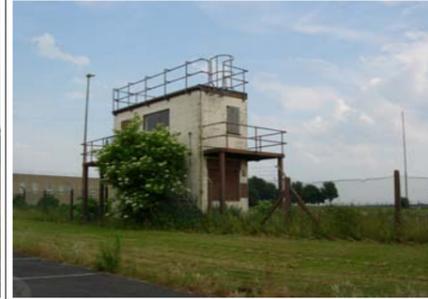
Building No.	597	599	UH15	UH3	UH5
Current Use	Waste disposal pit	Disused - baseball dugouts	Disused - former office	Sub station	Disused - former viewing tower
Date of Construction (NB: info from asset register)					
Floor Area/Volume m ² /m ³ (NB: info from asset register)					
Number of Floors		1	1		
Building Height (Eaves, Ridge) m, estimated	1.8	2.2, 2.4	2.6, 4	1.8	2; 4.8
Construction/Structure	Brick pits surrounded by timber fence supported by concrete posts. Barbed wire on top.	Blockwork walls with metal monopitch roof. Timber frames to openings covered by chicken wire.	Blockwork walls to 2m with metal cladding above. Metal pitched roof. Metal windows boarded up. Door opening boarded up.	1.8m high timber fence panels supported by concrete posts with barbed wire on top.	Painted blockwork walls with metal windows. Flat asphalt roof with viewing gantry. Metal stair & balcony.
Building/Setting Features & Characteristics of Note		Adjacent to baseball field.			Adjacent running track

Potential Uses					
Status/Condition	4 poor	3 fair	3 fair	3 fair	3 fair

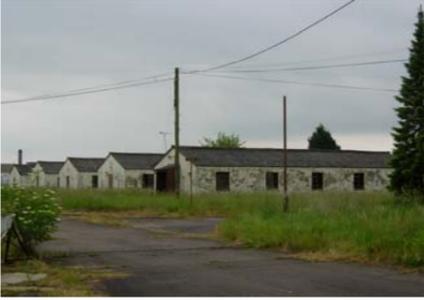
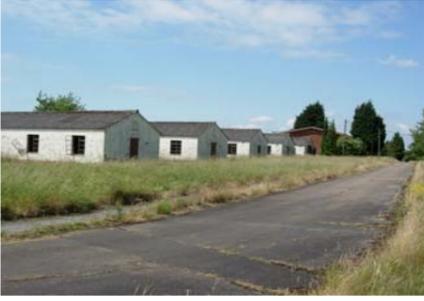
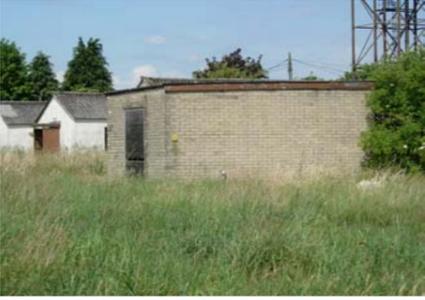
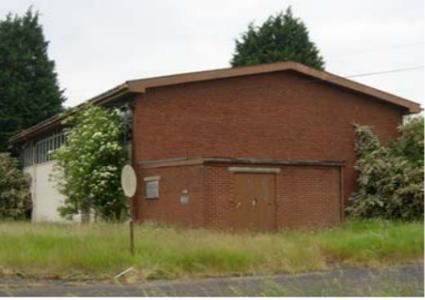
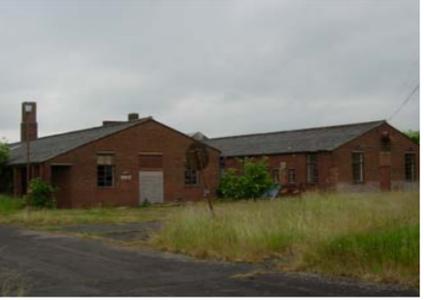
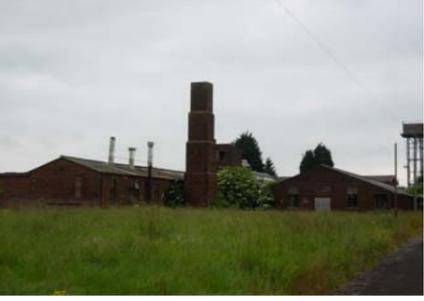
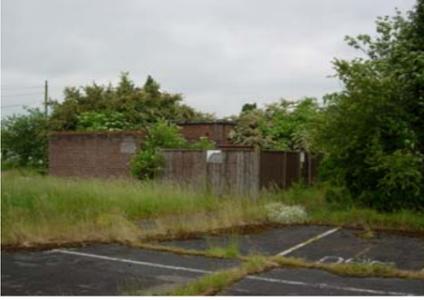
Building No.	804 (additional numbers below)	826	886	867	UH6
Current Use	Disused - former school	Disused	Gymnasium	Disused - former school / training	Sub-station
Date of Construction (NB: info from asset register)	1939		1971	1939	
Floor Area/Volume m²/m³ (NB: info from asset register)			365		
Number of Floors	1	1	1	1	1
Building Height (Eaves, Ridge) m, estimated	2.4, 3.5	2.4, 2.6	5, 6	3, 5.5	2
Construction/Structure	Rendered brick classroom units with pitched asbestos roofs, linked by flat roof corridors/volumes. Metal windows.	Buff brick walls with monopitch asbestos roof. Timber fascia and double doors to front.	Brick gable ends and corrugated metal clad side walls with clerestory windows. Possible corrugated asbestos roof with wooden fascia & deep overhang.	Red brindled brick walls with pitched asbestos roof. Metal windows.	Brick walls with asphalt flat roof. Surrounded by 1.8m high timber fence, supported by concrete posts.

Building/Setting Features & Characteristics of Note			Single storey, flat roofed, brick extension to one end.	Chimney to rear - approx 10m. Pitched roof units linked to form larger volume.	
Potential Uses					
Status/Condition	4 poor	3 fair	3 fair	4 poor	4 poor

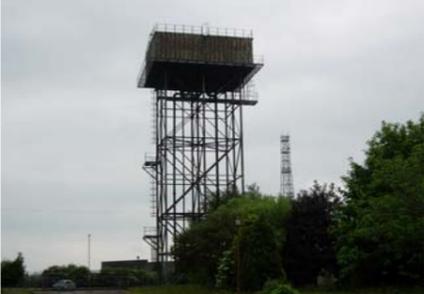
Building No.	UH74
Current Use	Water tower
Date of Construction (NB: info from asset register)	
Floor Area/Volume m²/m³ (NB: info from asset register)	
Number of Floors	10 equivalent
Building Height (Eaves, Ridge) m, estimated	25
Construction/Structure	Metal support structure to metal tank over.
Building/Setting Features & Characteristics of Note	
Potential Uses	
Status/Condition	3 fair

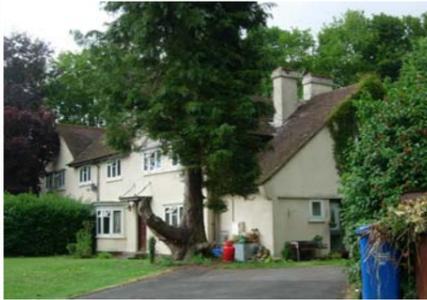
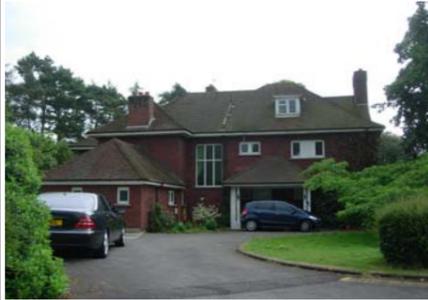
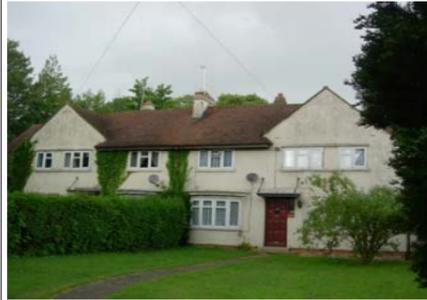
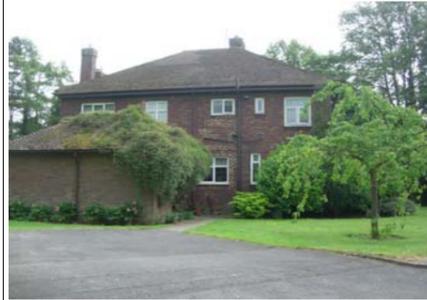
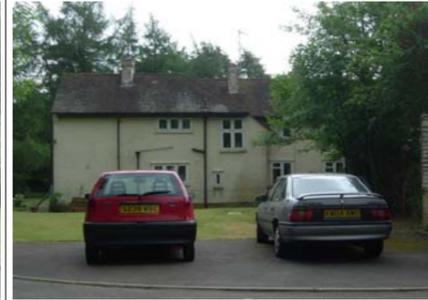
Building No.	1	2	3	4	5
Current Use	Housing	Housing	Housing	Housing	Housing
Date of Construction (NB: info from asset register)	1947	1947	1947	1947	1947
Floor Area/Volume m²/m³ (NB: info from asset register)	169	396	169	259	169
Number of Floors	2	2.5	2	2	2
Building Height (Eaves, Ridge) m, estimated	4.8, 6.5	4.8, 6.5	4.8, 6.5	4.8, 6.5	4.8, 6.5
Construction/Structure	Rendered brick walls with pitched, tiled roof. Rendered chimneys. Bay window at ground level & concrete entrance canopy.	Brindled red brick walls with pitched, tiled roof. Brick chimneys. Deep entrance canopy with tiled roof. Single storey extension to front also in brick with pitched, tiled roof. Dormer window in roof.	Rendered brick walls with pitched, tiled roof. Rendered chimneys. Bay window at ground level & concrete entrance canopy. Asbestos in pipes.	Red brindled brick with pitched, tiled, hipped roof. Brick chimneys. Single storey brick building at front, also brick with pitched, tiled roof.	Rendered brick walls with pitched, tiled roof. Rendered chimneys. Side entrance. Asbestos in pipes.

Building/Setting Features & Characteristics of Note	2 No. 4 bed semi detached houses in well maintained gardens/street.	5 bed detached house in well maintained gardens/street.	2 No. 5 bed semi detached houses in well maintained gardens/street.	5 bed detached house in well maintained gardens/street.	2 No. 4 bed semi detached house in well maintained gardens/street.
Potential Uses	Still in use	Still in use	Still in use	Still in use	Still in use
Status/Condition	1 excellent	1 excellent	2 good	1 excellent	1 excellent

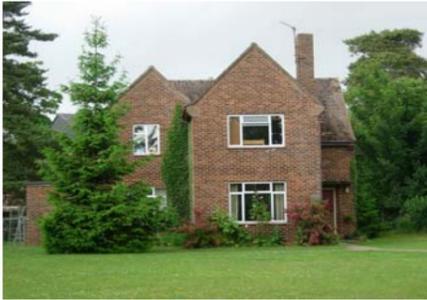
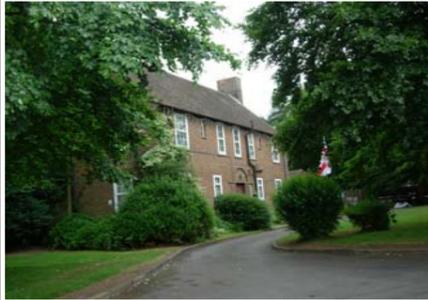
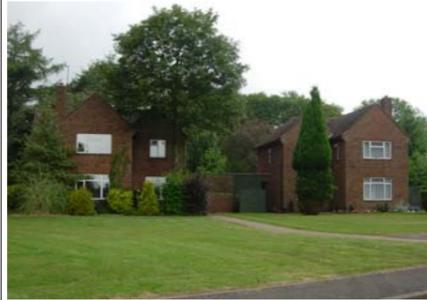
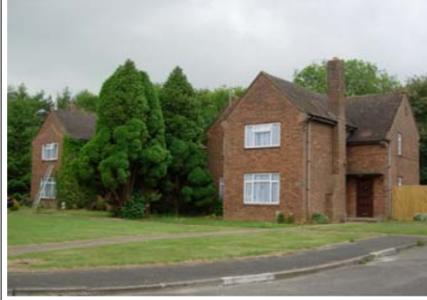
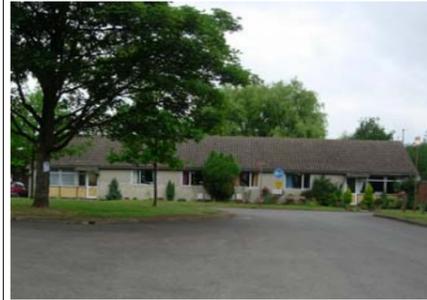
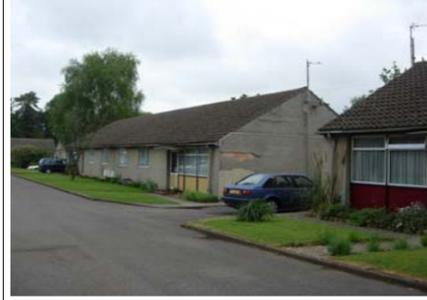
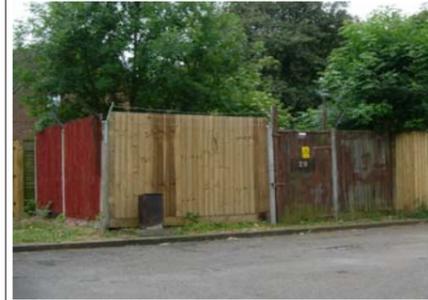
Building No.	6 & 7	8 & 9	10 & 11	13 & 15 (other numbers, see below)	29
Current Use	Housing	Housing	Housing	Housing	Electric sub-station
Date of Construction (NB: info from asset register)	1947	1947	1947	1956/1957	1950
Floor Area/Volume m ² /m ³ (NB: info from asset register)	167	271	333	231	
Number of Floors	2	2	2	1	1
Building Height (Eaves, Ridge) m, estimated	4.8, 6.5	4.8, 6.5	4.8, 6.5	2, 4	1.8
Construction/Structure	Red brindled brick walls with pitched, tiled roof. Tile corbel details at eaves. Brick chimney. Concrete entrance canopy. Asbestos in pipes.	Red brindled brick walls with pitched, tiled roof. Brick chimneys. Feature brick arch detail over door.	Red brindled brick walls with pitched, tiled roof. Tile corbel details at eaves. Brick chimney.	Pebble dashed prefabricated panel construction. Pitched, tiled roof. Minimal entrance canopy above door. Infil panels below windows adjacent to front door. Asbestos in pipes, asbestos roof sheets/barge boards.	1.8m high timber fence panel enclosure supported by concrete posts. Barbed wire on top of fence.

Building/Setting Features & Characteristics of Note	2 No. 3 bed detached houses in well maintained gardens/street.	4 bed detached house in well maintained gardens/street.	2 No. 3 bed semi detached house in well maintained gardens/street.	2 No. 3 bed semi detached houses	
Potential Uses	Still in use	Still in use	Still in use	Still in use	
Status/Condition	1 excellent	1 excellent	1 excellent	3 fair	3 fair

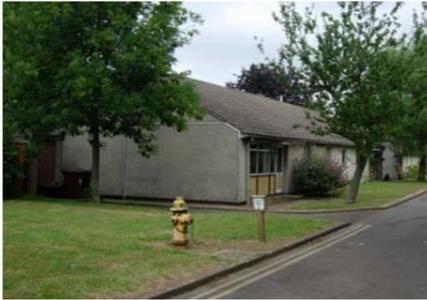
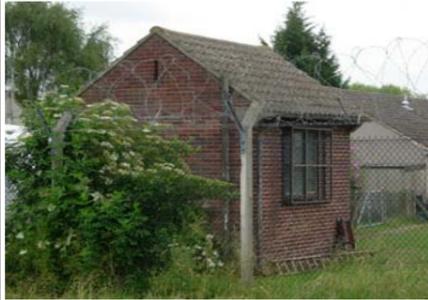
Building No.	42 & 44	UH 72
Current Use	1 No. 2 bed & 1 No. 4 bed semi detached houses	Store
Date of Construction (NB: info from asset register)	1957	
Floor Area/Volume m ² /m ³ (NB: info from asset register)	231	
Number of Floors	1	1
Building Height (Eaves, Ridge) m, estimated	2, 4	2.4, 3.4
Construction/Structure	Pebble dashed prefabricated panel construction. Pitched, tiled roof. Minimal entrance canopy above door. Infil panels below windows adjacent to front door. Asbestos in pipes, asbestos roof sheets/barge boards.	Brick walls with pitched, tiled roof. Corbel detail at eaves. Metal security bars over window.
Building/Setting Features & Characteristics of Note	1 No. 2 bed & 1 No. 4 bed semi detached houses	
Potential Uses	Still in use	
Status/Condition	2 good	3 fair

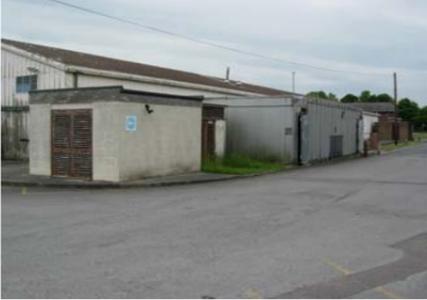
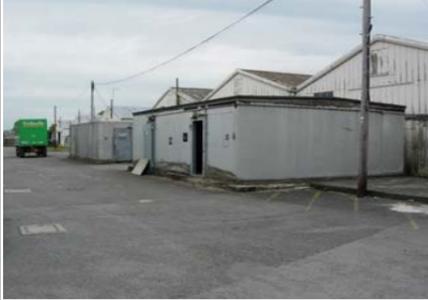
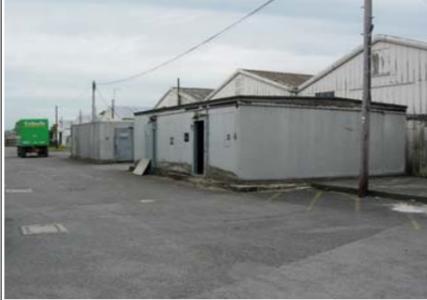
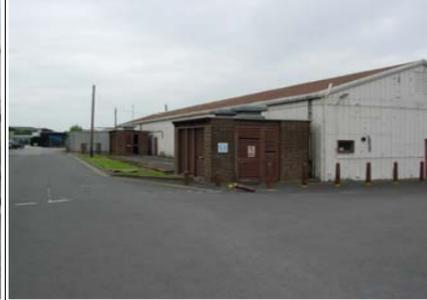
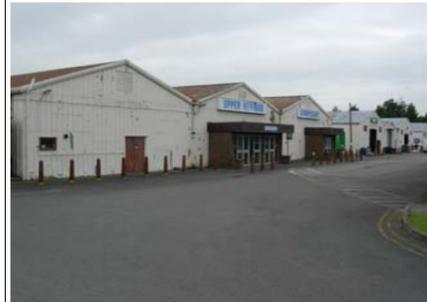
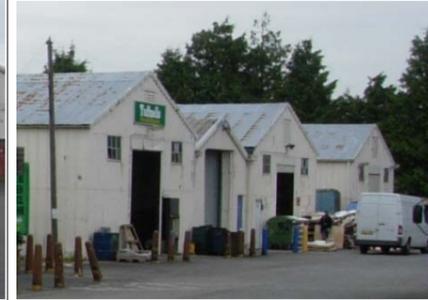
Building No.	2x	3x	4x	32 - 34	35
Current Use	Shed adjacent 32-34	Shed adjacent 32-34	Shed adjacent 32-34	General storage/workshops	Industrial Shed- Nationwide Access
Date of Construction (NB: info from asset register)				1947	1945
Floor Area/Volume m²/m³ (NB: info from asset register)				4735	745
Number of Floors	1	1	1	1	1
Building Height (Eaves, Ridge) m, estimated	2.3	2, 5	2.5	3.5, 5	3.5, 5
Construction/Structure	Lockable metal shed with flat metal roof.	Lockable metal shed with asphalt shallow pitched roof.	Lockable metal shed with flat metal roof.	Steel frame, metal clad, pitched metal roof industrial sheds. Brick porch entrances with timber weather boarding at high level. 2 no. brick plant stores with louvred openings adjacent.	Steel frame, metal clad, pitched metal roof industrial shed adjacent 32-34. (Furthest away in photo below)
Building/Setting Features & Characteristics of Note				Part: ANS Transport; Pride Mobility; Tuffnell Parcels Depot; Disused

Potential Uses	store	store	Store	Warehouse / industrial / gym / play centre	Warehouse / industrial / gym / play centre
Status/Condition	3 fair	3 fair	3 fair	3 fair	3 fair

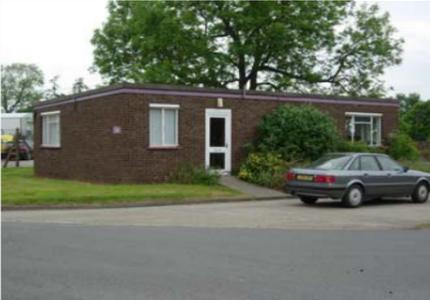
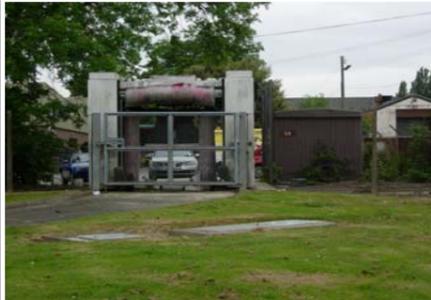
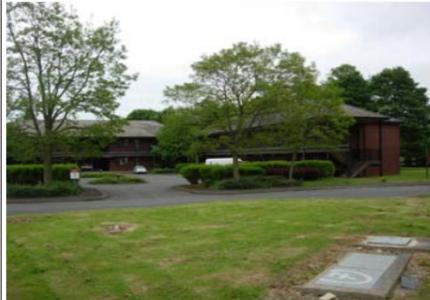
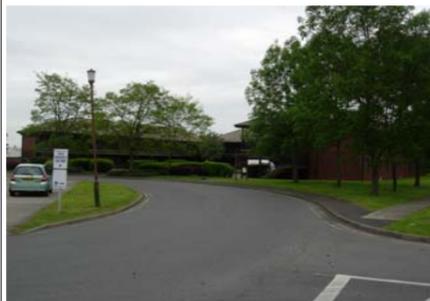
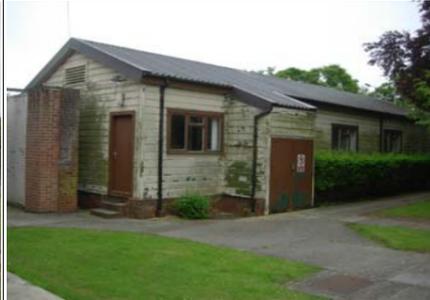
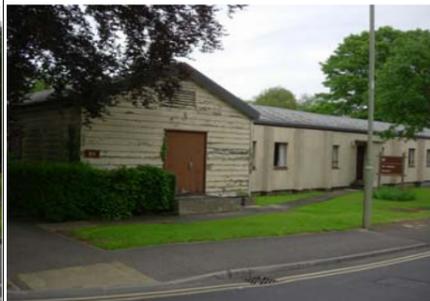
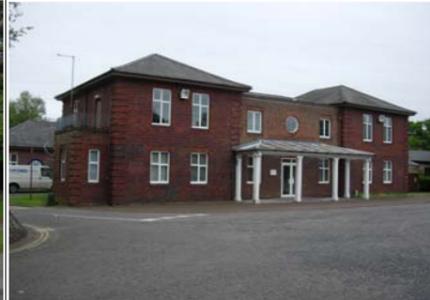
Building No.	36	38	41	51	52
Current Use	Office - Alan Consulting Engineers	Disused - carwash	Disused - former dormitory	Disused - former office/admin	Heyford House - Office/admin
Date of Construction (NB: info from asset register)	1970	1986	1987	1942	1935
Floor Area/Volume m²/m³ (NB: info from asset register)	88		1662	293	798
Number of Floors	1	1	2	1	2 & 1
Building Height (Eaves, Ridge) m, estimated	2.5	4	5, 7.5	3, 4	6, 8.5
Construction/Structure	Brown brick walls with flat asphalt roof. Metal windows. UPVC door.	Concrete	Red brick walls with pitched, tiled roof. Concrete floor slabs protrude to form balcony. Steel structure supports roof overhang to balcony.	Two linked structures. First with brick plinth, painted timber weather boarding, metal clad pitched roof. Second with brick plinth, possibly steel frame, rendered walls, painted metal windows, metal roof.	Load bearing brindled brick with black mortar. Timber double glazed windows with leaded panes. Tiled, pitched roof, glass roofed portico. Single storey extension to rear connected via flat roofed buildings. Internal asbestos.

Building/Setting Features & Characteristics of Note			Building elements arranged around courtyard parking with mature planting.	Prime site next to road, mature trees behind.	Prominent position next to road and at entrance to site. Double storey building noteworthy, single storey buildings to rear less so.
Potential Uses	Currently in use		Housing		Offices
Status/Condition	3 fair	4 poor	3 fair	4 poor	2 good

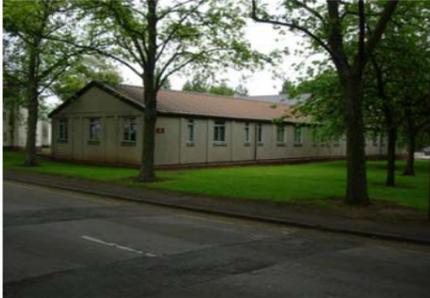
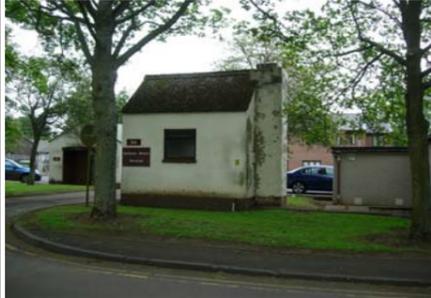
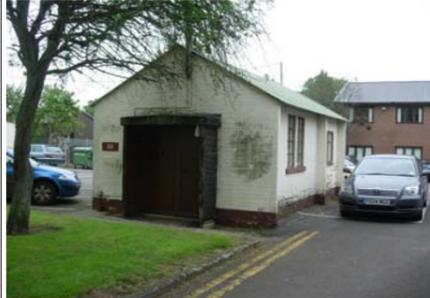
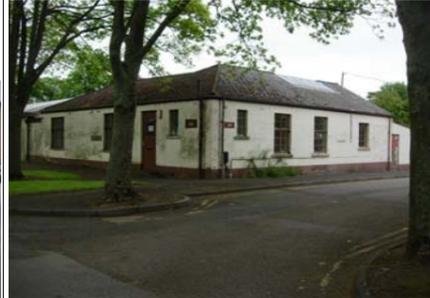
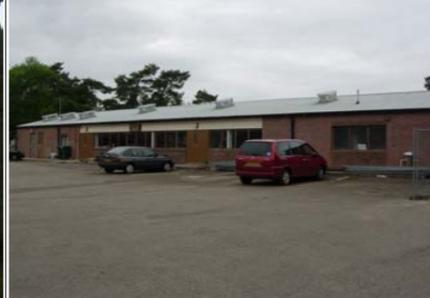
Building No.	53	54	56	59	62/69
Current Use	Office (vacant)	Disused	PT Integration Technology	Office - Millennium Tapestry Charity	Workshops
Date of Construction (NB: info from asset register)	1940	1940	1951	1940	1981
Floor Area/Volume m ² /m ³ (NB: info from asset register)	253	11	25	530	422
Number of Floors	1	1	1	1	1
Building Height (Eaves, Ridge) m, estimated	2.4, 4	2.8, 4.2	2.3, 3.4	2.5, 4	2.8,4
Construction/Structure	Brick base with pebble dashed prefabricated panel construction to walls. Metal pitched roof, aluminium windows.	Rendered walls with corrugated asbestos pitched roof. Rendered block chimney. Timber windows.	Load bearing painted brickwork. Metal pitched roof & windows.	Predominantly painted brickwork with some rendered additions and timber lean-to at rear. Asbestos tiles on pitched roof with roof lights. Steel frame, metal clad extension.	Brick externally with internal blockwork walls. Metal pitched roof with protruding roof lights. Asbestos in damp proofing.

Building/Setting Features & Characteristics of Note	Positioned on significant tree lined street. No architectural merit.				
Potential Uses	Office / nursery		Small office / community building eg scout hut	Currently in use	Currently in use
Status/Condition	3 fair	4 poor	3 fair	3 fair	3 fair

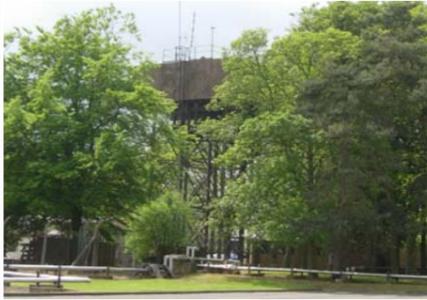
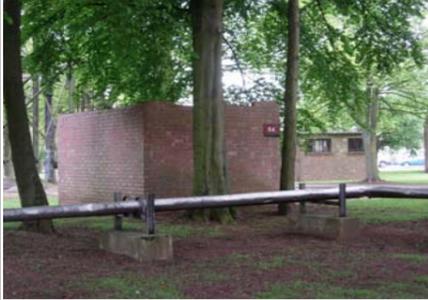
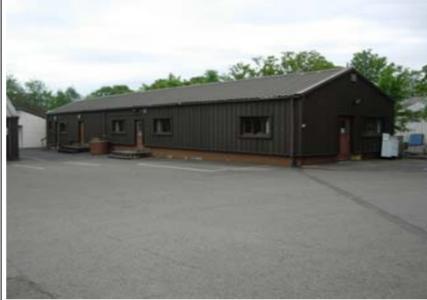
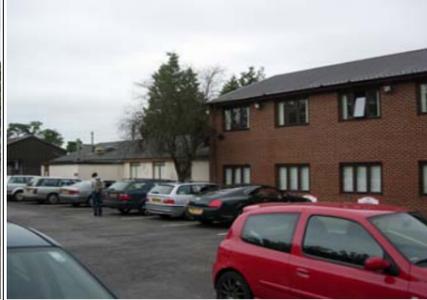
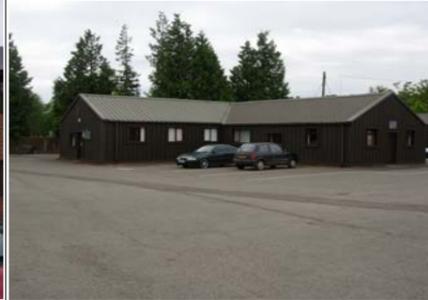
Building No.	63	64	65	66	68
Current Use	Water tank	Disused	Disused	Office - Transec	Office - Sensor Technology
Date of Construction (NB: info from asset register)	1952	1940	1945	1939	1940
Floor Area/Volume m ² /m ³ (NB: info from asset register)		13	212	539	316
Number of Floors	1	1	1	2 & 1	1
Building Height (Eaves, Ridge) m, estimated	15	2.3	2.8,4.5	5.2, 7 & 2.6, 4.8	2.8, 4.5
Construction/Structure	Metal structure supporting metal tank.	Brick walls, flat roof removed. Some bricks missing at the top of walls.	Rendered brick plinth, metal cladding & metal pitched roof.	2 storey brick building with metal pitched roof. Double glazed windows in metal frames. Adjacent building single storey painted concrete block with metal windows and asphalt pitched roof.	Brick plinth, metal cladding & metal pitched roof.
Building/Setting Features & Characteristics of Note					
Potential Uses			Office / community use	Currently in use	Currently in use

Status/Condition	3 fair	4 poor	3 fair	2 good	3 fair

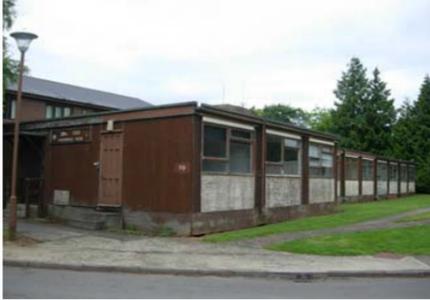
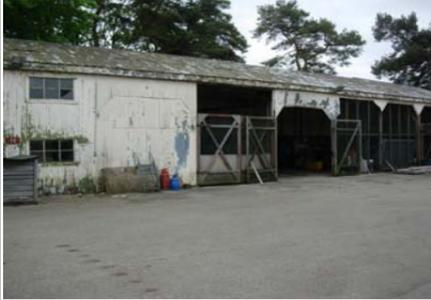
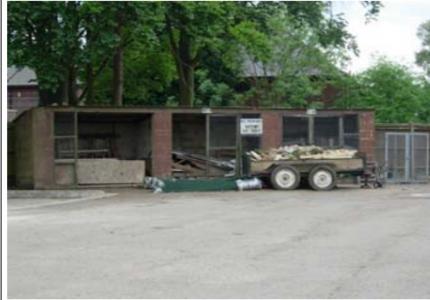
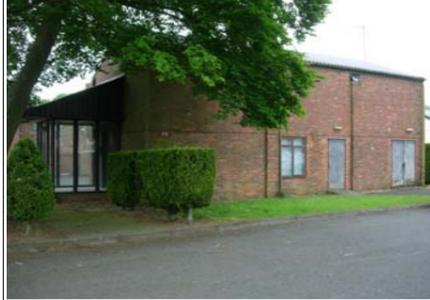
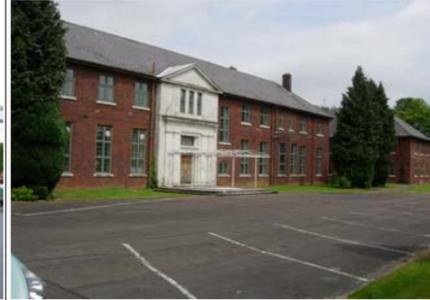
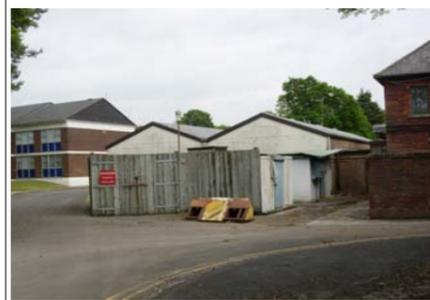
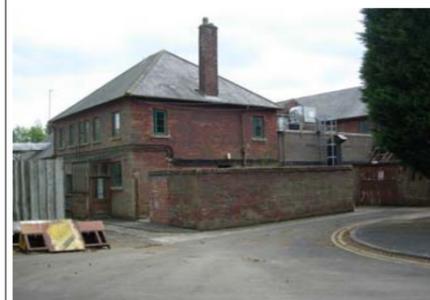
Building No.	70	72	72 (next to)	73	74
Current Use	Disused - former conference room (rabbit hutch)	Storage shed	Storage shed	Disused	Disused - former officers' mess
Date of Construction (NB: info from asset register)	1972	1940			1925
Floor Area/Volume m²/m³ (NB: info from asset register)	269	267			4020
Number of Floors	1	1 double height	1	1 double height	2 with high storey height at ground floor & 2 storey wings
Building Height (Eaves, Ridge) m, estimated	2.5	4.5, 5.5	2.5	5.2, 7	6, 8.5
Construction/Structure	Prefabricated unit raised off ground with timber surround at base. Timber clad, rotting timber windows, flat asphalt roof.	Steel frame with timber panel & wire mesh infill. Corrugated steel cladding. Single storey rendered extension to side with prefabricated panels on frame and shallow pitched roof.	Blockwork walls with corrugated metal mono pitch roof. Timber frames to openings infilled with wire mesh.	Brick walls with metal pitched roof and leaded double glazed wndows. Glazed front porch. Pipes enter the side of the building, mould growing down one side.	Red brick with steep pitched tiled roof. White stone portico with metal framed dilapidated entrance canopy. Metal windows in rotting timber sub frames. Original internal features; fireplace, architrave, cornice, skirting, paneling, lead windows. Some brick flat roofed buildings within internal courtyard to rear containing boiler, plant etc. Buildings to rear have external wires. Many additional extension buildings of no architectural merit.

Building/Setting Features & Characteristics of Note					Large rooms, prominent location set back from road with lawn in front. Fir trees as little as 500mm away from building block light to some windows.
Potential Uses		Warehouse / store / garages			Offices, luxury flats, hotel
Status/Condition	4 poor	4 poor	4 poor	3 fair	3 fair

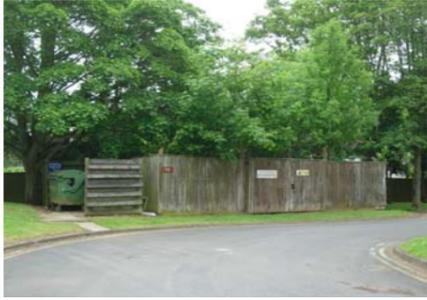
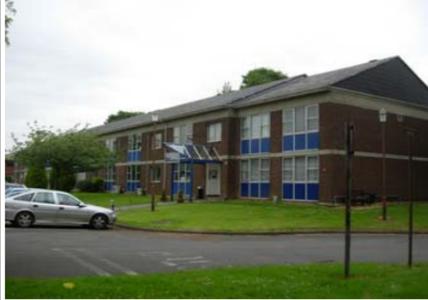
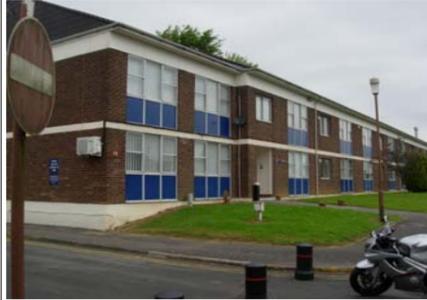
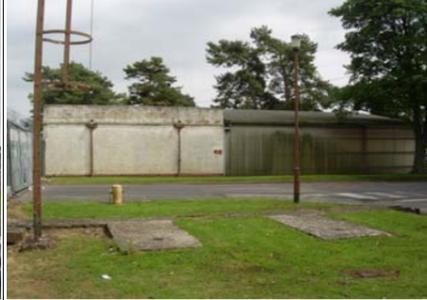
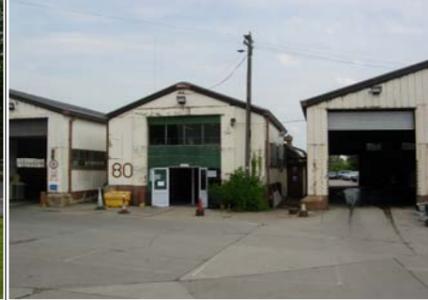
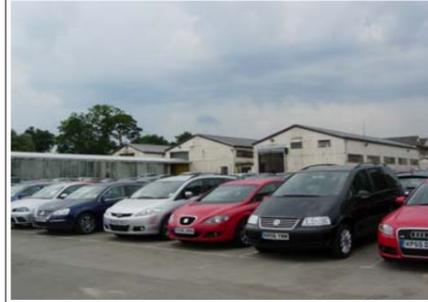
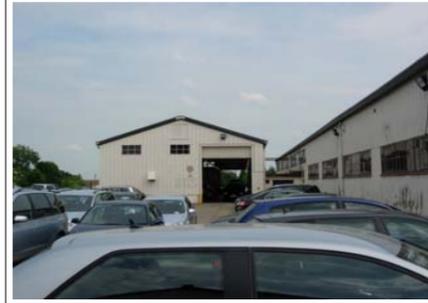
Building No.	75	77	78	79	80
Current Use	Water store	Offices - Oxford Innovation	Offices - Oxford Innovation	Vision Motorsport (garage)	Workshops, carwash - QEK
Date of Construction (NB: info from asset register)	1950	1971	1971	1940	
Floor Area/Volume m²/m³ (NB: info from asset register)		1624	1621	163	
Number of Floors	1	2	2	1 double height	
Building Height (Eaves, Ridge) m, estimated	1.8	6, 8.5	6, 8.5	4	4.2, 5.5
Construction/Structure	1.8m high timber fence enclosing pond supported by concrete posts, barbed wire on top.	Brick walls with exposed concrete floor slabs. Aluminium windows with infill panels below. Tiled, pitched roof. Metal and glass entrance canopy.	Concrete structure floor slabs exposed and painted, brickwork, aluminium windows in infill panels, tiled roof	Painted brick walls with parapet to flat roof. Steel frame extension to front with pitched roof - walls and roof clad in corrugated plastic.	Industrial shed type buildings. Some with rendered brick walls, others metal clad. Metal cladding to pitched roofs. Large metal roller shutter garage doors to ends.

Building/Setting Features & Characteristics of Note		Sits facing identical building on central parking court.	Sits facing identical building on central parking court.		Large mechanical metal car wash tunnel attached to rear of one of larger buildings.
Potential Uses		Currently in use	Currently in use	Currently in use	Currently in use
Status/Condition	3 fair	2 good	2 good	4 poor	3 fair

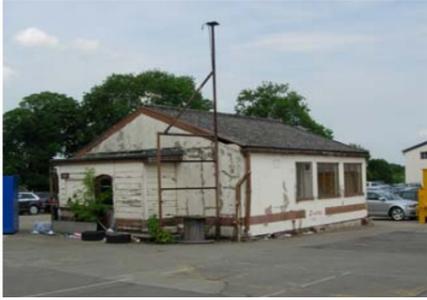
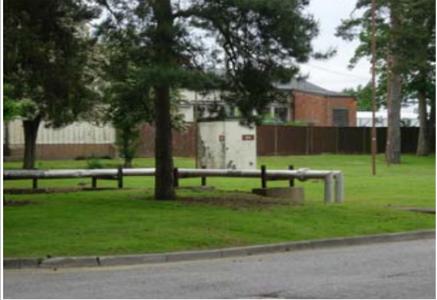
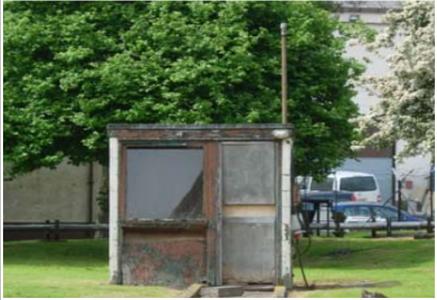
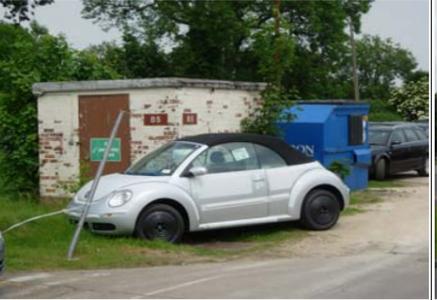
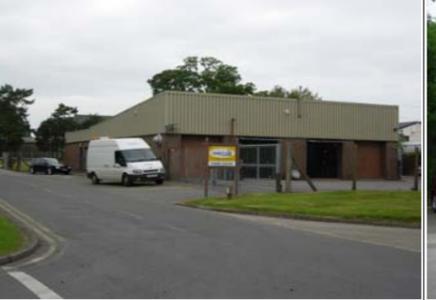
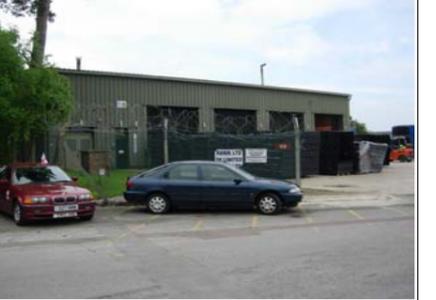
Area 6

Building No.	81	84	85	86	88
Current Use	Disused	Disused - petrol kiosk	Store	Tyre depot - QEK	Industrial shed - Ranik
Date of Construction (NB: info from asset register)	1940	1975		1981	1986
Floor Area/Volume m ² /m ³ (NB: info from asset register)	64	2		432	400
Number of Floors	1	1	1	1	1 double-triple height
Building Height (Eaves, Ridge) m, estimated	2.2, 3	2.3	2.3	3.2, 5	5, 6
Construction/Structure	Concrete panels to walls with pitched asbestos roof. Timber weather boarded porch with flat asphalt roof.	Painted concrete block, flat asphalt roof.	Painted brick wall, timber door, melted metal roof.	Brick walls with metal cladding at high level. Metal roof with inverted pitch.	Metal clad steel framed shed with shallow pitched, metal roof.
Building/Setting Features & Characteristics of Note					
Potential Uses				Currently in use	Currently in use
Status/Condition	4 poor	4 poor	4 poor	2 good	2 good

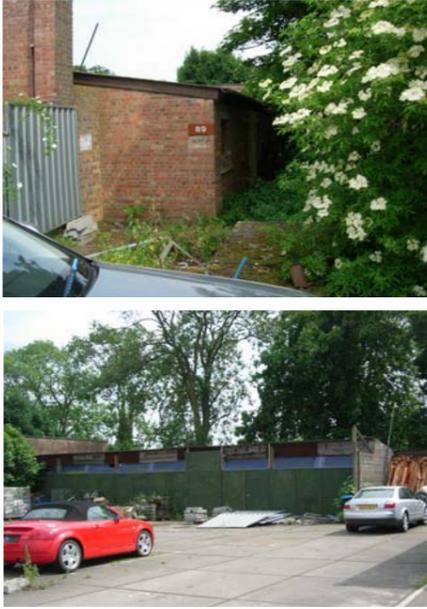
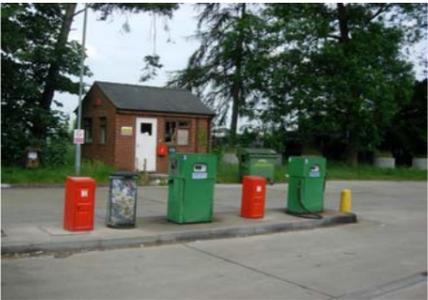
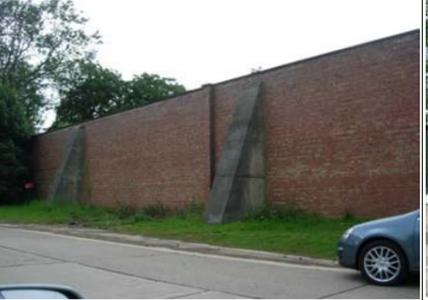
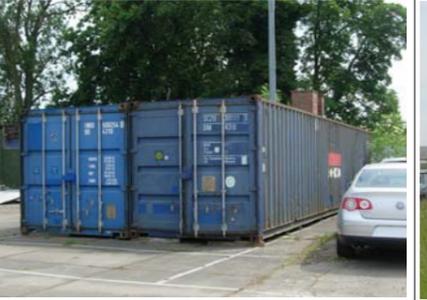
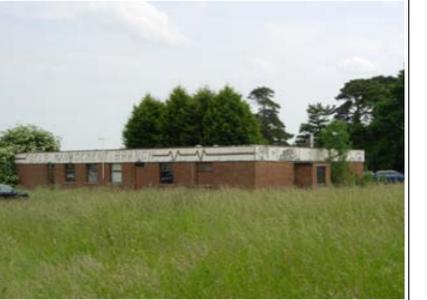
Area 6

Building No.	89	89a	89b	89c	352
Current Use	Disused	Petrol pump booth	Blast separation wall	Containers (2 no.)	Disused - office
Date of Construction (NB: info from asset register)	1939				1980
Floor Area/Volume m ² /m ³ (NB: info from asset register)					395
Number of Floors	1	1	2	1	1
Building Height (Eaves, Ridge) m, estimated	2.4, 3.2	2, 3	5	2.3	2.5
Construction/Structure	Brick walls with concrete lintels & cills to openings. Metal windows, bars on low level windows. Timber extension clad in timber OSB panels & timber weather boarding. Corrugated roof & corrugated plastic clerestory.	Brick walls with pitched tiled roof.	Brick wall with concrete buttresses.	Metal transport containers.	brick, flat roof, deep timber fascia, metal door, metal windows
Building/Setting Features & Characteristics of Note					
Potential Uses					
Status/Condition	4 poor	2 good	2 good	2 good	3 fair

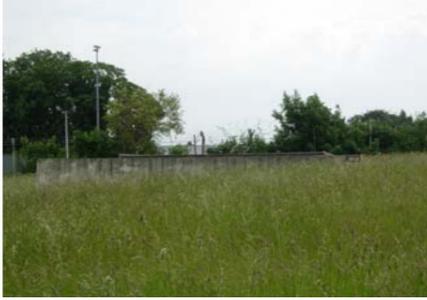
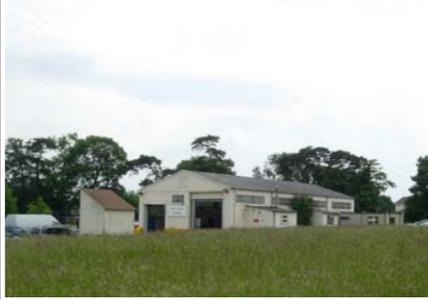
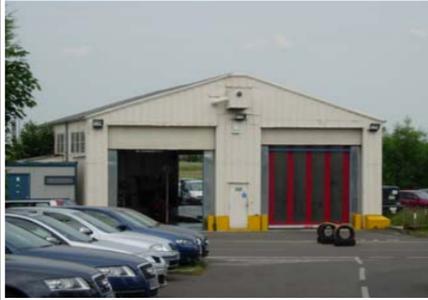
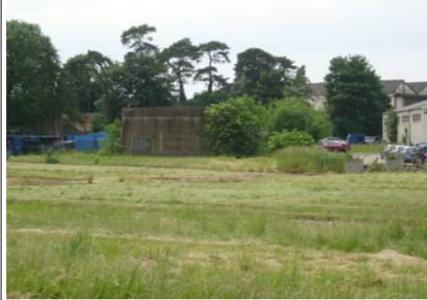
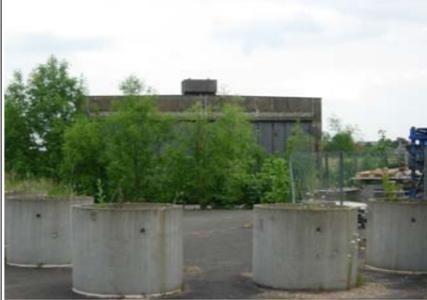
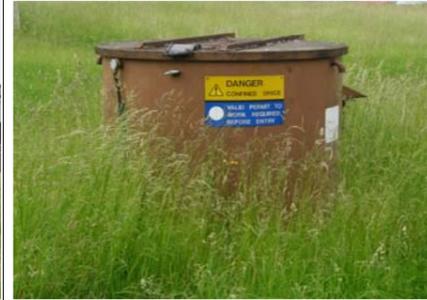
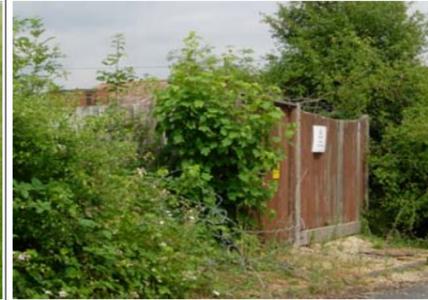
Area 6

Building No.	353	354	381	385	UH44
Current Use	Bunker	QEK Global Solutions (workshop)	Disused tanker garage	Access hatch	Electric sub-station
Date of Construction (NB: info from asset register)		1940	1980		
Floor Area/Volume m ² /m ³ (NB: info from asset register)		336	169		
Number of Floors	1	1	1		1
Building Height (Eaves, Ridge) m, estimated	2	4, 6	5	1	1.8
Construction/Structure	Concrete walls	Steel framed industrial shed. Metal cladding & metal pitched roof. Large garage doors with windows at high level. Brick single storey extension.	Concrete walls with flat roof & large metal doors.	Metal	Concrete plinth. Concrete posts support 1.8m high timber fence panels with barbed on top.
Building/Setting Features & Characteristics of Note					
Potential Uses		Currently in use			
Status/Condition	3 fair	2 good	3 fair	3 fair	3 fair

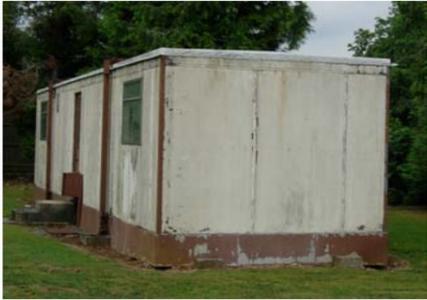
Area 6

Building No.	UH46
Current Use	Disused - office
Date of Construction (NB: info from asset register)	
Floor Area/Volume m²/m³ (NB: info from asset register)	
Number of Floors	1
Building Height (Eaves, Ridge) m, estimated	
Construction/Structure	Concrete plinth to metal clad prefabricated unit. Flat roof.
Building/Setting Features & Characteristics of Note	
Potential Uses	
Status/Condition	4 poor

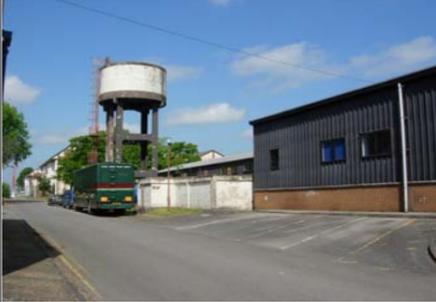
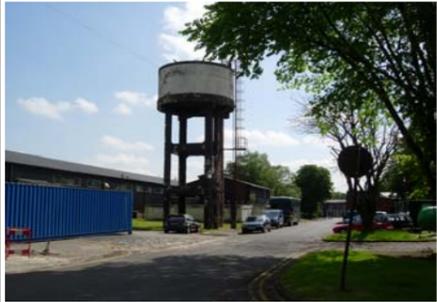
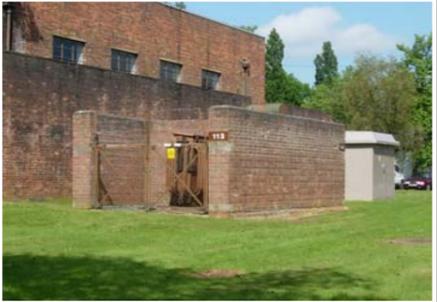
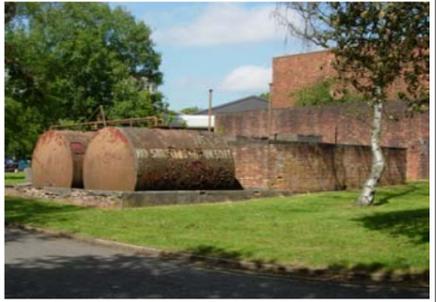
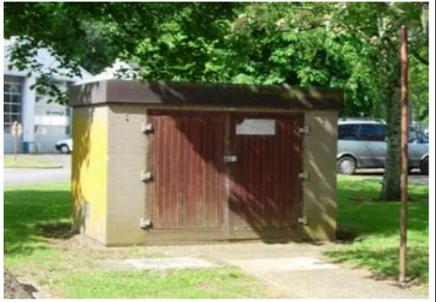
Area 7

Building No.	107	108	113	113a	113b
Current Use	Water tank	Water tower	Electric sub-station	Tanks	Electric sub-station
Date of Construction (NB: info from asset register)	1952	1952			
Floor Area/Volume m ² /m ³ (NB: info from asset register)					
Number of Floors	1	4 equivalent	1		1
Building Height (Eaves, Ridge) m, estimated	2.5	11	2.5	2	2.5
Construction/Structure	Concrete	Concrete structure supporting concrete tank.	Brick wall enclosure around sub-station. Metal gate at entry.	2 No. metal tanks on concrete plinth with brick walled enclosure behind.	Painted brick walls. Timber fascia to flat roof. Timber doors.
Building/Setting Features & Characteristics of Note					
Potential Uses					
Status/Condition	3 fair	3 fair	3 fair	4 poor	3 fair

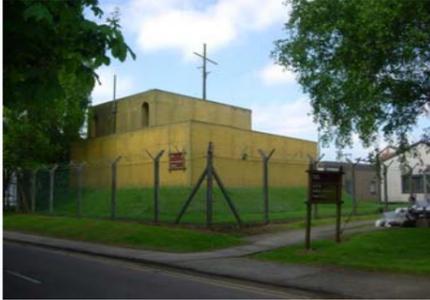
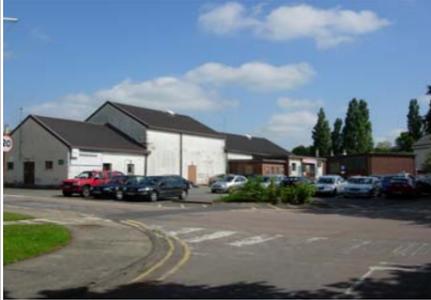
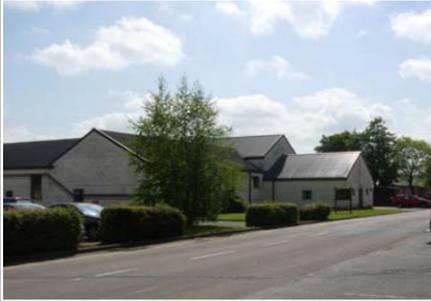
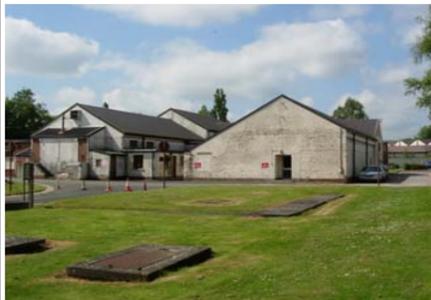
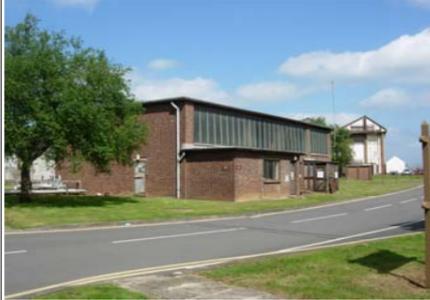
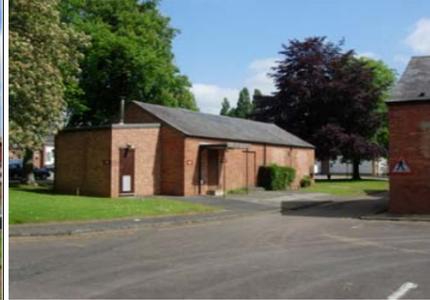
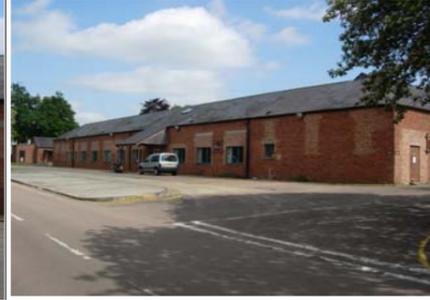
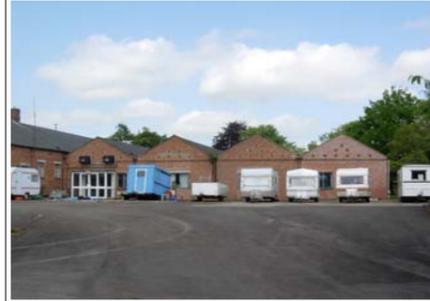
Building No.	129	130	131	132	133
Current Use	Disused - office/communication block	Disused - former cinema/theatre	Boiler house	Disused office	Junior Citizens & Thames Valley Medical Rescu
Date of Construction (NB: info from asset register)	1987	1940	1965	1926	1926
Floor Area/Volume m²/m³ (NB: info from asset register)	241	979	229	114	1946
Number of Floors	2 storey internal structure with 1 storey surrounding	1 & 2 equivalent	1 double height	1	1 tall storey
Building Height (Eaves, Ridge) m, estimated	3 & 5.5	3.1, 5; 5, 7	2.5 & 5	2.3, 3.2	4, 6; 3.5, 5
Construction/Structure	Rendered concrete.	Group of linked buildings: Painted brickwork with pitched metal roofs at varying heights, false ceiling visible through windows. Rusty metal windows with bricked up openings in gable end. Single storey red brick entry porch with flat roof.	Brick walls with flat asphalt roof. Metal screens in openings & large expanse of glazing at first storey height. Single storey, flat roofed volume at front.	Brick walls with pitched, tiled roof. Bricked up windows with flat roof porch on metal posts to entrance door. Adjoining brick plant room with asphalt roof.	Brick walls with pitched, tiled roof. Original large windows partially bricked up and replaced with smaller metal double glazed units. Original concrete lintels retained. Some subsidence and missing mortar from joints.

Building/Setting Features & Characteristics of Note	No windows				Large plan area, single storey volume with multiple pitched roofs.
Potential Uses					
Status/Condition	3 fair	4 poor	3 fair	3 fair	3 fair

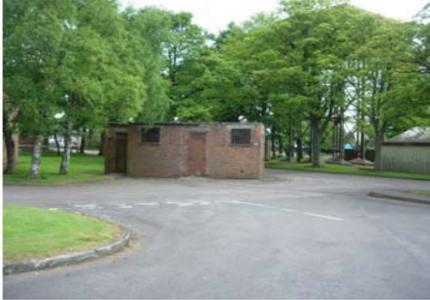
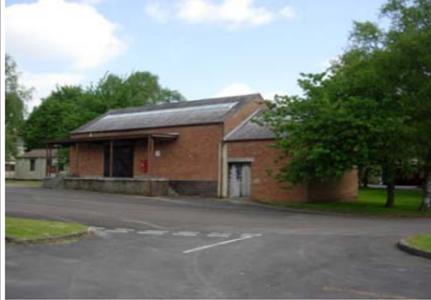
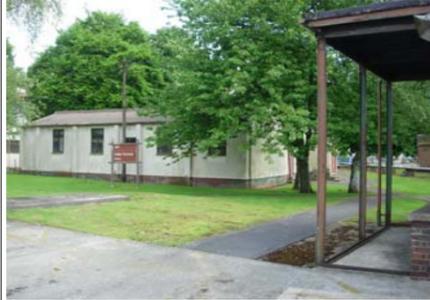
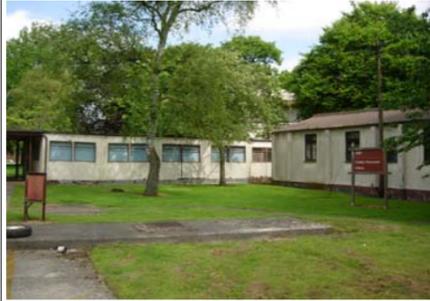
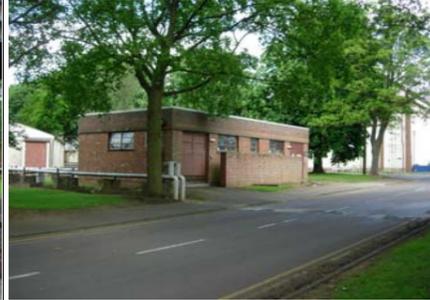
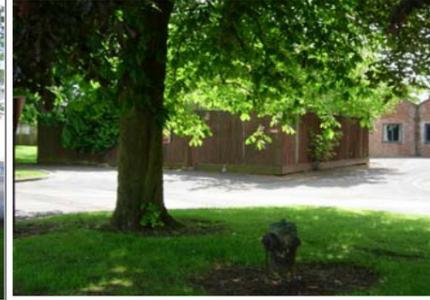
Building No.	145	146	147	148	149
Current Use	Disused	Disused	Disused office	Store/office - 'BT'	
Date of Construction (NB: info from asset register)	1935	1926	1935		1950
Floor Area/Volume m ² /m ³ (NB: info from asset register)	55	150	193		
Number of Floors	1	2 and 1 1/2	1	1	1
Building Height (Eaves, Ridge) m, estimated	2.3	2.5, 4.3	2.3, 3	2.8	1.8
Construction/Structure	Brick walls with flat roof. High level windows with metal bars over. Cows on roof.	Brick walls with pitched, tiled roof - roof light strip. Delivery platform with brick plinth & timber flat asphalt roof over.	Concrete single storey building with external piers. Possible asbestos shallow pitched roof. Dilapidated, timber single storey flat roofed extension with metal windows.	Brick walls with parapet to flat roof. Metal windows.	1.8m high timber panel fence enclosure supported by concrete posts.
Building/Setting Features & Characteristics of Note		No windows

Potential Uses					
Status/Condition	4 poor	3 fair	4 poor	3 fair	3 fair

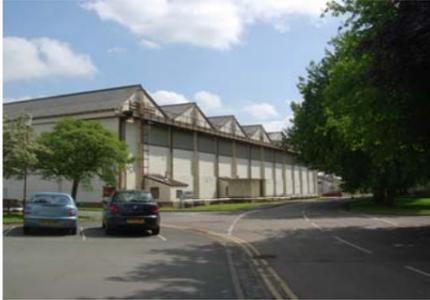
Area 7

Building No.	151	156	157	158	170
Current Use	Disused - store/workshops	Disused - store	Community - scouts	Store - 'Events management'	Electric sub-station
Date of Construction (NB: info from asset register)	1950	1935	1935	1935	1940
Floor Area/Volume m ² /m ³ (NB: info from asset register)	3927	21	239	53	
Number of Floors	1 triple height	1	1 & 2	1	1
Building Height (Eaves, Ridge) m, estimated	8, 10	1.7, 1.9	2.1 & 4, 6	4	2.1
Construction/Structure	Steel frame, concrete infill. Asbestos multi-pitched roof with corrugated plastic clerestory. Various lean-tos and adjacent brick plant buildings.	Brick walls with external piers & shallow monopitch metal roof.	Brick walls with pitched, metal roof. High level windows in parts of the 2 storey building some of which have been bricked up. No windows in single storey, metal roofed lean-to.	Painted brick walls with parapet to flatroof. Tall metal windows, 3 roller shutter large metal garage doors at front.	Painted brick walls with metal gate at entry.

Building/Setting Features & Characteristics of Note		No windows			
Potential Uses	Stores / workshops				
Status/Condition	3 fair	3 fair	3 fair	3 fair	3 fair
