heyford park

BUILDING APPRAISAL

ROGER EVANS ASSOCIATES LTD FOR NORTH OXFORDSHIRE CONSORTIUM LTD

Issued : July 2006

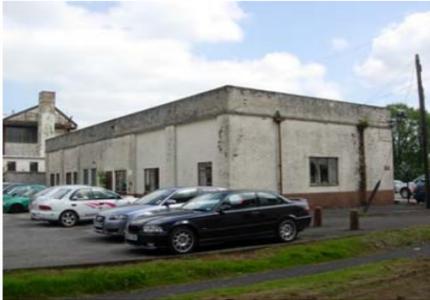
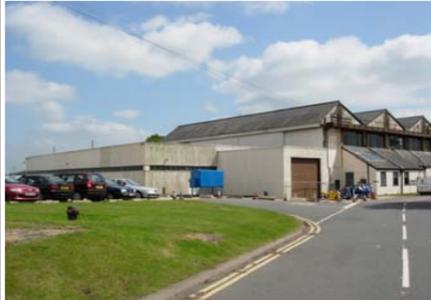
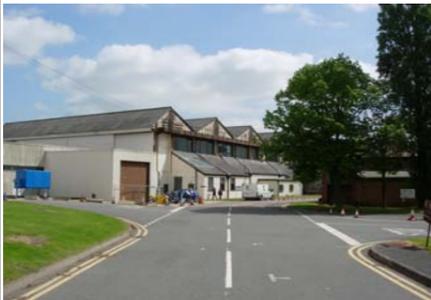
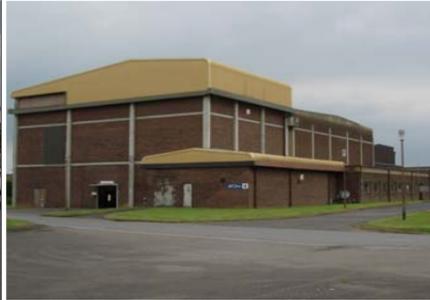
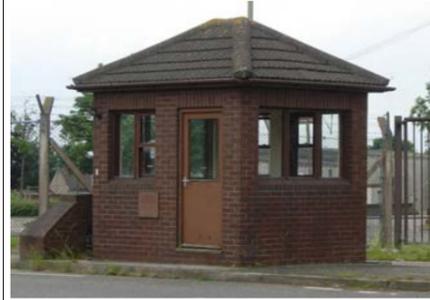
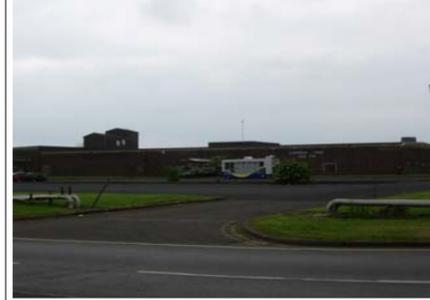
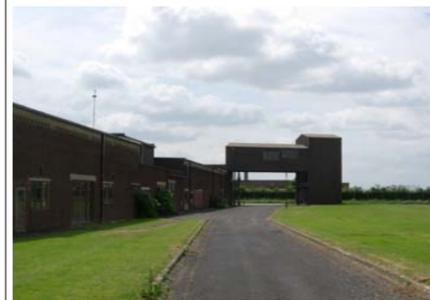
Area 7

Building No.	171	172	293	293a	294
Current Use	Disused office	Offices - 'QEK'	Workshop	Disused - gatehouse	Disused - workshop
Date of Construction (NB: info from asset register)	1935	1925	1971		1971
Floor Area/Volume m ² /m ³ (NB: info from asset register)	248	5135	1580		1774
Number of Floors	1	1 triple height		1	1
Building Height (Eaves, Ridge) m, estimated	4	8, 10	4, 4.5 & 12, 14	2.4, 3	5.0
Construction/Structure	Painted brick walls with parapet to flat roof. Mixture of timber and metal windows.	Steel frame, concrete infill. Asbestos multi-pitched roof with corrugated plastic clerestory. Single storey lean-to extends for most of length of main building. Metal clad flat roof extension to rear.	Concrete frame with concrete slabs and piers exposed and brick infill. Metal clad roof.	Brick walls with pitched, tiled roof. Metal windows & timber door	Brick walls with shallow pitched metal roof. Timber windows. Metal entrance porch with plastic barrel vault roof. 2 storey, metal clad tower and gantry over road to one side of building.

Building/Setting Features & Characteristics of Note	High ceilings internally. Plants growing inside.				Sprawling building with large car park at front. Few windows.
Potential Uses		Currently in use	Currently in use		
Status/Condition	4 poor	3 fair	2 good	2 good	3 fair

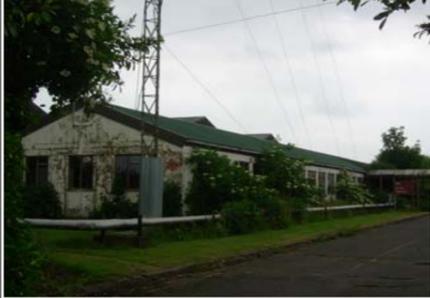
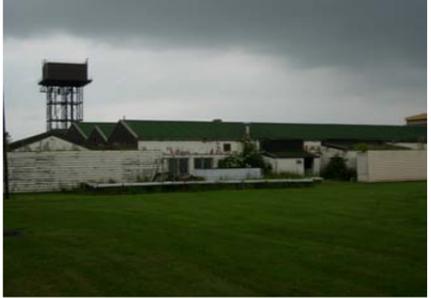
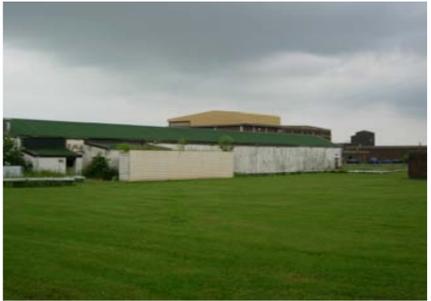
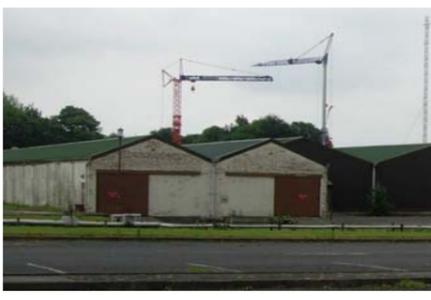
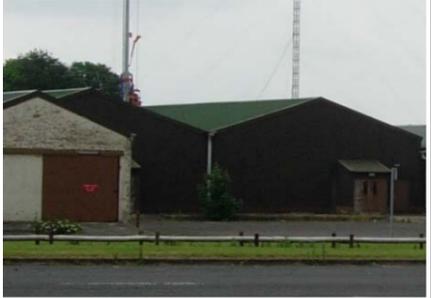
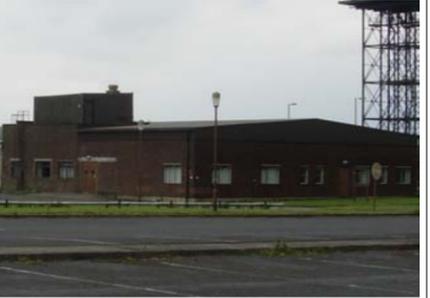
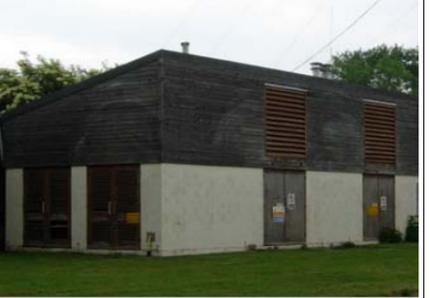
Area 7

Building No.	300A	300B	300C	300D	300E
Current Use	Disused office	Disused workshop	Disused workshop	Disused office	Disused plant
Date of Construction (NB: info from asset register)	1953				
Floor Area/Volume m²/m³ (NB: info from asset register)	3490 combined area	3490 combined area	3490 combined area	3490 combined area	3490 combined area
Number of Floors	1	1	1	1	1
Building Height (Eaves, Ridge) m, estimated	2.4, 3.5	2.4, 3	4, 5.5	4, 4.5	3.5, 4.5
Construction/Structure	Brick plinth with render panels above. Metal windows, metal pitched roof, metal porch with plastic barrel vault roof.	Brick plinth with rendered panels above. Metal windows, metal pitched roof. South side; brick piers, timber windows, loading ramps & metal doors.	Industrial sheds with brick plinth and metal cladding above. Pitched metal roof.	Brick walls with shallow pitched, metal roof. Metal windows with concrete lintels.	Blockwork walls to 2m height, timber weather boarding at high level. Louvred doors.

Building/Setting Features & Characteristics of Note					
Potential Uses					
Status/Condition	4 poor	4 poor	3 fair	3 fair	3 fair

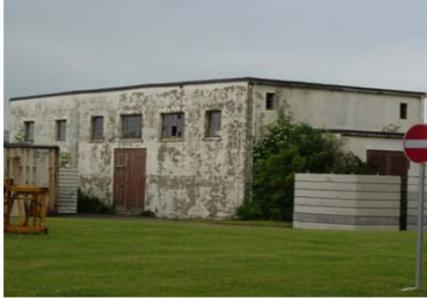
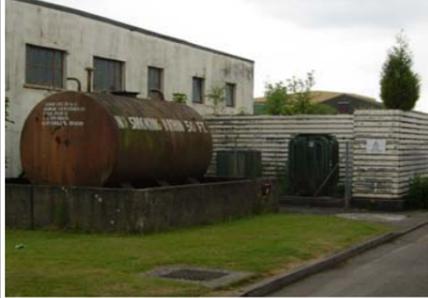
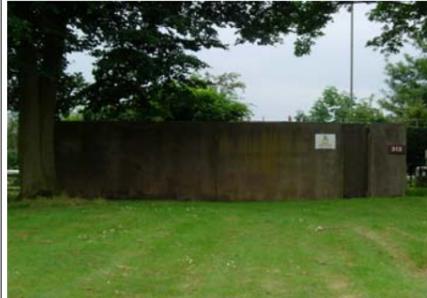
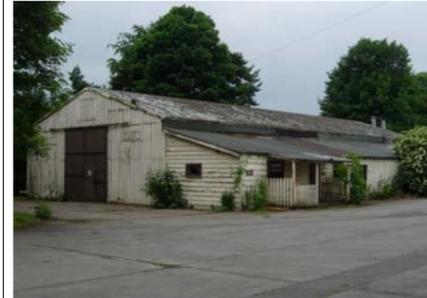
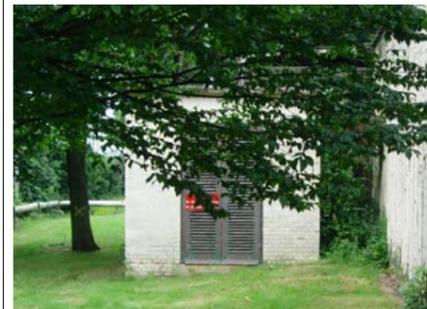
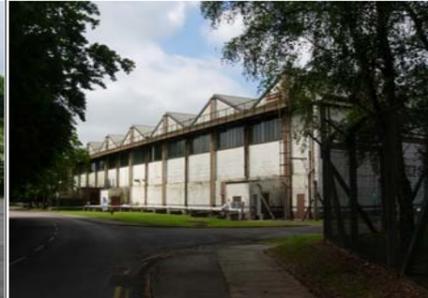
Area 7

Building No.	301	301a	312	313	315
Current Use	Generator	Storage tank	Electric sub-station	Disused workshop	Disused workshop
Date of Construction (NB: info from asset register)	1953		1940	1950	1926
Floor Area/Volume m ² /m ³ (NB: info from asset register)	180			517	3085
Number of Floors	1			1	1 triple height
Building Height (Eaves, Ridge) m, estimated	4.5		2.5	5, 7	8, 10
Construction/Structure	Rendered brick walls with flat asphalt roof. Timber door & metal windows.	Metal on concrete plinth.	Concrete walls to enclosure with metal & wire gates.	Steel frame with metal cladding & metal pitched roof. Corrugated metal surrounds large metal door. 1 No. timber weather boarded lean-to with asphalt roof and picket fence. 1 No. metal clad lean-to with timber windows. Brick & metal sheds at rear.	Steel frame, concrete infill. Asbestos multi-pitched roof with corrugated plastic clerestory. Various lean-tos and adjacent brick plant buildings.

Building/Setting Features & Characteristics of Note					
Potential Uses					
Status/Condition	4 poor	4 poor	3 fair	4 poor	3 fair

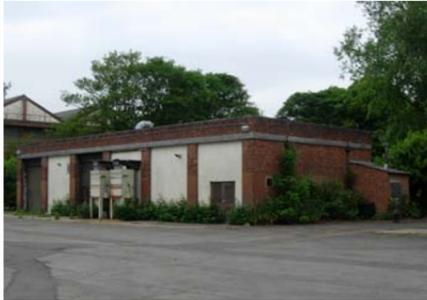
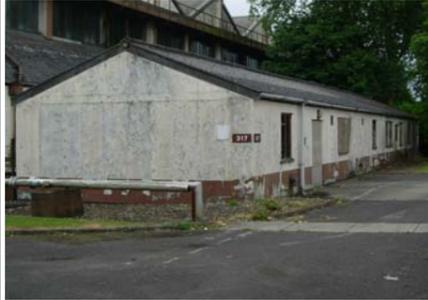
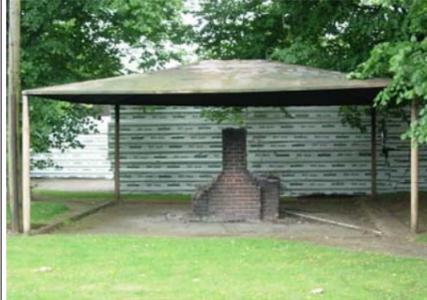
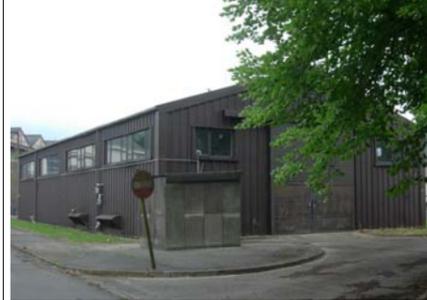
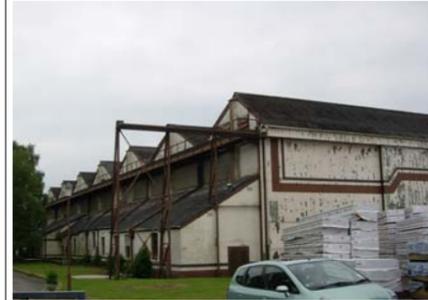
Area 7

Building No.	316	317	317a	318	320
Current Use	Disused workshop	Disused workshop	Disused canopy	Disused office	Workshop - 'Boise'
Date of Construction (NB: info from asset register)	1948	1950		1953	1925
Floor Area/Volume m ² /m ³ (NB: info from asset register)	251	227		340	3533
Number of Floors	1	1		1	1 triple height
Building Height (Eaves, Ridge) m, estimated	6	2.4, 3.5	2.4, 3.2	4, 6	8, 10
Construction/Structure	Brick end walls and piers, rendered infill panels. Roller shutter doors. Parapet to flat roof.	Rendered walls with pitched corrugated asbestos roof.	Remains of brick chimney, covered by metal canopy on metal posts.	Metal clad industrial shed with metal pitched roof & metal windows at high level. Large doors at gable end.	Steel frame, concrete infill. Asbestos multi-pitched roof with corrugated plastic clerestory. Lean-to along one side.
Building/Setting Features & Characteristics of Note

Potential Uses					Currently in use
Status/Condition	3 fair	4 poor	4 poor	2 good	3 fair

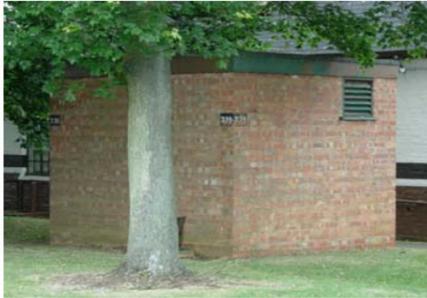
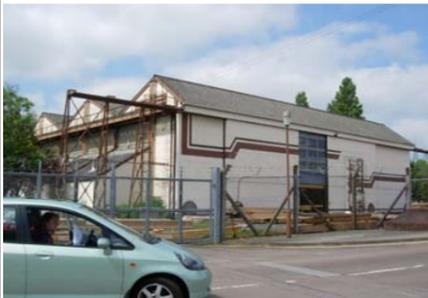
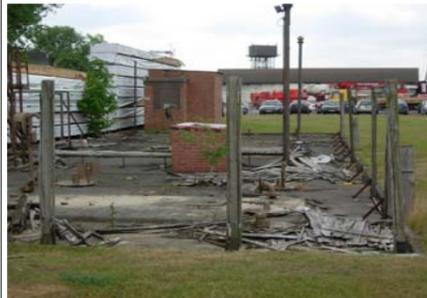
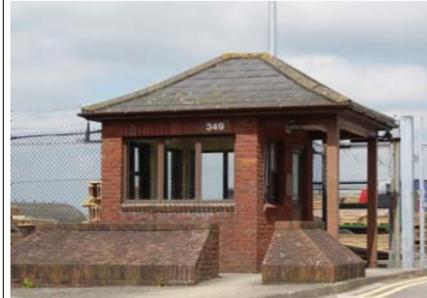
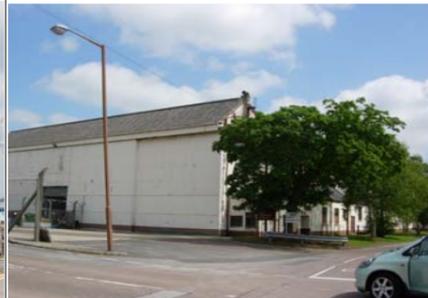
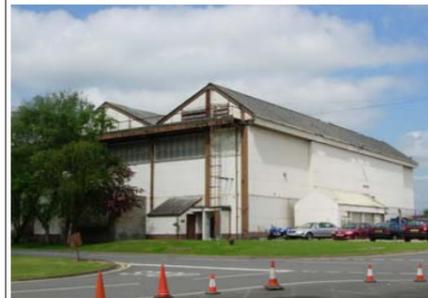
Area 7

Building No.	339	345	346	349	350
Current Use	Com air plant	Workshop - 'Boise'	Disused	Gate house - 'QEK'	Workshops - 'QEK'
Date of Construction (NB: info from asset register)	1982	1925		1990	1925
Floor Area/Volume m ² /m ³ (NB: info from asset register)	7	3533		15	4701
Number of Floors	1	1 triple height	1	1	1 triple height
Building Height (Eaves, Ridge) m, estimated	2.5	8, 10	2.4	2.5, 3.5	6, 8
Construction/Structure	Brick walls containing vents. Timber fascia to flat asphalt roof. Timber double doors.	Steel frame, concrete infill. Asbestos multi-pitched roof with corrugated plastic clerestory. Lean-to along one side.	Brick walls with shallow metal mono-pitch roof. Timber door. Fuel tanks adjacent. Surrounding fence no longer there, concrete posts remain.	Brick walls with pitched, tiled roof partially supported by timber posts.	Steel frame, concrete infill. Asbestos multi-pitched roof with corrugated plastic clerestory. Various lean-tos and adjacent brick plant buildings.

Building/Setting Features & Characteristics of Note					
Potential Uses		Currently in use			Currently in use
Status/Condition	3 fair	3 fair	4 poor	2 good	3 fair

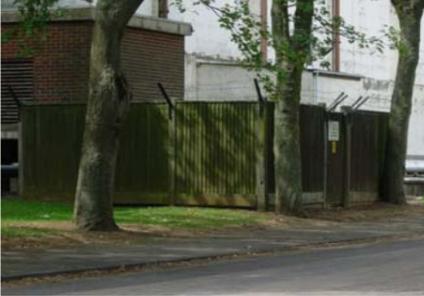
Area 7

Building No.	UH40
Current Use	Electric sub-station
Date of Construction (NB: info from asset register)	
Floor Area/Volume m²/m³ (NB: info from asset register)	
Number of Floors	1
Building Height (Eaves, Ridge) m, estimated	1.8
Construction/Structure	1.8m high timber fence panel enclosure supported by concrete posts. Barbed wire on top.
Building/Setting Features & Characteristics of Note	
Potential Uses	
Status/Condition	3 fair

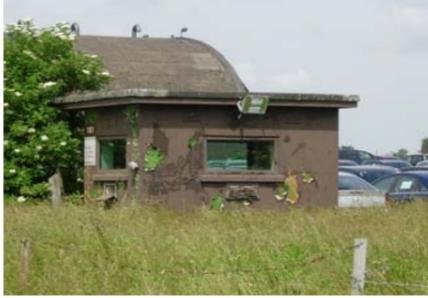
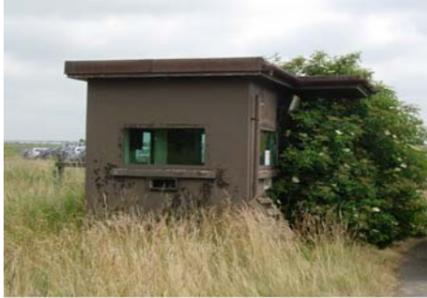
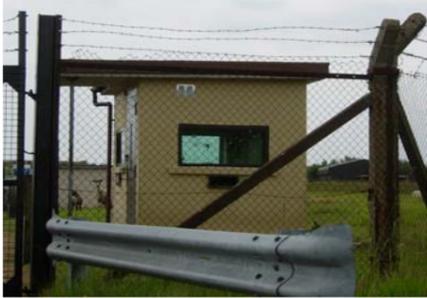
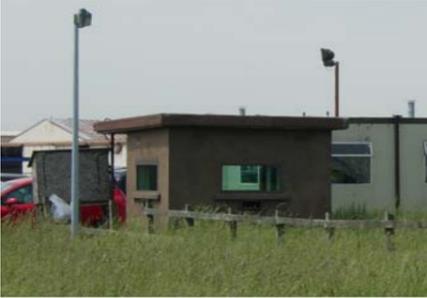
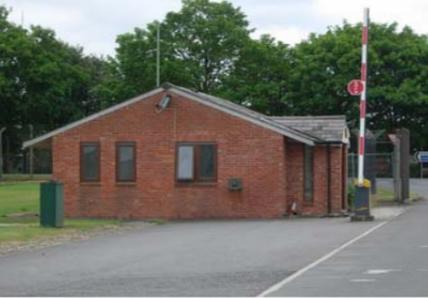
Building No.	181	182	186	189	195
Current Use	Disused - pill box	Disused - pill box	Disused - pill box	Disused - pill box	Main gatehouse
Date of Construction (NB: info from asset register)	1983	1988	1988	1988	1988
Floor Area/Volume m ² /m ³ (NB: info from asset register)	7	7	7	7	72
Number of Floors	1	1	1	1	1
Building Height (Eaves, Ridge) m, estimated	2.5	2.5	2.5	2.5	2.1, 3.5
Construction/Structure	Painted concrete walls and asphalt covered concrete roof, metal doors and window.	Painted concrete walls and asphalt covered concrete roof, metal doors and window.	Painted concrete walls and asphalt covered concrete roof, metal doors and window.	Painted concrete walls and asphalt covered concrete roof, metal doors and window.	Red/orange brindled brick, tile roof, timber windows and doors, timber fascia, pitched roof porch to front.
Building/Setting Features & Characteristics of Note	Paint peeling away, overgrown.	Paint peeling away, overgrown.	Paintwork & glazing intact.	Paint peeling away.	Soldier course over end gable openings, 600mm overhang to roof. Former office currently in use as gatehouse.

Potential Uses					
Status/Condition	4 Poor	3 Fair	3 Fair	3 Fair	2 Good

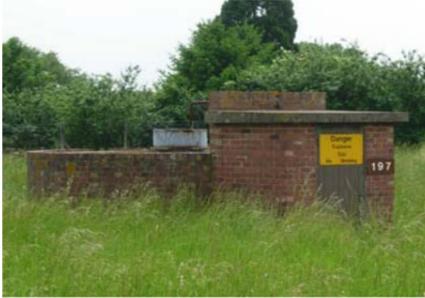
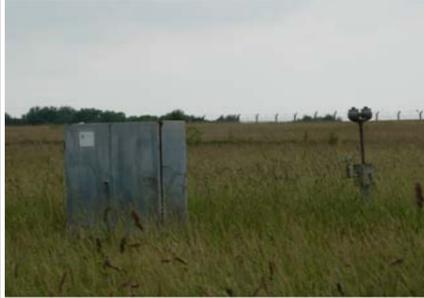
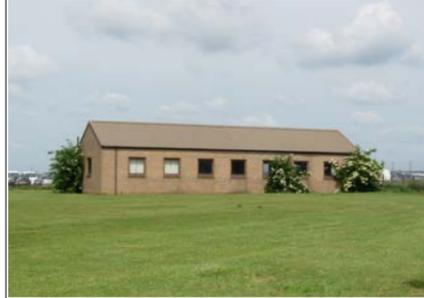
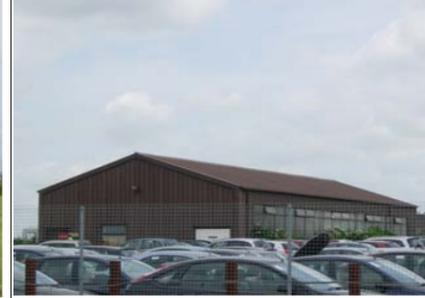
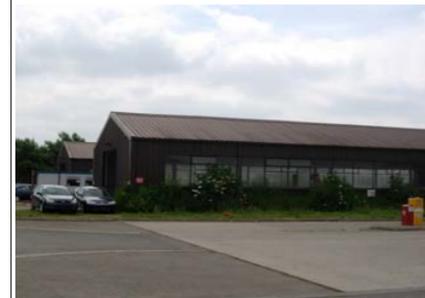
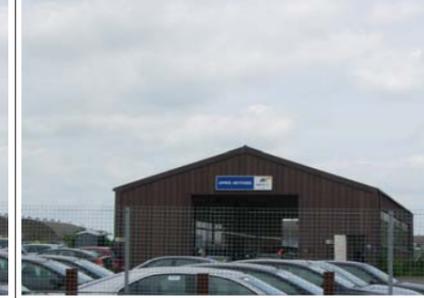
Building No.	197	203	205	259	260
Current Use	Sewage pumping station	Technical equipment & housing	Office	Car cleaning & repair	Car cleaning & repair
Date of Construction (NB: info from asset register)	1945	1989	1983	1935	1935
Floor Area/Volume m ² /m ³ (NB: info from asset register)	2		111	372	372
Number of Floors	1		1	2	2
Building Height (Eaves, Ridge) m, estimated	2.2		2.8, 4.5	6, 8	6, 9
Construction/Structure	Brick, flat concrete roof, circular brick wall 1.5m high adjacent.	Metal cabinet & vertical pipe.	Brick, steel profile roof, timber windows and doors, brick cills.	2 no. steel frame, metal clad industrial sheds, metal windows along either side.	3 no. steel frame, metal clad industrial sheds, metal windows along either side.
Building/Setting Features & Characteristics of Note	Circular wall adjacent 1.5m high brick.	Located at end of main runway	Next to sports pitches, becoming overgrown	Portakabin between 259 & 260	One of the sheds has large long garage size doors.

Potential Uses	Original use only	Original use only	Club house		
Status/Condition	3 Fair	3 Fair	3 Fair	2 Good	2 Good

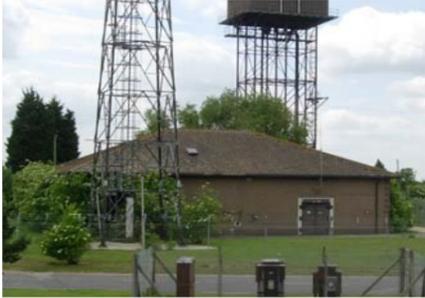
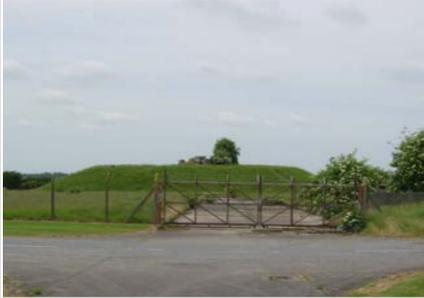
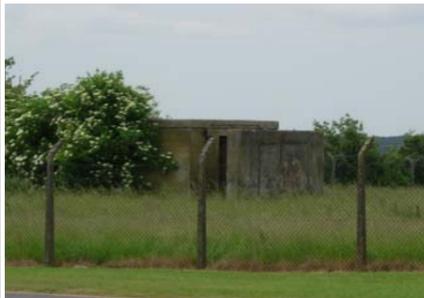
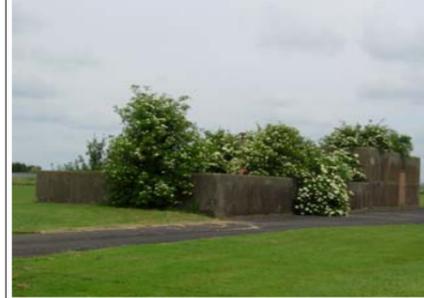
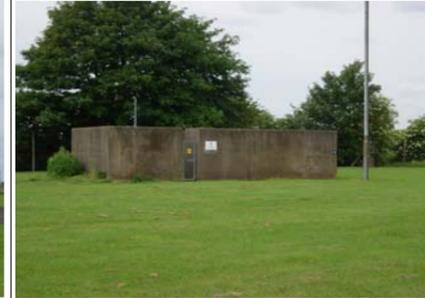
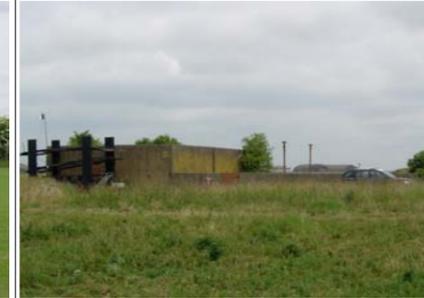
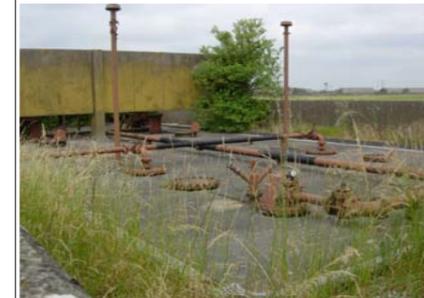
Building No.	268	269/POL24	270	271	274
Current Use	Office / admin	Fuel storage tank	Fuel storage tank	Sub-station	Fuel tank storage
Date of Construction (NB: info from asset register)	1988	1974	1961	1940	1961
Floor Area/Volume m ² /m ³ (NB: info from asset register)	369				
Number of Floors	1	1	1	1	1
Building Height (Eaves, Ridge) m, estimated	4, 5.5	2, 4	1.5, 3	2.2	1.5, 3
Construction/Structure	Brick, concrete tile roof, metal grilled openings and steel door.	Concrete enclosures, inspection covers. Earth mound over tanks.	Concrete wall surrounding fuel tanks which are below ground, high level concrete wall on concrete pillars, metal doors into enclosure.	Concrete walled enclosure with galvanised steel mesh gate.	Concrete wall surrounding fuel tanks which are below ground, high level concrete wall on concrete pillars, metal doors into enclosure.
Building/Setting Features & Characteristics of Note		Overgrown.	Overgrown.

Potential Uses		Original use only	Original use only	Original use only	Original use only
Status/Condition	2 Good	3 Fair	3 Fair	2 Good	3 Fair

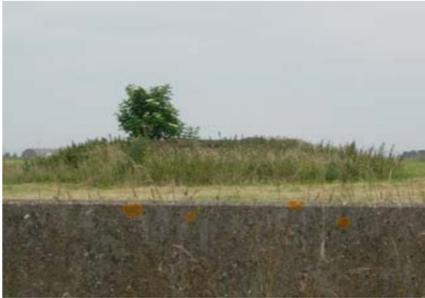
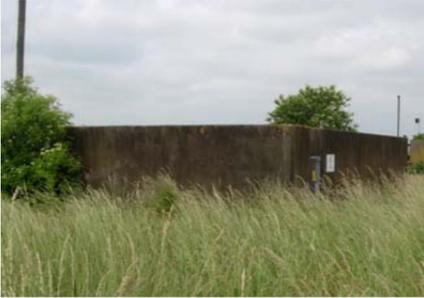
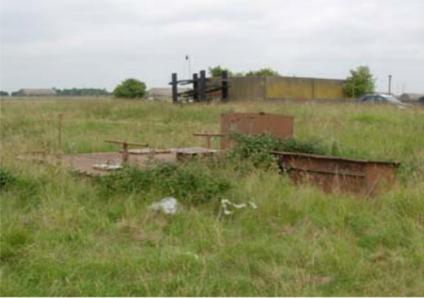
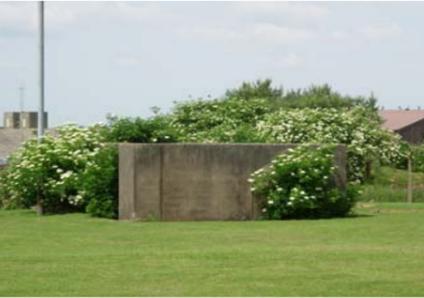
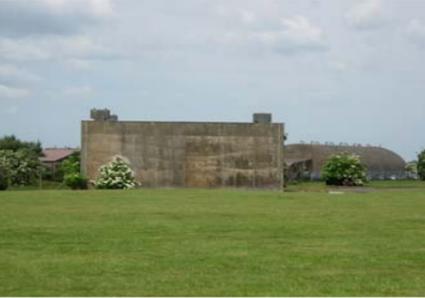
Building No.	274A	275	275A	276	279
Current Use	Bunker	Electricity sub station	Hatch	Sub-station	Disused tanker bay
Date of Construction (NB: info from asset register)		1940		1940	1980
Floor Area/Volume m ² /m ³ (NB: info from asset register)					169
Number of Floors		1		1	1
Building Height (Eaves, Ridge) m, estimated	1.0	2.0		2.3	4.5
Construction/Structure	Sunken into ground	Surrounded by concrete walls, metal gate.	Various metal hatches.	Concrete walled enclosure on concrete plinth .	Concrete walls, flat roof, small steel hatch and large steel double doors.
Building/Setting Features & Characteristics of Note				Next to sports pitches, overgrown.	Next to sports pitches.
Potential Uses	Original use only	Original use only	Original use only	Existing use only	
Status/Condition	3 Fair	3 Fair	4 Poor	3 Fair	3 Fair

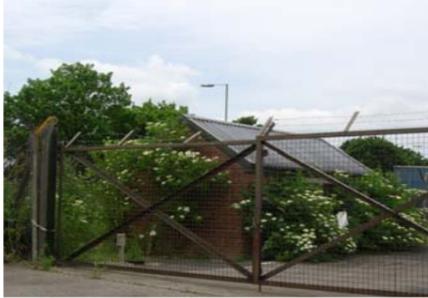
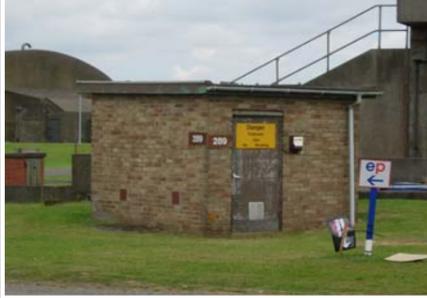
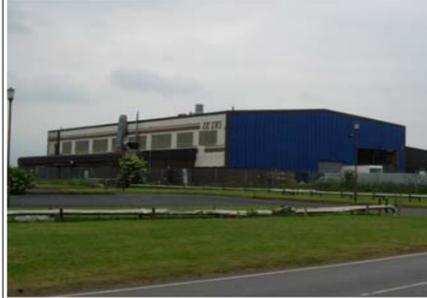
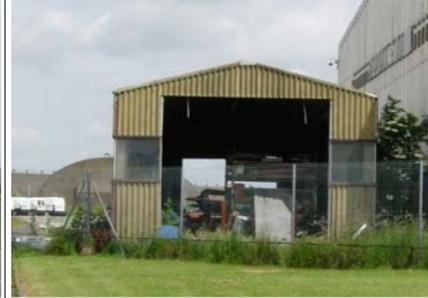
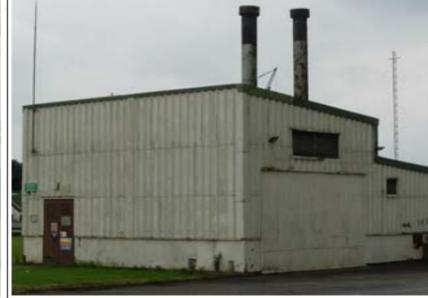
Building No.	286	289	292	292A	295
Current Use	Disused	Sewage pumping station	Workshop	Garage	Boiler house
Date of Construction (NB: info from asset register)	1967	1980	1971		1971
Floor Area/Volume m ² /m ³ (NB: info from asset register)			2070		136
Number of Floors	1	1	1		1
Building Height (Eaves, Ridge) m, estimated	2.4, 3.5	2.4	8.0	3.5, 4	4 & 6
Construction/Structure	Red brick, metal roof & flashing, concrete lintel over openings, pitched roof.	Brick with flat asphalt roof, timber doors.	Brick at low level to 2.5m height then metal clad, metal roof with shallow pitch. Asbestos in roof/walls.	Corrugated metal shed, corrugated metal pitched roof, garage doors.	Render at low level, corrugated metal clad above, metal shallow pitched roof, timber door.
Building/Setting Features & Characteristics of Note	Inaccessible, behind large gates.	No windows.			
Potential Uses		Original use only			
Status/Condition	3 Fair	3 Fair	3 Fair	3 Fair	3 Fair

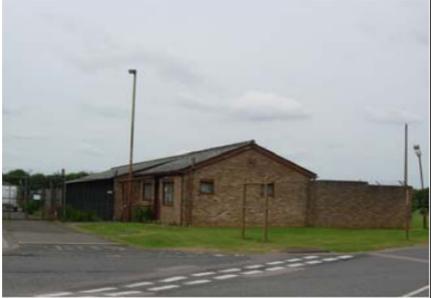
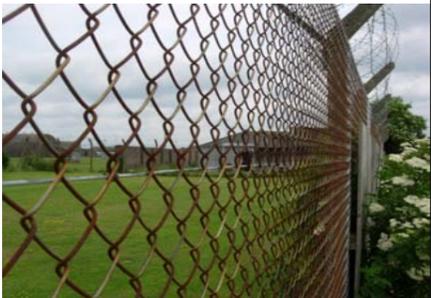
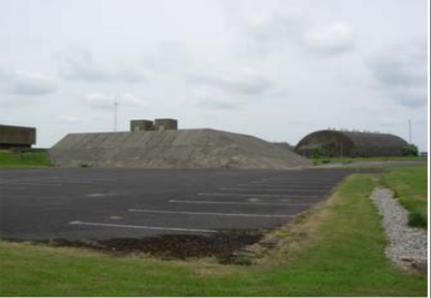
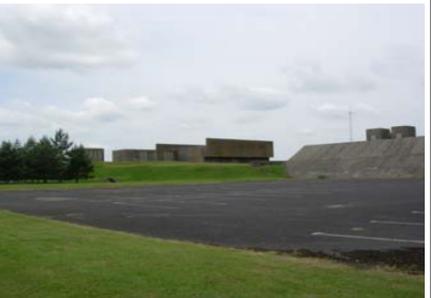
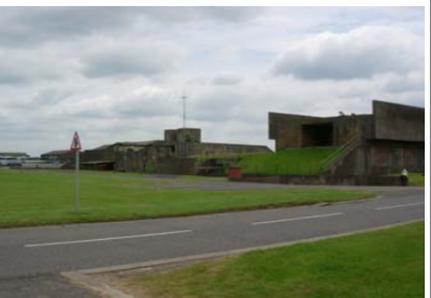
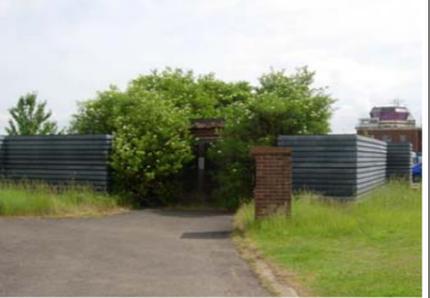
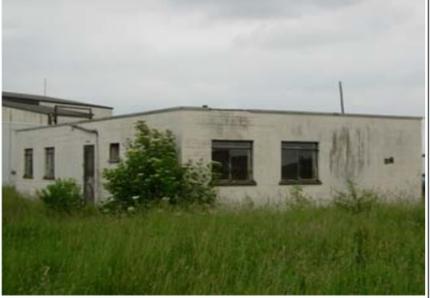
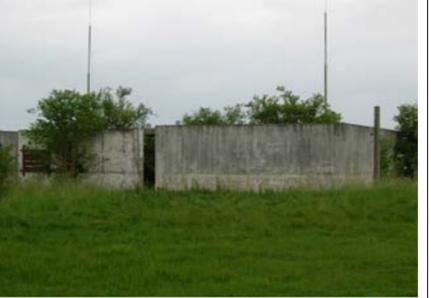
Building No.	296/297	299	310	311	314
Current Use	Kennels and housing	Workshop	Sub-station	Office	Radar bunker
Date of Construction (NB: info from asset register)	1971	1980		1981	
Floor Area/Volume m ² /m ³ (NB: info from asset register)		2676		116	
Number of Floors	1	2	1	1	1
Building Height (Eaves, Ridge) m, estimated	2.4, 3.8	5.5 top of pyramid, plus 2m for turrets	2.5	2.8	2.5
Construction/Structure	Brick walls, metal windows, asbestos roof. Kennels sit on concrete plinth with concrete blockwork expressed internally and then profiled metal sheet above and open fronts.	Concrete bunker with sloping sides, partial earth mound over, turrets protruding with vent grilles. Mast protruding from earth. Access hatches in ground. Large concrete volume protruding from mound.	Brick walls, timber louvred door, timber structure, asphalt roof. Surrounded by profiled metal walls.	Painted blockwork walls with flat roof & metal fascia. Metal windows with timber cills.	Fibreglass and metal box. 2.5m high sat on concrete plinth, surrounded by concrete walls.

Building/Setting Features & Characteristics of Note	Plastic coated chain link fence enclosure.	Large parking area.			
Potential Uses					
Status/Condition	3 Fair	3 Fair	3 Fair	4 Poor	4 Poor

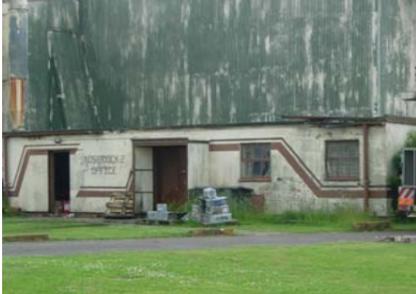
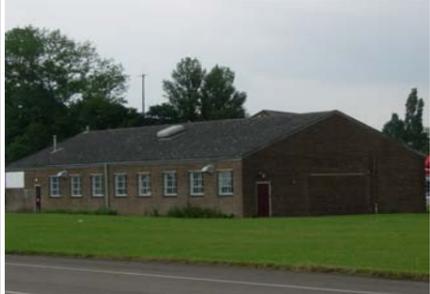
Area 8

Building No.	323	324	325	326	327
Current Use	Office	Office	Nose Dock	Sub-station	Nose Dock
Date of Construction (NB: info from asset register)	1962	1971	1959	1940	1959
Floor Area/Volume m ² /m ³ (NB: info from asset register)	57	372	769		702
Number of Floors	1	1	1	1	1
Building Height (Eaves, Ridge) m, estimated	2.5	3.2, 5.5	8.0	2.5	8.0
Construction/Structure	Rendered, asphalt roof with metal door & windows.	Brick walls with metal windows. Concrete lintels & tiled eills. Asbestos pitched roof.	Steel frame, corrugated metal clad, metal roof. Large sliding metal doors to front.	Brick building with asphalt covered concrete roof. Concrete walls enclose adjacent sub station.	Steel frame, corrugated metal clad, metal roof. Large sliding metal doors to front.
Building/Setting Features & Characteristics of Note		High level windows.			
Potential Uses		Currently in use			
Status/Condition	4 Poor	2 Good	3 Fair	3 Fair	3 Fair

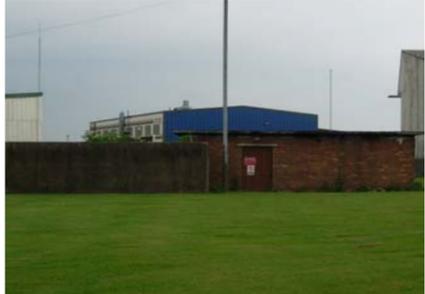
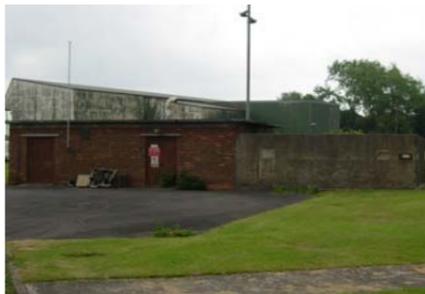
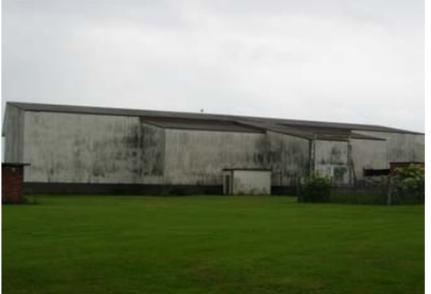
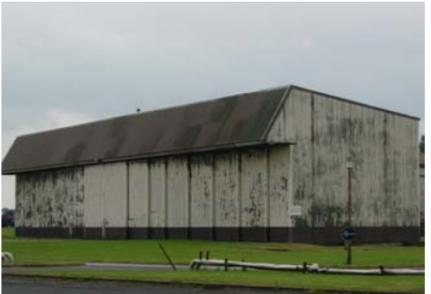
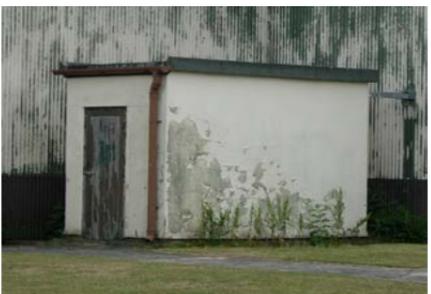
Area 8

Building No.	328	329	330	331	331A
Current Use	Nose Dock	Sub station	Car store (fire training)	Store	Gate house
Date of Construction (NB: info from asset register)	1959	1962	1973	1935	
Floor Area/Volume m ² /m ³ (NB: info from asset register)	725	8		43	
Number of Floors	1	1	2	1 & 1 1/2	1
Building Height (Eaves, Ridge) m, estimated	8.0	2.5	6, 7.5	3.5, 4	2.4
Construction/Structure	Steel frame, corrugated metal clad, metal roof. Large sliding metal doors to front.	Rendered walls with asphalt roof & timber door.	Concrete fire practice tower, metal balcony, metal shutters to some openings, balustrade to roof.	Rendered walls with piers around perimeter, flat asphalt roof, metal windows. Storage tank in ground adjacent. 2nd smaller single storey volume adjacent with metal roof, slight monopitch, metal windows.	Portakabin
Building/Setting Features & Characteristics of Note			Concrete circle in ground for fire practice, lip approx. 1m high, concrete base. Timber sheds to side.	Large pit & H2O also to side.

Potential Uses					Currently in use
Status/Condition	3 Fair	3 Fair	3 Fair	4 Poor	2 Good
	as 327

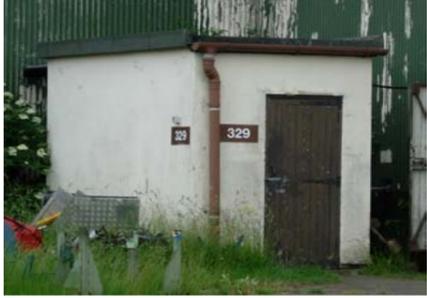
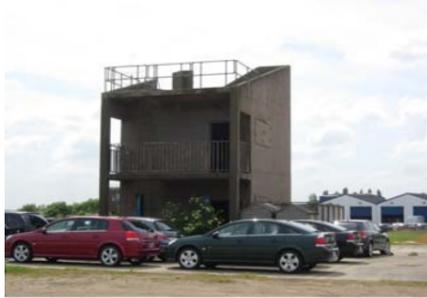
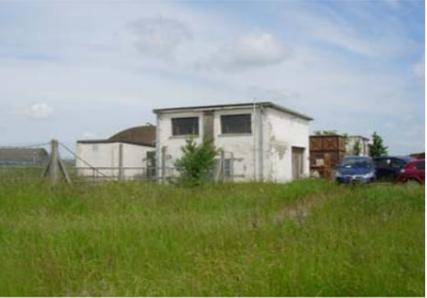
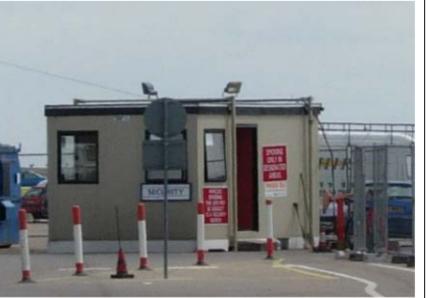
Area 8

Building No.	331B	333	335	336	337
Current Use	Storage tank	Store	Nose Dock	Office	Old fire station
Date of Construction (NB: info from asset register)		1935	1959	1973	1953
Floor Area/Volume m ² /m ³ (NB: info from asset register)		139	769	800	1388
Number of Floors		1 & 11/2	1	1	1
Building Height (Eaves, Ridge) m, estimated	2.5	3.5, 4	8.0	4, 6	5, 7
Construction/Structure	Metal fuel tank surrounded by black boarding	Rendered walls with piers around perimeter, flat asphalt roof, metal windows. Asbestos downpipes & gutters	Steel frame, corrugated metal clad, metal roof. Asbestos rainwater goods & eaves. Large sliding metal doors to front.	Concrete plinth, steel frame, brick at low level with profiled metal sheet above and large sliding metal doors. Asbestos in roof, walls, downpipe & gutters.	Blockwork walls with metal cladding at high level. Buildings at rear are metal clad with brickwork expressed internally to height of 2m & metal pitched roof. Blockwork lean-to with shallow metal monopitch roof & metal windows.

Building/Setting Features & Characteristics of Note		Blockwork enclosure to side. Large water storage tank adjacent, enclosed in chicken wire fence.			
Potential Uses					Currently in use as workshop
Status/Condition	2 Good	4 Poor	2 Good	3 Fair	2 Good

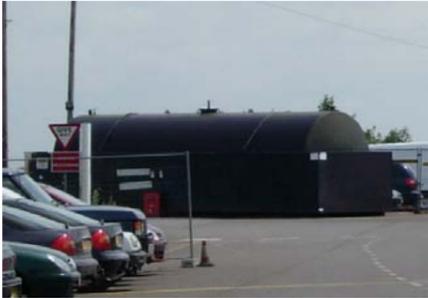
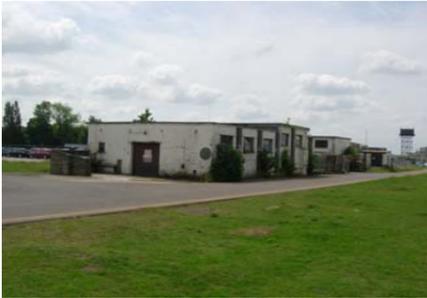
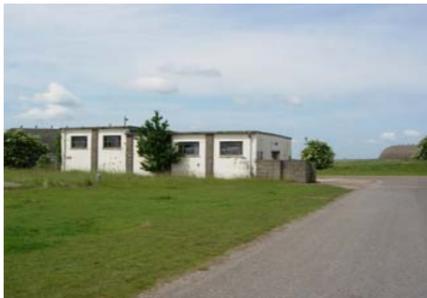
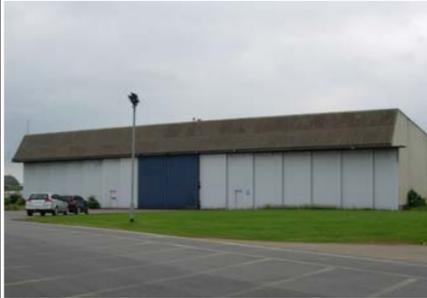
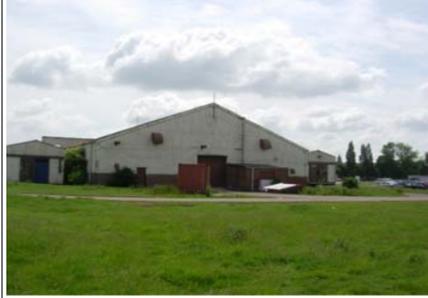
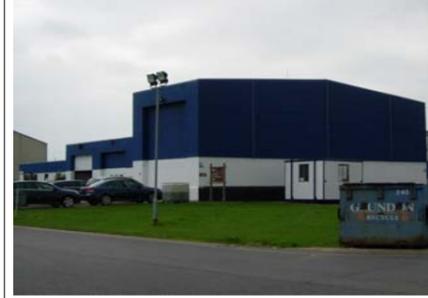
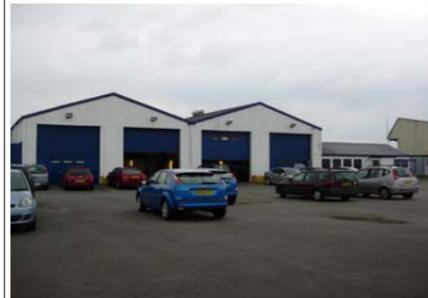
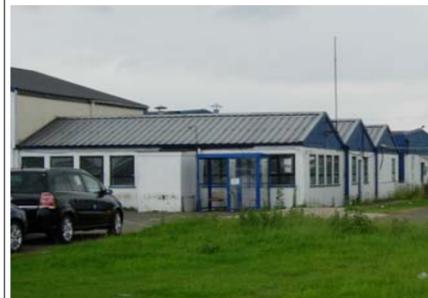
Area 8

Building No.	338	340	341	342	344
Current Use	Generator	Disused control tower	Office	Office	Water tank
Date of Construction (NB: info from asset register)	1959	1953	1939	1940	1967
Floor Area/Volume m ² /m ³ (NB: info from asset register)	30	418	74	259	
Number of Floors	1	3	1	1	
Building Height (Eaves, Ridge) m, estimated	2.5	10.0	2.2, 3	2.4, 4	
Construction/Structure	Brick walls with asphalt flat roof. Large metal vent to side and metal roller shutter door at front.	Brickwalls with concrete roof. Metal railings on roof & metal viewing area on top. Metal windows. Asbestos in roof & wall.	Prefabricated unit with metal panel walls, metal windows, timber door & metal pitched roof.	Concrete plinth, rendered panels, metal pitch roof, metal windows, UPVC doors, brick entrance porch with flat asphalt roof.	Sunken concrete tank with metal railings around perimeter, surrounded by concrete posts and chain link fence.

Building/Setting Features & Characteristics of Note		Bars to ground floor windows.			
Potential Uses			Currently in use		
Status/Condition	2 Good	3 Fair	2 Good	2 Good	3 Fair

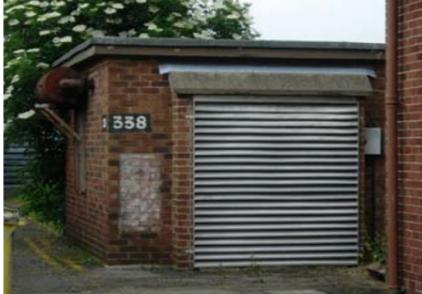
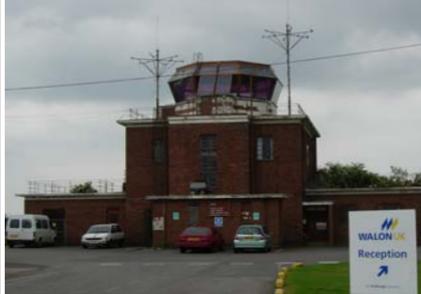
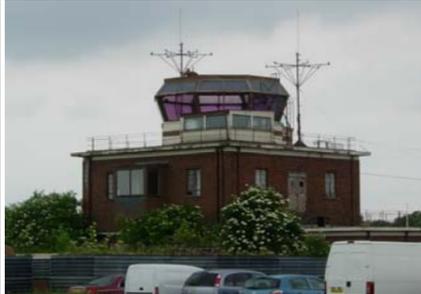
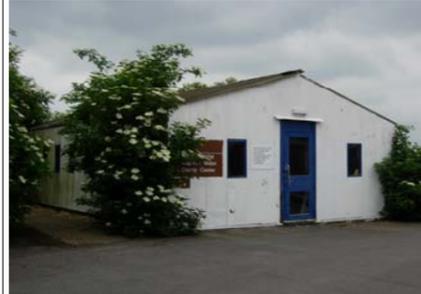
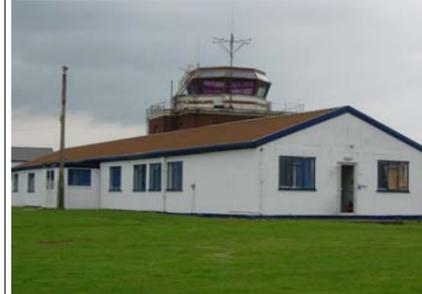
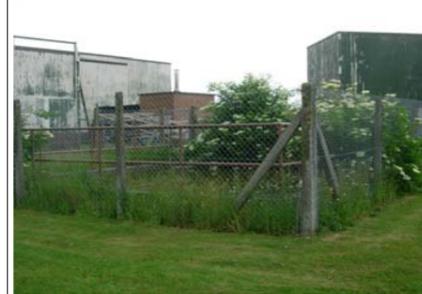
Area 8

Building No.	351	355	357	359	360
Current Use	Water tank	Radio mast	Office	Sub-station	Control tower
Date of Construction (NB: info from asset register)	1967	1981	1972	1972	1973
Floor Area/Volume m ² /m ³ (NB: info from asset register)		0	730	26	14
Number of Floors			2	1	
Building Height (Eaves, Ridge) m, estimated		18.0	6, 7.5	3.5	10.0
Construction/Structure	Sunken concrete tank with metal railings around perimeter, surrounded by concrete posts and chain link fence.	Metal viewing platform, surrounded by 2.5m high concrete wall. Metal clad sub station within enclosure at base of mast with concrete plinth, metal windows & metal pitched roof. (Eaves 2.2m, Ridge 3m)	Brick walls with pitched, tiled roof. Metal windows with metal cills. Timber doors.	Brick walls on concrete plinth. Concrete flat roof with metal over. Metal door & metal windows.	Metal structure with metal platform, glazed enclosure on top with metal roof.

Building/Setting Features & Characteristics of Note			Some bricks missing.	Windows smashed.	
Potential Uses					
Status/Condition	3 Fair	2 Good	3 Fair	3 Fair	4 Poor

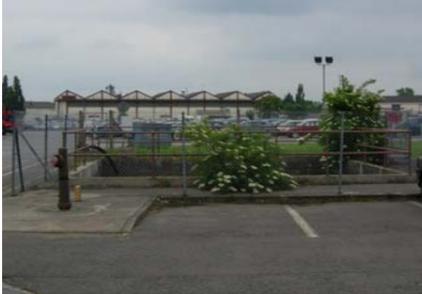
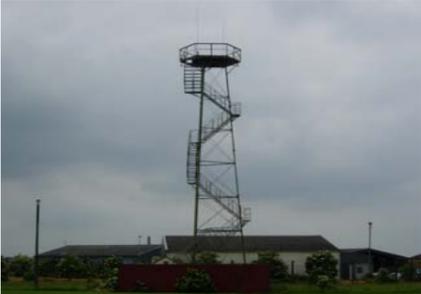
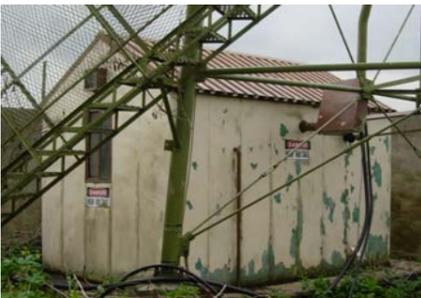
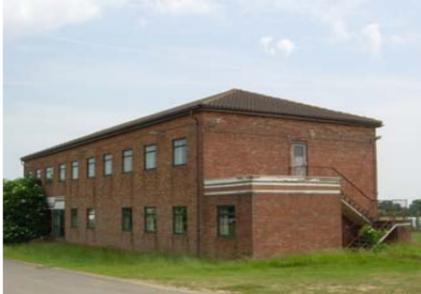
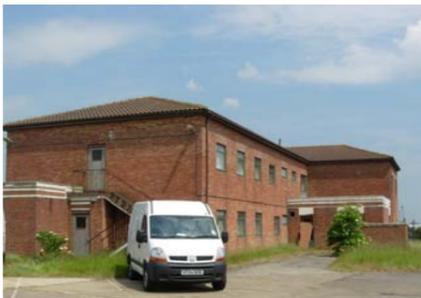
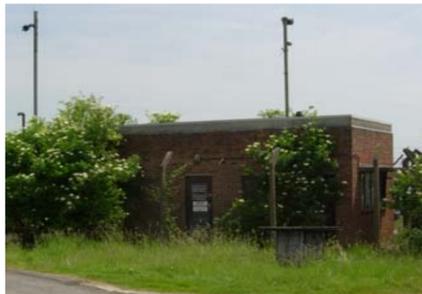
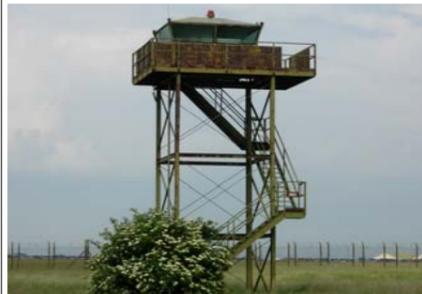
Area 8

Building No.	360A	361	362	365	366
Current Use	EWS pit	Sub-station	Sub-station	Fuel storage tank	Workshop
Date of Construction (NB: info from asset register)		1940	1940	1961	1976
Floor Area/Volume m ² /m ³ (NB: info from asset register)					1656
Number of Floors		1	1	1	1
Building Height (Eaves, Ridge) m, estimated	1.8	2.0	2.0	2 & 4	8.0
Construction/Structure	Sunken concrete pit surrounded by 1.8m high chain link fence.	Surrounded by blockwork walls.	Surrounded by concrete walls.	Concrete wall surrounding fuel tanks which are below ground. High level concrete wall on concrete pillars. Metal doors into enclosure.	Steel frame with corrugated metal cladding to walls. Sliding front façade. Metal pitched roof. Single storey extension to rear
Building/Setting Features & Characteristics of Note		Cracks visible in wall.	Becoming overgrown.	Overgrown inside.	Good condition internally.
Potential Uses					Currently in use by QEK

Status/Condition	3 Fair	4 Poor	4 Poor	4 Poor	3 Fair

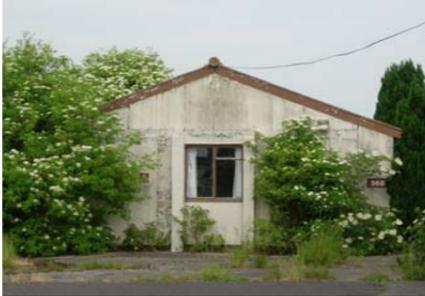
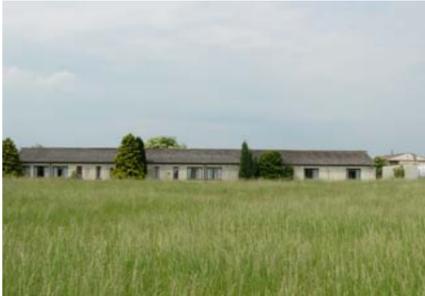
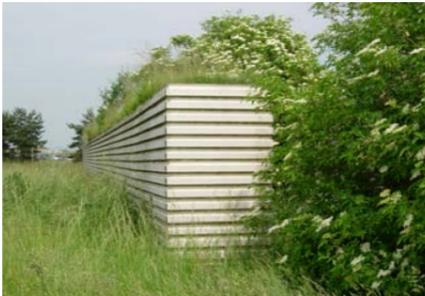
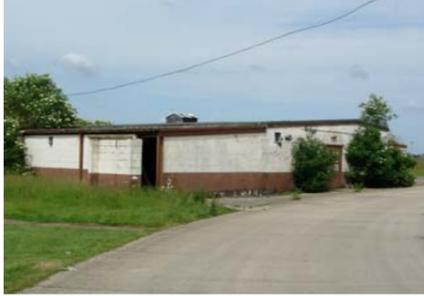
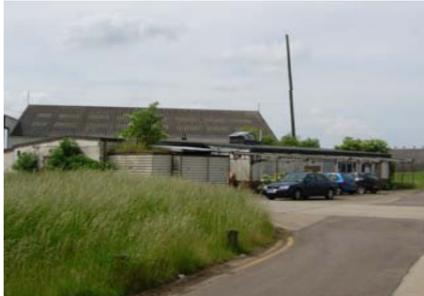
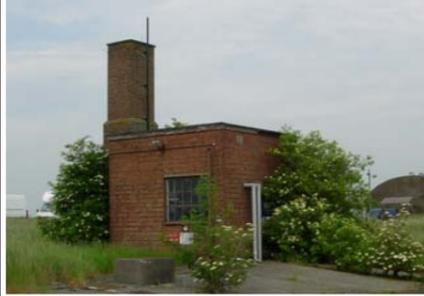
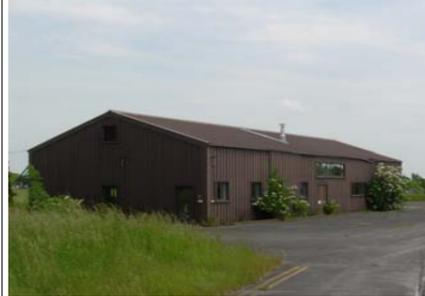
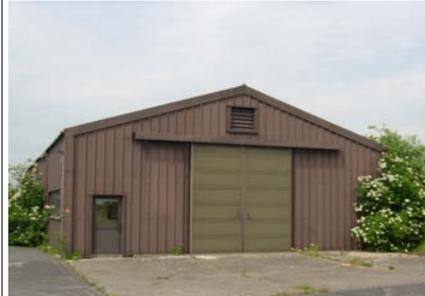
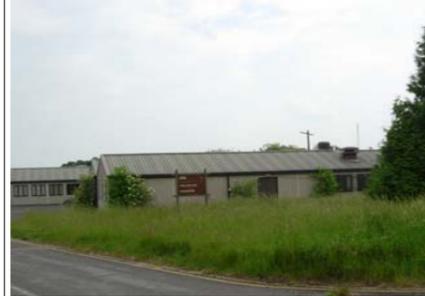
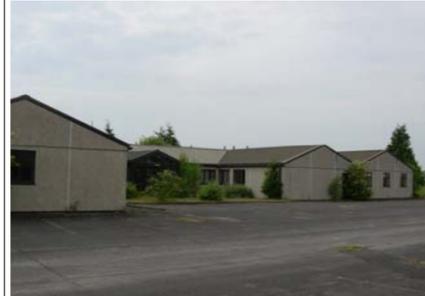
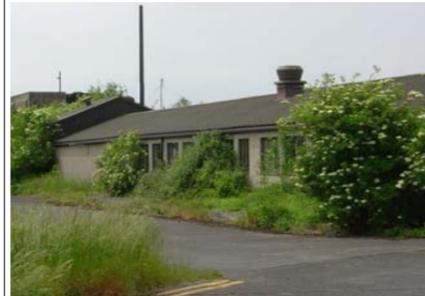
Area 8

Building No.	368K	368W	368a	369	370
Current Use	Workshop	Office	Boiler	Office	Office
Date of Construction (NB: info from asset register)		1968		1940	1953
Floor Area/Volume m ² /m ³ (NB: info from asset register)		319		378	1747
Number of Floors	1	1			1
Building Height (Eaves, Ridge) m, estimated		3, 4	3 & 4.5 (chimney)	4, 5.5	2.2, 3
Construction/Structure	Rendered walls with asbestos pitched roof.	Painted brick walls with shallow pitched asphalt roof & metal baffles under tin roof with steel structure to one end. Protruding skylight. Metal windows & doors. Some boarded openings. Blockwork extension to rear with corrugated plastic roof on steel supports.	Brick walls with flat asphalt roof & brick chimney.	Steel frame with metal cladding to walls & metal pitched roof. Metal windows & large sliding doors at rear.	Brick plinth with pebble dashed walls. Metal windows & metal pitched roof.
Building/Setting Features & Characteristics of Note	Corrugated metal barrier filled with ballast/earth runs the length of one side.

Potential Uses					
Status/Condition	4 Poor	4 Poor	3 Fair	3 Fair	3 Fair

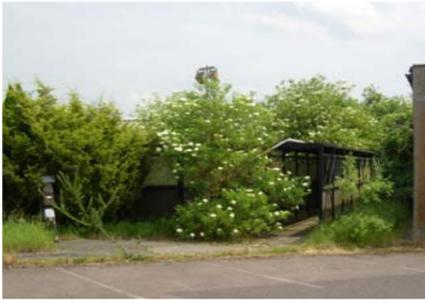
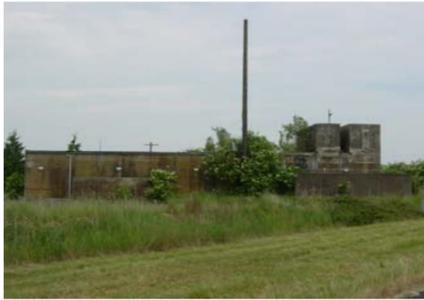
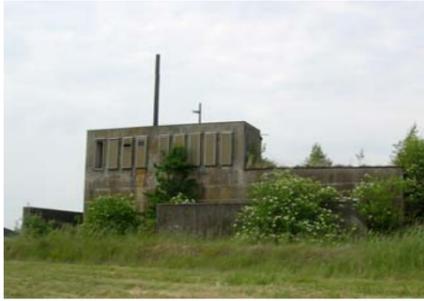
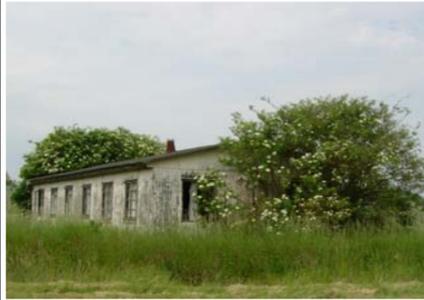
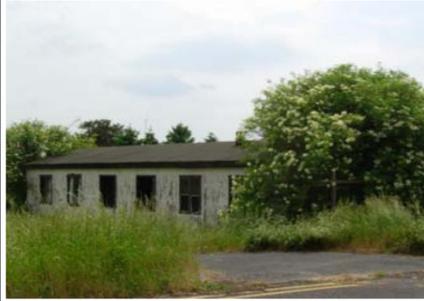
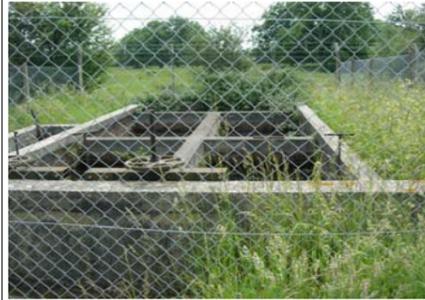
Area 8

Building No.	370b	370c	371	372	375A, B , C & D / POL 20
Current Use	Covered walkway between buildings	Generator	Office	Pit	Fuel storage tank
Date of Construction (NB: info from asset register)			1935		
Floor Area/Volume m ² /m ³ (NB: info from asset register)			89		
Number of Floors		1	1		
Building Height (Eaves, Ridge) m, estimated	2.2	3 & 4	2.4, 3.5		
Construction/Structure	Metal structure with plastic roof.	Concrete walls & flat concrete roof. Secondary concrete wall surrounds building at lower level.	Concrete plinth with painted timber weatherboarding to walls. Timber windows & asphalt shallow pitched roof.	Sunken pit with concrete sides which protrude above the ground. Enclosed in 1.8m high chain link fence.	Not accessible
Building/Setting Features & Characteristics of Note	Overgrown			Becoming overgrown.	
Potential Uses					
Status/Condition	4 Poor	4 Poor	4 Poor	3 Fair

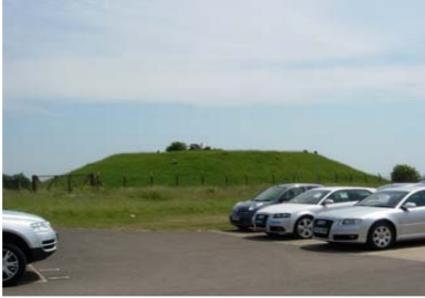
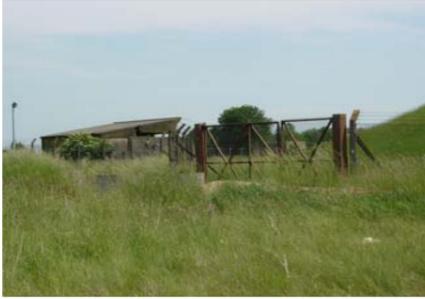
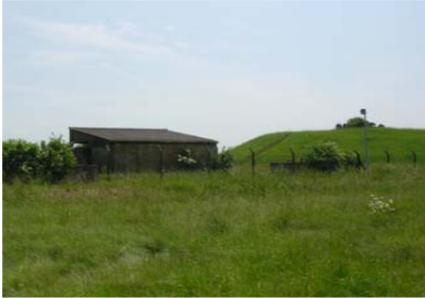
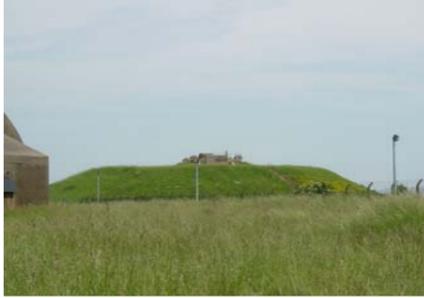
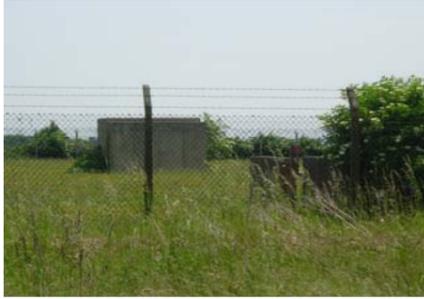
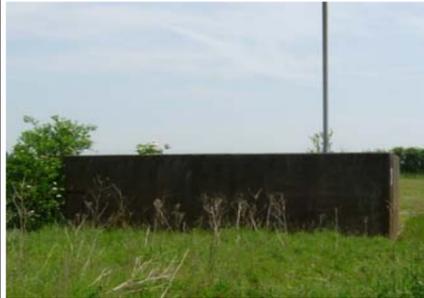
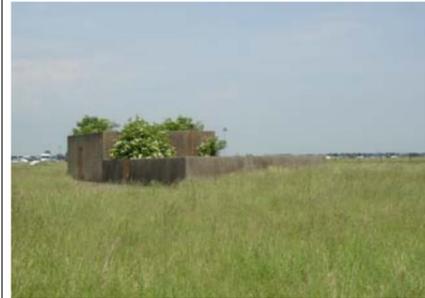
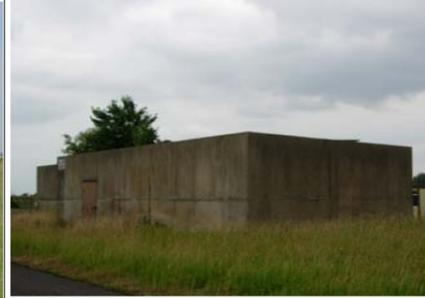
Area 8

Building No.	376	377	379	382	385
Current Use	Fuel storage tank	Fuel storage tank	Sub-station	Fuel storage tank	Fuel storage tank
Date of Construction (NB: info from asset register)	1974	1974	1940	1961	1961
Floor Area/Volume m ² /m ³ (NB: info from asset register)					
Number of Floors			1	1	1
Building Height (Eaves, Ridge) m, estimated	4.5	4.5	2.4	2 & 4	2, 4
Construction/Structure	Earth mound covering concrete holding tanks. Vents protrude out of mound.	Earth mound covering concrete holding tanks. Vents protrude out of mound.	Concrete walls surrounding sub station, metal gate.	Concrete enclosure with inspection covers inside.	Concrete walls surround machinery & pumps which are covered by an asbestos roof supported on a metal frame.
Building/Setting Features & Characteristics of Note	Other shed type structures in enclosure of mixed construction - both metal and concrete.	Other shed type structures in enclosure of mixed construction - both metal and concrete.		Overgrown inside.	Overgrown inside.

Potential Uses					
Status/Condition	3 Fair	3 Fair	3 Fair	3 Fair	3 Fair
