heyford park

BUILDING APPRAISAL

ROGER EVANS ASSOCIATES LTD FOR NORTH OXFORDSHIRE CONSORTIUM LTD

Issued : July 2006

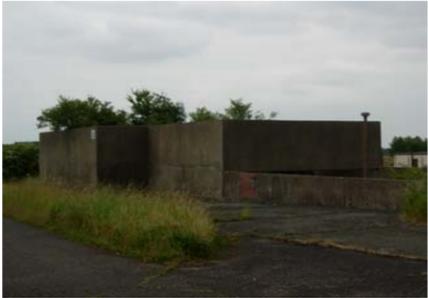
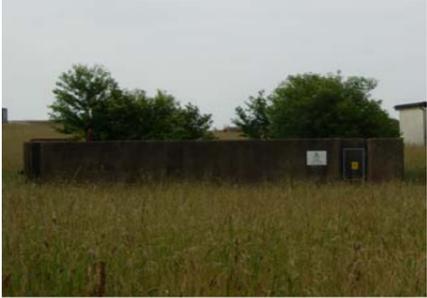
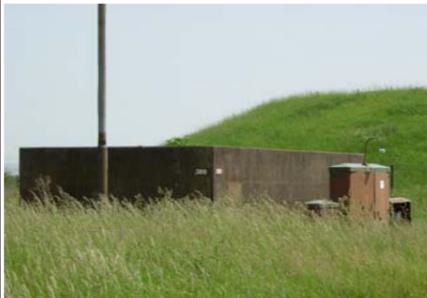
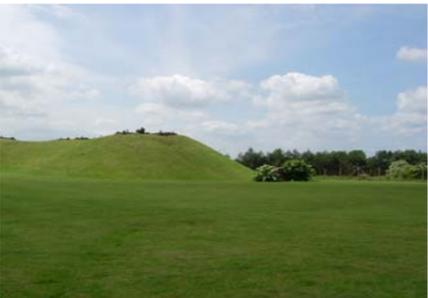
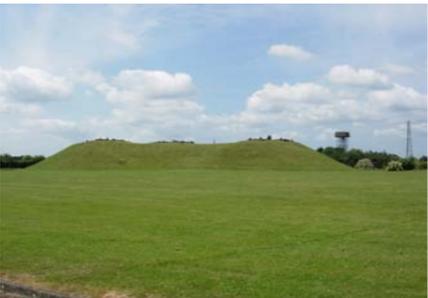
Area 8

Building No.	386	387	389	391	392
Current Use	Fuel storage tank	Sub-station	Electricity sub station	Small structure adjacent runway	Fuel storage tank
Date of Construction (NB: info from asset register)	1961	1940	1940		1961
Floor Area/Volume m ² /m ³ (NB: info from asset register)					
Number of Floors	1				
Building Height (Eaves, Ridge) m, estimated	2, 4	2.0	2.0		4.5
Construction/Structure	Concrete walls surround machinery & pumps.	Sub-station surrounded by concrete walls, metal gate.	Sub-station surrounded by concrete walls, metal gate.	Not accessible	Earth mound covering 3 No. concrete holding tanks. Vents protrude out of mound. Adjacent steel switchgear housings on concrete plinth.
Building/Setting Features & Characteristics of Note	Overgrown inside.	Overgrown inside.			
Potential Uses					
Status/Condition	3 Fair	3 Fair	3 Fair		2 Good

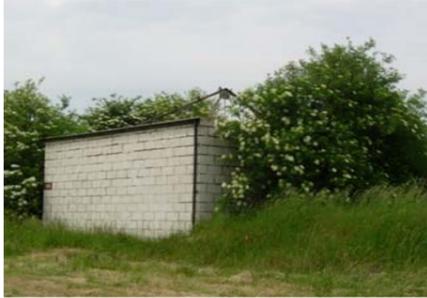
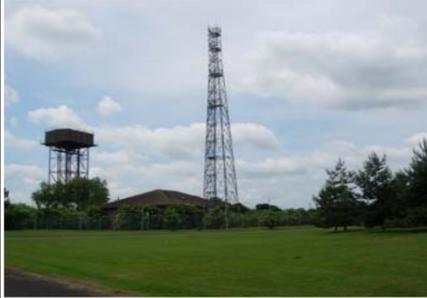
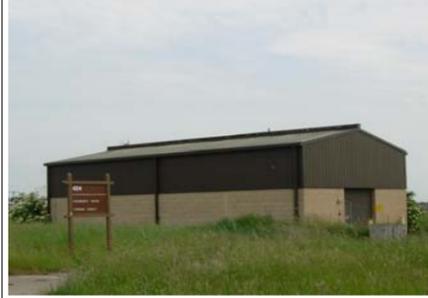
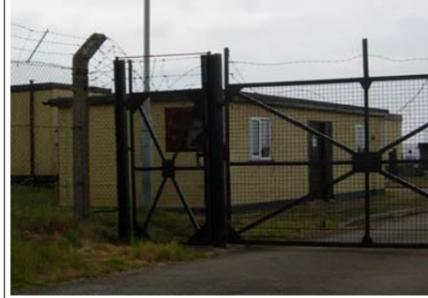
Area 8

Building No.	397	399	416	424	1100
Current Use	Small structure adjacent runway	Store	Mast	Store	Gate house
Date of Construction (NB: info from asset register)		1940	1988		1955
Floor Area/Volume m ² /m ³ (NB: info from asset register)		54			34
Number of Floors		1		1	1
Building Height (Eaves, Ridge) m, estimated		2, 3.5	16.0	3.5, 4.2	2.4
Construction/Structure	Not accessible	Blockwork walls. Roof covering gone & metal structure exposed.	Steel framed mast.	Blockwork walls, metal clad at high level. Metal pitched roof & metal roller shutter door.	Painted brick walls with flat asphalt roof. Mostly doubled glazed UPVC windows & some metal windows at rear. Timber door, soldier course over windows, concrete cills.
Building/Setting Features & Characteristics of Note		Overgrown.			
Potential Uses					
Status/Condition		4 Poor	2 Good	2 Good	2 Good

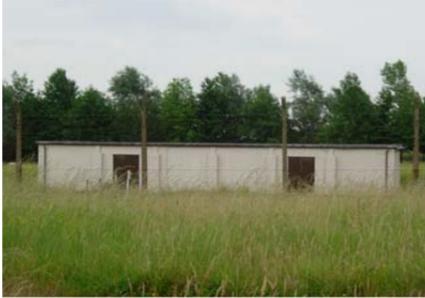
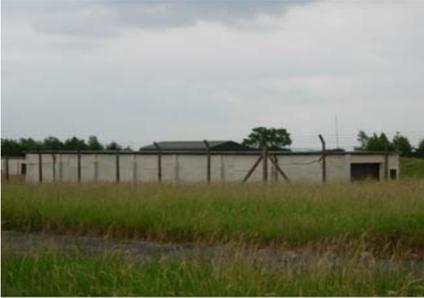
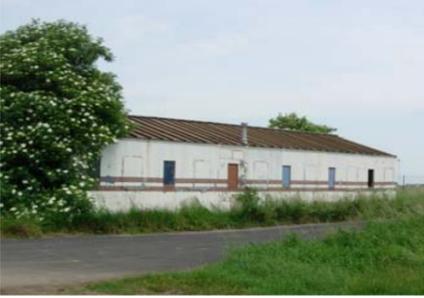
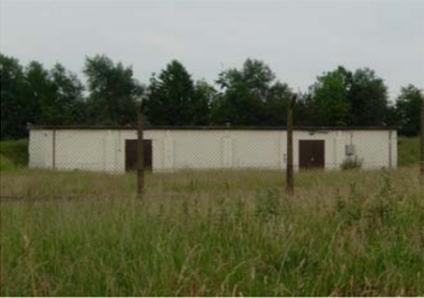
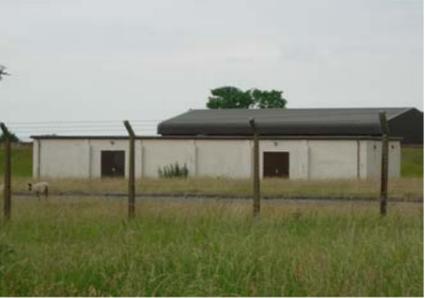
Building/Setting Features & Characteristics of Note	Large HVAC system to rear & cable tray around gutter zone. Render cracking & spalled all round.	Render & bricks badly damaged. Windows on side infilled with brick.	Boarded windows.	Bad cracks to render & spalled all round. Earth mound behind. (Photography not permitted within compound)	Bad cracks to render & spalled all round. (Photography not permitted within compound)
Potential Uses					
Status/Condition	4 Poor	4 Poor	4 Poor	4 Poor	4 Poor

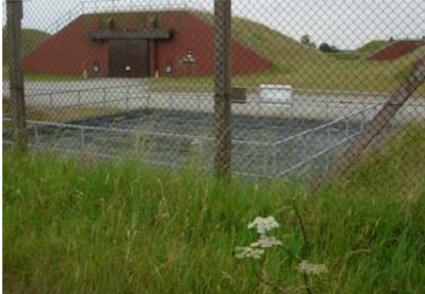
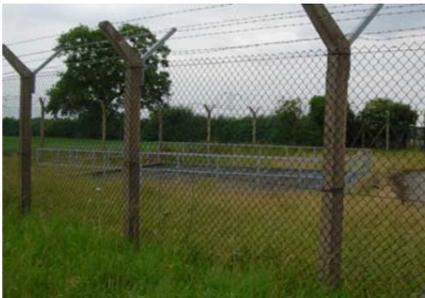
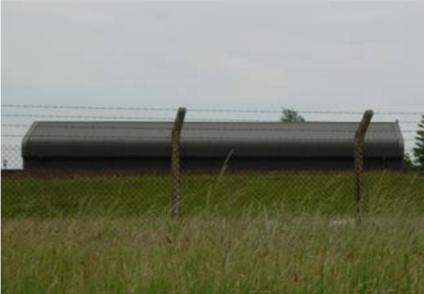
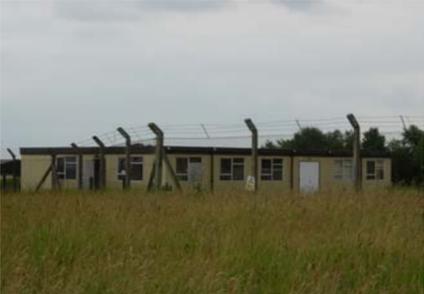
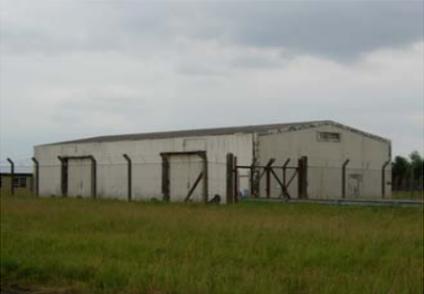
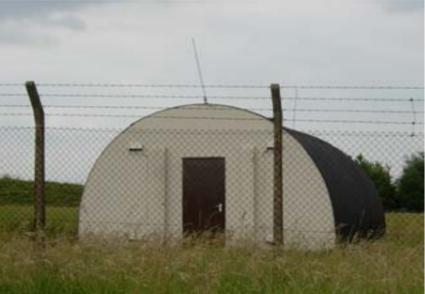
Building/Setting Features & Characteristics of Note	also 1118, 1150, 1153, 1154, 1186, 1189 (Photography not permitted within compound)	Metal canopy adjacent approx 3m high. All structures enclosed in concrete wall 3.5m high with earth mound around. Metal clad portaloos opposite. (Photography not permitted within compound)	Garden fenced off at front, concrete steps to entry/exits, metal screening around plinth. (Photography not permitted within compound)	2 No. large folding garage doors to side. (Photography not permitted within compound)	Render cracked and spalled in places & bricks damaged. (Photography not permitted within compound)
Potential Uses					
Status/Condition	2 Good	3 Fair	2 Good	3 Fair	3 Fair

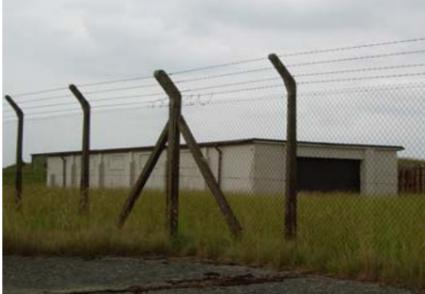
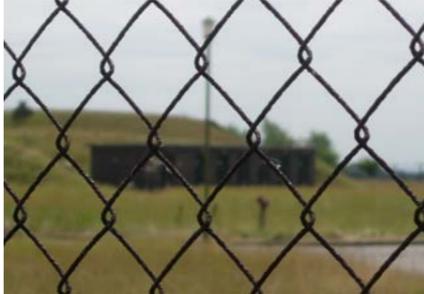
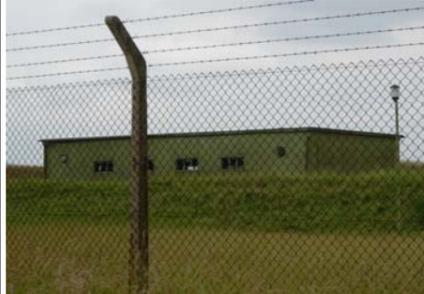
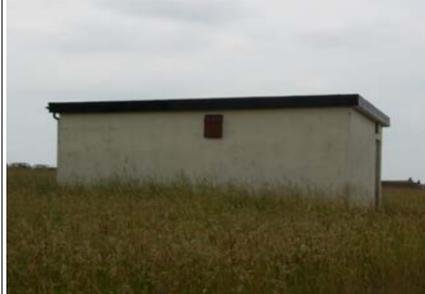
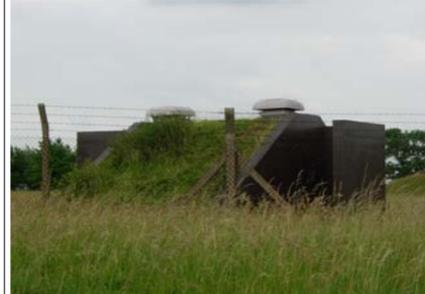
Building/Setting Features & Characteristics of Note	Some cracking & spalling to render, some damage to bricks, large cracks through structure at ends, timber fascia badly damaged, windows bricked up on both sides. (Photography not permitted within compound)	Surrounded to rear & sides by earth mound. (Photography not permitted within compound)	Concrete badly cracked & falling off façade. Side structure for powerhouse also concrete & enclosed by earth mound. (Photography not permitted within compound)		(Photography not permitted within compound)
Potential Uses					
Status/Condition	4 Poor	3 Fair	4 Poor	3 Fair	3 Fair

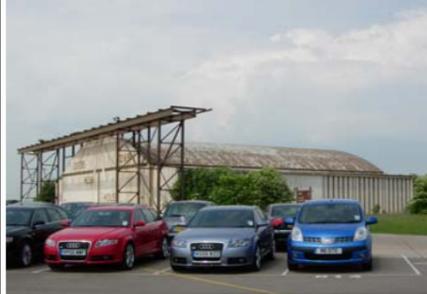
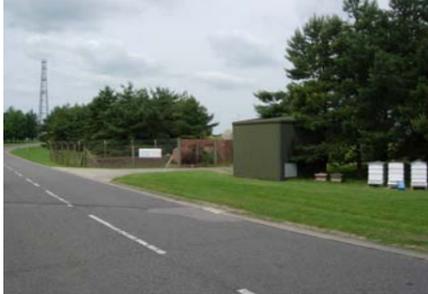
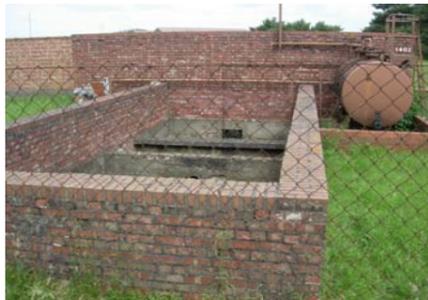
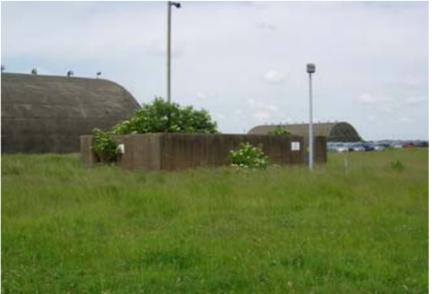
Potential Uses		Currently in use			
Status/Condition	4 Poor	2 Good	3 Fair	2 Good	3 Fair
	No photo available, see 1140	No photo available, see 1601-1625

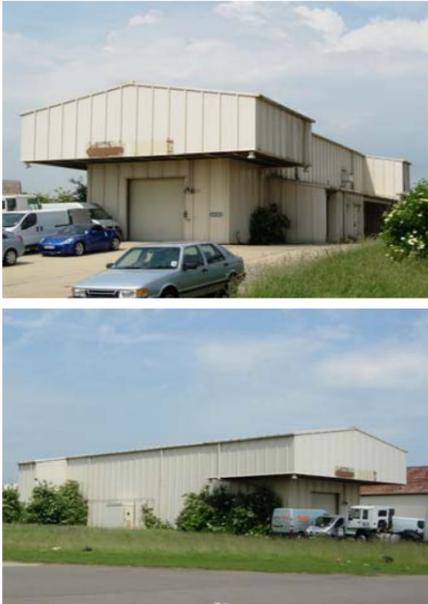
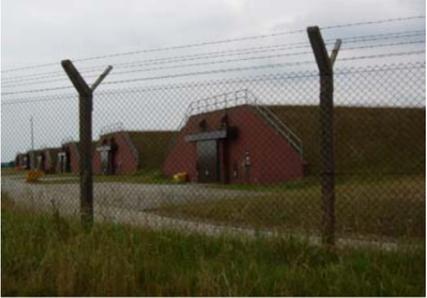
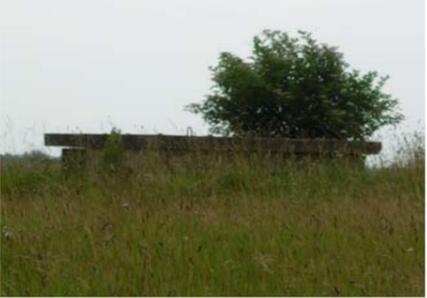
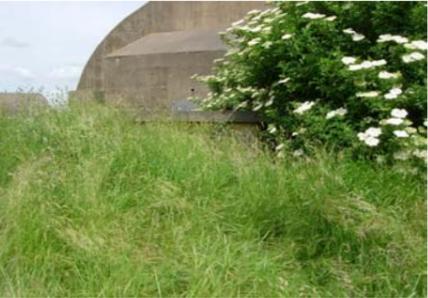
Potential Uses					
Status/Condition	3 Fair	2 Good	3 Fair	3 Fair	2 Good

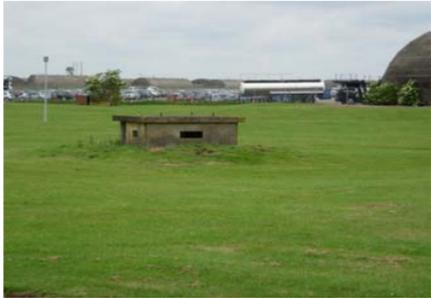
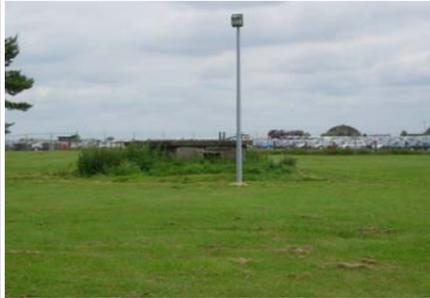
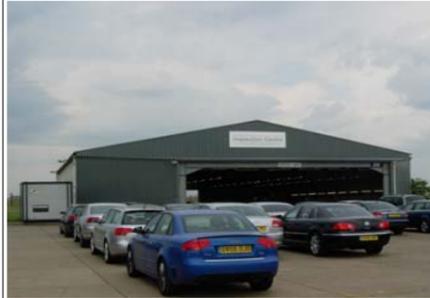
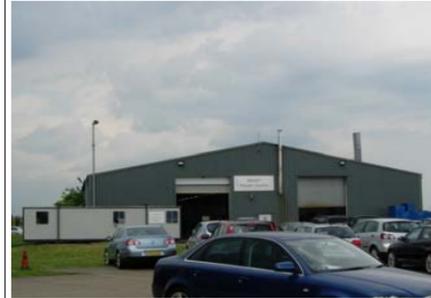
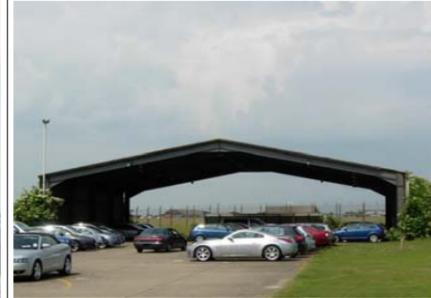
Potential Uses					
Status/Condition	3 Fair	3 Fair	2 Good	2 Good	2 Good

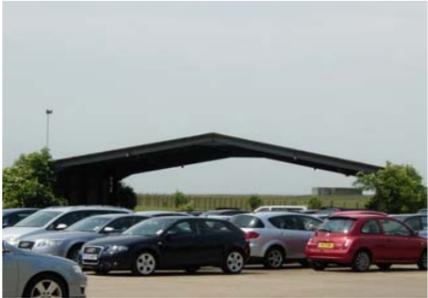
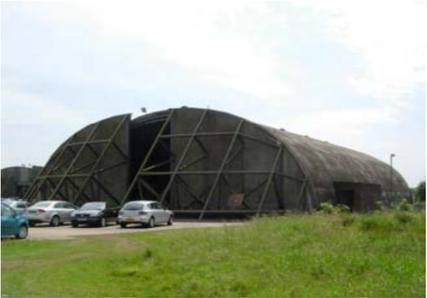
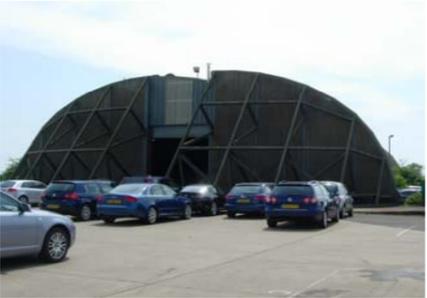
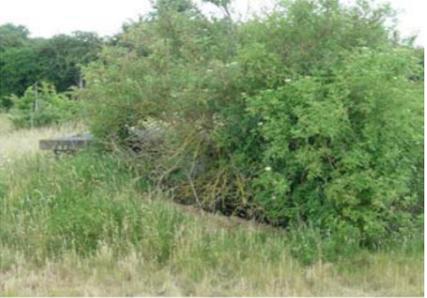
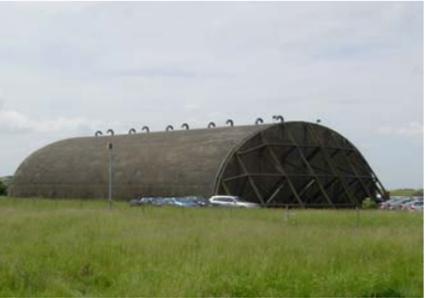
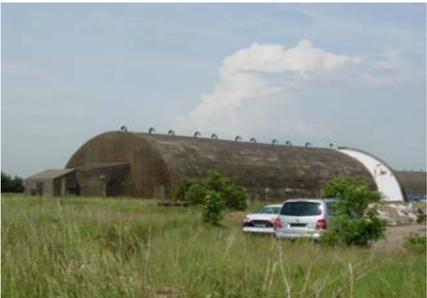
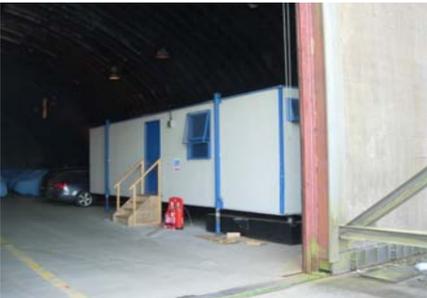
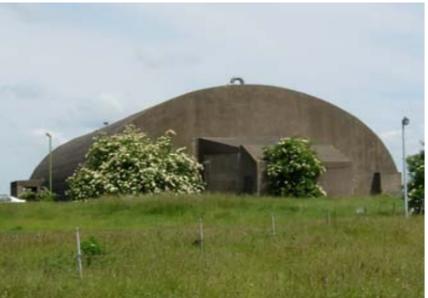
Building/Setting Features & Characteristics of Note	Trees growing up the side. also 2005, 2006, 2007, 2008, 2009	also 3037, 3039, 3041, 3042	also 3040	Sunken into ground	also 3044, 3045, 3046, 3047, 3048, 3049, 3050, 3051
Potential Uses			Currently in use by QEK		
Status/Condition	2 Good	3 Fair	3 Fair	3 Fair	3 Fair

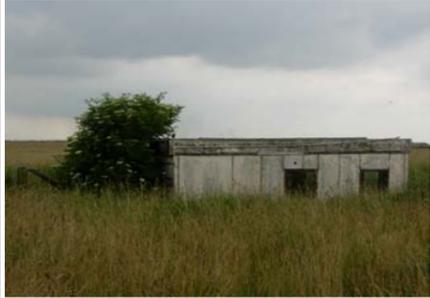
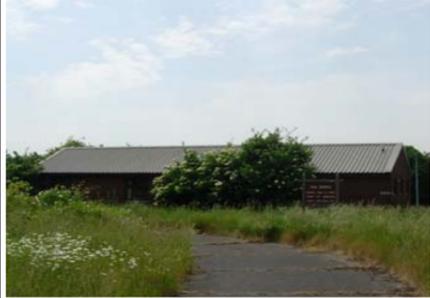
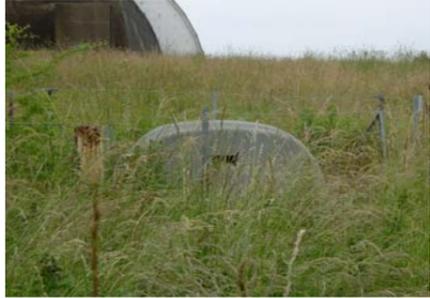
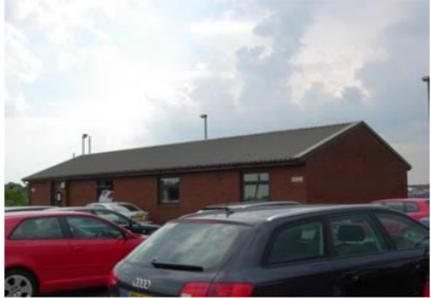
Building No.	3109b	3127B	3204	3204A	3205
Current Use	Small structure adjacent runway	Office	Workshop	Sewage tank	Office
Date of Construction (NB: info from asset register)			1986		1986
Floor Area/Volume m ² /m ³ (NB: info from asset register)			142		142
Number of Floors		1	1		1
Building Height (Eaves, Ridge) m, estimated		2.4	2.4, 3.6	1.2	2.4, 3.6
Construction/Structure	Not accessible	Cement boarded walls. Flat roof. Timber windows & doors.	Brick walls with metal pitched roof. Timber door. Metal windows in timber frames.	Semi circular tank in plastic or fibre glass housing.	Brick walls with metal pitched roof. Timber door. Metal windows in timber frames.
Building/Setting Features & Characteristics of Note		Sunken below ground level, steps with metal hand rail lead down to.			
Potential Uses					Currently in use
Status/Condition		4 Poor	3 Fair	3 Fair	2 Good

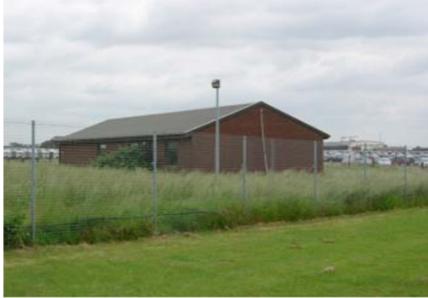
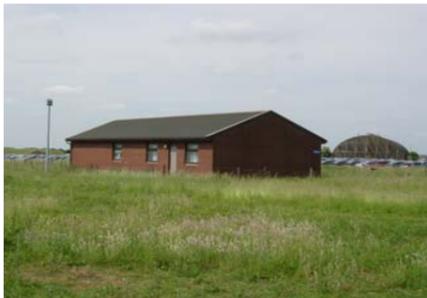
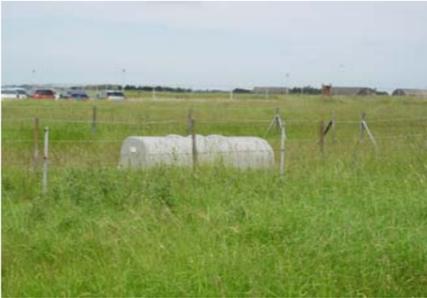
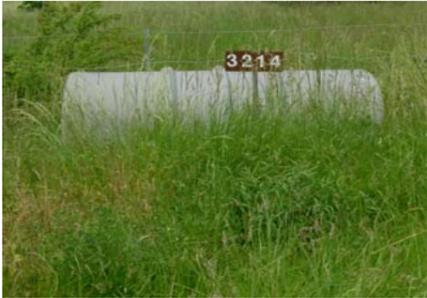
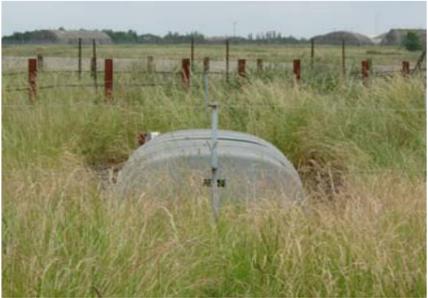
Building No.	3208	3210	3210 A	3214	3218
Current Use	Workshop	Workshop	Tank	Sewage tank	Sewage tank
Date of Construction (NB: info from asset register)	1986	1986		1986	1986
Floor Area/Volume m ² /m ³ (NB: info from asset register)	142	142			
Number of Floors	1	1			
Building Height (Eaves, Ridge) m, estimated	2.4, 3.6	2.4, 3.6	1.2		
Construction/Structure	Brick walls with metal pitched roof. Timber door. Metal windows in timber frames.	Brick walls with metal pitched roof. Timber door. Metal windows in timber frames.	Semi circular tank in plastic or fibre glass housing.	Semi circular tank in plastic or fibre glass housing.	Semi circular tank in plastic or fibre glass housing.
Building/Setting Features & Characteristics of Note					
Potential Uses		Housing			
Status/Condition	2 Good	2 Good	3 Fair	3 Fair	3 Fair

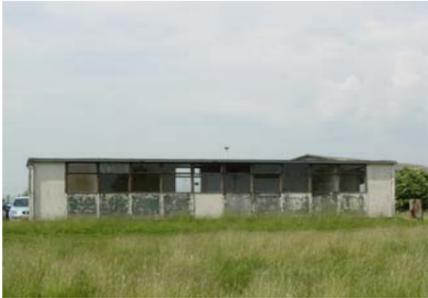
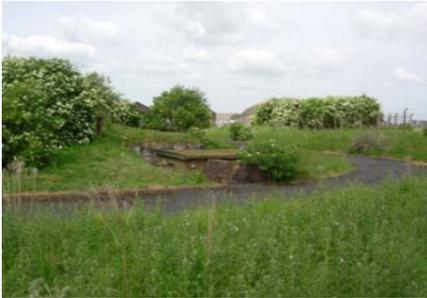
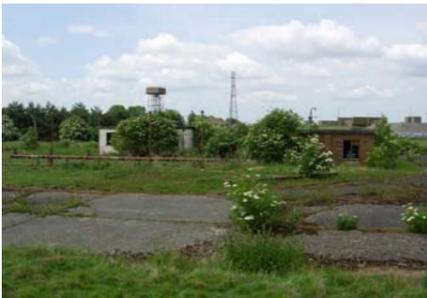
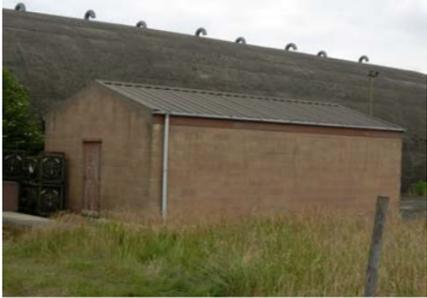
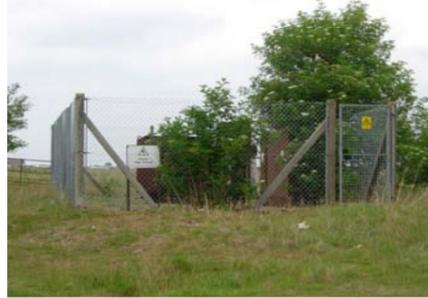
Building No.	5022	POL 2	UH16	UH17	UH19
Current Use	Disused	Storage tanks	Small structure adjacent runway	Store	Sub-station
Date of Construction (NB: info from asset register)					
Floor Area/Volume m ² /m ³ (NB: info from asset register)					
Number of Floors	1			1	
Building Height (Eaves, Ridge) m, estimated	2.4			3, 3.5	
Construction/Structure	Timber clad prefabricated unit. Rotting timber windows with metal skirting & shallow barrel vault roof.	Various small buildings in fenced enclosure: 1) Painted rendered walls, flat asphalt roof, metal windows. 2) Corrugated metal shed, metal structure 3) Concrete bunker type construction pipework overground etc, chicken wire & concrete post fence.	Not accessible	Blockwork, timber door, metal fascia, metal pitched roof.	Enclosed by 1.8m high chain link fence with concrete posts & metal gate.
Building/Setting Features & Characteristics of Note					Overgrown.

Potential Uses					
Status/Condition	4 Poor	4 Poor		2 Good	3 Fair

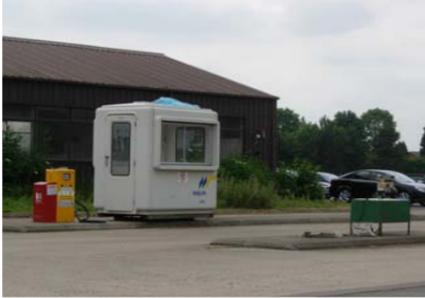
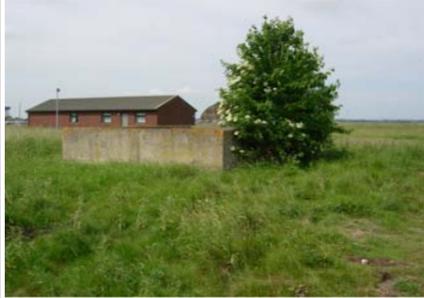
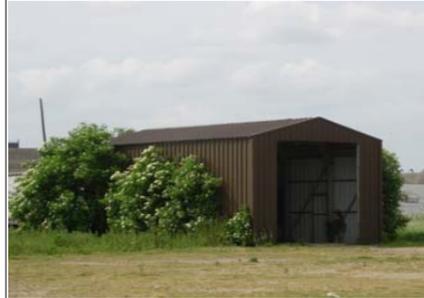
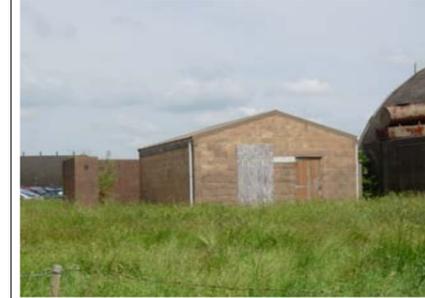
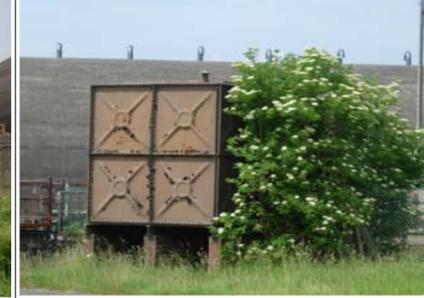
Building No.	UH21	UH27	UH28	UH29	UH30
Current Use	Fuel pumps	Tank	Store	Store	Water tank
Date of Construction (NB: info from asset register)					
Floor Area/Volume m²/m³ (NB: info from asset register)					
Number of Floors	1		1	1	1
Building Height (Eaves, Ridge) m, estimated	2.0	1.5	3.2	2.7, 3.6	3.4
Construction/Structure	Plastic booth adjacent to pumps.	Poured concrete holding tank for water.	Steel frame with metal cladding on concrete slab. Cantilvered metal box to one side.	Concrete block walls with timber door and profile metal sheet pitched roof.	Steel pressed panels to tank on I beams on top of brick walls.
Building/Setting Features & Characteristics of Note				Boarded up door.	
Potential Uses					
Status/Condition	2 Good	2 Good	3 Fair	3 Fair	4 Poor

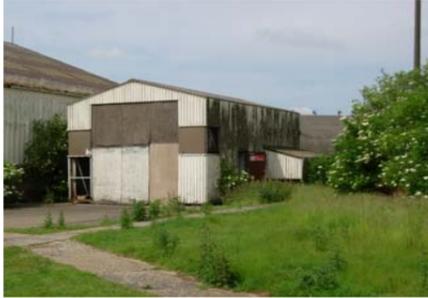
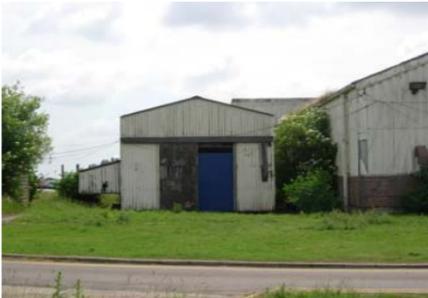
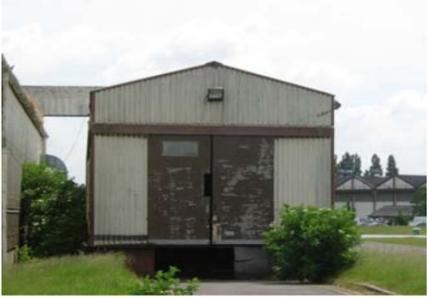
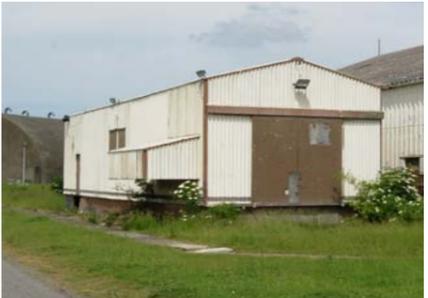
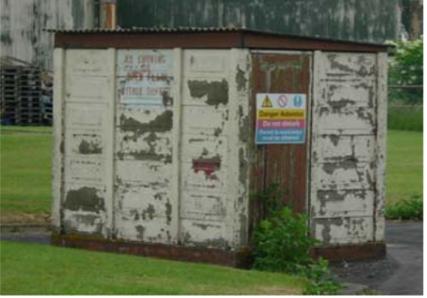
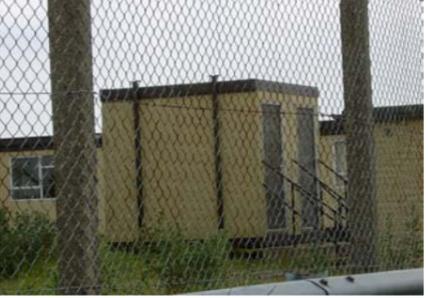
Building No.	UH31	UH32	UH35	UH51/52	UH53
Current Use	Store	Store	Store	EWS tank	WC portakabin
Date of Construction (NB: info from asset register)					
Floor Area/Volume m ² /m ³ (NB: info from asset register)					
Number of Floors	1	1	1		
Building Height (Eaves, Ridge) m, estimated	3.2, 4.2	4.2, 5.2	2.0	1.8	2.4
Construction/Structure	Metal clad steel frame on concrete slab with cantilvered metal box to one side and timber door. Shallow pitched roof.	Metal clad steel frame on concrete slab with cantilvered metal box to one side and timber door. Shallow pitched roof.	Concrete plinth with concrete frame infilled with small concrete panels to walls. Asbestos shallow pitched roof.	Brick walls around pit, surrounded by concrete post & 1.8m high chain link fence.	WC portakabin behind 1100 with concrete steps up to it, 2 No. WCs.
Building/Setting Features & Characteristics of Note		Boarded up door and window.

Potential Uses					
Status/Condition	4 Poor	4 Poor	3 Fair	3 Fair	2 Good

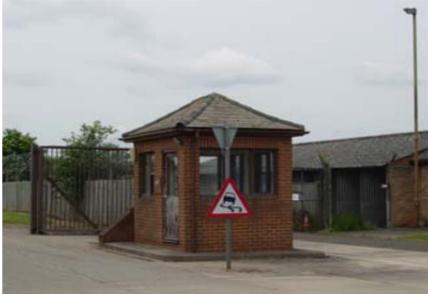
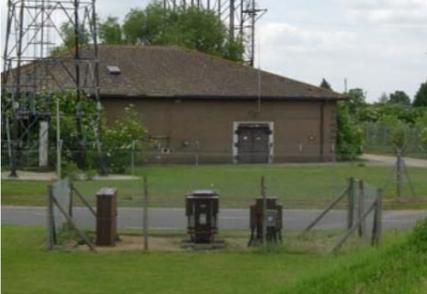
Building No.	UH68	UH69	UH73
Current Use	Entry guard box	Sub-station	Blast/screening wall
Date of Construction (NB: info from asset register)			
Floor Area/Volume m²/m³ (NB: info from asset register)			
Number of Floors	1	1	
Building Height (Eaves, Ridge) m, estimated	2.5	1.8	2.4
Construction/Structure	Brick walls, timber windows and door with tiled roof and slanting curved brickwork wall to front.	Enclosure of 1.8m high chain link fence on concrete posts and metal framed gate around sub-station equipment.	Metal baffle wall to rear of fireworks stores.
Building/Setting Features & Characteristics of Note			(Photography not permitted in compound)
Potential Uses			
Status/Condition	2 Good	3 Fair	3 Fair

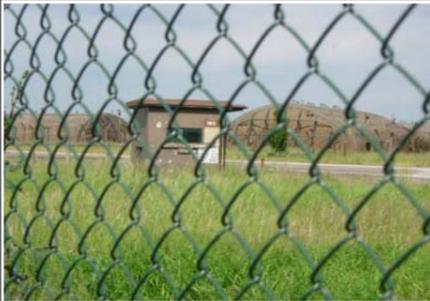
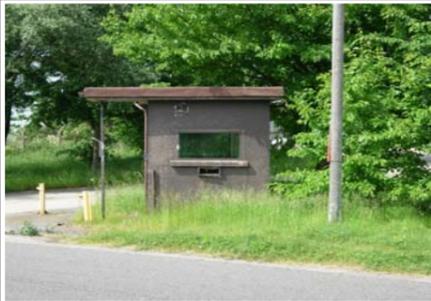
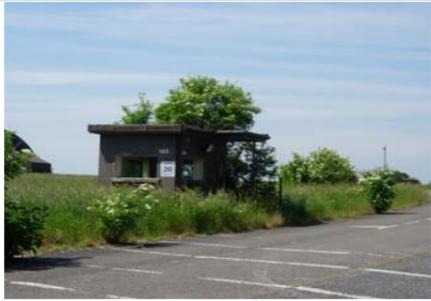
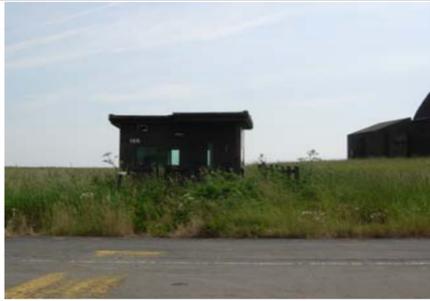
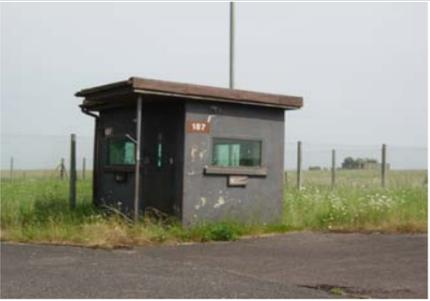
Building No.	183	184	185	186	187
Current Use	Disused pill box				
Date of Construction (NB: info from asset register)	1988	1988	1988	1988	1988
Floor Area/Volume m ² /m ³ (NB: info from asset register)	7	7	7	7	7
Number of Floors	1	1	1	1	1
Building Height (Eaves, Ridge) m, estimated	2.5	2.5	2.5	2.5	2.5
Construction/Structure	Concrete walls with metal windows. Asphalt flat roof on concrete. Steel framed porch.	Concrete walls with metal windows. Asphalt flat roof on concrete. Steel framed porch.	Concrete walls with metal windows. Asphalt flat roof on concrete. Steel framed porch.	Concrete walls with metal windows. Asphalt flat roof on concrete. Steel framed porch.	Concrete walls with metal windows. Asphalt flat roof on concrete. Steel framed porch.
Building/Setting Features & Characteristics of Note					
Potential Uses					
Status/Condition	4 Poor	4 Poor	4 Poor	4 Poor	4 Poor

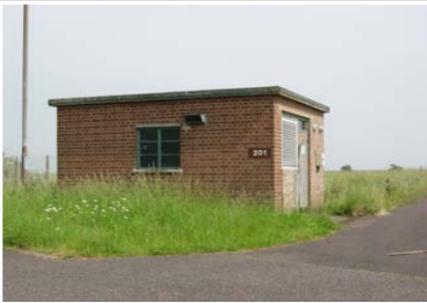
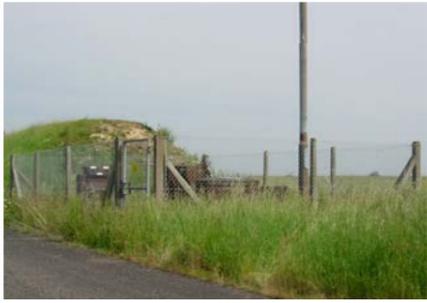
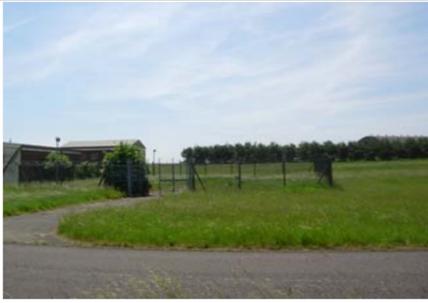
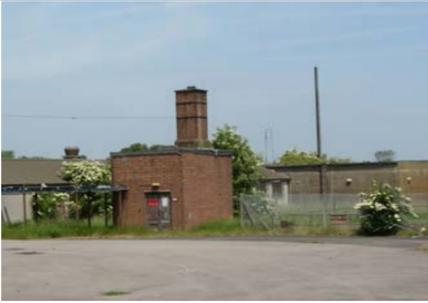
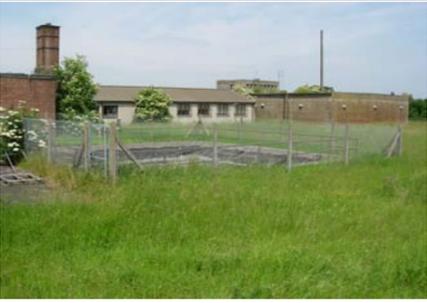
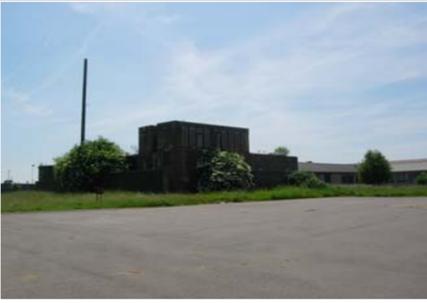
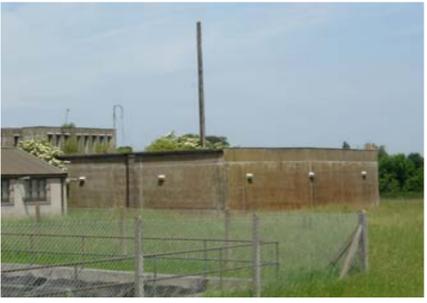
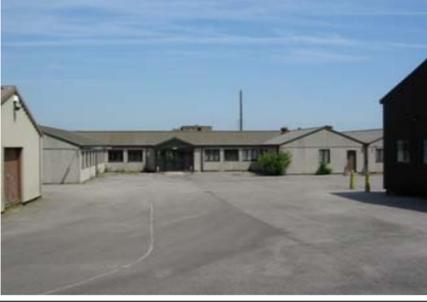
Building No.	201	202	207	208	209
Current Use	Generator and sub-station	Disused sub-station	Boiler house	EWS tank	Disused office
Date of Construction (NB: info from asset register)	1959		1959	1950	1954
Floor Area/Volume m²/m³ (NB: info from asset register)	19		16		1659
Number of Floors	1	1	1		1 & 2 & 3 equivalent
Building Height (Eaves, Ridge) m, estimated	2.5	2.4	4.3		A: 2.4, 3.8 B: 3.5 & 5.5
Construction/Structure	Brick walls, timber doors, metal window. Flat asphalted concrete roof. Asbestos in soffit.	Chain link fence and concrete post enclosure only. Sub-station removed.	Brick with steel windows, flat asphalt roof and brick chimney.	1.8m high enclosure of metal mesh fence on concrete posts.	A: Prefabricated pebbledash rendered units with metal windows, brick plinth, metal pitched roof. B: Concrete bunker with metal doors, metal windows and boarded up entry. Asbestos in lining boards, undersink pads & heating pipes.

Building/Setting Features & Characteristics of Note	Chain link fence on concrete posts enclosure to sub-station to side.				
Potential Uses					Offices
Status/Condition	3 Fair	3 Fair	3 Fair	2 Good	3 Fair

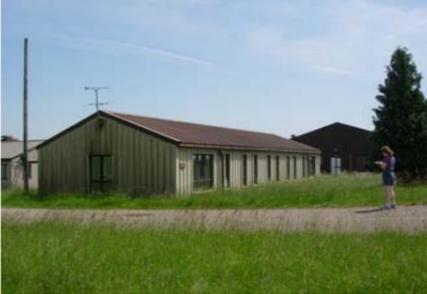
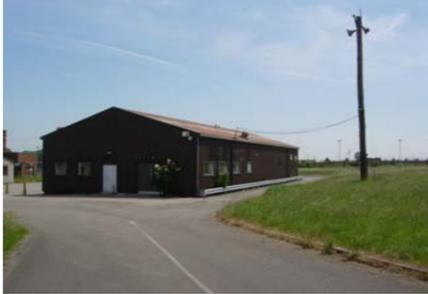
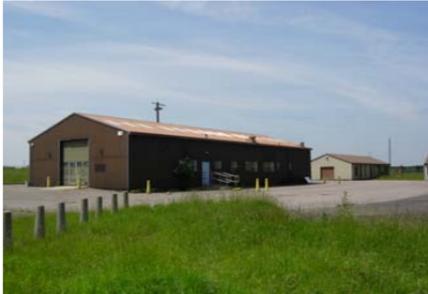
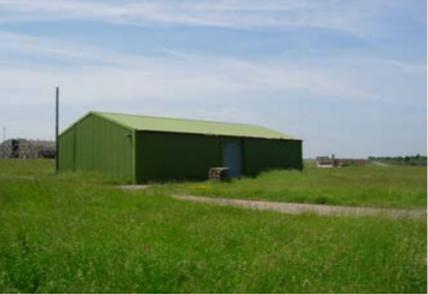
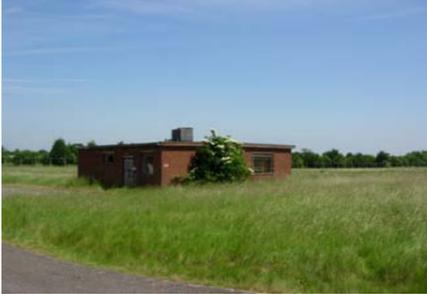
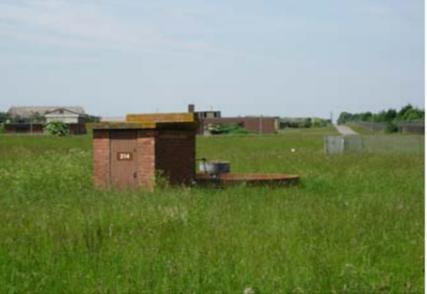
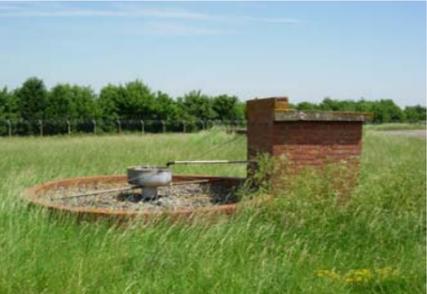
Area 9

Building No.	210	211	212	213	214
Current Use	Disused office	Disused - workshop	Disused - store	disused - store	Disused
Date of Construction (NB: info from asset register)	1949	1950	1971	1971	1945
Floor Area/Volume m ² /m ³ (NB: info from asset register)	177	378	125	125	2
Number of Floors	1	1	1	1	1
Building Height (Eaves, Ridge) m, estimated	2.3, 3.8	3, 4.5	3, 4.5	2.6	2
Construction/Structure	Metal cladding to walls and roof on concrete plinth, deep metal windows and double timber doors to one end.	Metal frame with metal cladding to walls and roof, metal windows, timber doors, concrete plinth and large metal garage door to one end.	Metal clad roof and walls, large shuttered metal doors to either side.	Brick walls, metal windows with bars over, timber doors and flat asphalt roof.	Brick walls, timber door, flat concrete roof with brick upstand to rear. Circular brick enclosure to rear.
Building/Setting Features & Characteristics of Note

Potential Uses					
Status/Condition	3 Fair	3 Fair	3 Fair	4 Poor	4 Poor

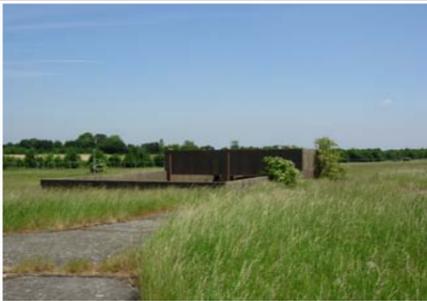
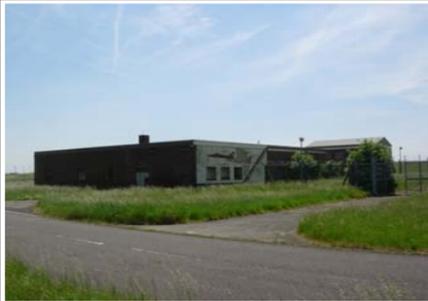
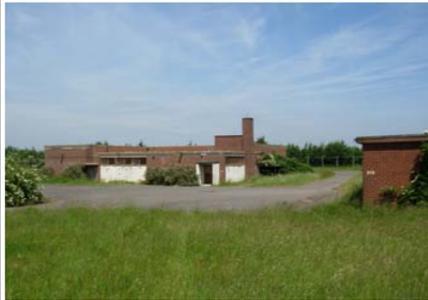
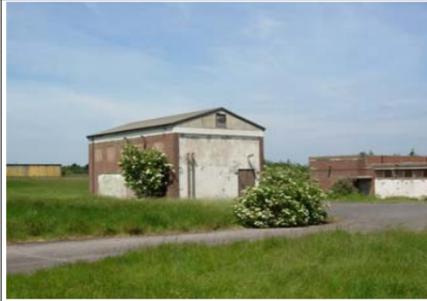
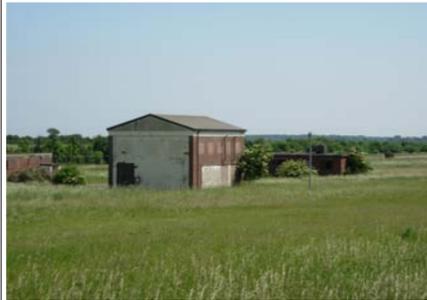
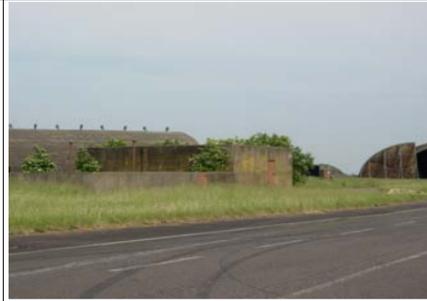
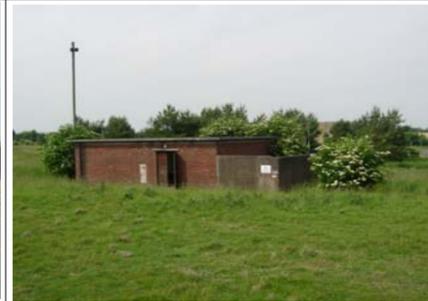
Area 9

Building No.	215 POL9	216	217	219 POL10	220
Current Use	Fuel storage tank	Disused - squadron HQ	Disused	Fuel storage tank	Sub-station
Date of Construction (NB: info from asset register)	1961	1964		1961	1973
Floor Area/Volume m ² /m ³ (NB: info from asset register)	378.5			378.5	
Number of Floors	1 & 1.5	1 double height	1 double height	1 and 1.5	1
Building Height (Eaves, Ridge) m, estimated	1.5 & 4	4 & 3 to rear	5, 6.5	1.5 & 4	3.0
Construction/Structure	Concrete enclosure, metal inspection covers	Partially rendered brick walls with some metal cladding and blockwork. Flat asphalt roof with deep cracked concrete fascia. Metal windows with concrete tile cill and timber sub-frame. Brick and render single storey extension to rear with metal capped wall & bars to windows. Porch with asphalt canopy and brick chimney.	Brick side walls, rendered end walls. Concrete lintels. Metal door. Pitched metal roof.	Concrete enclosure, inspection covers.	Brick walls, timber double doors, flat asphalted concrete roof. Concrete enclosure to side.

Building/Setting Features & Characteristics of Note	overgrown	Boarded up door opening.	Boarded up windows to both sides with large doorway also bricked up and rendered.	Overgrown.	
Potential Uses					
Status/Condition	3 Fair	4 Poor	4 Poor	3 Fair	3 Fair

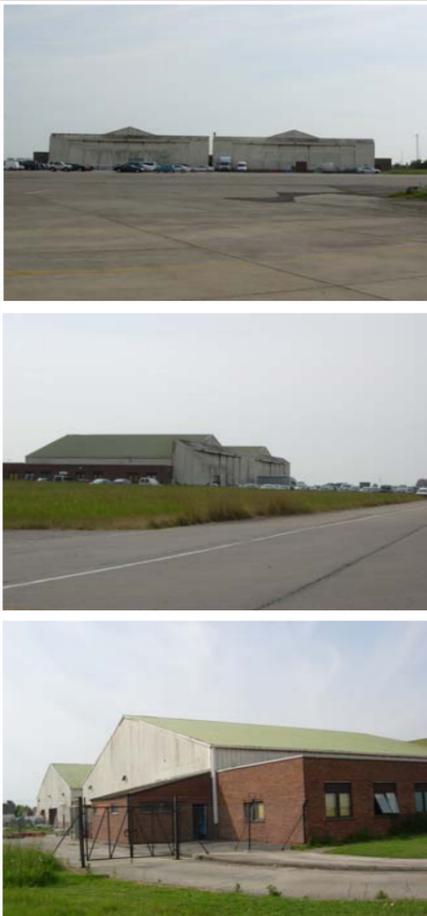
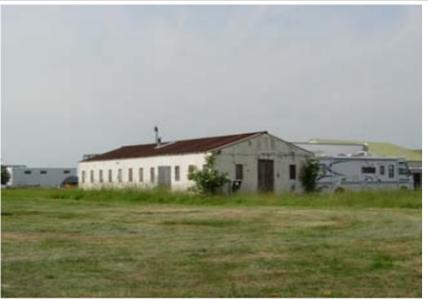
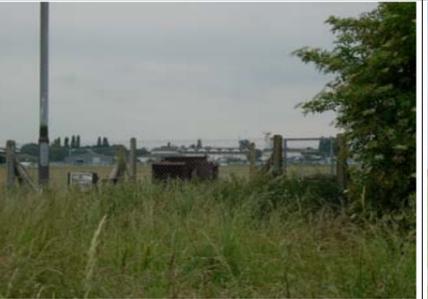
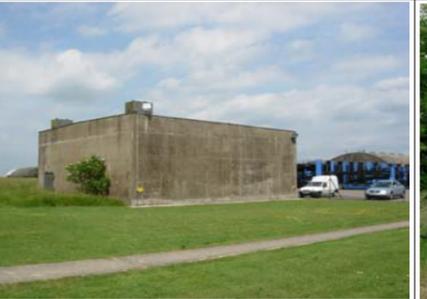
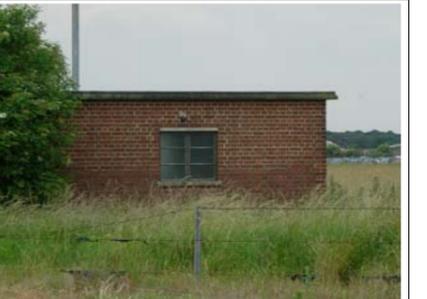
Area 9

Building No.	221	223	225	226	227
Current Use	Store / workshops	Disused	Generator	Disused tanker bay	Disused store
Date of Construction (NB: info from asset register)	1973	1971	1959	1980	1945
Floor Area/Volume m ² /m ³ (NB: info from asset register)	2391	89	19	169	
Number of Floors	1	1		1	1
Building Height (Eaves, Ridge) m, estimated	5, 7	2.6, 3.5	1.5	4.0	2.5
Construction/Structure	2 no. hanger structures with metal cladding to walls and roof. Large sliding doors along length of front facade. Three garage shutter doors to rear. Brick walled extension with metal roof to rear.	Metal clad walls on concrete plinth. Timber doors & metal windows. Metal clad pitched roof.	Concrete posts support chain link fence	Concrete walls, large steel double doors and hatch, flat roof with metal capping to parapet.	Brick walls with metal windows. Asphalt flat roof. Boarded door & louvred windows.
Building/Setting Features & Characteristics of Note		Boarded up windows.		No windows.

Potential Uses					
Status/Condition	3 Fair	4 Poor	3 Fair	3 Fair	3 Fair

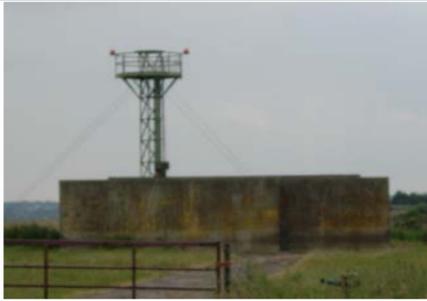
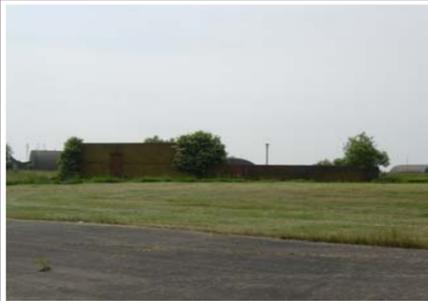
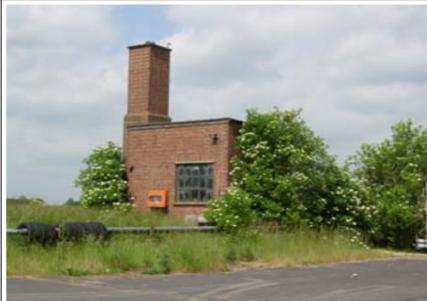
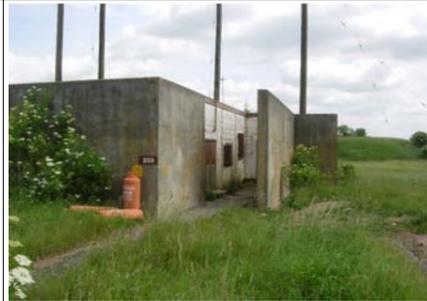
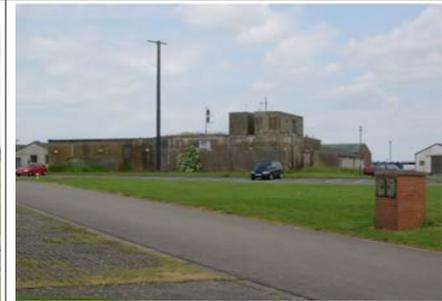
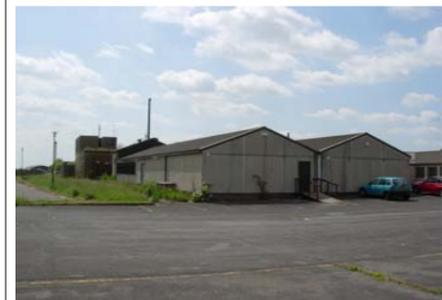
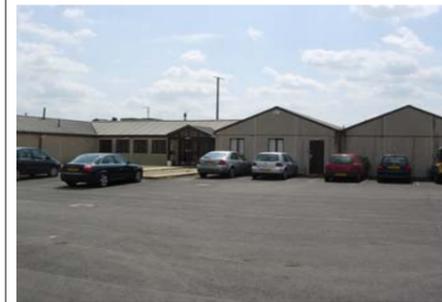
Area 9

Building No.	228	229	231	233	234
Current Use	Electric sub-station	Fuel storage tank	Boiler house	Disused	Offices / admin
Date of Construction (NB: info from asset register)		1969	1940	1957	1953
Floor Area/Volume m ² /m ³ (NB: info from asset register)		189.3	18	223	1670
Number of Floors		1 & 1.5	1	1.5	1, 1.5 & 2
Building Height (Eaves, Ridge) m, estimated	2.2	1.5 & 4	4.3	3.5	
Construction/Structure	Concrete walls.	Concrete enclosure, metal inspection covers.	Brick with steel windows, flat asphalt roof and brick chimney.	250mm thick concrete surround. Steel structure inside enclosure with painted blockwork infill and internal walls. Flat roof with timber fascia and metal capping. Metal windows with external bars. Timber door.	Amalgamation of two buildings. A: Concrete with aluminium grilled openings and flat roof. B: Pebble-dashed panel walls on brick plinth. Aluminium windows and glazed porch. Pitched metal roof.

Building/Setting Features & Characteristics of Note	Metal tower to rear.	Overgrown.			
Potential Uses					
Status/Condition	3 Fair	3 Fair	3 Fair	4 Poor	A: 3 B: 2 A: Fair B: Good

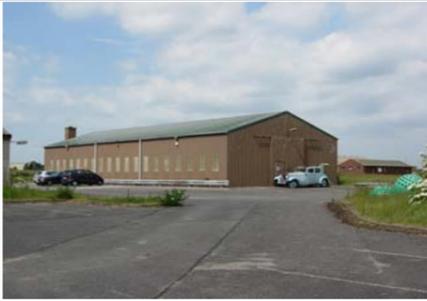
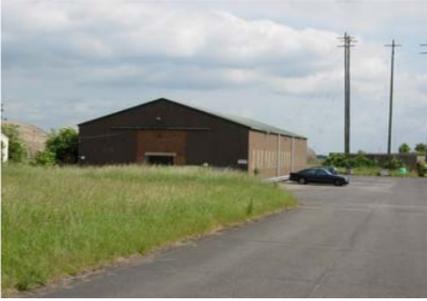
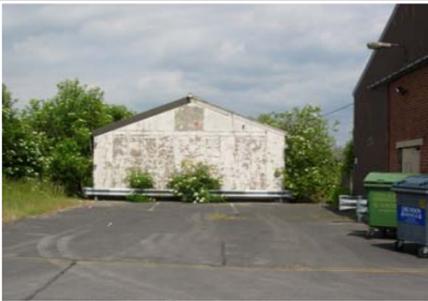
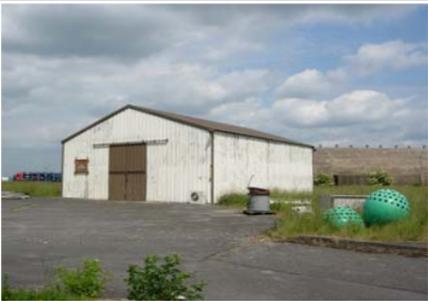
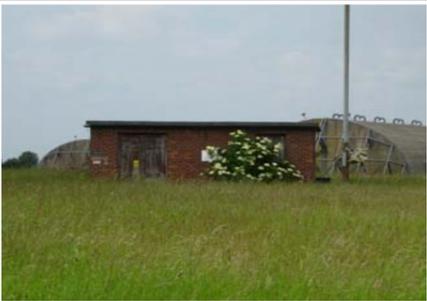
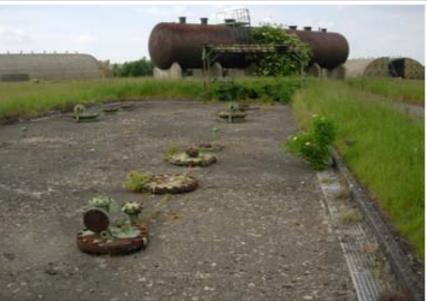
Area 9

Building No.	237	238	239	240	241 POL15
Current Use	Store	Disused office	Workshop	Sub-station	Fuel storage tank
Date of Construction (NB: info from asset register)	1940	1940	1971	1940	1961
Floor Area/Volume m ² /m ³ (NB: info from asset register)	378	119	183		383.8
Number of Floors		1	1.5	1	1
Building Height (Eaves, Ridge) m, estimated		2.4, 3.2	4, 6	2.2	2.4
Construction/Structure	Steel frame, metal cladding and roof with large sliding door to front.	Painted concrete panels on brick base. Steel windows with aluminium secondary glazing. Timber double doors. Porch with steel posts to timber asphalt covered roof. Asbestos roof sheets, gutter & downpipes.	Steel frame & cladding on a concrete plinth with metal roof. Large sliding doors to front and rear.	Brick walls with flat asphalt roof and timber doors.	Remnants of steel framed structure on concrete base with steel hatches protruding.
Building/Setting Features & Characteristics of Note	Infilled windows and possible asbestos.		No windows.

Potential Uses					
Status/Condition	3 Fair	4 Poor	3 Fair	3 Fair	4 Poor

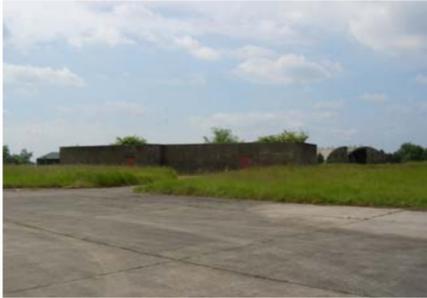
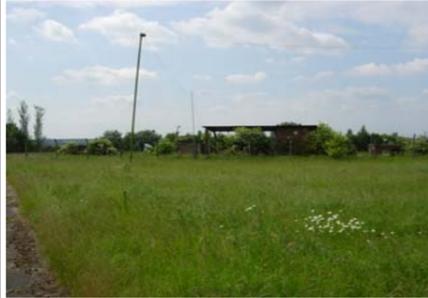
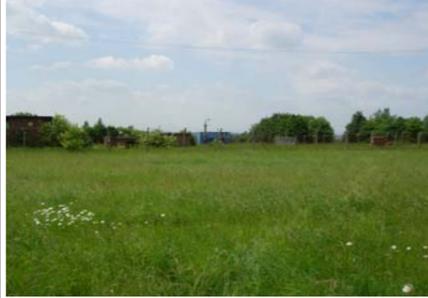
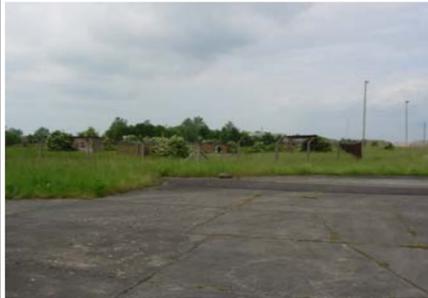
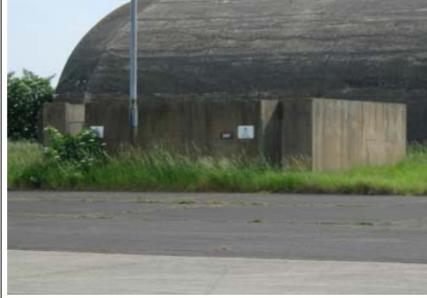
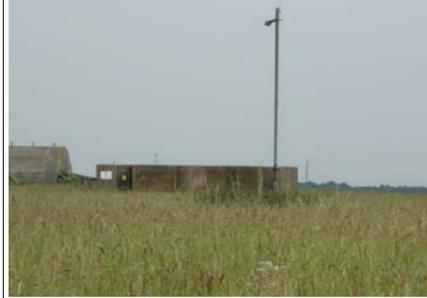
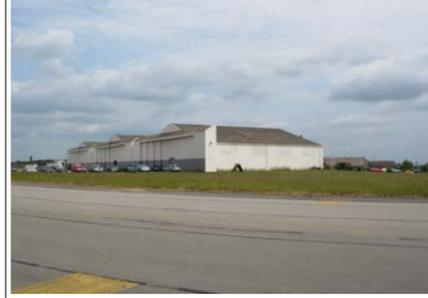
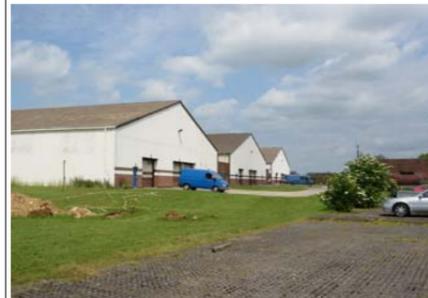
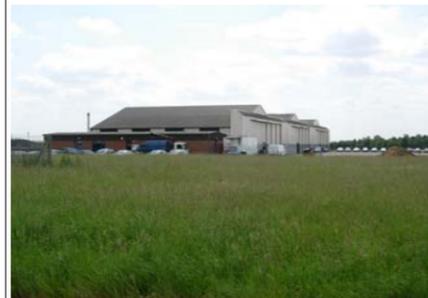
Building No.	242 / POL 16	245a-d	247	248	249
Current Use	Fuel storage tank	Fuel storage tank	Sub-station	Sub-station	Workshop
Date of Construction (NB: info from asset register)	1961	1961	1940	1940	1973
Floor Area/Volume m ² /m ³ (NB: info from asset register)	189.3	658.6			3273
Number of Floors	1	1	1	1	1
Building Height (Eaves, Ridge) m, estimated	3	2.4	2.2	2.2	5, 7
Construction/Structure	Concrete walls and profile metal sheet flat roof.	Low level structures some with brick walls & flat asphalt roofs, some with steel frame & partial metal cladding to walls and roof. Possible asbestos cement sheeting & cladding.	Concrete walled enclosure with metal mesh gates.	Concrete walled enclosure with metal mesh gates.	Amalgamation of three no. steel frame hanger structures with profile metal sheet cladding to walls and roof. Large sliding metal doors to front and metal garage doors to rear with timber doors and metal windows.

Building/Setting Features & Characteristics of Note		Chain link fence enclosure 1.8m high around structures.			
Potential Uses					
Status/Condition	3 Fair	4 Poor	3 Fair	3 Fair	3 Fair

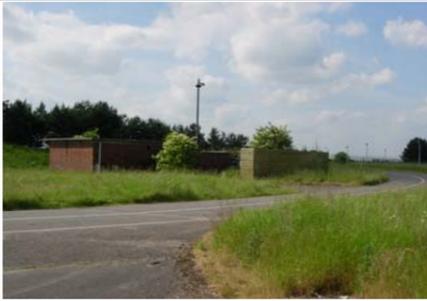
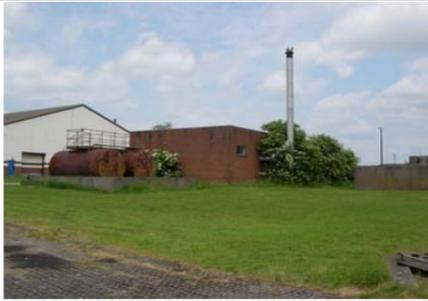
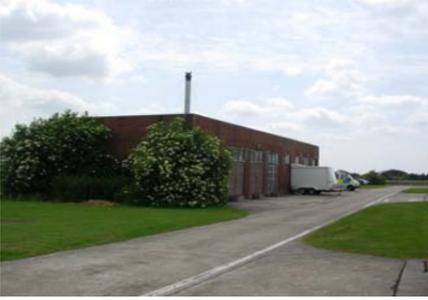
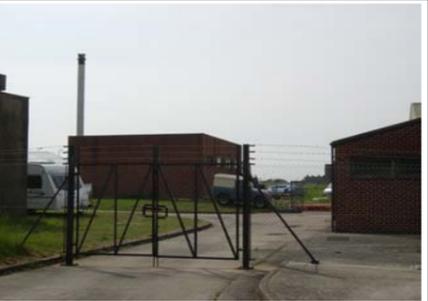
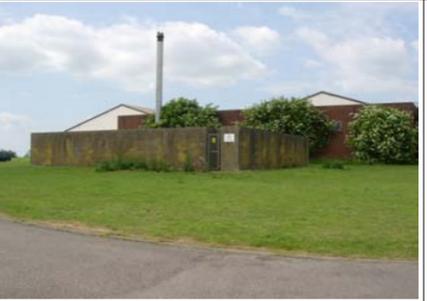
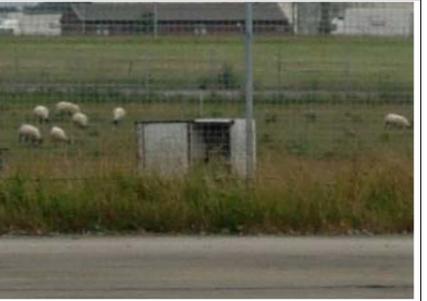
Area 9

Building No.	251	253	255	262	272
Current Use	Sub-station	Generator	Boiler house	Sub-station	Wind measuring
Date of Construction (NB: info from asset register)	1972	1973	1973	1973	
Floor Area/Volume m ² /m ³ (NB: info from asset register)			80		
Number of Floors	1	1	1	1	
Building Height (Eaves, Ridge) m, estimated	2.5	4.5	4	2.2	1.6
Construction/Structure	Brick walls with concrete roof and adjoining profiled metal sheet clad enclosure with galvanised steel mesh gates.	Brick walls.	Brick walled flat roofed building with chimney, metal windows and concrete cills.	Concrete walled enclosure with metal mesh gates, timber windows, metal garage doors and flat roof with metal capping to parapet.	Metal cabinet.
Building/Setting Features & Characteristics of Note			Adjacent metal tank on concrete plinth.		
Potential Uses					
Status/Condition	3 Fair	3 Fair	3 Fair	3 Fair	4 Poor
