heyford park

BUILDING APPRAISAL

ROGER EVANS ASSOCIATES LTD FOR NORTH OXFORDSHIRE CONSORTIUM LTD

Issued : July 2006

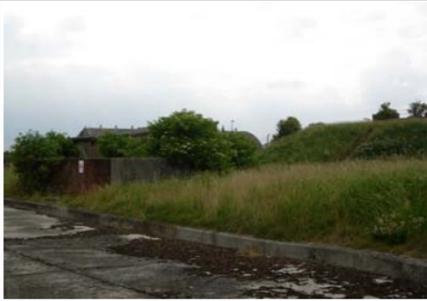
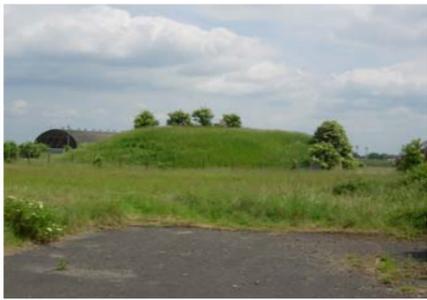
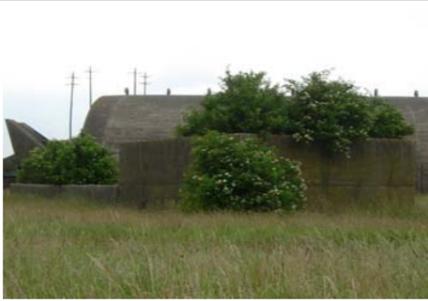
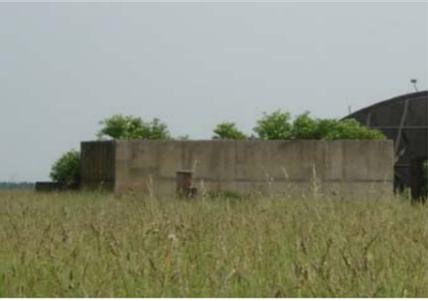
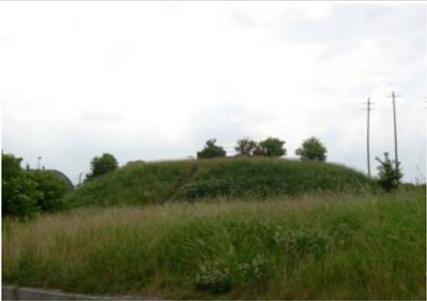
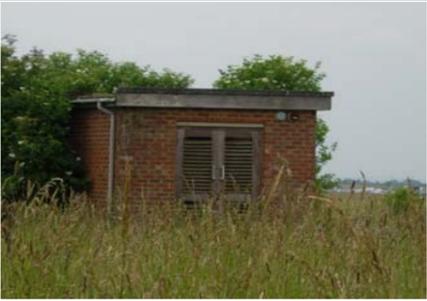
Area 9

Building No.	281 POL 23b	283	284 POL14	285 POL 23a	307
Current Use	Fuel storage tank	Fuel storage tank	Fuel storage tank	Fuel storage tank	Generator
Date of Construction (NB: info from asset register)	1974	1961	1961	1973	1981
Floor Area/Volume m ² /m ³ (NB: info from asset register)	1946.6	189.3	378.5	4440.5	14
Number of Floors					1
Building Height (Eaves, Ridge) m, estimated	2 & 5 (mound)	1.5, 2.5	1.5, 2.5	2 & 5 (mound)	2.5
Construction/Structure	Various small low level structures adjacent earth mound covering storage tanks.	Concrete	Concrete	Various small low level structures adjacent earth mound covering storage tanks.	Brick walls with flat asphalt roof & timber louvred door.
Building/Setting Features & Characteristics of Note		Overgrown			
Potential Uses					
Status/Condition	3 Fair	3 Fair	3 Fair	3 Fair	3 Fair

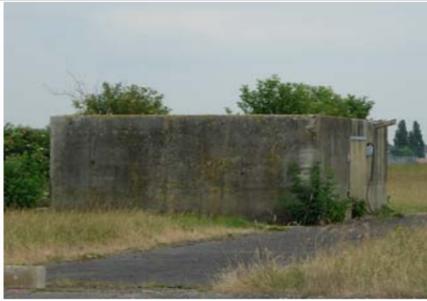
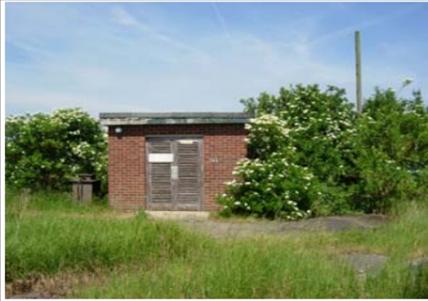
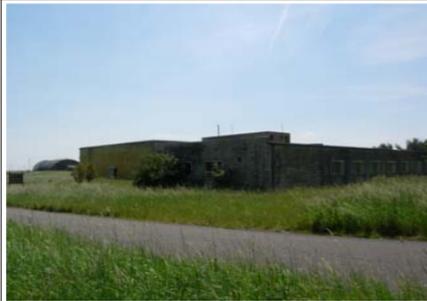
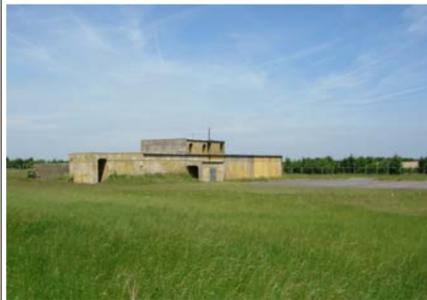
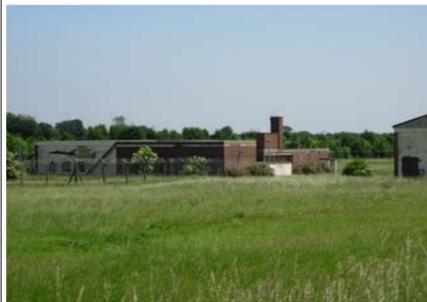
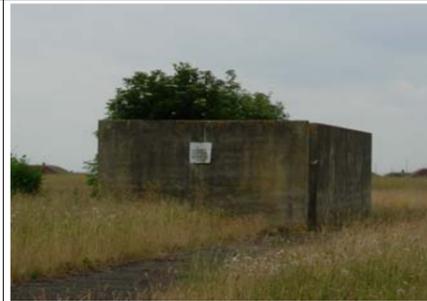
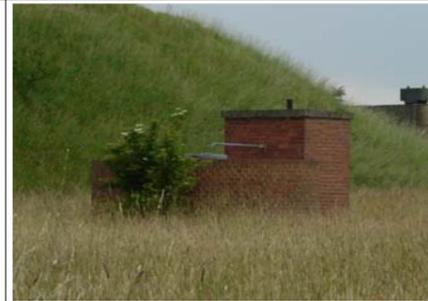
Area 9

Building No.	309	343	383	389	395
Current Use	Store	Generator	Disused offices	Electricity sub station	Sewage pumping station
Date of Construction (NB: info from asset register)	1981	1981	1984	1940	
Floor Area/Volume m ² /m ³ (NB: info from asset register)	11	19	1426		
Number of Floors	1	1	2 & 3 equivalent; extension - 1 & 1.5 equivalent	1	1
Building Height (Eaves, Ridge) m, estimated	2.5	2.4	5 & 7.5; 3 & 4.5 (extension)	2.5	1.2, 2.4
Construction/Structure	Concrete walls	Red brick walls, timber slatted doors and asphalt roof with deep timber fascia. Fume vents protruding.	Concrete construction building. Large metal doors, metal windows with timber cill and sub-frame. Chimney vents from roof and boarded door. Concrete block walled flat asphalt roofed extension.	Concrete walled enclosure.	Brick, flat concrete roof.
Building/Setting Features & Characteristics of Note		No windows.		Overgrown inside enclosure.

Potential Uses					
Status/Condition	3 Fair	4 Poor	4 Poor	4 Poor	3 Fair

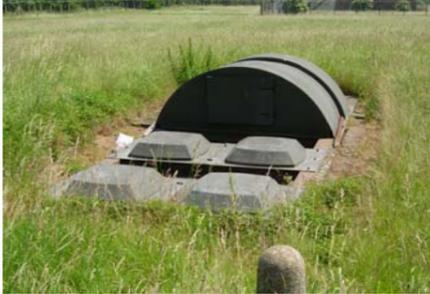
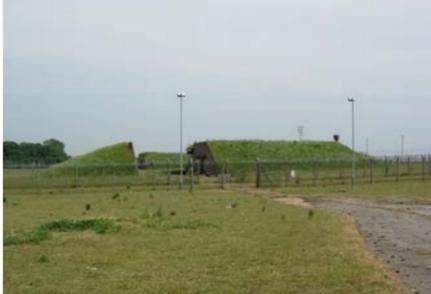
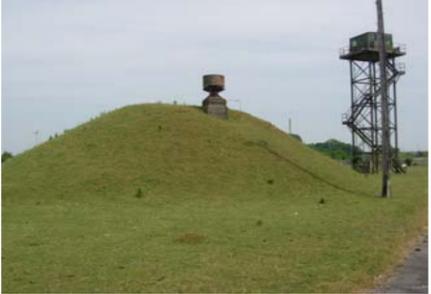
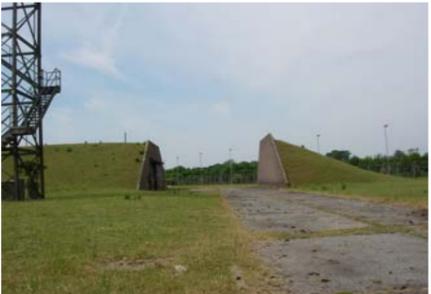
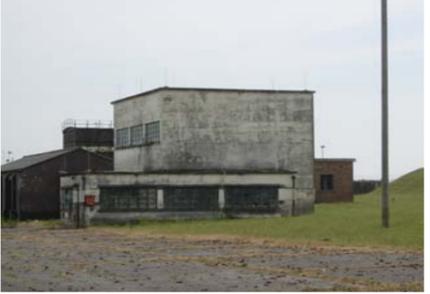
Area 9

Building No.	421	1001 - 1004	1005	1006	1007
Current Use	Sewage pumping station	Disused store	Disused store	Disused workshop	Disused store
Date of Construction (NB: info from asset register)	1988	1953	1953	1953	1953
Floor Area/Volume m ² /m ³ (NB: info from asset register)		193	193	524	162
Number of Floors		2 equivalent	2 equivalent	2 equivalent	1 and 2
Building Height (Eaves, Ridge) m, estimated	1.2	5.0	5.0	5.5	2.6, 6
Construction/Structure	Semi-circular arched tank	Two grass mounds split by road 1/3:2/3. Steel door to larger mound and concrete end panels.	Two grass mounds split by road 1/3:2/3. Steel door to larger mound and concrete end panels.	3 no. mounds divided by roads, 2 large and 1 small steel doors to large mound, at opposite end 2 large and 2 small steel doors. Turrets and vent to top of mound. Blast doors cover push button coded door.	White painted rendered walls. Metal windows and door with concrete cills and lintels. Flat concrete roof. Windows at low level.

Building/Setting Features & Characteristics of Note	Located adjacent car park.				Some blocked up openings
Potential Uses					
Status/Condition	2 Good	2 Good	2 Good	2 Good	4 Poor

Equivalent to 1005

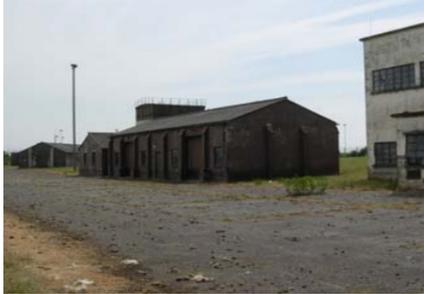
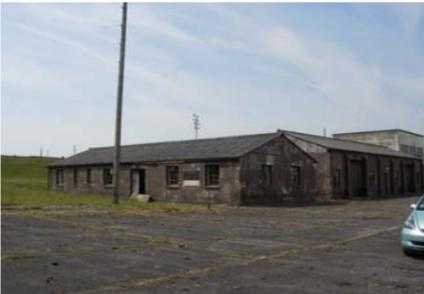
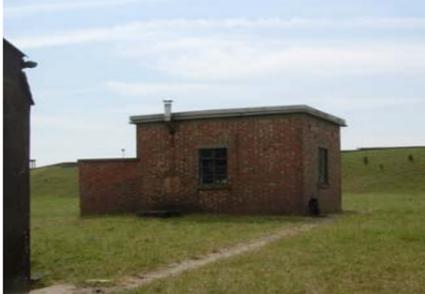
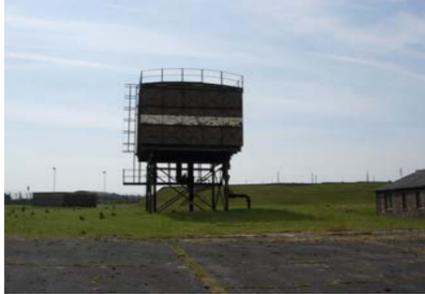
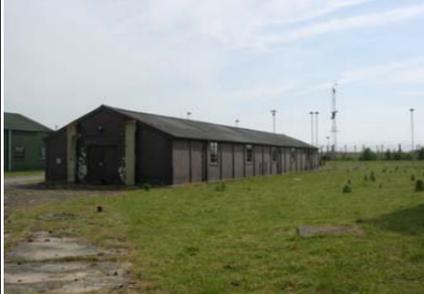
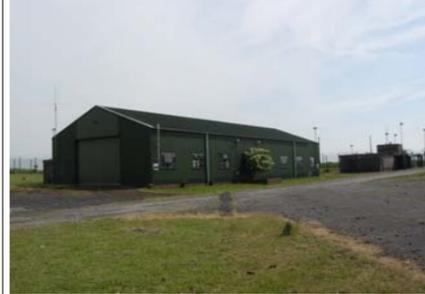
Area 9

Building No.	1008	1009	1010	1011	1023
Current Use	Disused store	Disused boiler room	Water tank	Disused workshop	Disused store
Date of Construction (NB: info from asset register)	1953	1953	1952	1953	1958
Floor Area/Volume m²/m³ (NB: info from asset register)	318	24		239	372
Number of Floors	1 & 1.5 equivalent	1	3.5 equivalent	1	2 equivalent
Building Height (Eaves, Ridge) m, estimated	3, 4.5 and 2.4, 4	3.0	8.0	2.6, 4	4, 6.5
Construction/Structure	Rendered brick walls with piers surrounding with tile tops. Metal windows, timber door and two large metal doors to front, asbestos pitched roof.	Brick walls, metal windows with concrete cills and lintels, timber doors with vents, flat concrete roof with metal capping.	Metal structure with large metal tank over	Rendered walls with surrounding piers with tile tops. Double doors to one end. Metal windows with concrete cills. Concrete plinth & timber pitched roof. Asbestos in roof, guttering & downpipes.	Metal cladding to walls and pitched roof. Large metal door to one end & metal windows. Rendered plinth. Small blockwork shed to side with metal clad mono-pitch roof and timber doors

Building/Setting Features & Characteristics of Note	Two further buildings linked by corridor. Asbestos in roof & guttering.	Smaller 2m high volume to side.			
Potential Uses					
Status/Condition	4 Poor	3 Fair	3 Fair	3 Fair	3 Fair

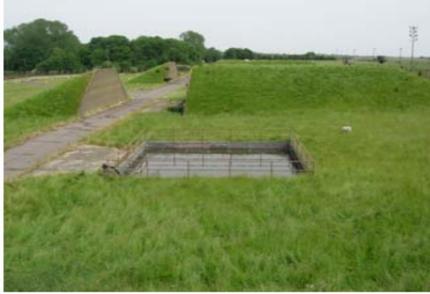
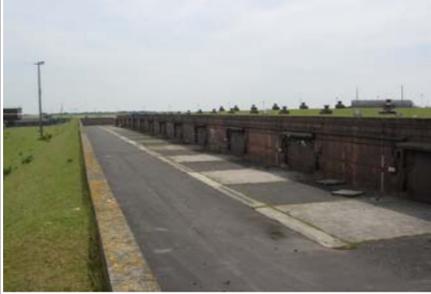
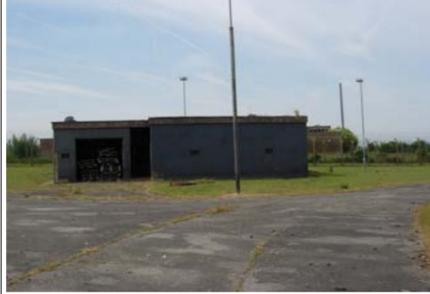
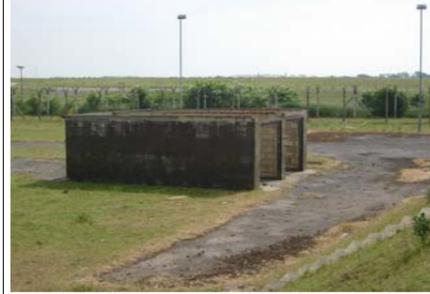
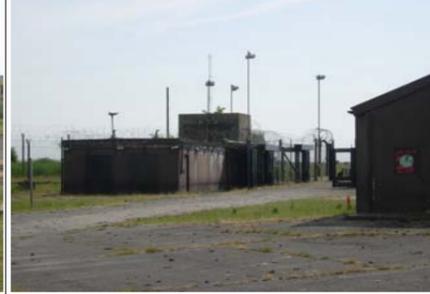
Building No.	1025	1026 - 1048	1050	1059	1060
Current Use	EWS tank	Disused store	Disused store	Sub-station?	Disused gate house
Date of Construction (NB: info from asset register)	1964	1971	1979	1977	1979
Floor Area/Volume m ² /m ³ (NB: info from asset register)		97	144	34	96
Number of Floors		1	1	1	1 with 2 storey tower
Building Height (Eaves, Ridge) m, estimated		3.0	3.5	2.2	2.4 & 4.5 (tower)
Construction/Structure	1.8m high enclosure of metal chain link fence on concrete posts	Concrete retaining wall to front with 250mm thick large metal sliding double doors. Earth covered.	Concrete walls with concrete flat asphalt roof with large fascia. Small holes in walls.	Concrete walled enclosure with metal mesh gates, timber windows, metal garage doors and flat roof with metal capping to parapet.	Concrete walls with steel slot openings in tower. Steel doors and turnstyle. Asphalt roofing and areas of polycarbonate roofing. Chainlink fence enclosure on concrete posts.

Building/Setting Features & Characteristics of Note		1026-1048 inclusive all same			
Potential Uses					
Status/Condition	2 Good	3 Fair	4 Poor	4 Poor	4 Poor

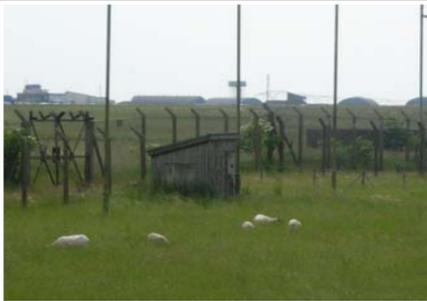
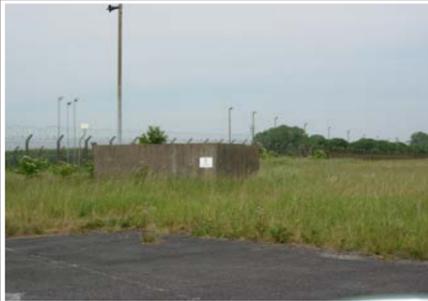
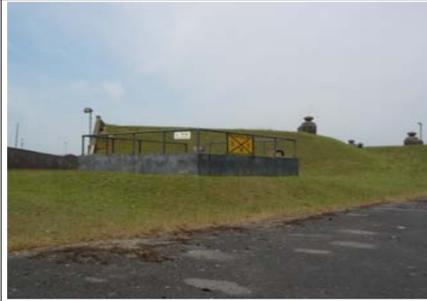
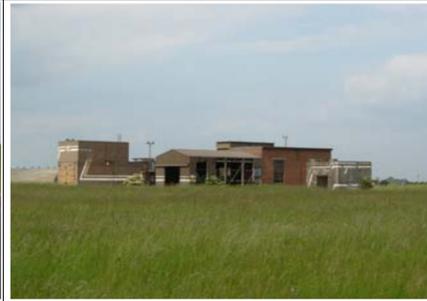
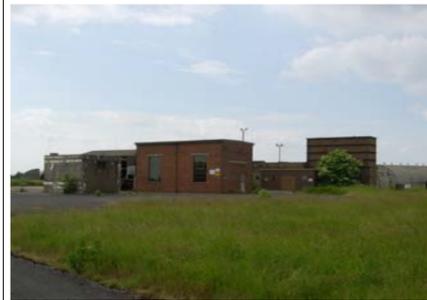
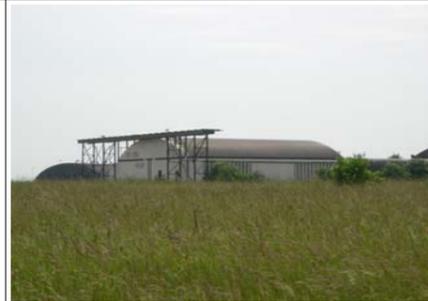
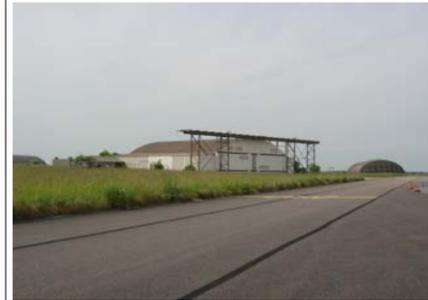
Area 9

Building No.	1061	1065	1080	1319	1372
Current Use	Disused	Sub-station	Water tank	Disused	Hush house
Date of Construction (NB: info from asset register)	1979	1979	1978	1959	1984
Floor Area/Volume m ² /m ³ (NB: info from asset register)	4				
Number of Floors		1			2 equivalent
Building Height (Eaves, Ridge) m, estimated	1.5 to 2 m	2.2	1.5	A: 4, 5 B: 5, C: 3.5, D: 6	5.5, 8
Construction/Structure	Timber walls with mono-pitch asphalt roof.	Concrete walled enclosure with metal mesh gates.	Metal rails fixed to concrete upstand.	Amalgamation of different structures. A: Steel framed with metal clad walls and roof. B: Brick walls, flat asphalt roof and metal windows. C: Concrete walls with large opening and flat roof. D: Metal containers two storey with large double steel doors.	Steel frame, metal clad, rolling metal doors with steel support structure, barrel roof.
Building/Setting Features & Characteristics of Note					Blast silencer at rear.

Potential Uses					
Status/Condition	4 Poor	3 Fair	3 Fair	A, D, C: 4 B: 3 A, D, C: Poor B: Fair	3 Fair

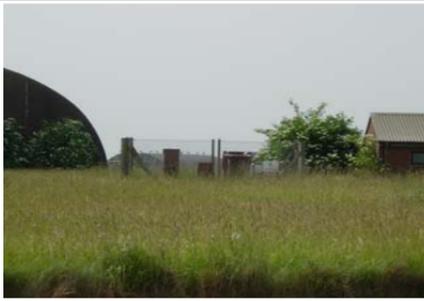
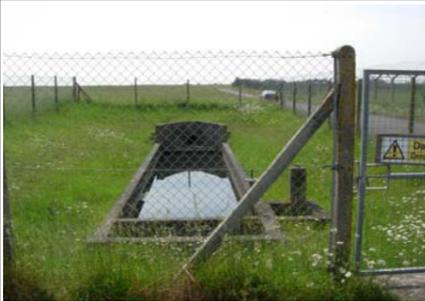
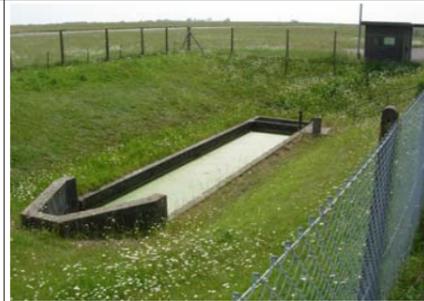
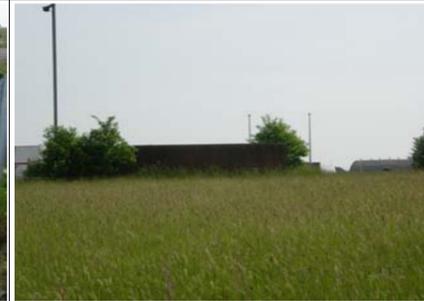
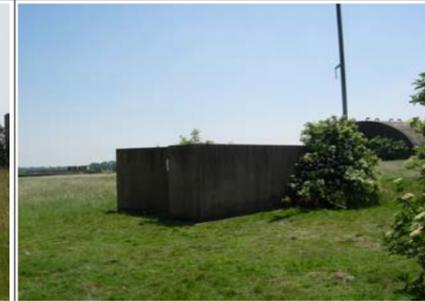
Area 9

Building No.	1388	1398	1399	1405	1409
Current Use	Sub-station	EWS	EWS	Sub-station	Sub-station
Date of Construction (NB: info from asset register)	1984	1979	1975	1973	1973
Floor Area/Volume m ² /m ³ (NB: info from asset register)					
Number of Floors				1	1
Building Height (Eaves, Ridge) m, estimated	1.8	1.8		1.8	1.8
Construction/Structure	Chain link fence & concrete post enclosure.	Chain link fence & concrete post enclosure.	Chain link fence & concrete post enclosure.	Concrete walled enclosure with galvanised steel mesh gates.	Concrete walled enclosure with galvanised steel mesh gates.
Building/Setting Features & Characteristics of Note					
Potential Uses					
Status/Condition	3 Fair	3 Fair	3 Fair	3 Fair	3 Fair

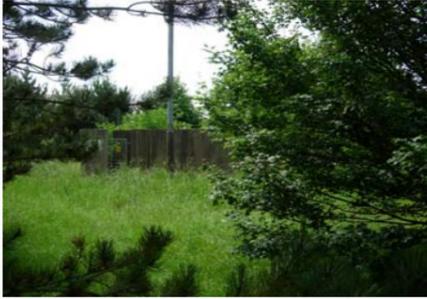
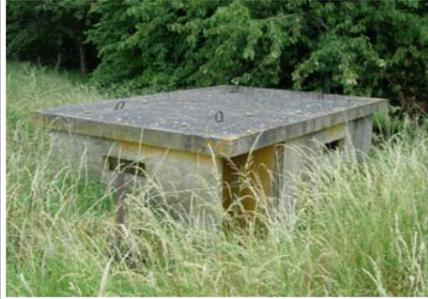
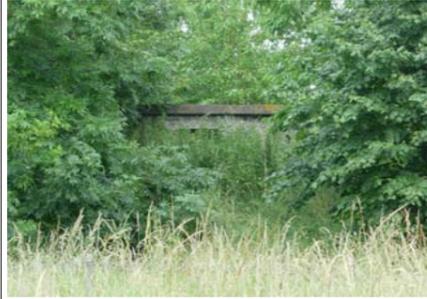
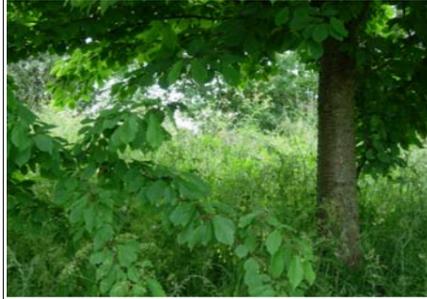
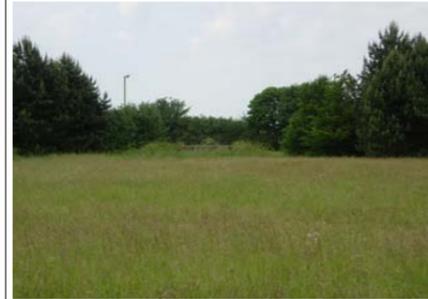
Area 9

Building No.	1439	1802	1803	1804	1807
Current Use	Sub-station	Bunker	Bunker	Bunker	Bunker
Date of Construction (NB: info from asset register)	1979				
Floor Area/Volume m ² /m ³ (NB: info from asset register)					
Number of Floors	1				
Building Height (Eaves, Ridge) m, estimated	1.8	1.0	1.0	1.0	1.0
Construction/Structure	Concrete walled enclosure with galvanised steel mesh gates.	Concrete walls and roof with slot openings.	Concrete walls and roof with slot openings.	Concrete walls and roof with slot openings.	Concrete walls and roof with slot openings.
Building/Setting Features & Characteristics of Note		Sunken into ground	Sunken into ground	Sunken into ground	Sunken into ground
Potential Uses					
Status/Condition	4 Poor	4 Poor	4 Poor	4 Poor	4 Poor

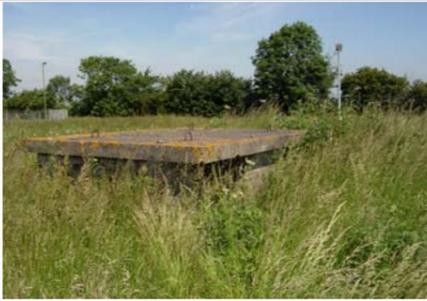
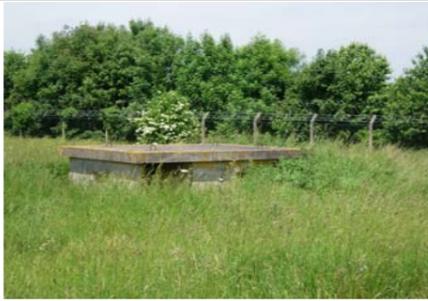
Area 9

Building No.	1808	1813	1865, 1866	1867, 1868, 1869 + 1871	1870
Current Use	Bunker	Bunker	Bunker	Turret	Disused
Date of Construction (NB: info from asset register)					
Floor Area/Volume m ² /m ³ (NB: info from asset register)					
Number of Floors					1
Building Height (Eaves, Ridge) m, estimated	1.0	1.0	1.0	1.0	2.2
Construction/Structure	Concrete walls and roof with slot openings.	Concrete walls and roof with slot openings.	Concrete walls and roof with slot openings.	Concrete roof on steel supports on top of munitions stores.	Concrete enclosure with concrete roof on steel supports.
Building/Setting Features & Characteristics of Note	Sunken into ground	Sunken into ground	Sunken into ground	Sunken into munitions store mound.	
Potential Uses					
Status/Condition	4 Poor	4 Poor	3 Fair	3 Fair	3 Fair

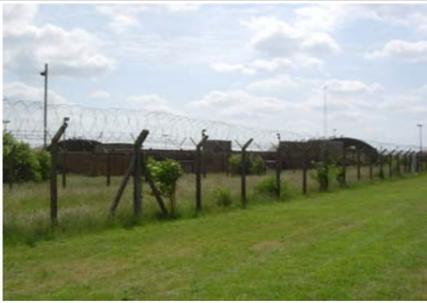
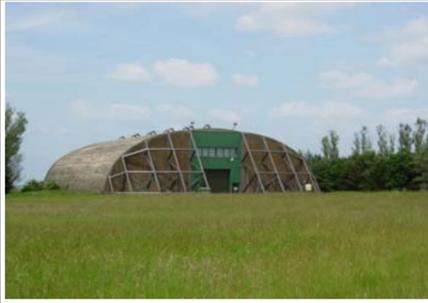
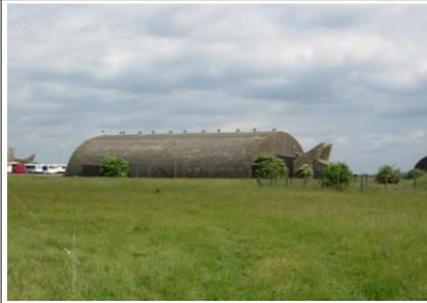
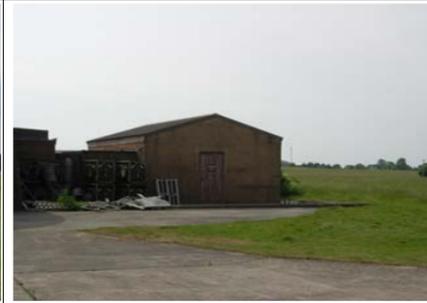
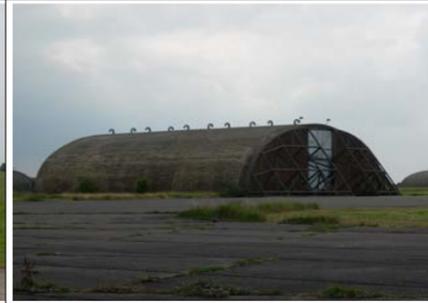
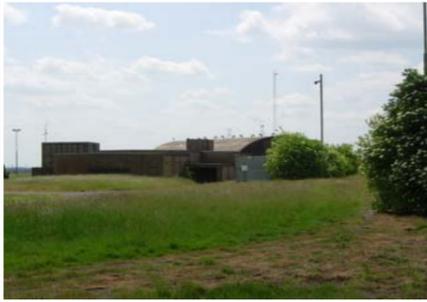
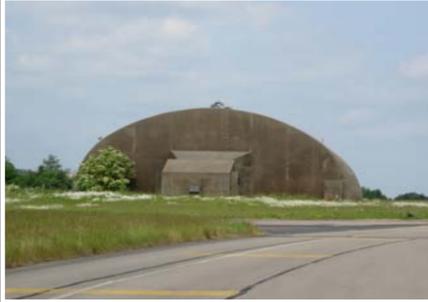
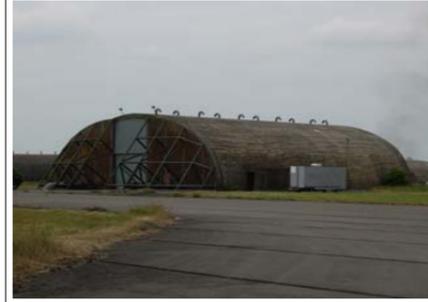
Area 9

Building No.	2010	3001 (see additional numbers below)	3015 (see additional numbers below)	Extension to 3026	3028 (see additional numbers below)
Current Use	Disused	Hardened aircraft hanger	Hardened aircraft hanger	Store?	Hardened aircraft hanger
Date of Construction (NB: info from asset register)		1974	1979		1979
Floor Area/Volume m²/m³ (NB: info from asset register)		930	930		930
Number of Floors	1.5 with 2 storey towers			1	
Building Height (Eaves, Ridge) m, estimated	4 & 5.5			3.2, 4.2	
Construction/Structure	Concrete walls with metal grided openings and flat concrete roof. (Not accessible)	Concrete barrel vault with large sliding doors to front with steel framing and metal infill panel to rear with garage door and metal windows over. Asbestos in rear & side doors.	Concrete barrel vault with large sliding doors to front with steel framing. Asbestos in blast/side doors	Concrete block walls, timber door, no windows. Metal clad pitched roof with timber fascia.	Concrete barrel vault with large sliding doors to front with steel framing. Doors infilled with metal roller door. Asbestos in blast/side doors.

Building/Setting Features & Characteristics of Note		also 3002, 3003, 3004, 3005, 3006, 3007, 3008, 3009, 3010, 3011, 3012, 3013, 3014	also 3016, 3017, 3018, 3019, 3020, 3021, 3022, 3023, 3024, 3025, 3026, 3027, 3030, 3031,		also 3029
Potential Uses					
Status/Condition	3 Fair	3 Fair	3 Fair	3 Fair	3 Fair

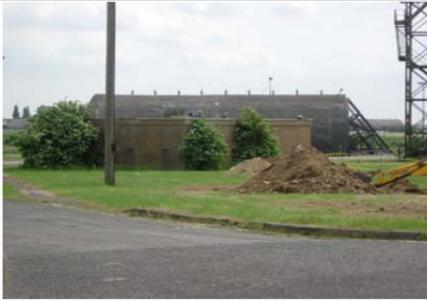
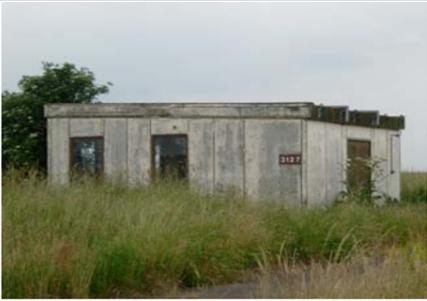
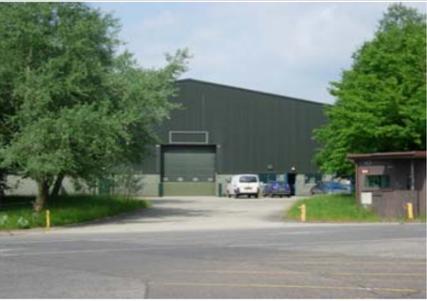
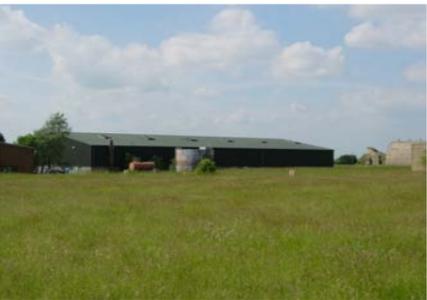
Area 9

Building No.	3104	3105	3109a	3127A	3135
Current Use	Disused workshop	EWS tank	Disused office	Disused office	Store
Date of Construction (NB: info from asset register)	1981				1986
Floor Area/Volume m ² /m ³ (NB: info from asset register)	144				3189
Number of Floors	1		1	1	1
Building Height (Eaves, Ridge) m, estimated		1.8	2.6	2.6	4, 6
Construction/Structure	Concrete panelled walls with no windows. Steel doors and flat roof with parapet. (Not accessible)	1.8m high enclosure of metal chain link fence on concrete posts. (Not accessible)	Cement board walls with timber windows & doors. Flat roof. (Not accessible)	Cement board walls with timber windows & doors. Flat roof.	Concrete block base of 2.1m height with profiled metal sheet cladding above and to roof. Timber doors, large metal warehouse door and metal windows.
Building/Setting Features & Characteristics of Note					
Potential Uses					
Status/Condition	4 Poor	3 Fair	4 Poor	4 Poor	2 Good

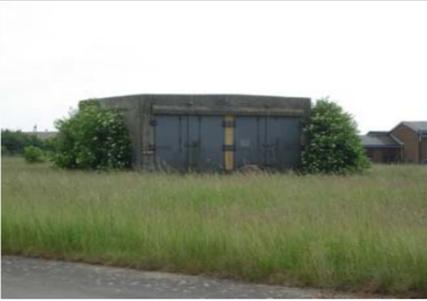
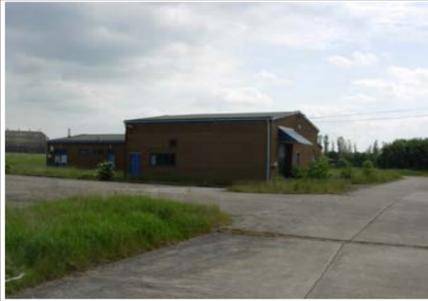
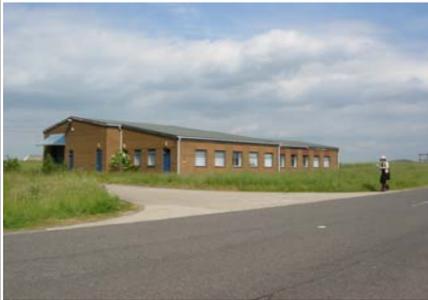
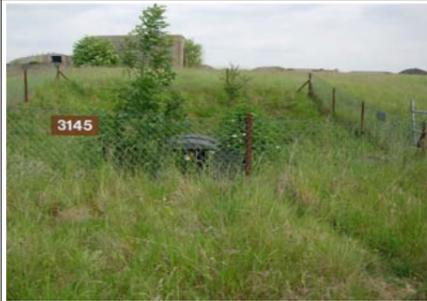
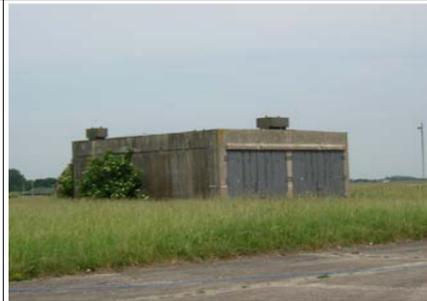
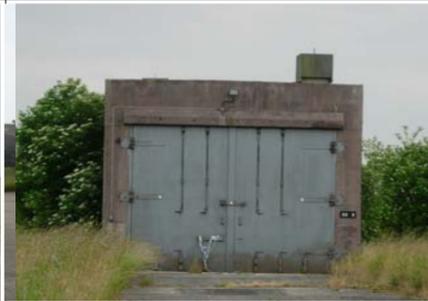
Area 9

Building No.	3136	3140	3145	3200, 3201, 3202	3203
Current Use	Disused tanker bay	Workshop	Sewage pumping station	Disused tanker bay	Disused tanker bay
Date of Construction (NB: info from asset register)	1987	1984	1984	1980	1985
Floor Area/Volume m ² /m ³ (NB: info from asset register)	64	527		169	60
Number of Floors	1		1	1	1
Building Height (Eaves, Ridge) m, estimated	3	3.5 to lowest eaves, 4.6 to highest eaves, 5.7 ridge	1	3.0	3.0
Construction/Structure	Concrete walls, large steel double doors and hatch, flat roof with metal capping to parapet.	Brick walls with steel windows and some concrete spandrel panels. Timber doors & steel and timber cantilevered porch. Asbestos in ceiling panels at fire escape & pipeworks gaskets.	Chain link fence enclosure to pit with steel semi circular arched structure inside.	Concrete walls with flat roof and large steel doors, vents to roof.	Concrete walls with flat roof and large steel doors, vent to roof.

Building/Setting Features & Characteristics of Note					
Potential Uses					
Status/Condition	3 Fair	3 Fair	3 Fair	3 Fair	3 Fair

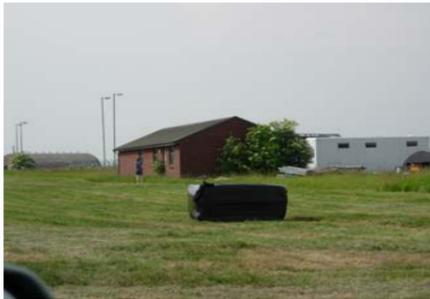
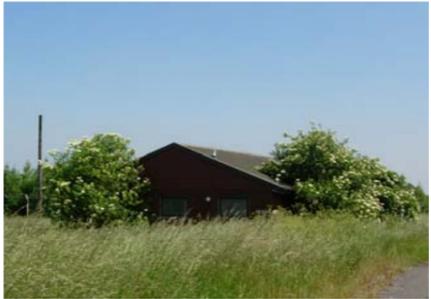
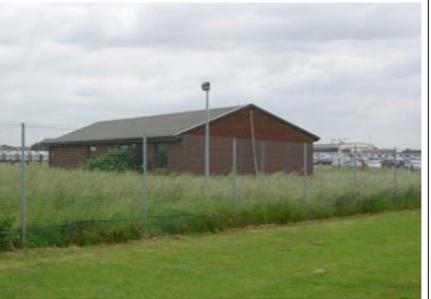
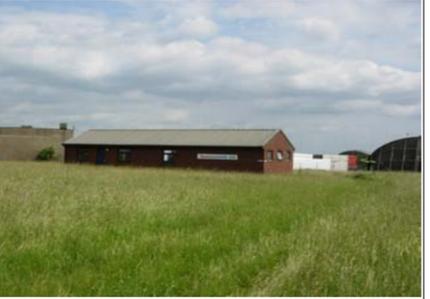
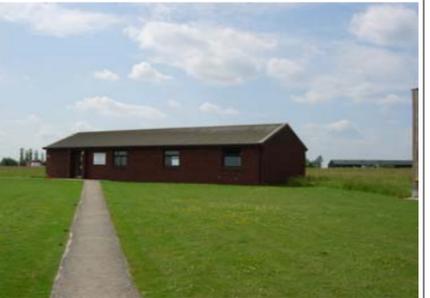
Area 9

Building No.	3206	3207	3208	3209	5066
Current Use	Disused workshop	Disused workshop	Workshop	Dawsons Rentals office	Bunker
Date of Construction (NB: info from asset register)	1986	1986	1986	1986	
Floor Area/Volume m ² /m ³ (NB: info from asset register)	142	142	142	142	
Number of Floors	1	1	1	1	
Building Height (Eaves, Ridge) m, estimated	2.1, 3.5	2.1, 3.5	2.1, 3.5	2.1, 3.5	1
Construction/Structure	Brick walls, metal windows in timber subframe with brick cills. Metal clad pitched roof.	Brick walls with metal windows with soldier course over. Metal roof with 300mm overhang to eaves.	Brick walls with metal windows with soldier course over. Metal roof with 300mm overhang to eaves.	Brick walls with metal windows with soldier course over. Metal roof with 300mm overhang to eaves.	Concrete walls and roof with slot openings
Building/Setting Features & Characteristics of Note	Arched tank adjacent.	Overgrown

Potential Uses					
Status/Condition	3 Fair	3 Fair	3 Fair	2 Good	3 Fair

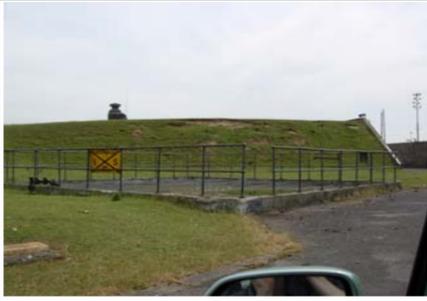
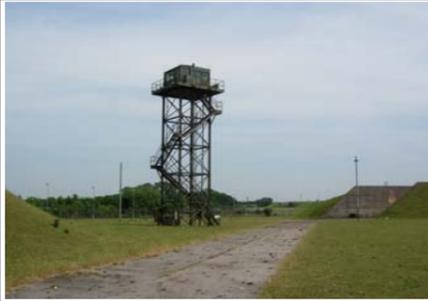
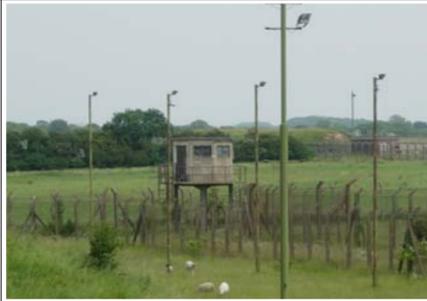
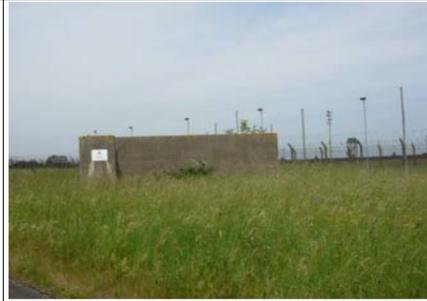
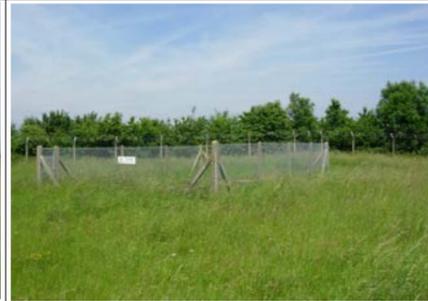
Area 9

Building No.	UH48	UH49	UH50	UH56	UH57
Current Use	EWS	Observation tower	Observation tower	Sub-station	EWS
Date of Construction (NB: info from asset register)					
Floor Area/Volume m²/m³ (NB: info from asset register)					
Number of Floors		5 equivalent	2	1	
Building Height (Eaves, Ridge) m, estimated	1.5	10	4.0	2.2	1.8
Construction/Structure	Metal rails on concrete upstand.	Steel framed tower with flat roofed metal clad observation room at top with metal windows	Concrete supports with concrete observation room over.	concrete walled enclosure with glavanised steel mesh gates	1.8m high enclosure of metal chain link fence on concrete posts. Concrete tanks.
Building/Setting Features & Characteristics of Note					
Potential Uses					
Status/Condition	3 Fair	3 Fair	3 Fair	3 Fair	3 Fair

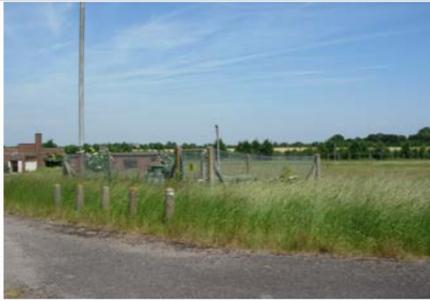
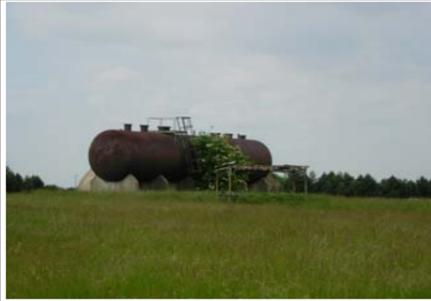
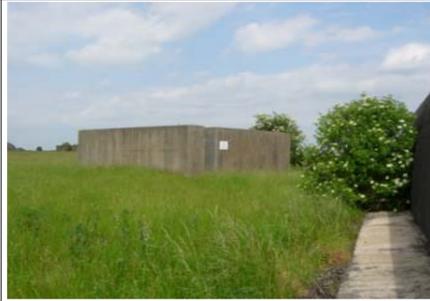
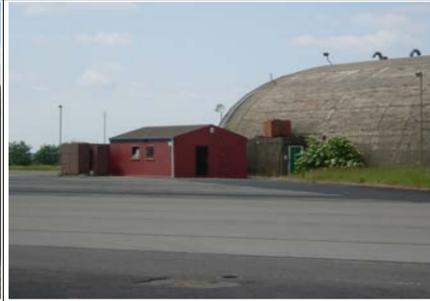
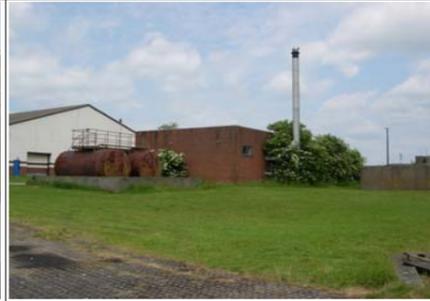
Area 9

Building No.	UH58	UH59	UH60	UH61	UH62
Current Use	Sub-station	Storage tank	Sub-station	Store	Storage tanks
Date of Construction (NB: info from asset register)					
Floor Area/Volume m²/m³ (NB: info from asset register)					
Number of Floors		1	1	1	1
Building Height (Eaves, Ridge) m, estimated	1.8	3.5	2.2	2.2, 2.4	2.5
Construction/Structure	1.8m high enclosure of metal chain link fence on concrete posts.	Steel tank on concrete support walls.	Concrete walled enclosure with galvanised steel mesh gates.	Concrete block walls with timber windows, profile metal roof and timber door	Steel tanks set within a 1m high concrete walled enclosure
Building/Setting Features & Characteristics of Note				Concrete baffle walls to rear	
Potential Uses					
Status/Condition	3 Fair	4 Poor	3 Fair	2 Good	4 Poor

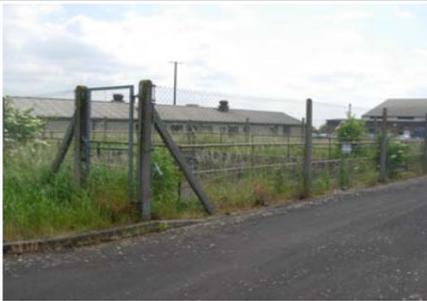
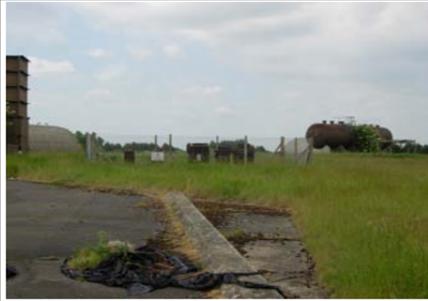
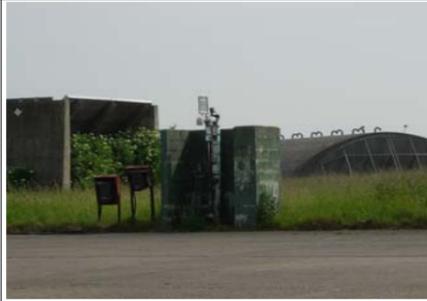
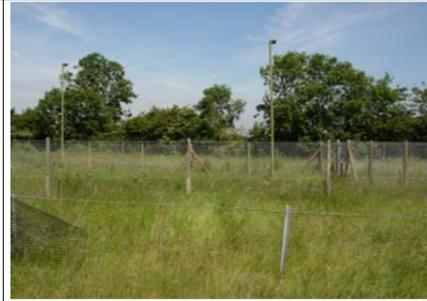
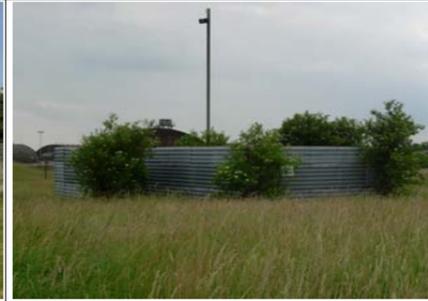
Area 9

Building No.	UH63	UH64	UH65	UH67	UH76
Current Use	EWS tank	Sub-station	Pump	EWS tank	Sub-station
Date of Construction (NB: info from asset register)					
Floor Area/Volume m²/m³ (NB: info from asset register)					
Number of Floors		1			
Building Height (Eaves, Ridge) m, estimated	1.8	1.8	2.0	1.8	2.0
Construction/Structure	1.8m high enclosure of metal chain link fence on concrete posts enclosing concrete pit with surrounding galvanised steel rail.	1.8m high enclosure of chain link fence on concrete posts.	Blockwork surrounding wall enclosing pumps.	1.8m high enclosure of chain link fence on concrete posts.	Surrounded by corrugated metal walls.
Building/Setting Features & Characteristics of Note					Overgrown inside
Potential Uses					
Status/Condition	3 Fair	3 Fair	4 Poor	3 Fair	4 Poor

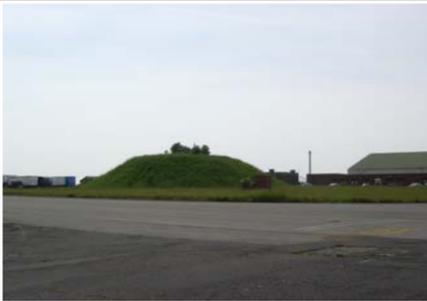
Area 9

Building No.	POL22	
Current Use	Storage tank	
Date of Construction (NB: info from asset register)		
Floor Area/Volume m²/m³ (NB: info from asset register)		
Number of Floors	2 equivalent	
Building Height (Eaves, Ridge) m, estimated	4.5	
Construction/Structure	Earth mound covering tanks. Hatches on top.	
Building/Setting Features & Characteristics of Note		
Potential Uses		
Status/Condition	3 Fair
