Future Defence Storage and Redistribution Programme,
Redevelopment of MOD Bicester
Graven Hill: Land Quality Assessments
- Phase 1 and Phase 2

Site D and Site E, DSDC Bicester

Land Quality Assessment

Phase One: Desk Study
DE Project No.: 13104

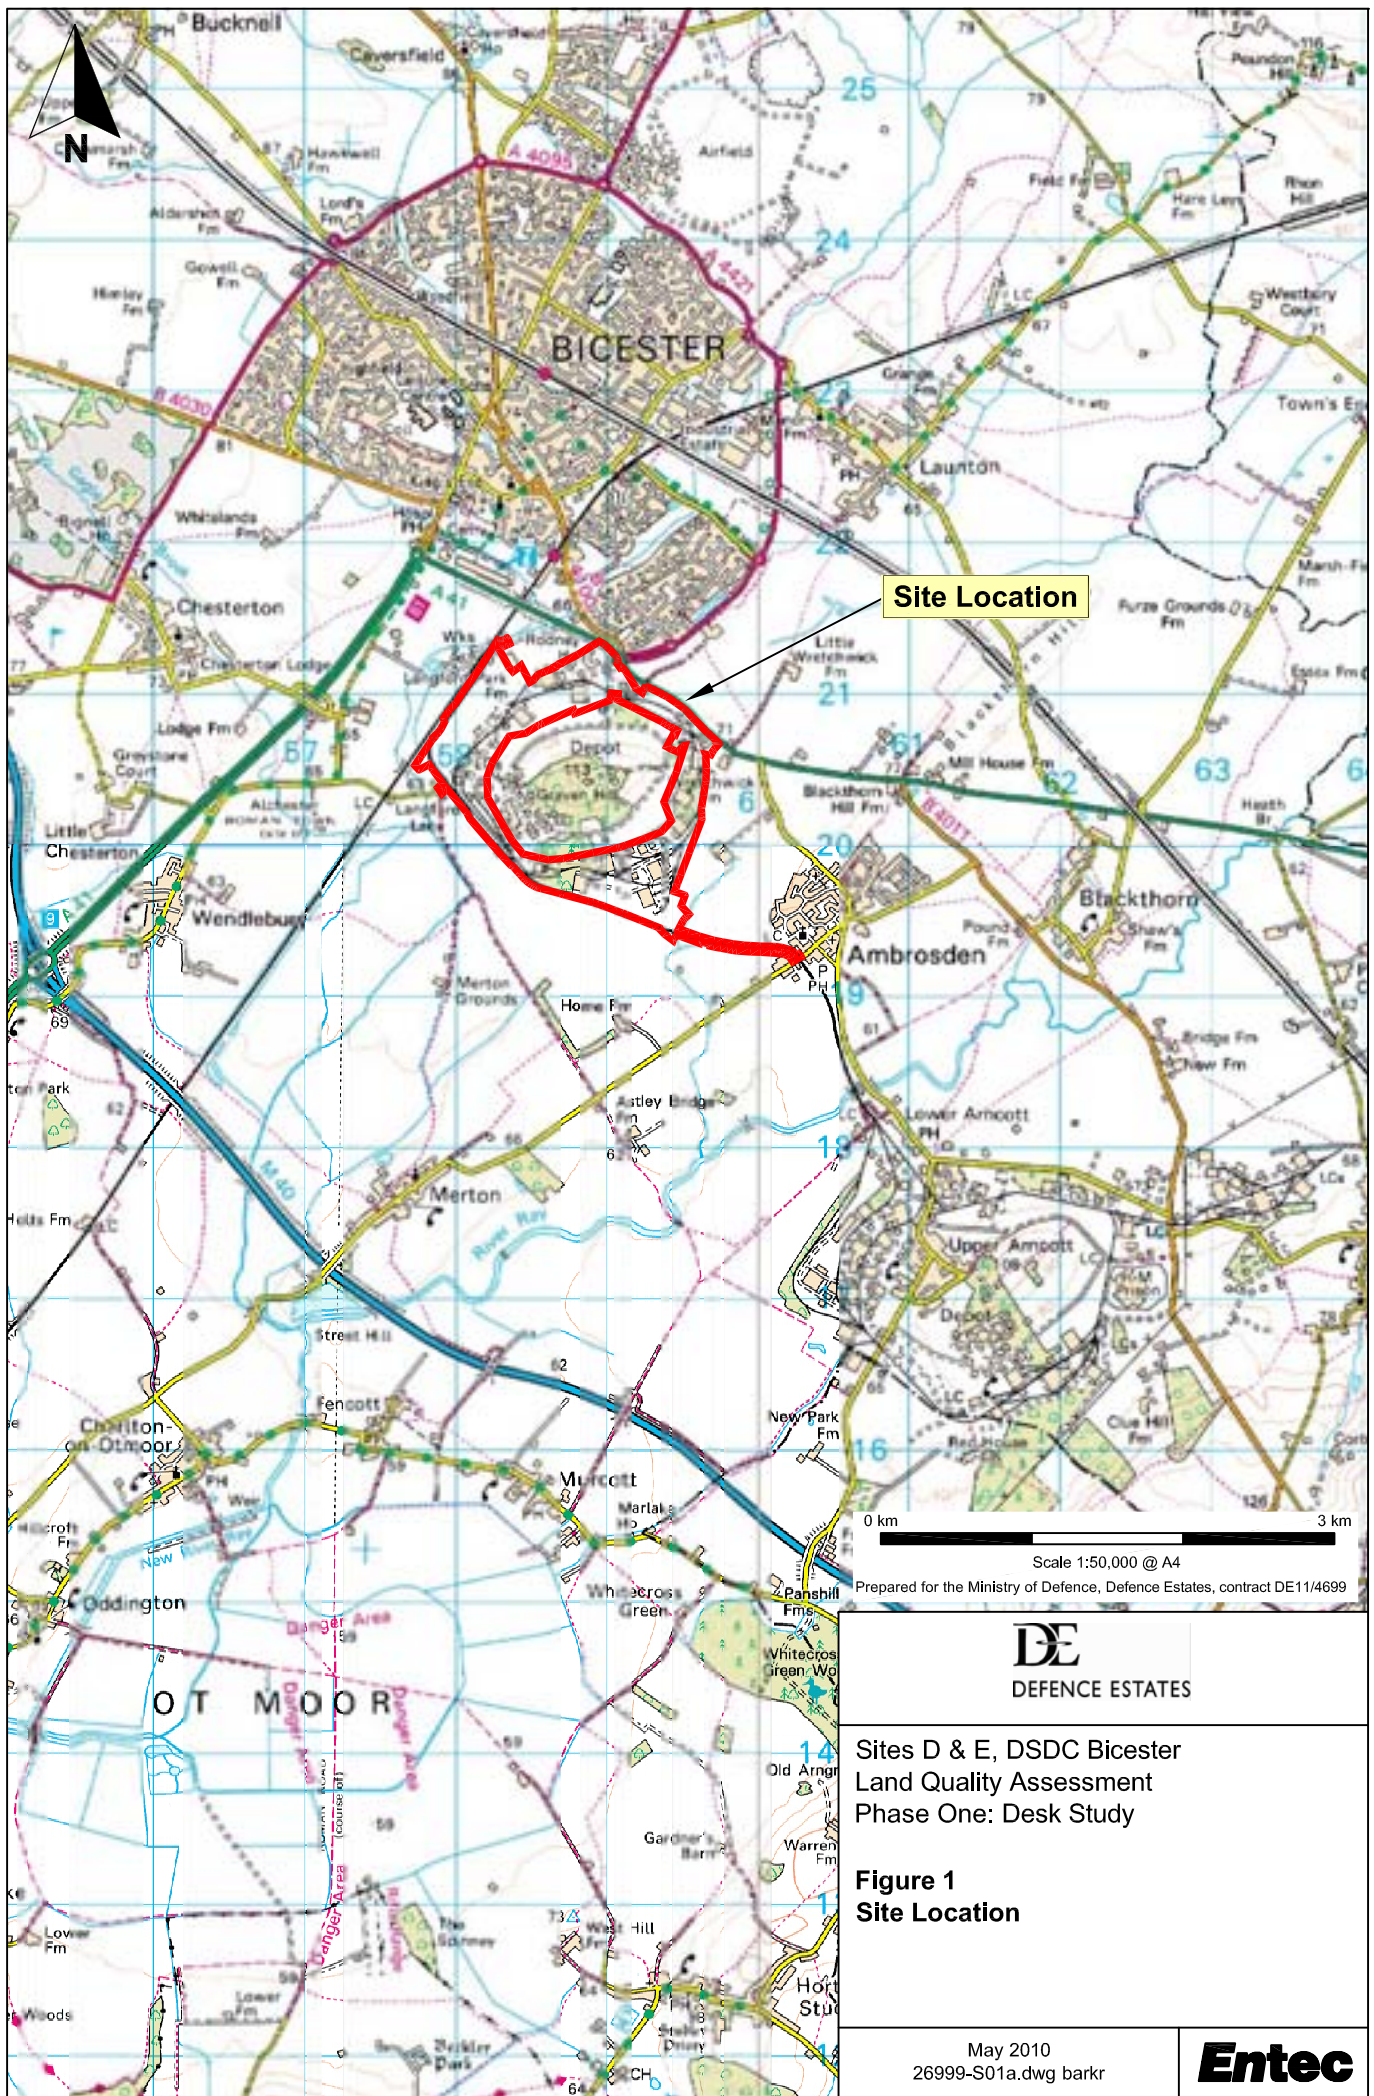
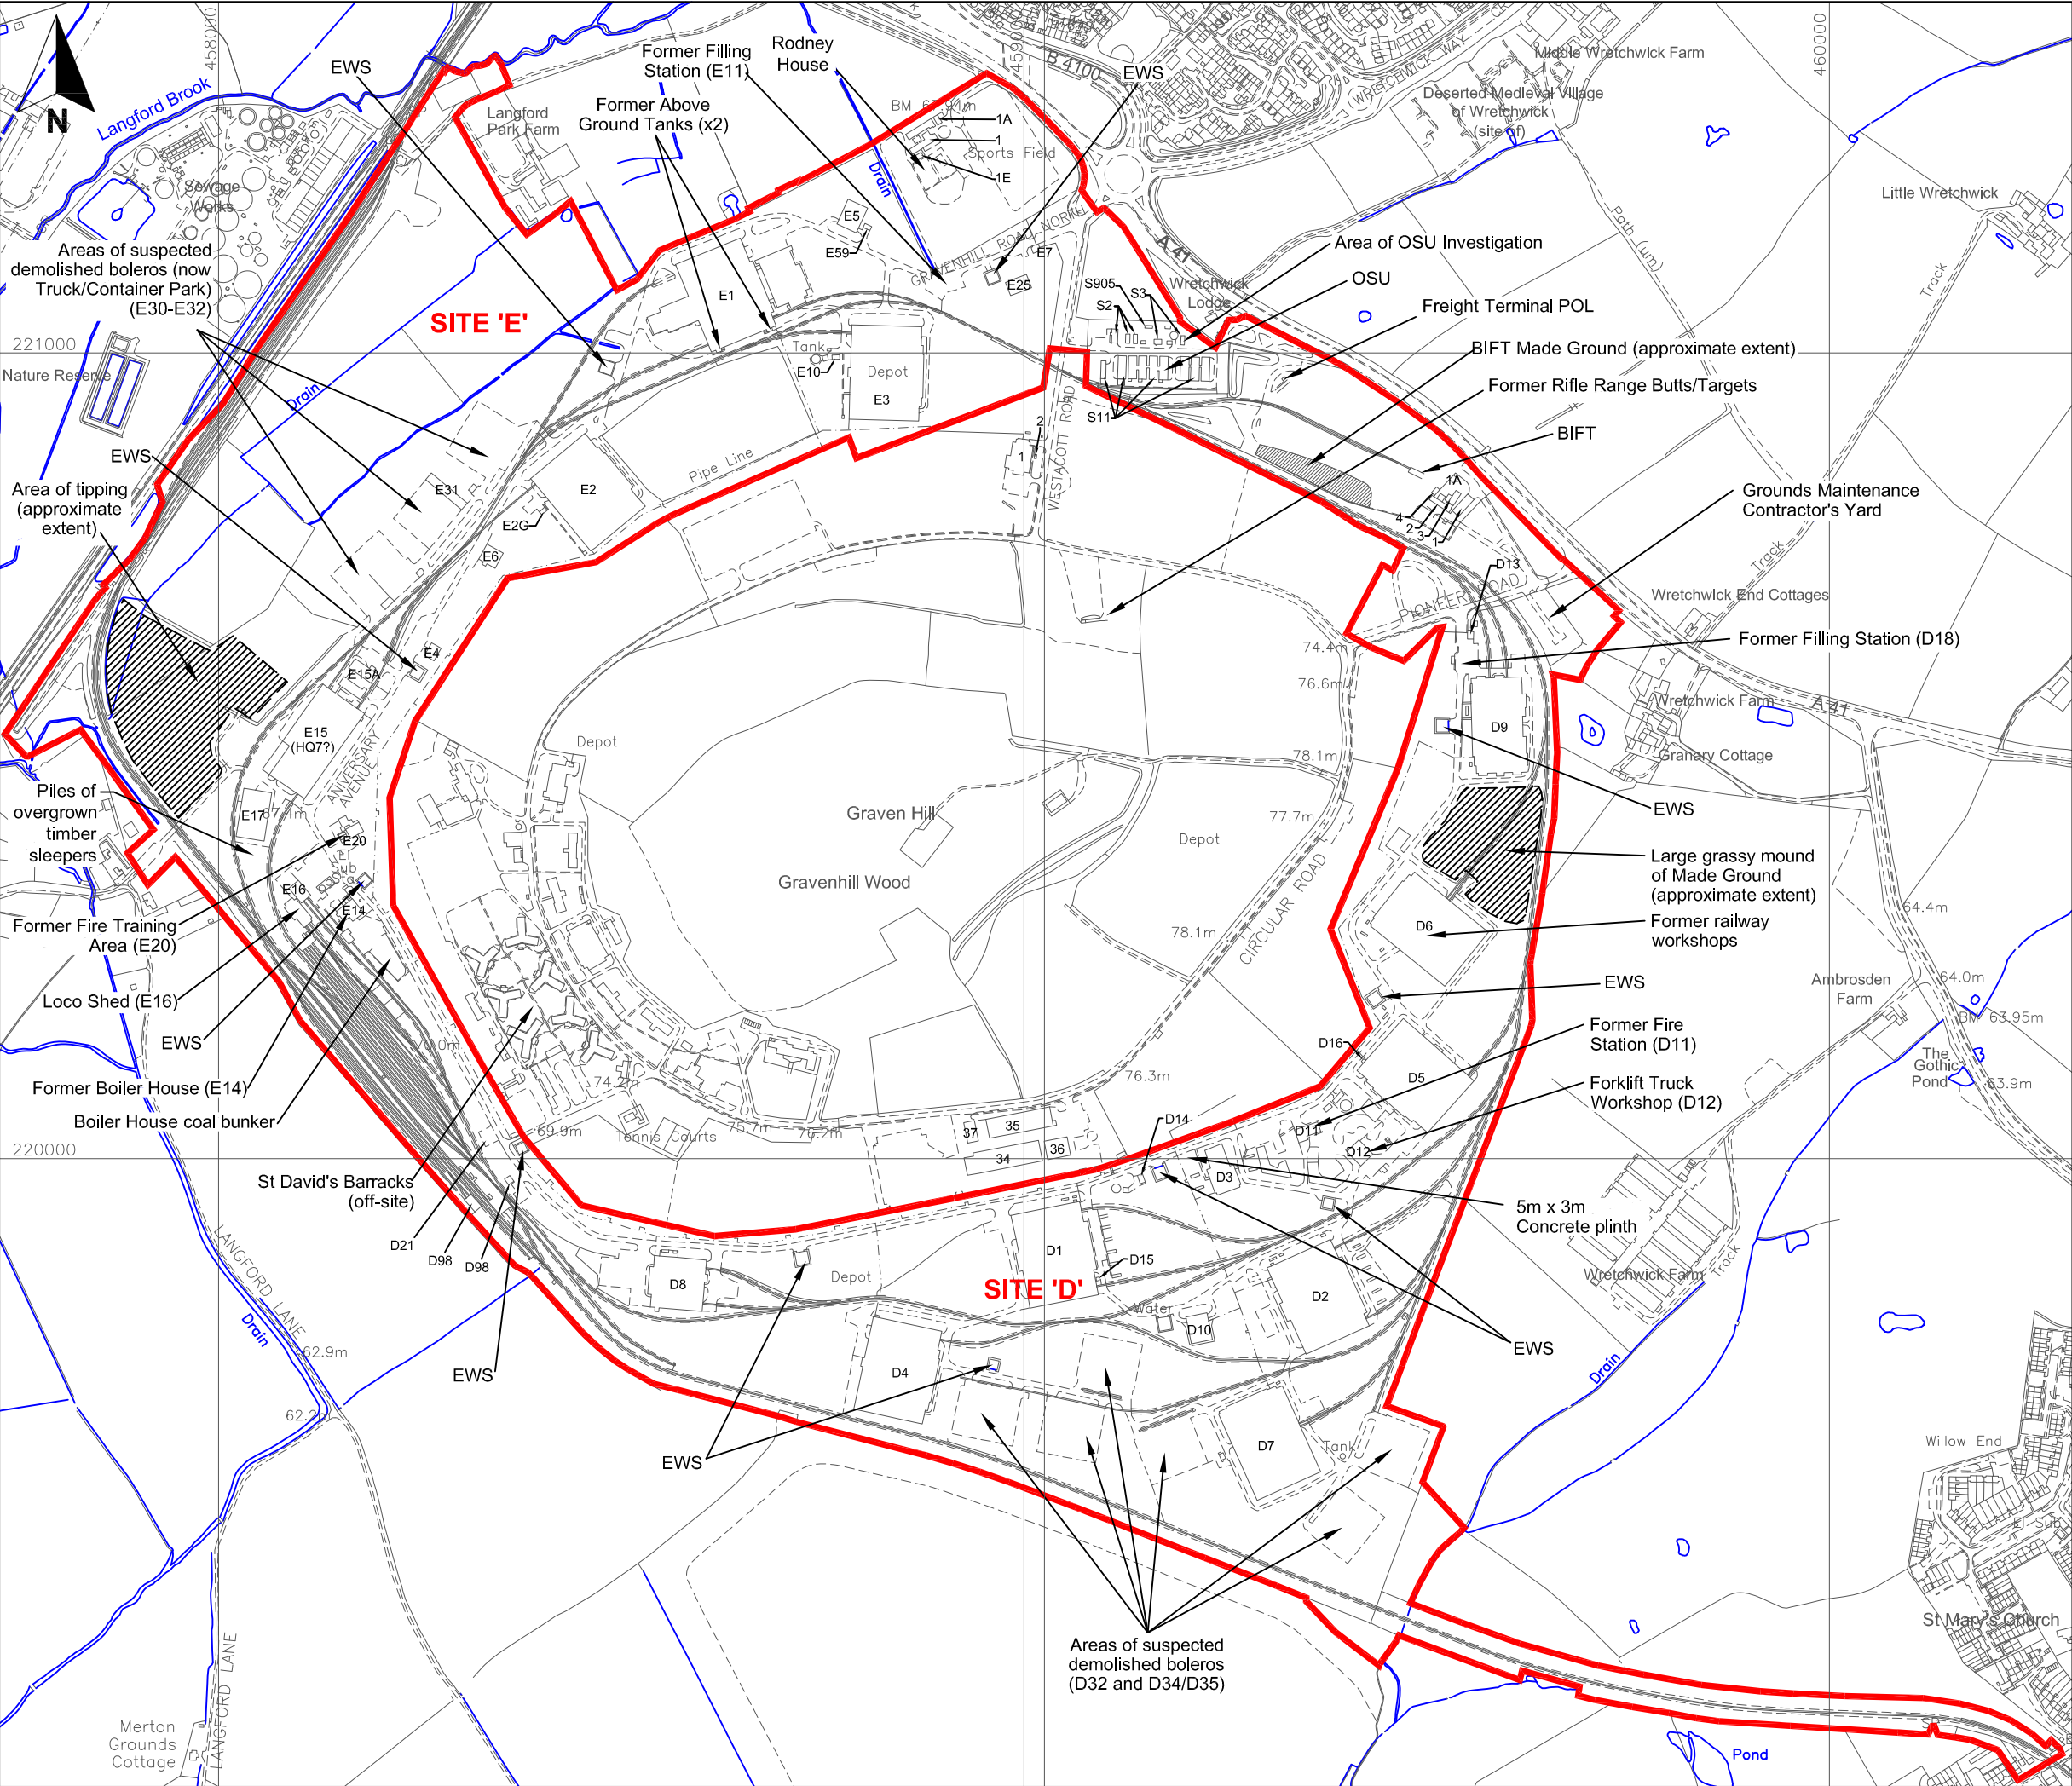
Figure 2
Site Layout

With reference to Figure 2, Table 1.1 summarises the buildings/activities within each area of the site.

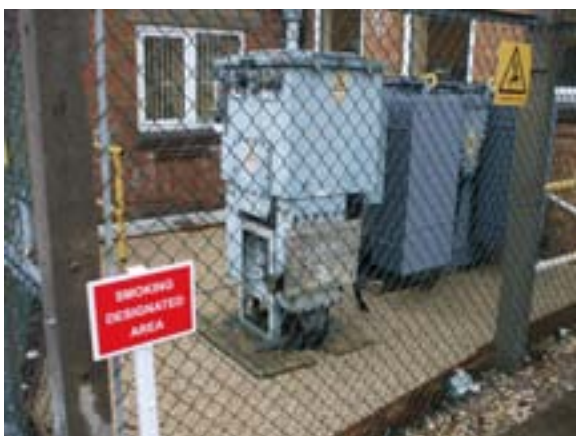
Plate 3: DSS Typical Arrangement

There are many distribution substations (DSS) across the site; each of the large warehouse buildings appears to have at least one DSS. They all appear to be in good order with no obvious signs of leaks (see Plate 3 in Annex A). However, the ground within the DSS compounds has recently been covered with gravel, making it difficult to check for signs of previous leaks. During the site walkover, contractors were noted on site replacing some of the transformers and laying down gravel. They do not recollect there being any obvious signs of major leakage at any of the DSS. According to the contractors, transformers within the DSS compounds are
