Iain Soden Heritage Services Ltd

A Heritage Asset Survey of former farm buildings at Crockwell Farm, Great Bourton, Oxfordshire

May 2016

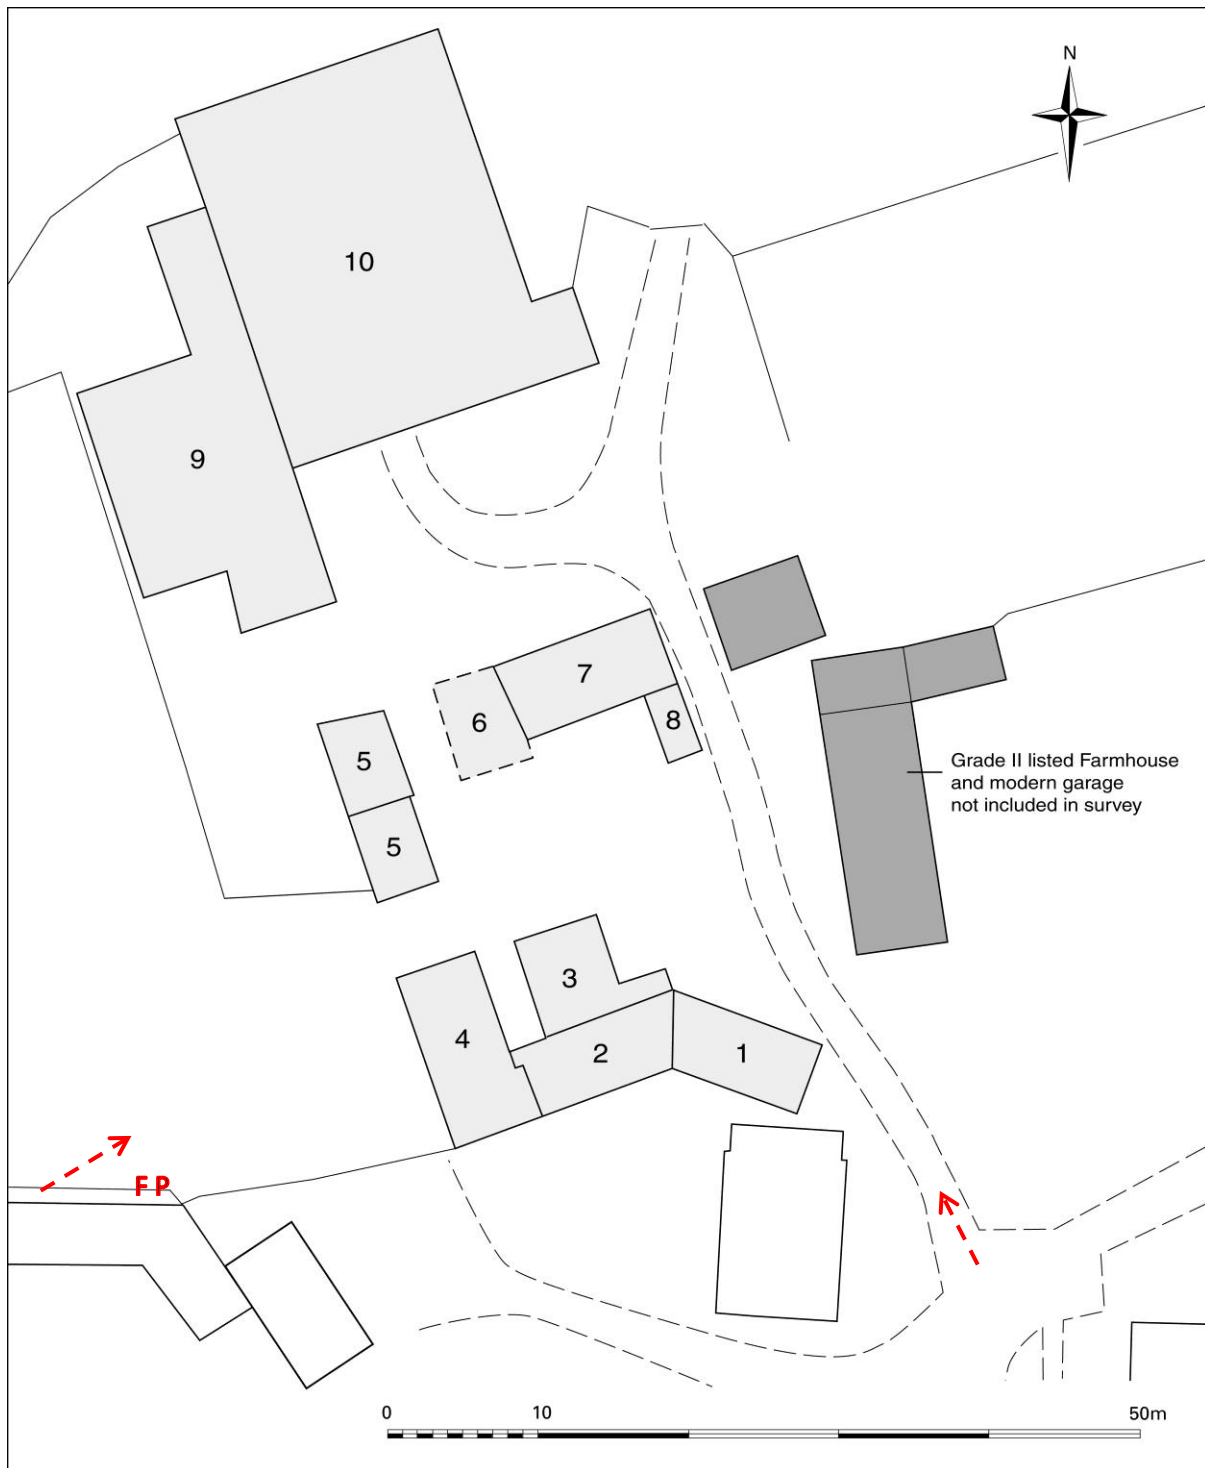
The farmyard and farmhouse lie on an east-facing slope which has been enhanced by the creation of a small bowl-like scarp to create a level plat on which the farmyard has been laid out. It has grown organically, with 19th-century additions, since the 17th century, seeing the last expansion northwards in the 1970s, since when decline has been rapid. The farmyard is entirely derelict and many buildings are in an advanced state of decay or complete ruin.

Fig 2: The layout of the farmyard (Andy Isham after Roger Coy Partnership); Building 11 lies 30m west of Building 5, out of the frame. The dashed red line shows the restricted public views.

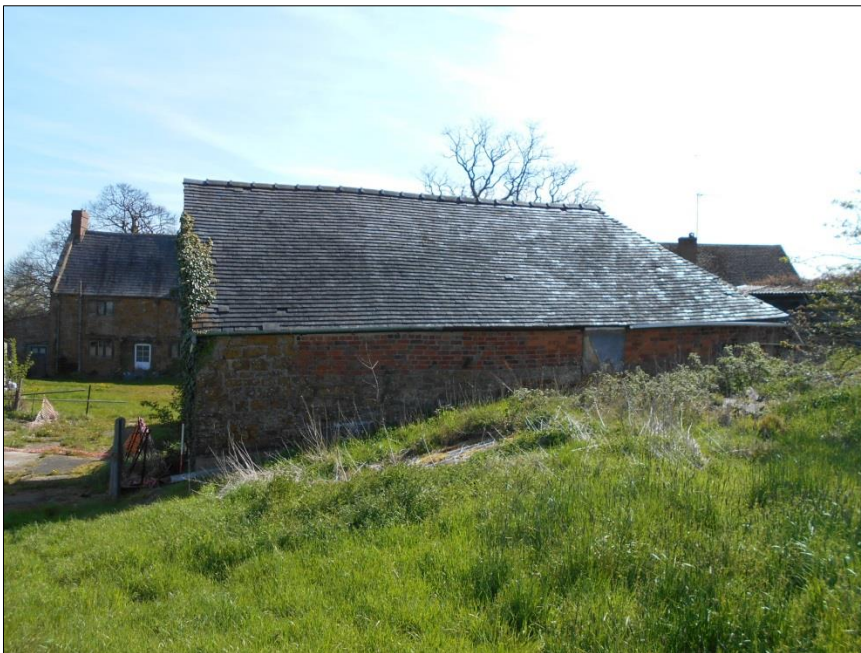
Formerly an open-fronted shed with rear and gable ends of Hornton ironstone ashlar, similar to the 17th-century farmhouse. One gable widened and heightened during its life. The east-facing front was filled-in with brick and the interior provided with pig-pens. A date scrawled into the wet concrete floor indicates this was in 1962. The roof is of machine-sawn pine in common with Buildings 1-2. The same blue engineering tiles cover it.

Fig 9: Building 4, looking east, farmhouse beyond; viewpoint is halfway to Building 11, adjacent to a footpath (at far right).

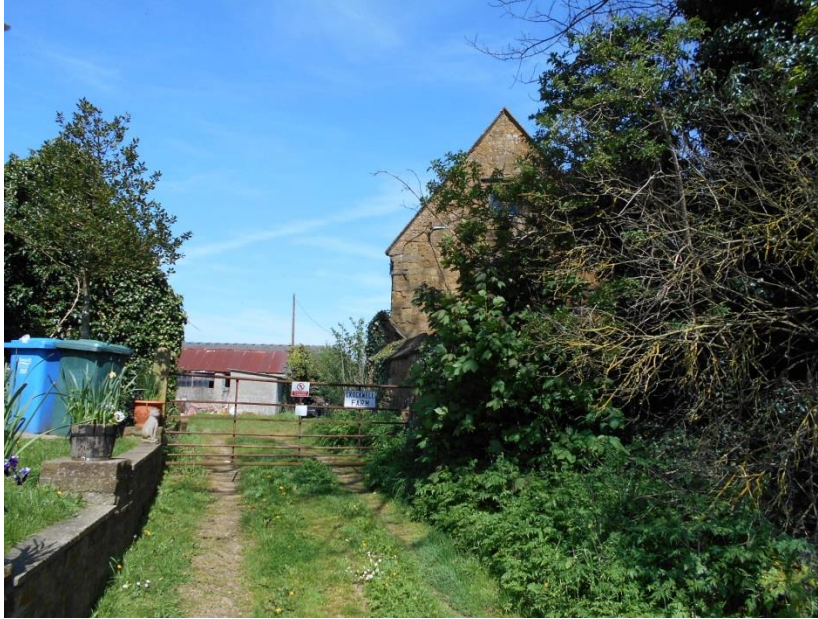
There is very little public view of the farmyard or the listed farmhouse, both glimpsed through the farmyard gate on Manor Road, or from a distance from a public footpath to the north-west. Both views are of overgrown dereliction and ruin as the frame for the listed building.

Fig 18: The public view of the listed farmhouse (right) and farmyard from Manor Road; a glimpse of Buildings 7 and 8 through the gate. The ivy-clad gable to the left is Building 1.

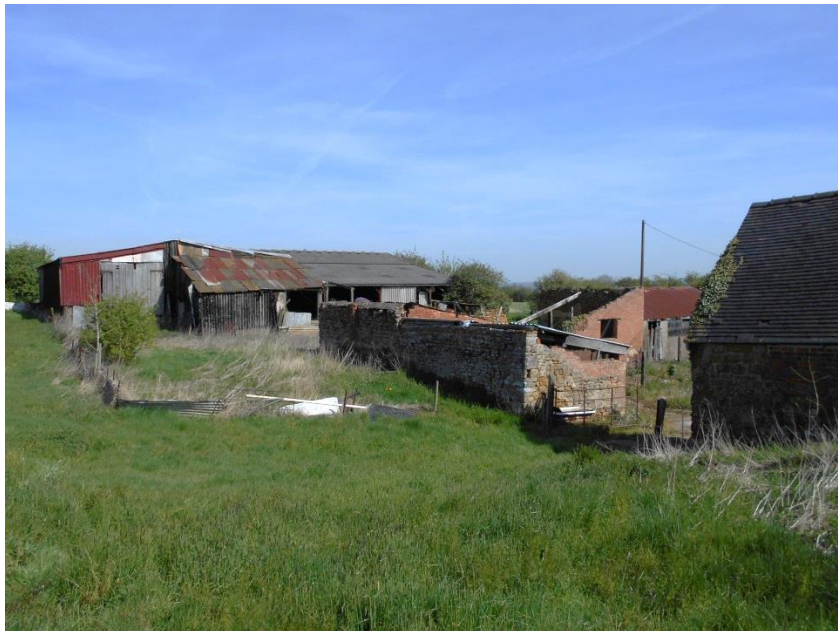
Fig 19: The public view of the farmyard from a footpath to the south-west; Building 5 is in the centre, Building 9 to the left; Building 4 to the right blocks views of the farmhouse.
