Gladman Developments Ltd

Land to the West of White Post Road, Banbury

Arboricultural Assessment

April 2016

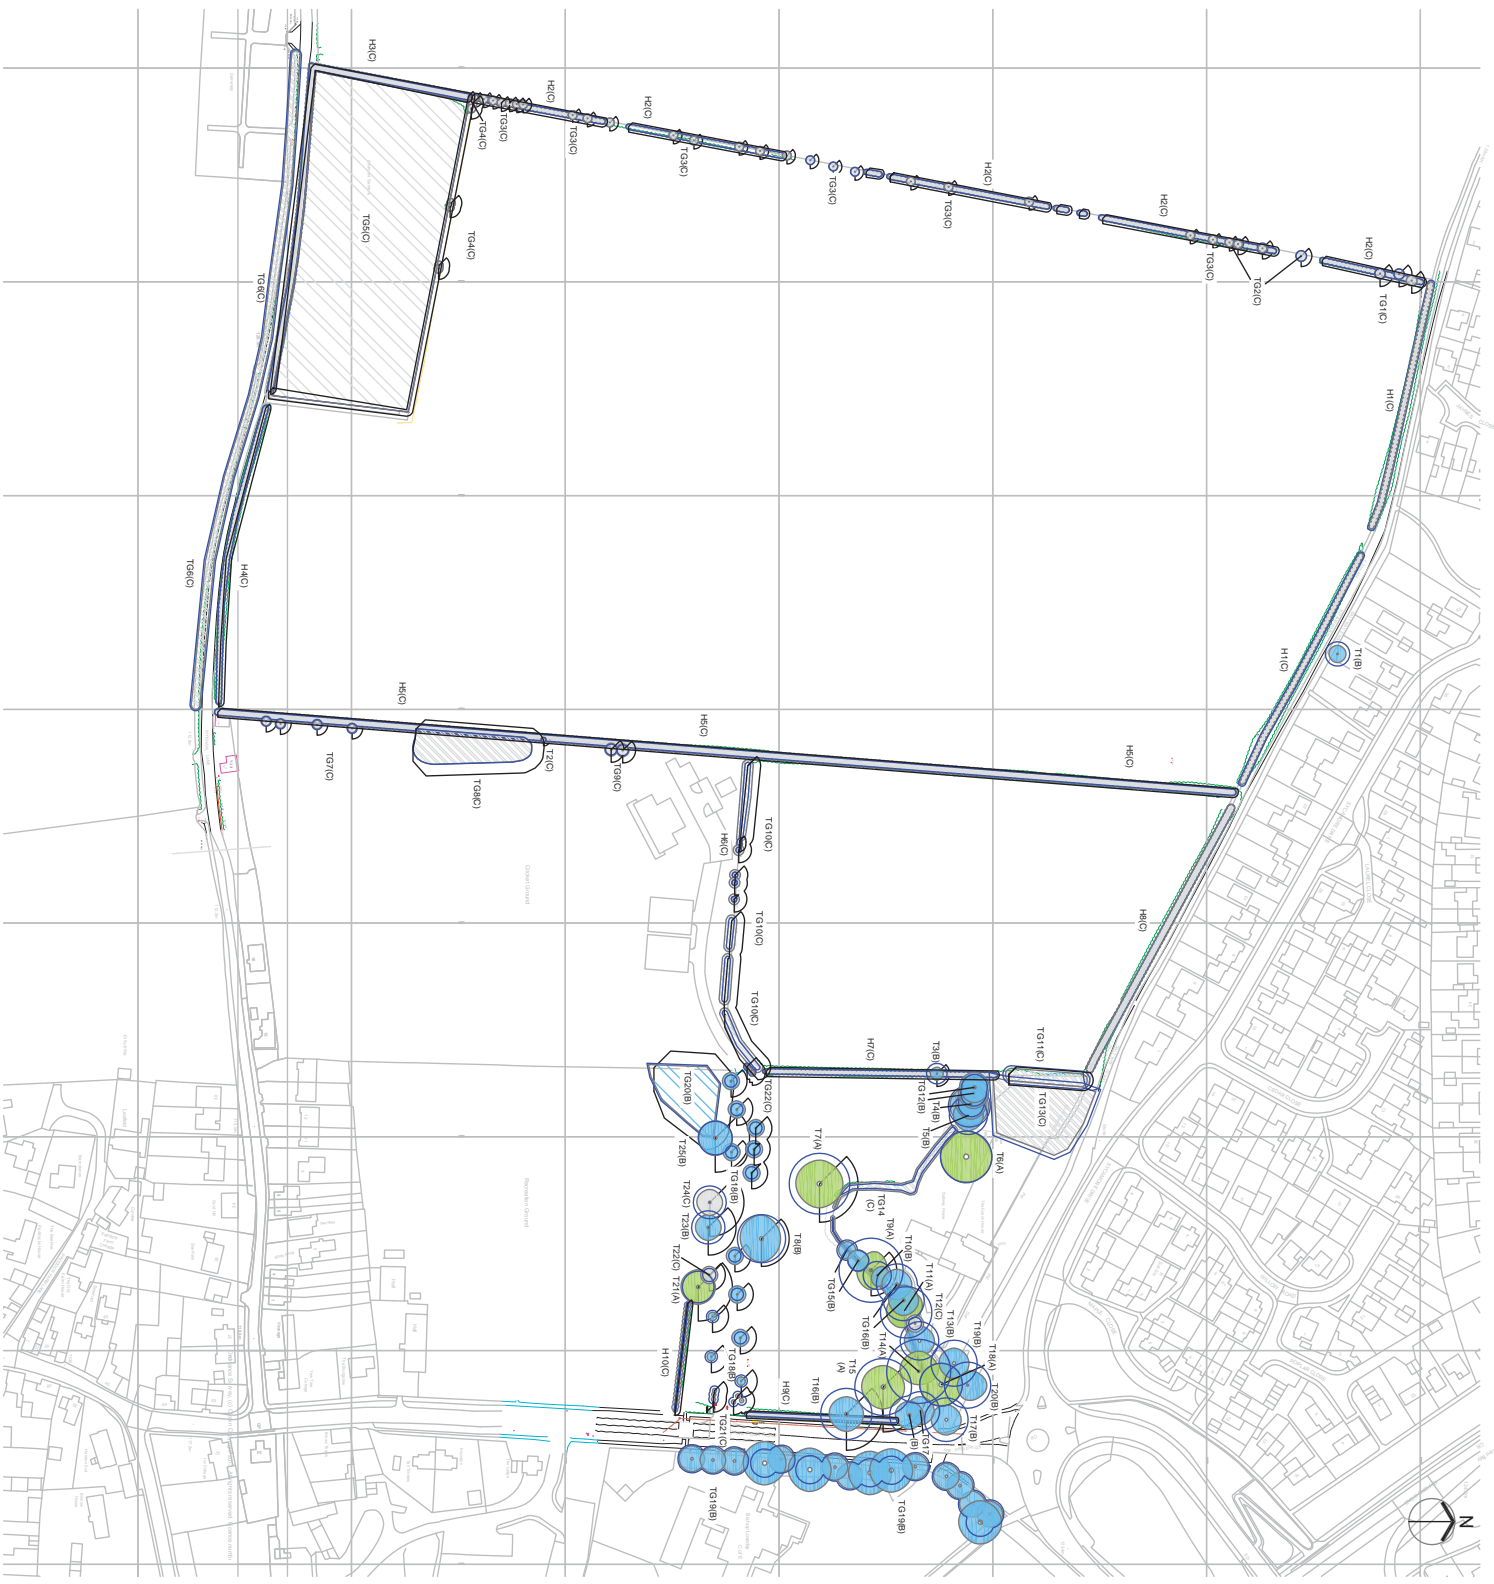
Figure 2: Tree Survey Plan (5773-A-02)

- 2.13 The individual positions of trees and groups have been shown on the Tree Survey Plan, Figure 2 (drawing no. 5773-A-02). The positions of trees are based on a topographical / land survey, as far as possible, supplied by the client. The crown spread, root protection area and shade pattern (where appropriate) are indicated on this plan.

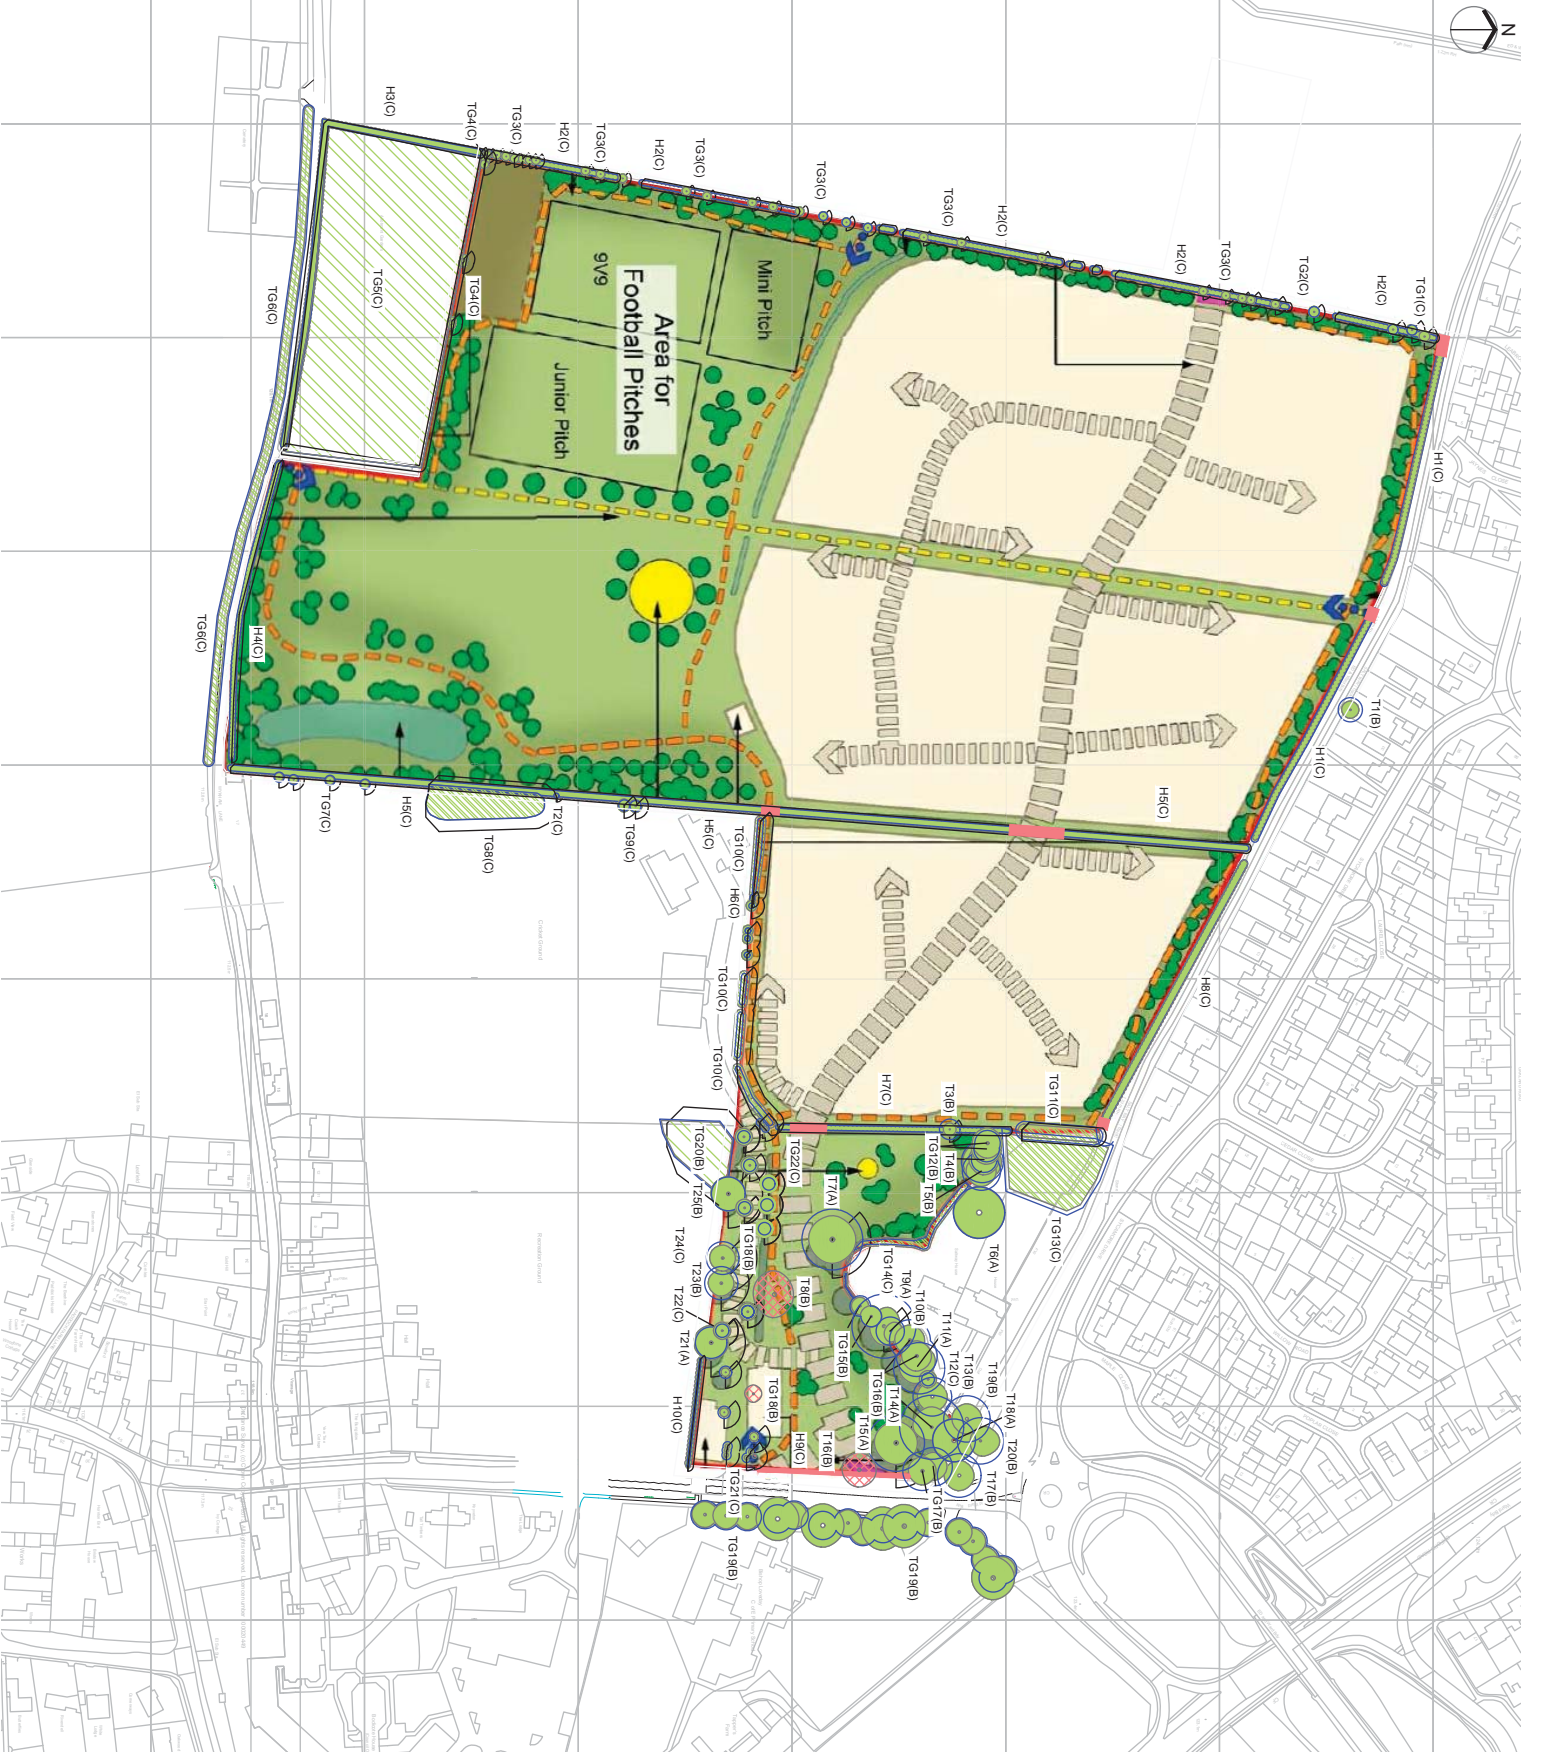
Project Title: TREE RETENTION PLAN
Figure 3

- 2.14 As part of the Arboricultural Impact Assessment, an updated Tree Retention Plan, Figure 3 (drawing no. 5773-A-03 Rev A) has been prepared to show the proposed layout in relation to the existing tree cover allowing an assessment of any potential conflicts. The plan also identifies which trees that are to be removed or retained as part of the proposed development and also trees considered unsuitable for retention through the assessment process (Category U).

- 4.5 An overlay of the above layout has been incorporated in the Tree Retention Plan (Figure 3) to assist in identifying potential conflicts with the existing trees.
