Gladman Developments Ltd

Land to the West of White Post Road, Banbury

Arboricultural Assessment

April 2016

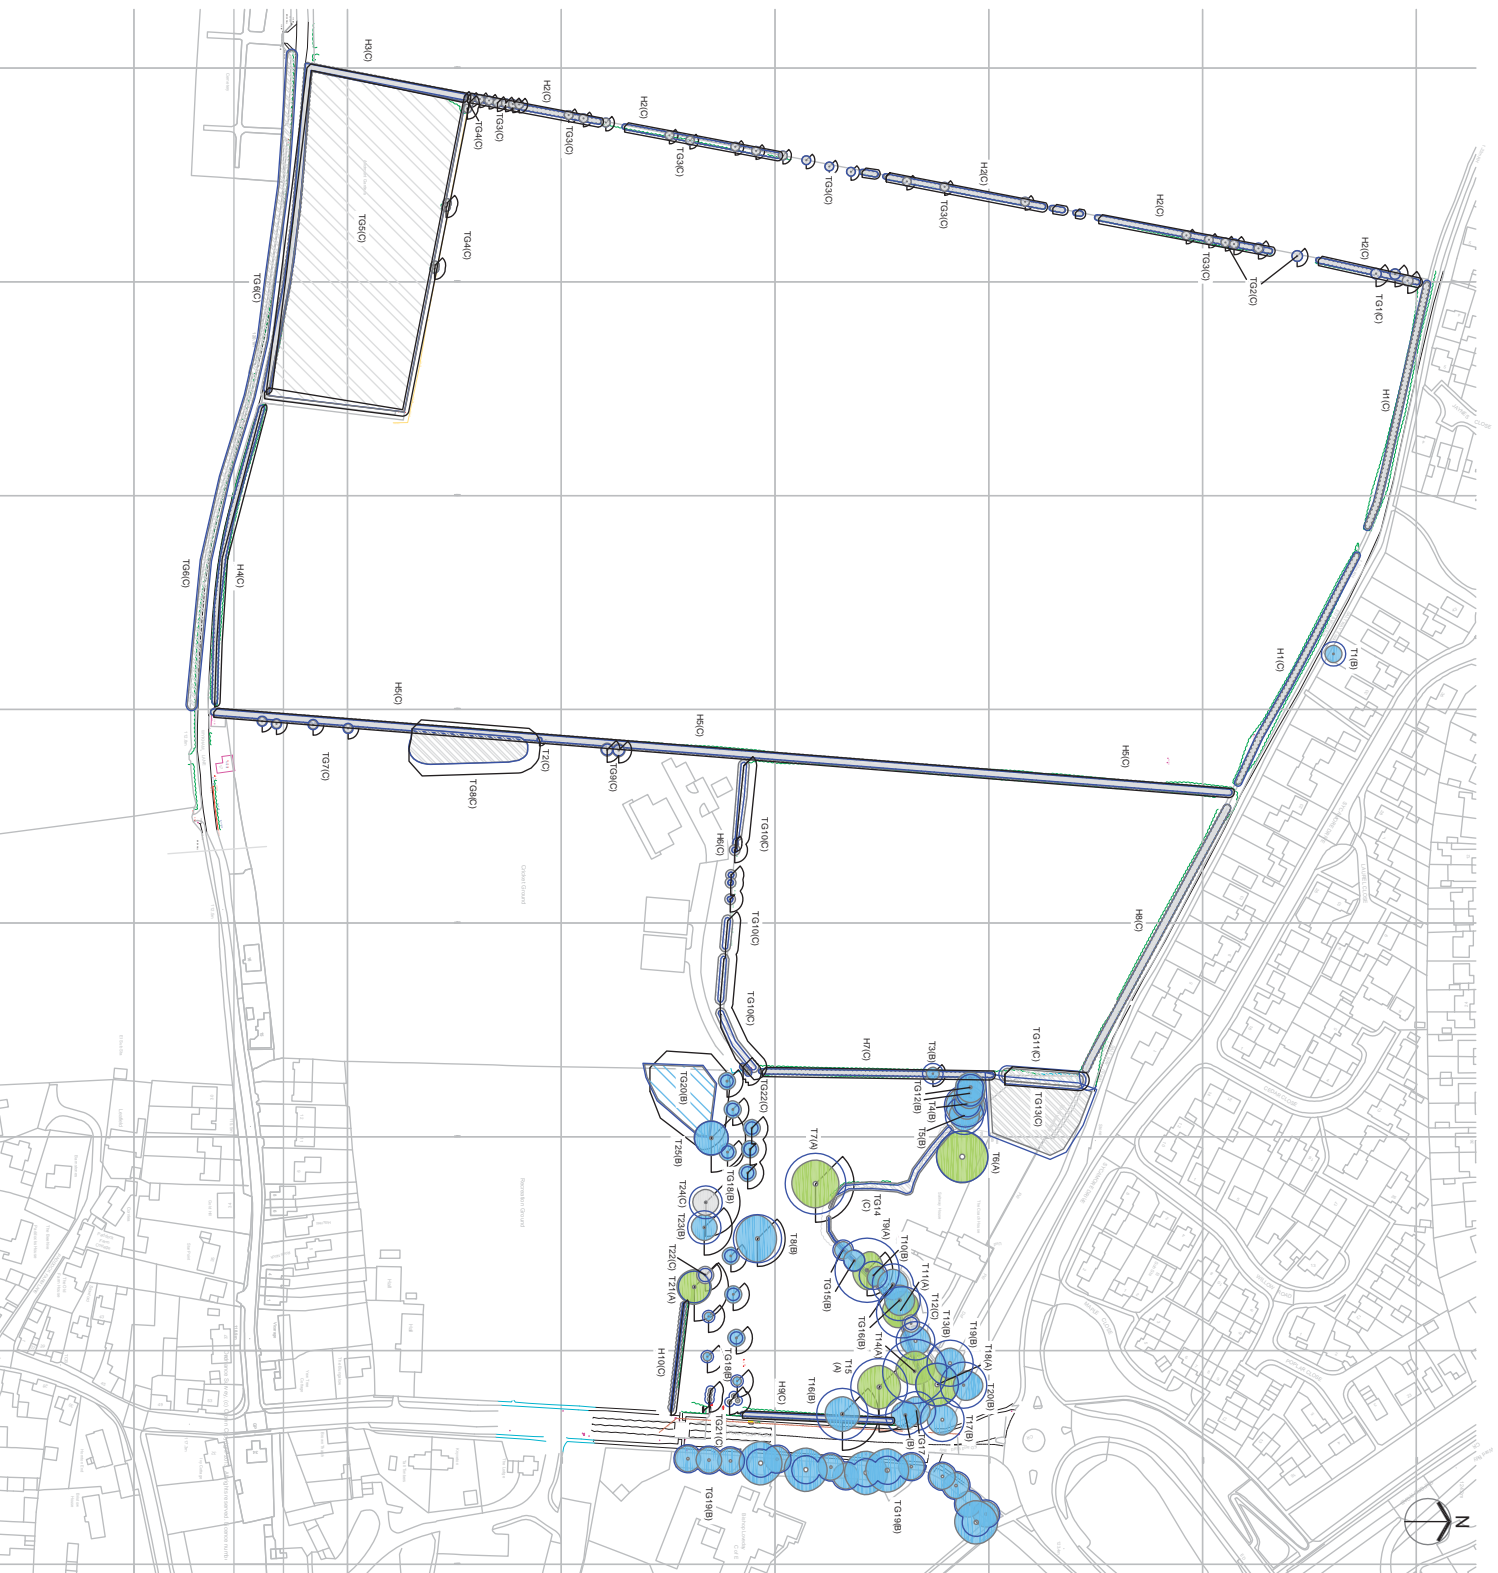
FIGURE 2

- 2.13 The individual positions of trees and groups have been shown on the Tree Survey Plan, Figure 2 (drawing no. 5773-A-02). The positions of trees are based on a topographical / land survey, as far as possible, supplied by the client. The crown spread, root protection area and shade pattern (where appropriate) are indicated on this plan.

3.1 A total of twenty-five individual trees, twenty two groups of trees and ten hedgerows were surveyed as part of the arboricultural assessment. Trees were surveyed as individual trees and groups / blocks of trees where examples are clearly present as such per the description. Refer to Figure 2 – Tree Survey Plan (drawing no. 5773-A-02) and Appendix A – Tree Schedule for full details of the trees included in this assessment. The table below summarises the trees assessed. Several of the trees have been discussed in more detail following the table, owing to their physical condition or arboricultural significance.

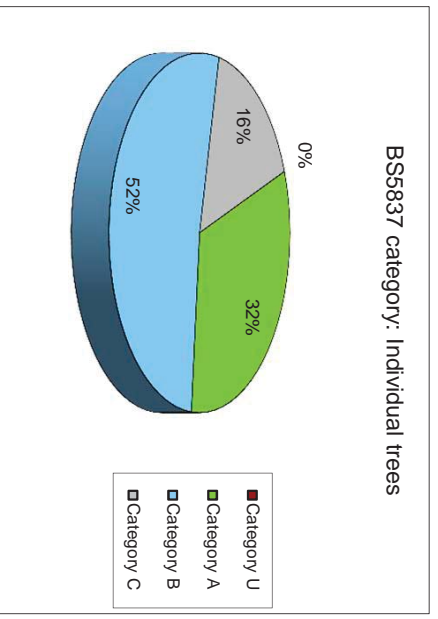
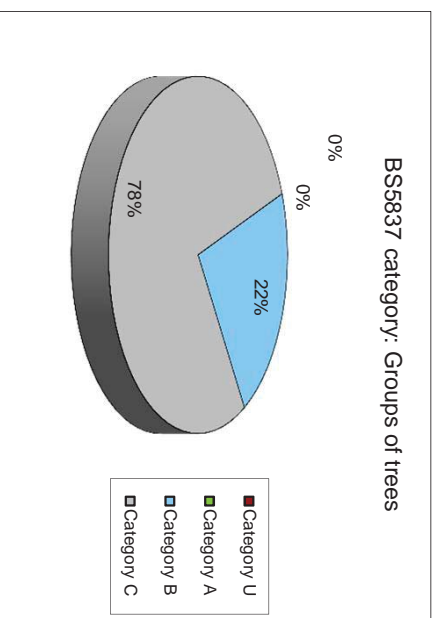
Tree No	Species	Height	Stem Dia.	Crown Radius	Age Class	Overall Condition	Structural Condition	RPA	RPA Radius	BS5837 Cat
INDIVIDUAL TREES										
T1	Field Maple Acer campestre	12	180	4	EM	G	Situated within residential gardens Typical species form with no major defects	103	5.7	B (i)
T2	Horse Chestnut Aesculus hippocastanum	3	est 100	1	Y	F	Situated within H5 hedgerow Minor deadwood	5	1.2	C (i)
T3	English Holly Ilex aquifolium	6	est 400	3	M	G	Dense canopy typical characteristic of species Previously maintained as a shrub with a tidy appearance. No major defects.	72	4.8	B (i)
T4	Common Ash Fraxinus excelsior	13	430 660 230	9	M	G	Multiple stem union situated at 1.2m above ground. Dense ivy covering 6 - 7m of the tree stem, which prevented a thorough assessment Minor deadwood evident within the crown	305	9.8	B (i)
T5	Common Beech Fagus sylvatica	10	440 480 350	7	M	G	Fall damage evident on lower half of the southern canopy Stubs had resulted from flail damage Few areas of major deadwood Suppressed canopy forms from the present of competing trees Interlocking branches within canopy and against T4	247	8.9	B (i)

T6	English Oak Quercus robur	25	est 1000	12	M	G	Multiple stem union forming at approximately 5m above ground. High canopy forming at approximately 13m Situated within a residential garden and therefore I was unable to gain access	452	12.0	A (i)
T7	English Oak Quercus robur	18	1180	11	M	F	Lower branch removals to raise height of crown to 3m above ground Minor deadwood evident sporadically spread across crown Two torn branches on the south side of the tree's canopy Increment split on major branch, facing east Stubs from past pruning operations Black spots on increment split Major deadwood in lower crown Bark wounds evident on the stem and the canopy Exposed roots resulting from poaching of the soil with damage observed	630	14.2	A (i)

Tree No	Species	Height	Stem Dia.	Crown Radius	Age Class	Overall Condition	Structural Condition	RPA	RPA Radius	BS5837 Cat
T8	Horse Chestnut <i>Aesculus hippocastanum</i>	13	940	N - 9 S - 10 E - 11 W - 11	M	P	Major deadwood evident 5m large split on major limb forming a potential hazard beam Exposed wounds and bark necrosis on the stem; most prevalent in the lowest 2m Low canopy in places Soil poaching near the roots has occurred that has resulted in exposure Bleeding canker <i>Pseudomonas syringae</i> pv. <i>aesculi</i> present	400	11.3	B (i)
T9	Holm Oak <i>Quercus ilex</i>	12	est 1250	N - 7 S - 7 E - 9 W - 9	M	G	Minor deadwood evident Dense canopy with a minor amount of interlocking branches Suppressed canopy by the competing trees TG15 and T10 Ivy covering up to 4m of the stem Situated offsite by 1m No major defects	707	Capped at 15m	A (i)
T10	Yew <i>Taxus baccata</i>	9	est 550	S - 3 5	M	G	Situated offsite by approximately 2m Ivy was covering the tree up to 5m Suppressed growth to the canopy caused by the close presence of T9	137	6.6	B (i)

T11	Common Lime <i>Tilia x europaea</i> 'Pallida'	25	est 1000	N.E - 6 9	M	G	Dense ivy covering the tree up to 13m above ground Good canopy form Minor deadwood Offsite by 2 - 3m Minor deadwood evident	452	12.0	A (i)
T12	Common Ash <i>Fraxinus excelsior</i>	13	est 250	4	SM	G	Positioned offsite by 1.5m Ivy covering the tree at 9m above ground Suppressed canopy caused by T11 and T13	28	3.0	C (i)
T13	Common Ash <i>Fraxinus excelsior</i>	18	est 750	7	M	G	Positioned offsite by approximately 2m Stem bifurcates at 5m Minor deadwood evident Ground clearance of 3m No major defects	254	9.0	B (i)

Tree No	Species	Height	Stem Dia.	Crown Radius	Age Class	Overall Condition	Structural Condition	RPA	RPA Radius	BS5837 Cat
T14	Copper Beech Fagus sylvatica 'Purpurea'	22	1480	E - 6 9	M	G	Exposed roots on the east side caused by vehicular access Poached soil all round the tree Numerous bulges up to 1m Few areas of major deadwood Typical species form with no major defects	707	Capped at 15m	A (i)
T15	Common Beech Fagus sylvatica	21	1110	10	M	G	High proportion of major deadwood in the lower canopy; up to 5m long Small quantity of minor deadwood located sporadically throughout the crown Poached soil all round the tree Exposed and damaged roots on the west side of the tree caused by vehicular access Stubs in the lower half of the canopy from past pruning operations The ground clearance of the canopy was 3m	557	13.3	A (i)
T16	Common Lime Tilia x europaea 'Pallida'	17	est 1000	8	M	F	Major epicormic growth throughout the tree; typical for cultivar type Exposed and damaged roots on the west side due to vehicular access A very dense canopy with many interlocking branches Minor deadwood mostly on the west side	452	12.0	B (i)
