**St. George's Catholic Church,  
Round Close Road, Adderbury, Oxfordshire**

**Protected Species Survey Report**

**November 2015**

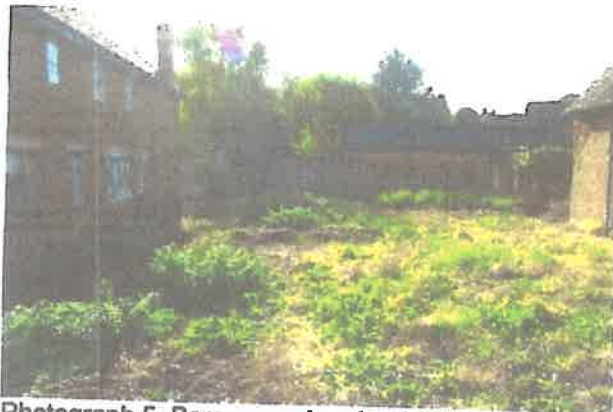
A number of snowberry *Symphoricarpos albus* saplings are present within an area of rubble to the south of the church. Young snowberry and young holly *Ilex aquifolium* shrubs were noted growing to the south-western corner of the church.

Photograph 5. Bare ground and ruderal vegetation.
