**CONTAMINATION HOTSPOT
REMOVAL VERIFICATION REPORT
FOR
CAULCOTT PARK,
LOWER HEYFORD ROAD,
CAULCOTT,
BICESTER
OXFORDSHIRE
FOR
DAVID SMITH**

**REPORT NO. SE1311C
JUNE 2016**

**CONTAMINATION HOTSPOT REMOVAL VERIFICATION REPORT FOR
CAULCOTT PARK, LOWER HEYFORD ROAD, CAULCOTT, BICESTER,
OXFORDSHIRE**

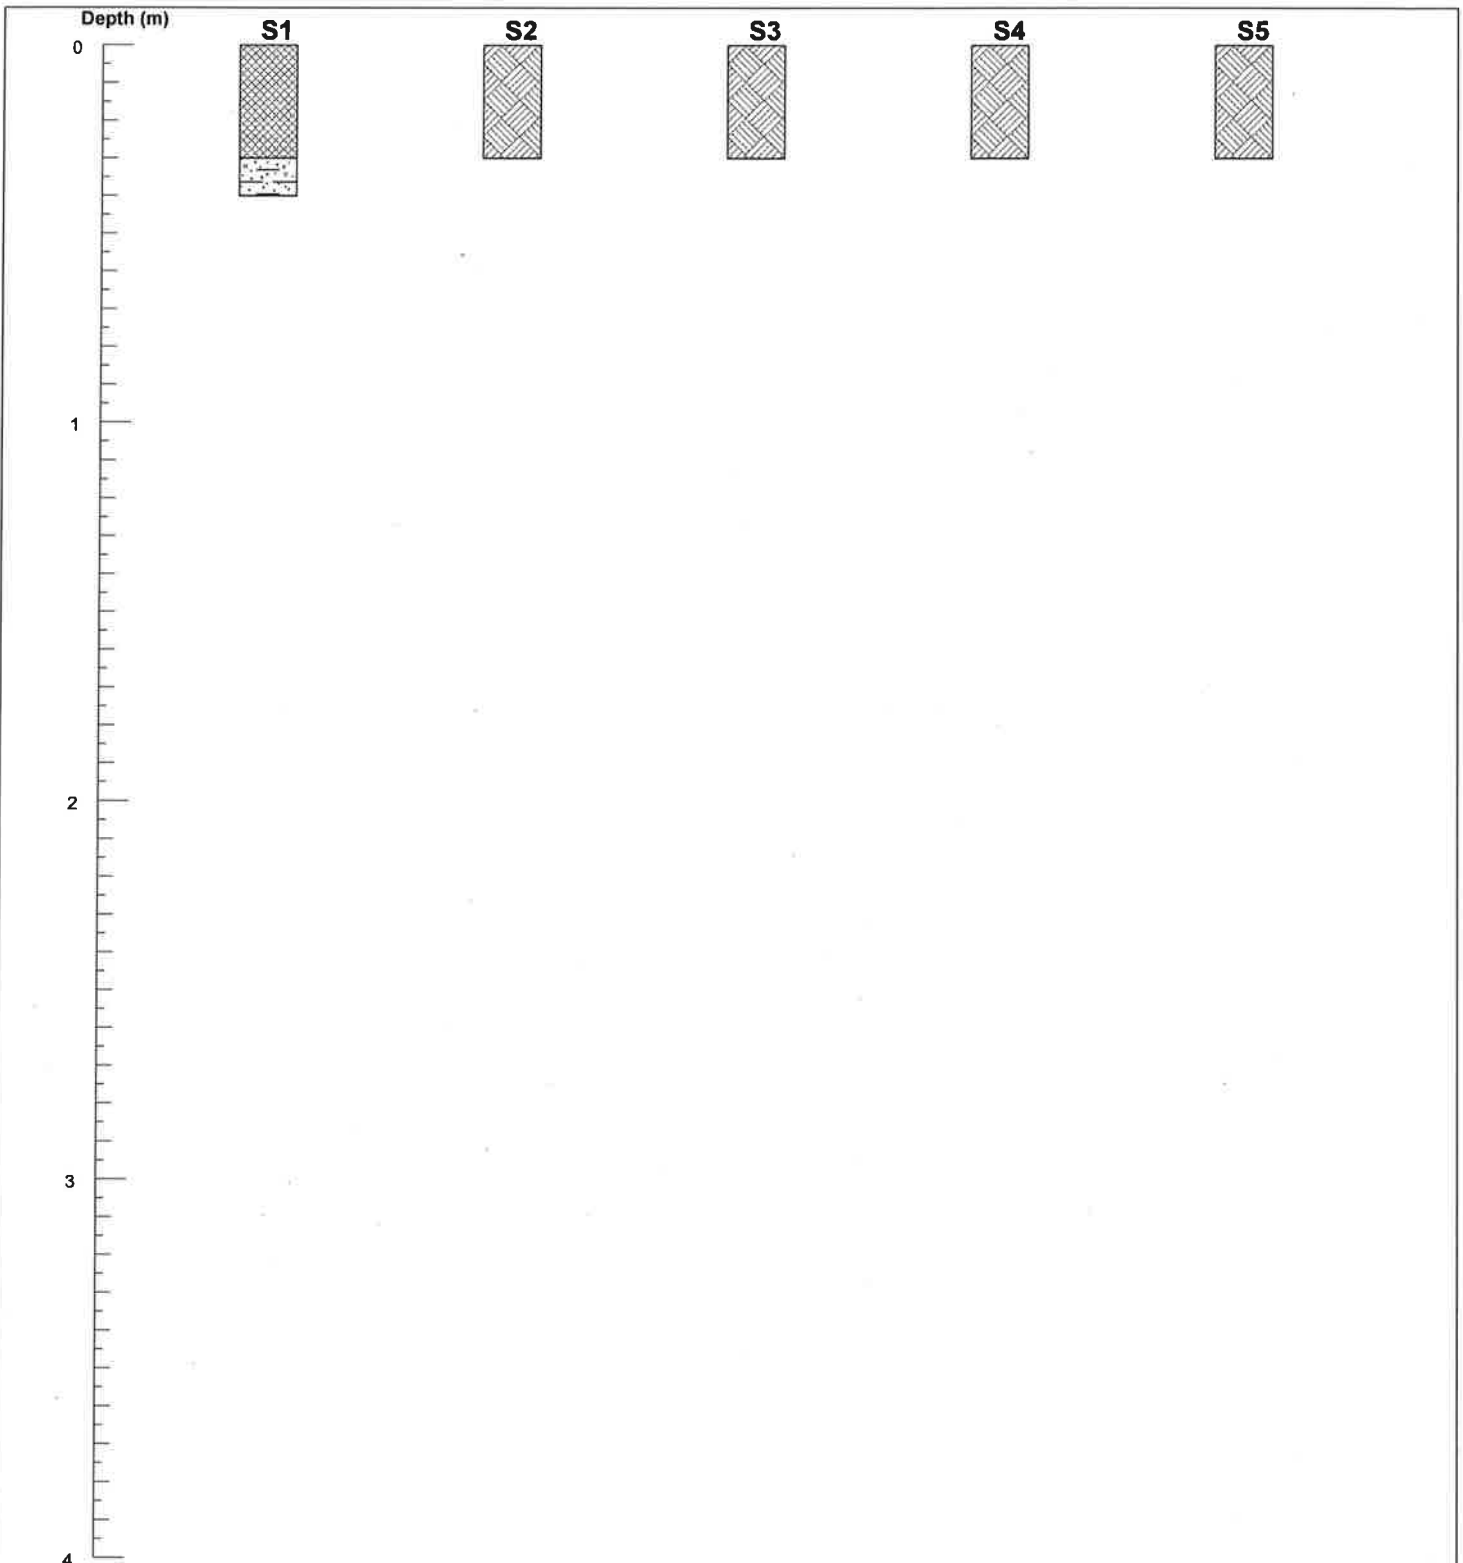
Plan 	Remarks A = 250ml amber glass jar		
	Scale (approx) 1:25	Logged By GM/SJ	Figure No. SE1311C.S4

Depth (m)	Sample / Tests	Water Depth (m)	Field Records	Level (mOD)	Depth (m) (Thickness)	Description	Legend	Water
0.10	A		22/04/2016:		(0.30) 0.30	TOPSOIL: grass over brown sandy slightly gravelly clay. Gravel is subrounded to subangular fine to coarse limestone. Complete at 0.30m

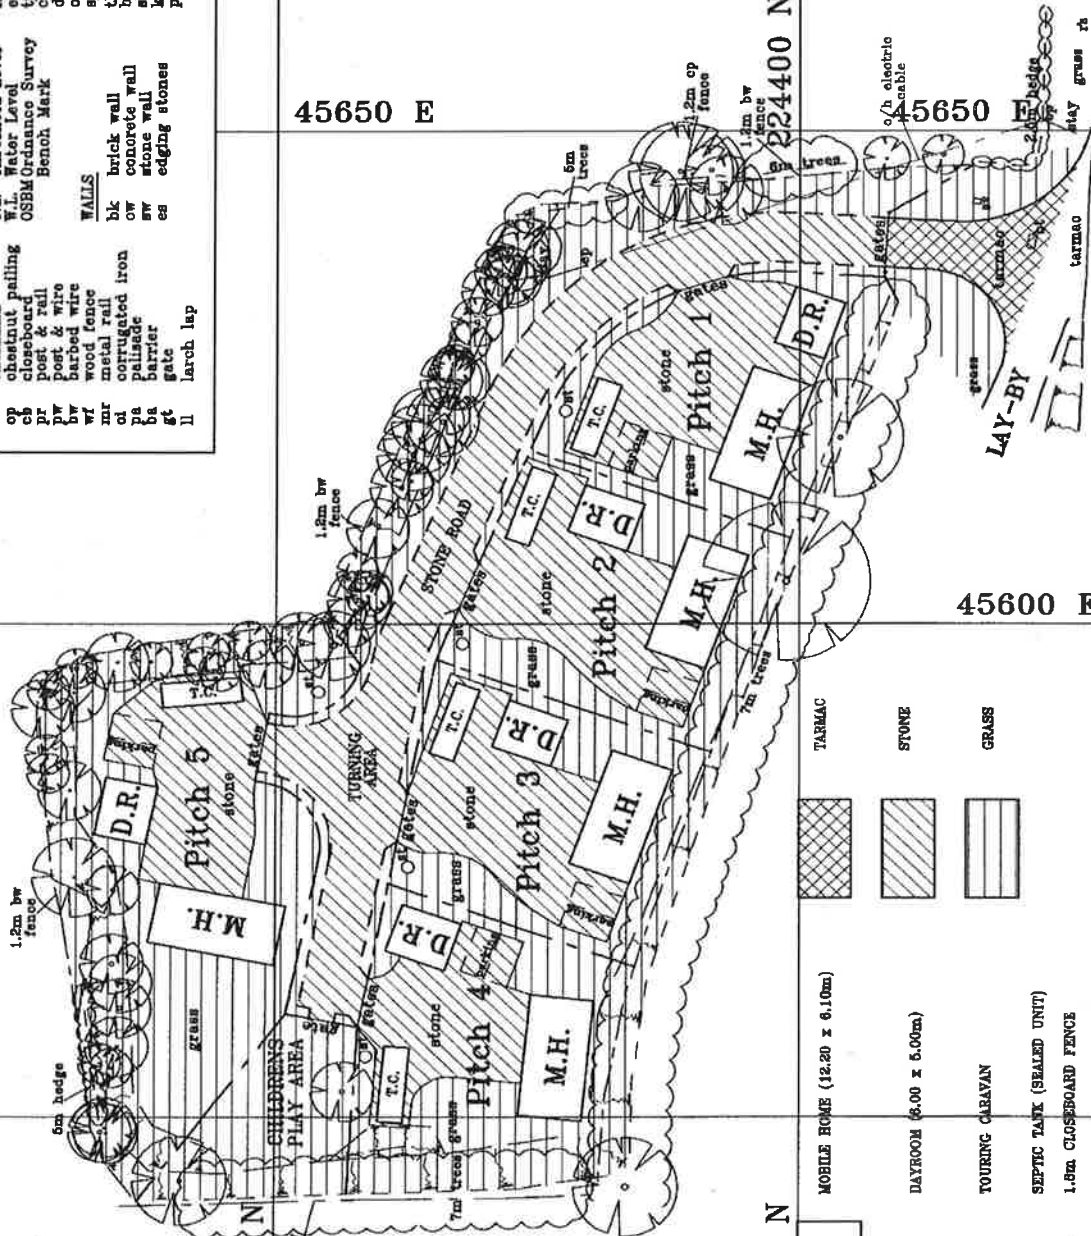
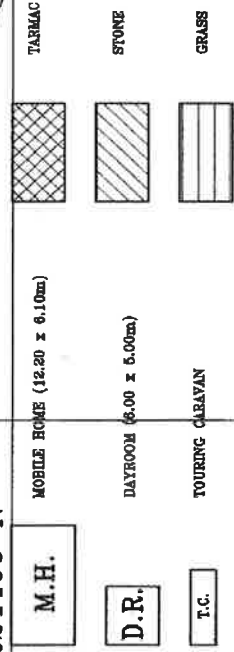
Job No. SE1311C
Site CAULCOTT PARK, LOWER HEYFORD ROAD, CAULCOTT, BICESTER, OXFORDSHIRE	Drawn By TP	Checked By	Scale -	Figure No. 3
Client DAVID SMITH

The purpose of the Verification Report is to document the removal of a contamination hotspot identified within the made ground during the Phase II ground investigation, as indicated on Figure 3.

A visual inspection was also undertaken in an area in the south west of the site, as indicated in Figure 3, where topsoil had been recently removed. There was no visual or olfactory evidence found of any contamination or potentially contaminative made ground being present.

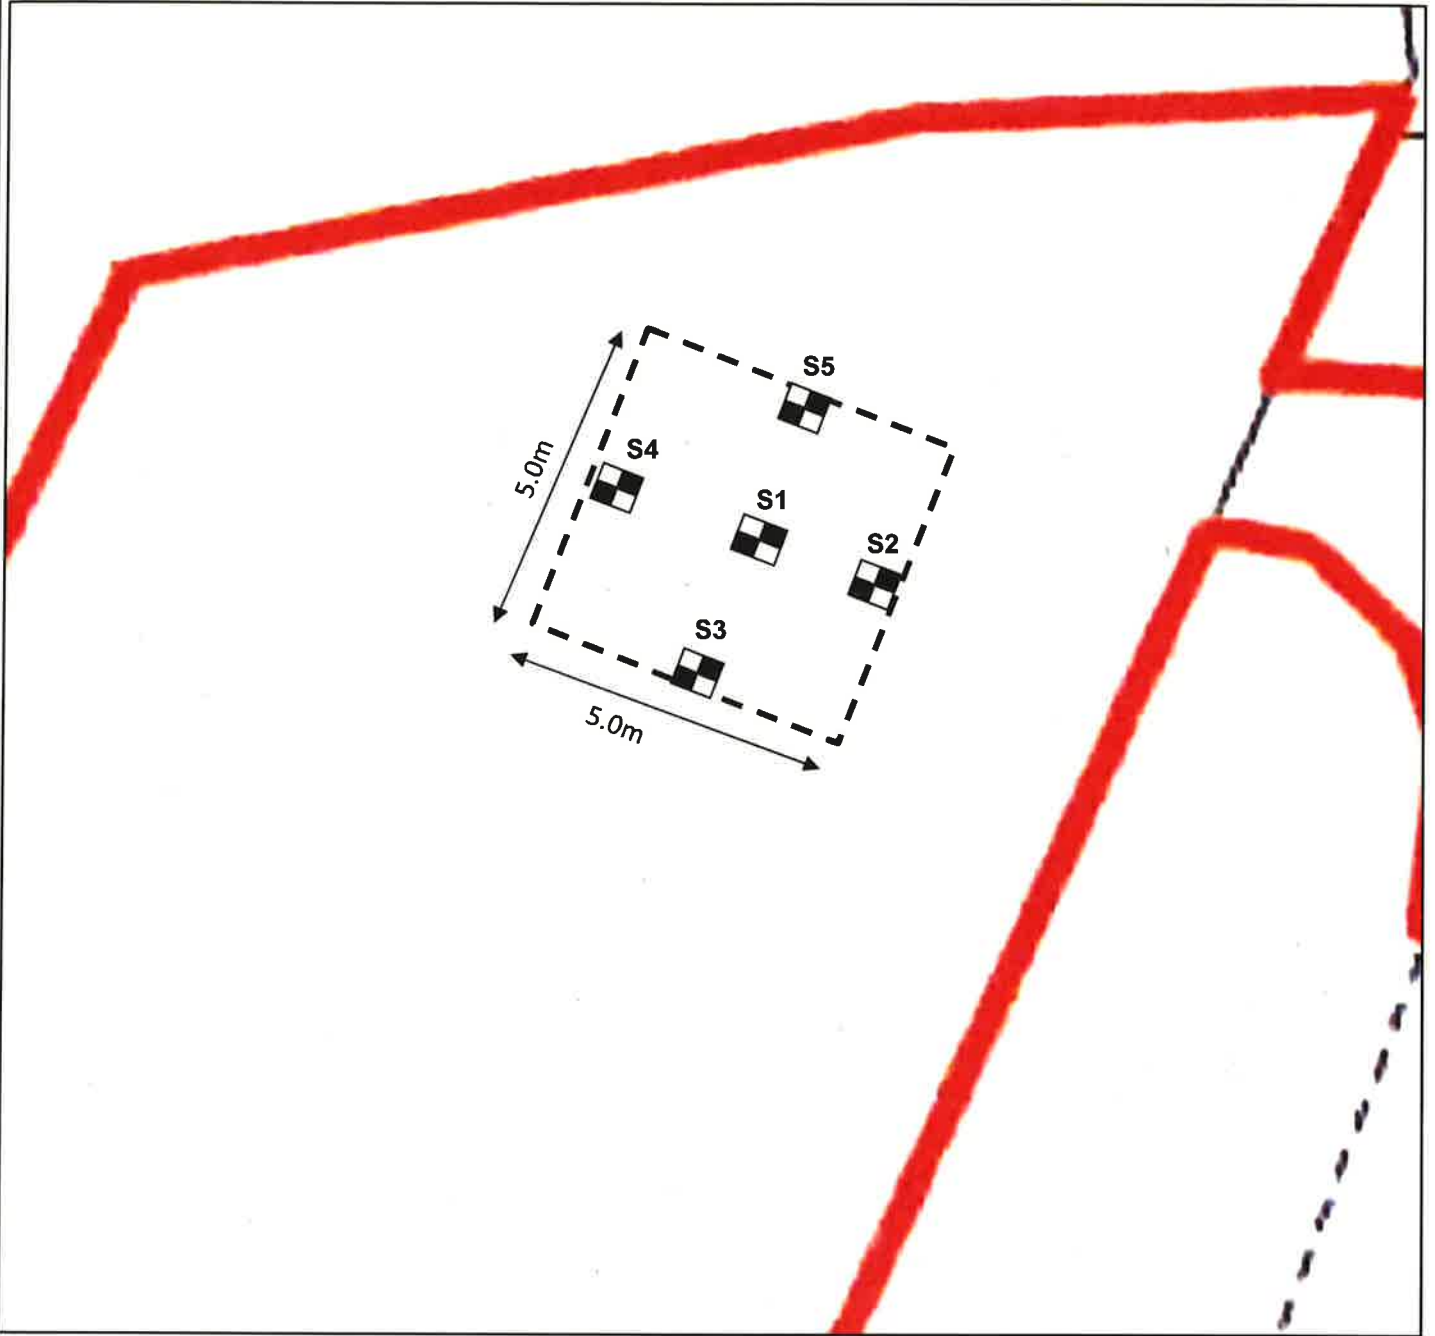
Work was undertaken on 22nd April 2016. A 5m square excavation was removed to a depth of 0.30m from the area surrounding M5. Samples were taken from the base and sides, as shown in Figure 4, and sent for PAH chemical contamination analysis. Excavation record sheets detailing the strata found at sampling locations are appended.
