Project name	Heyford Park - Proposed new primary school		
Design note title	Structural condition survey of existing hangers		
Document reference	04583-HYD-SCH-ZZ-RP-S-0001		
Author	R Bareham		
Revision	P01		
Date	22 September 2021	Approved	✓

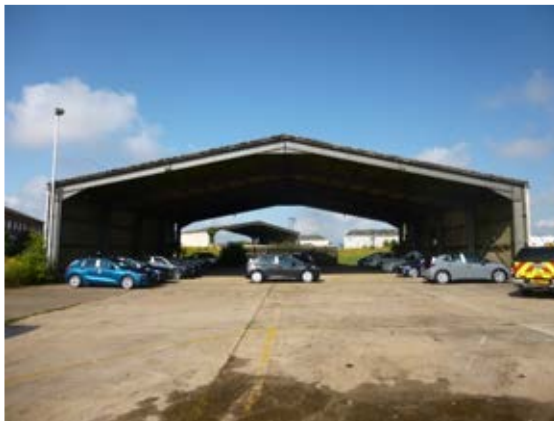
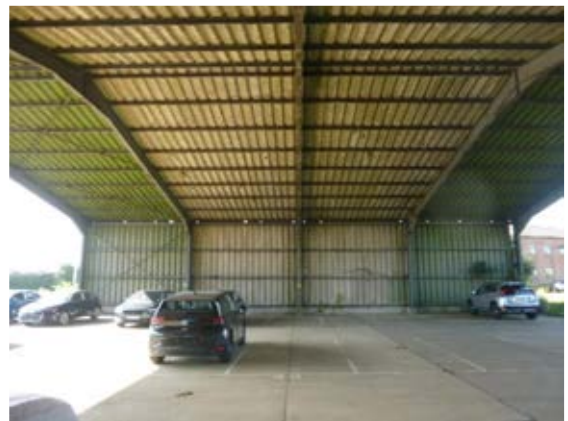
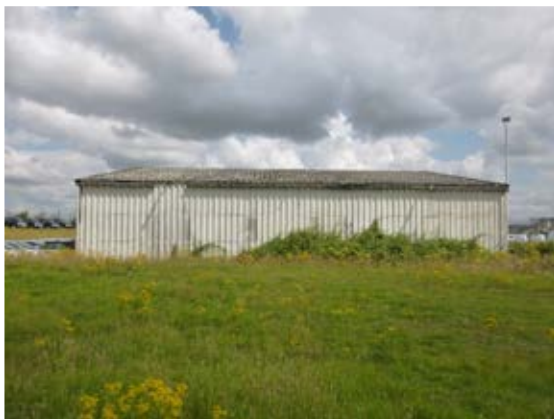
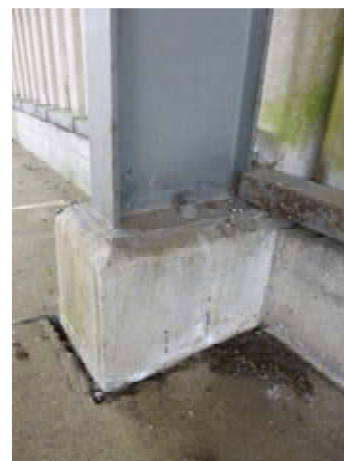
General arrangement pictures of the hangers given below.

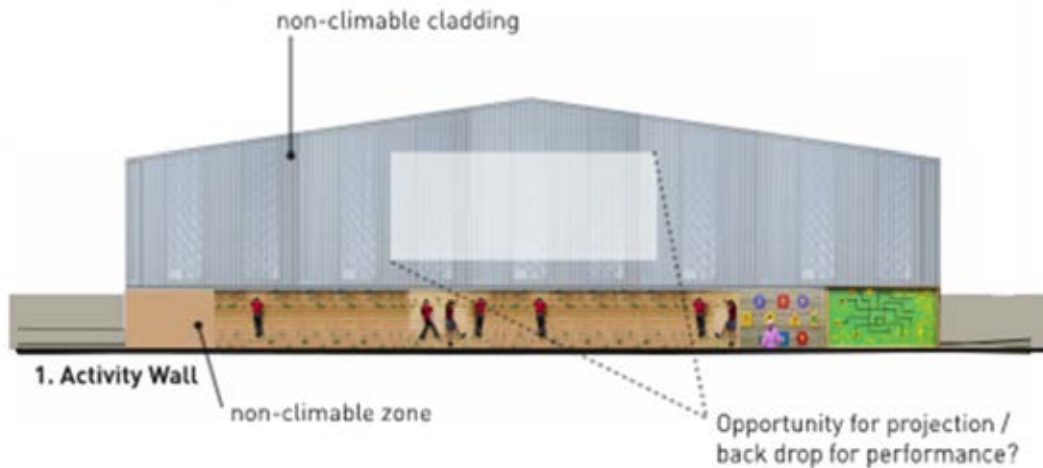
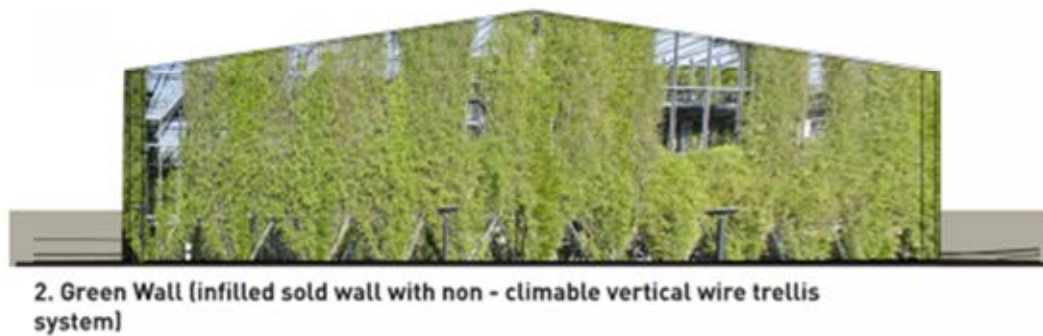
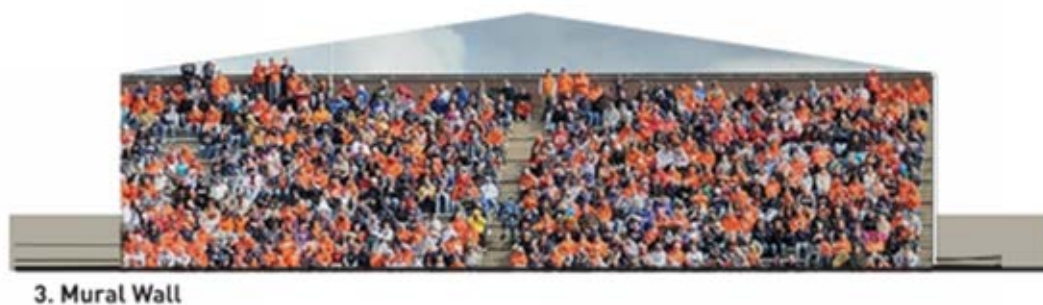
It is noted that three of the hangers have closing walls built across one end, as suggested architectural elevations below. This will cause increase in wind forces acting on the structure and increased bracing

will be required to supplement the existing structure to support them. With the back-analysis and careful contrivance of new structure this could be achieved quite efficiently making best use of the original structure.

Again, data on the existing foundations will be available to undertake checks to resist the resulting wind forces on the structure.
