## A Heritage Asset Survey of former farm buildings at Crockwell Farm, Great Bourton, Oxfordshire

Iain Soden BA MCIfA

May 2016

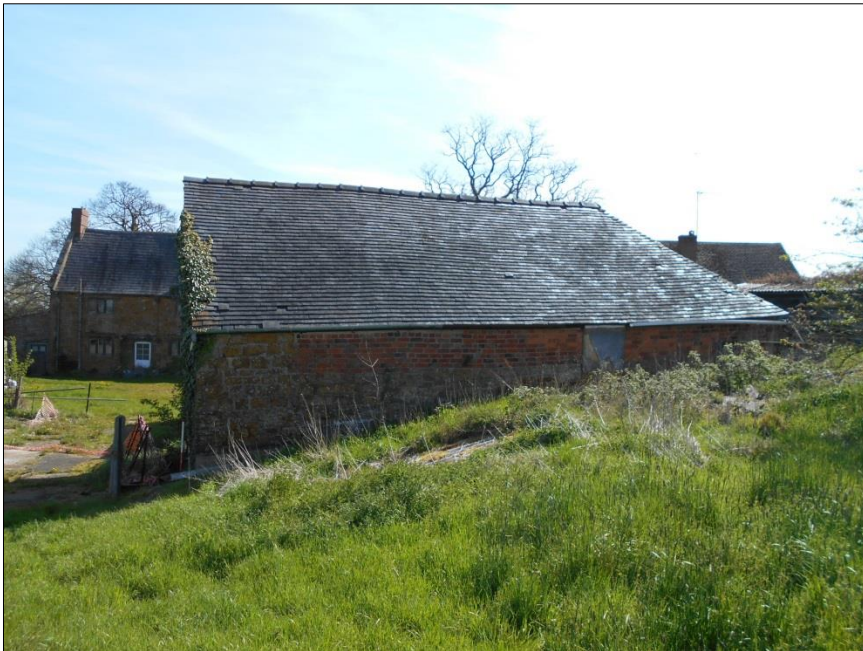
Formerly an open-fronted shed with rear and gable ends of Hornton ironstone ashlar, similar to the 17<sup>th</sup>-century farmhouse. One gable widened and heightened during its life. The east-facing front was filled-in with brick and the interior provided with pig-pens. A date scrawled into the wet concrete floor indicates this was in 1962. The roof is of machine-sawn pine in common with Buildings 1-2. The same blue engineering tiles cover it.

Fig 9: Building 4, looking east, farmhouse beyond; viewpoint is halfway to Building 11, adjacent to a footpath (at far right).
