David J Stewart Associates
 Chartered Architects
 Architects • Interior Design • Town Planning • Project Management
 Stable Barn
 Acacia Cottage
 South Side
 Steeple Aston
 Oxfordshire
 OX25 4RT
 T: 01295 267565
 E: djs@djsa.co.uk

2018-1014-GA02 **SERVICE MARKUP**

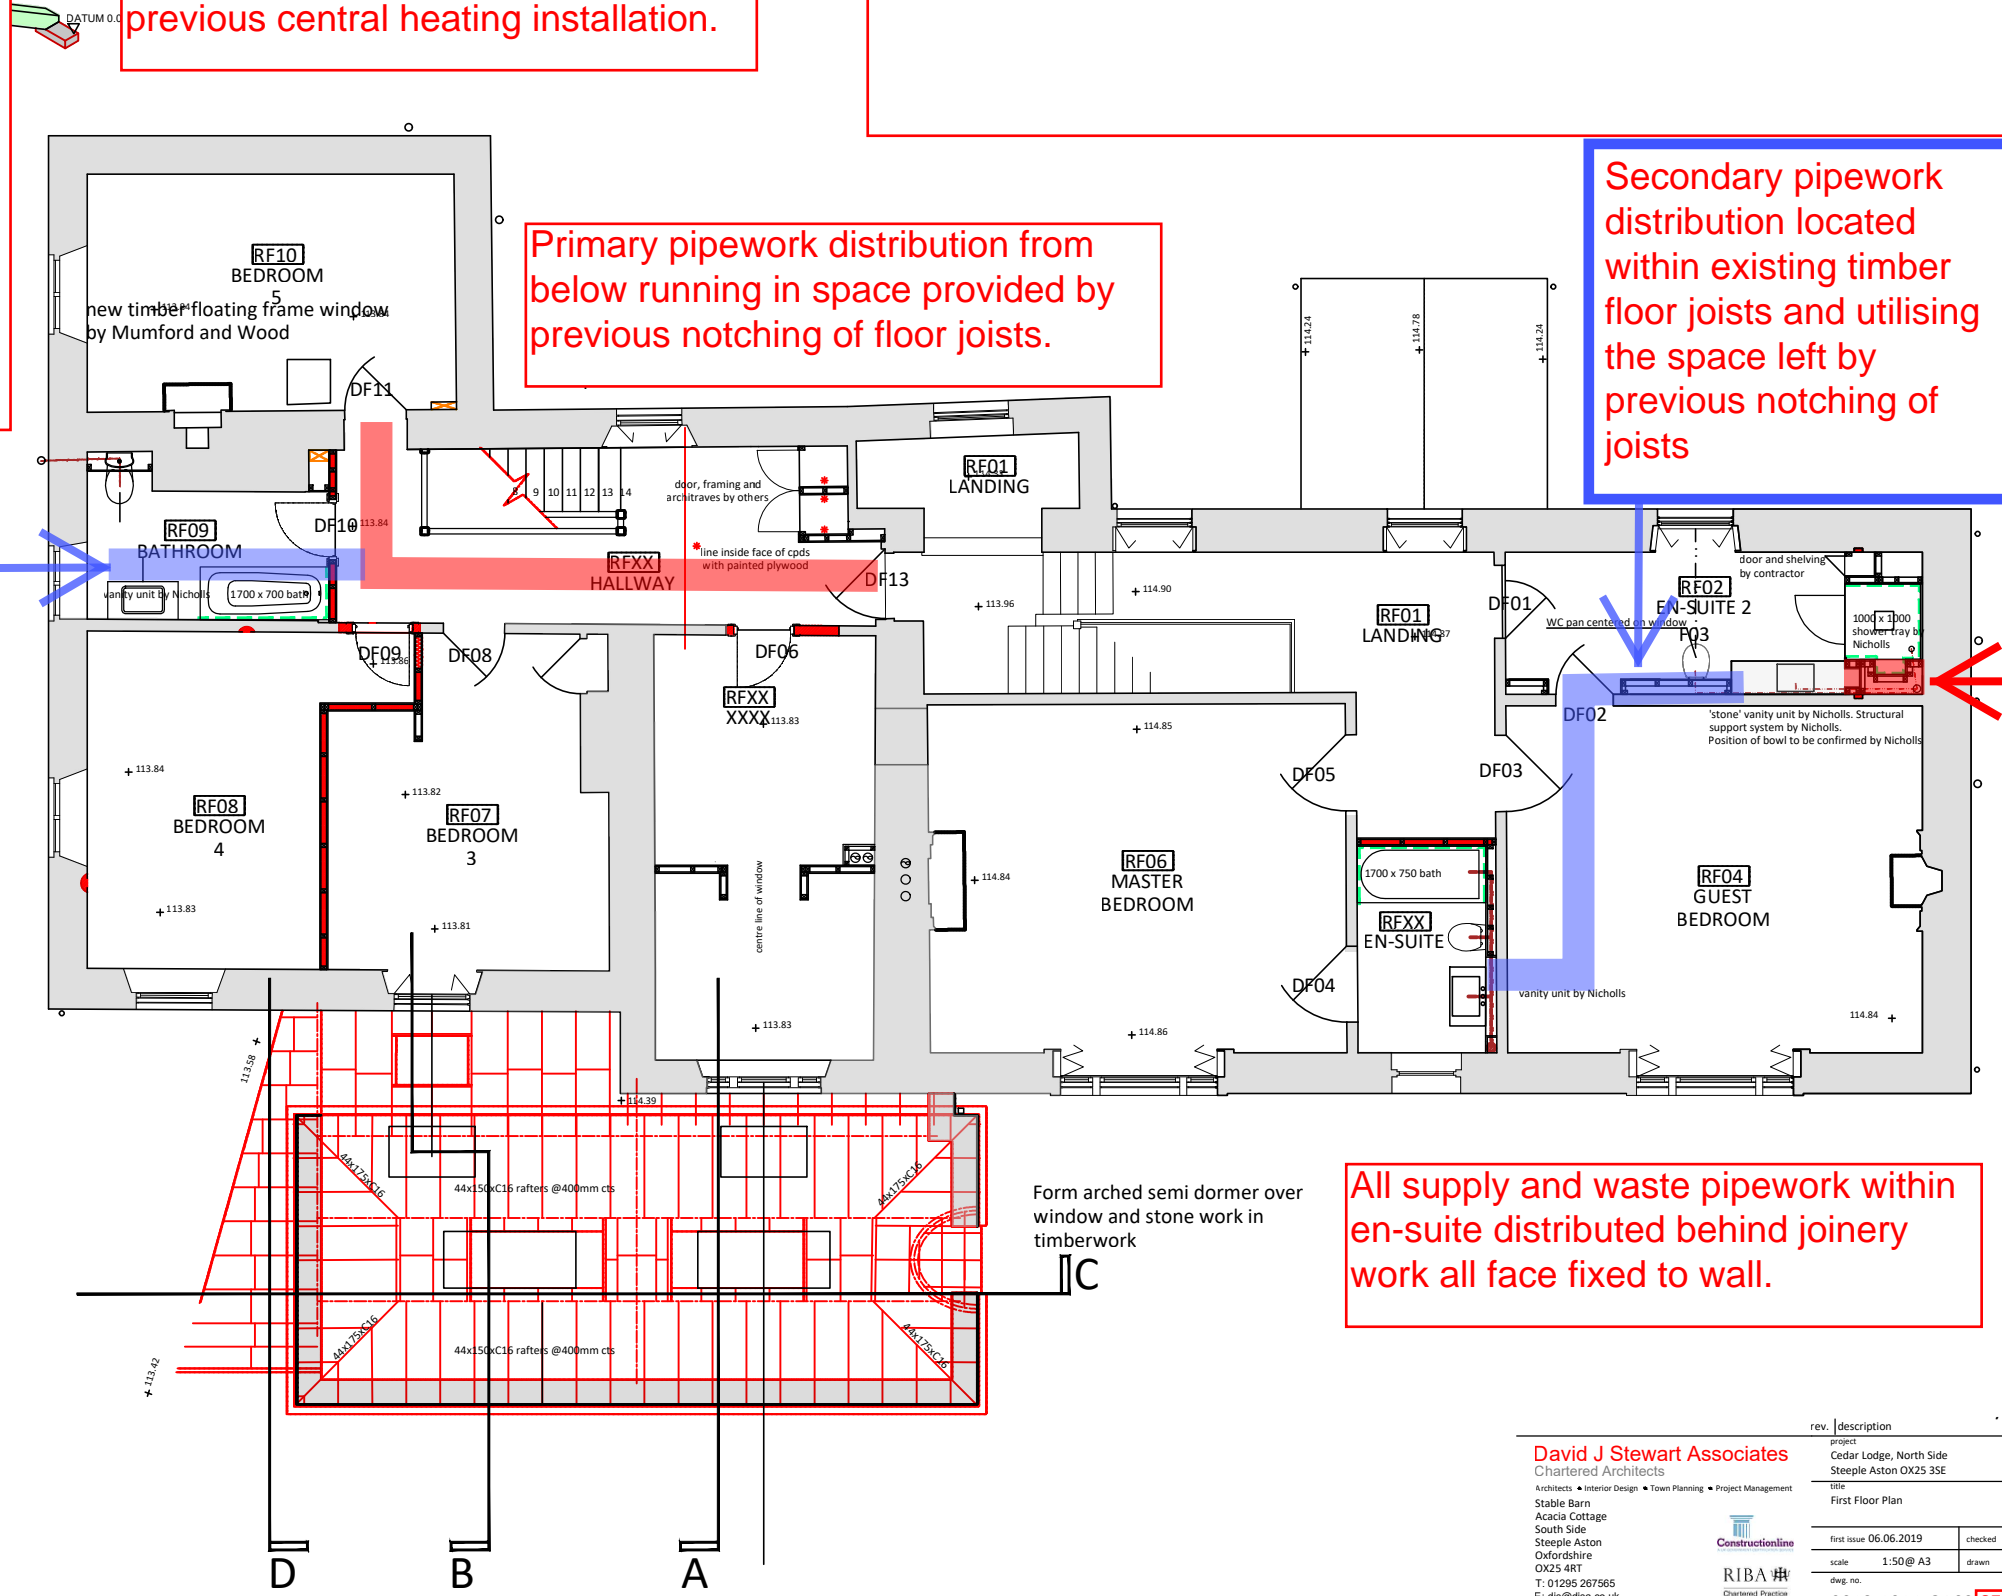
All secondary radiator pipework to occupy previously notched joists from previous central heating installation.

Vertical riser containing all distribution pipework from below and ventilation extract duct.
 Extract duct to continue vertically up into loft space and to terminate in a tile vent located in existing roof slates on the inside valley gutter side between the two roofs.

Primary pipework distribution from below running in space provided by previous notching of floor joists.

Secondary pipework distribution located within existing timber floor joists and utilising the space left by previous notching of joists

Secondary pipework distribution located within existing timber floor joists and utilising the space left by previous notching of joists that contained previous installation. Waste from sanitary appliances connected into existing external soil and vent pipes utilising existing holes within wall

All supply and waste pipework within en-suite distributed behind joinery work all face fixed to wall.
