## **Groundsure Geoinsight**

# Groundsure Geoinsight

Address: Ardley, Junction 10 M40, Oxfordshire, OX27 7SS,

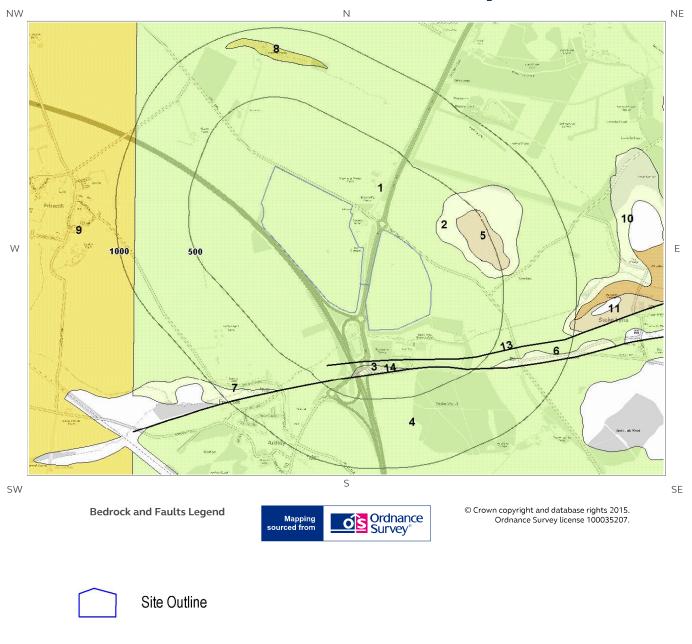
# 1.3 Bedrock and Faults Map

Distance (m)	Direction	Flow Type	Maximum Permeability	Minimum Permeability
0.0	On Site	Fracture	Very High	Very High
0.0	On Site	Fracture	Very High	Very High
