# heyford park

BUILDING APPRAISAL

ROGER EVANS ASSOCIATES LTD FOR NORTH OXFORDSHIRE CONSORTIUM LTD

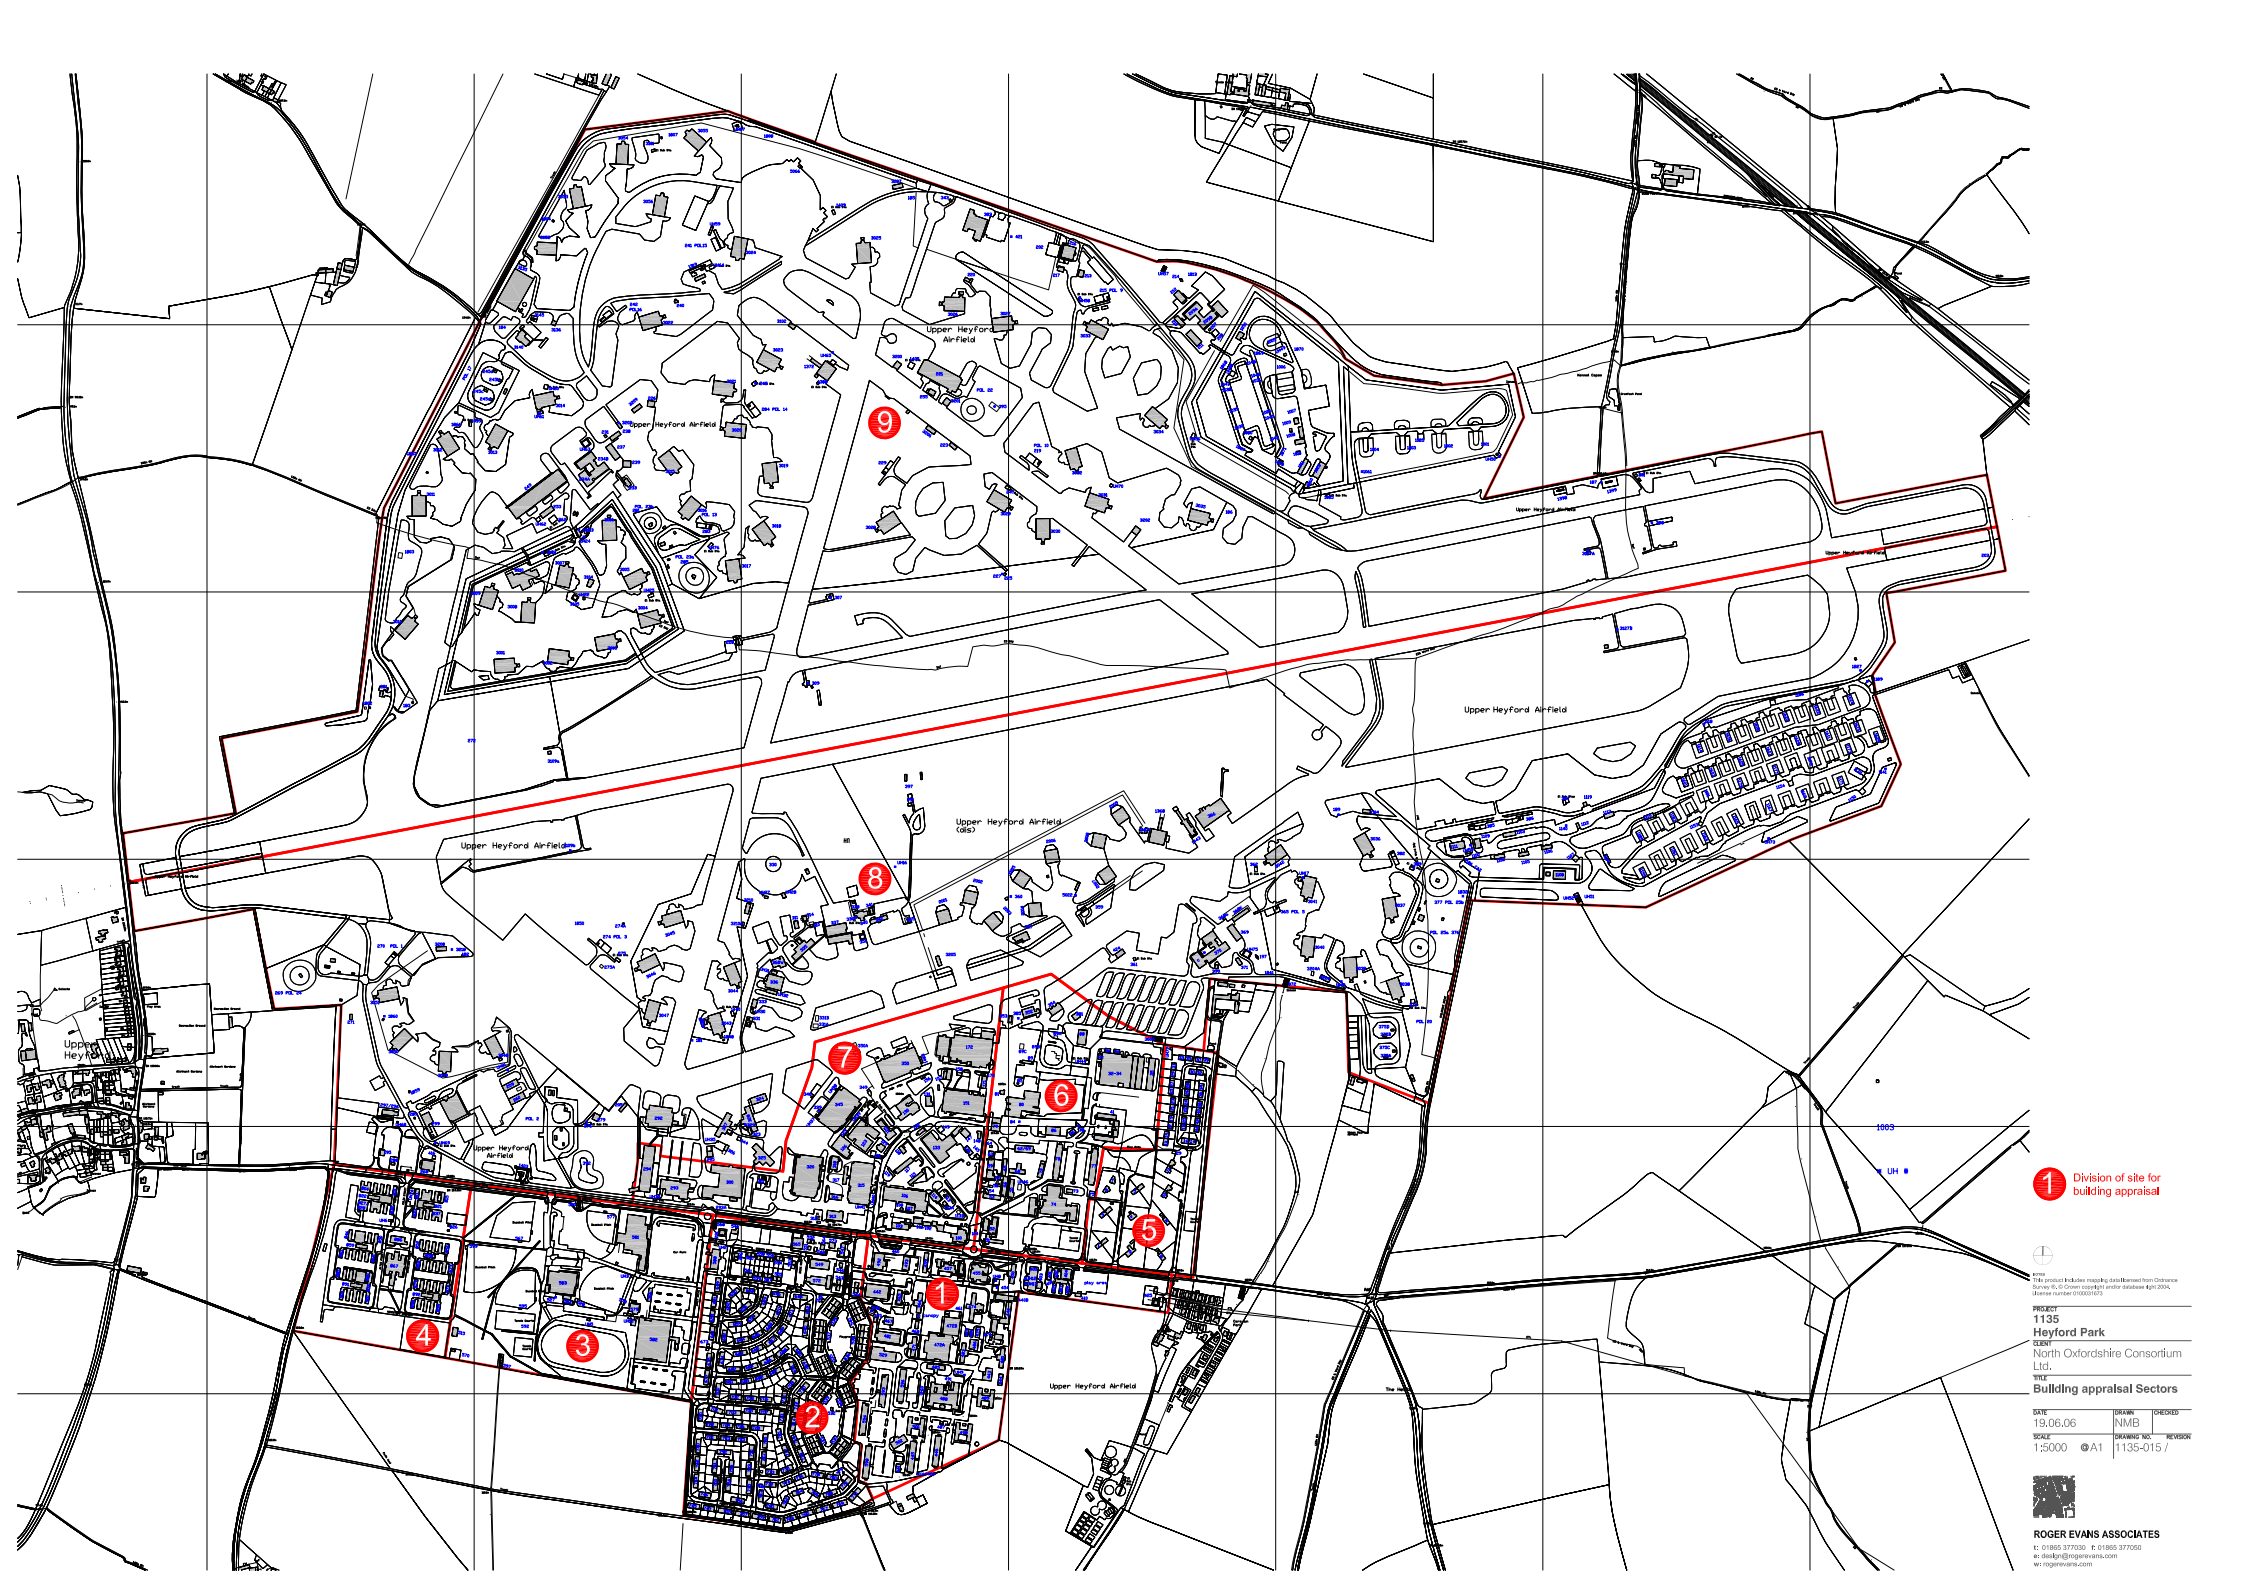
1 Division of site for building appraisal

Building appraisal Sectors
