Castle Street, Banbury

Flood Risk & Drainage Technical Note

Project No.	1260
Revision	B
Date	7 th December 2021
Client	Churchill Retirement Living
Prepared	L Blackmore
Checked	A Hanks
Authorised	C Yalden
File Ref.	P:\1260 Castle Street, Banbury\C Documents\Reports\1260 - Castle Street, Banbury - Flood Risk & Drainage Technical Note

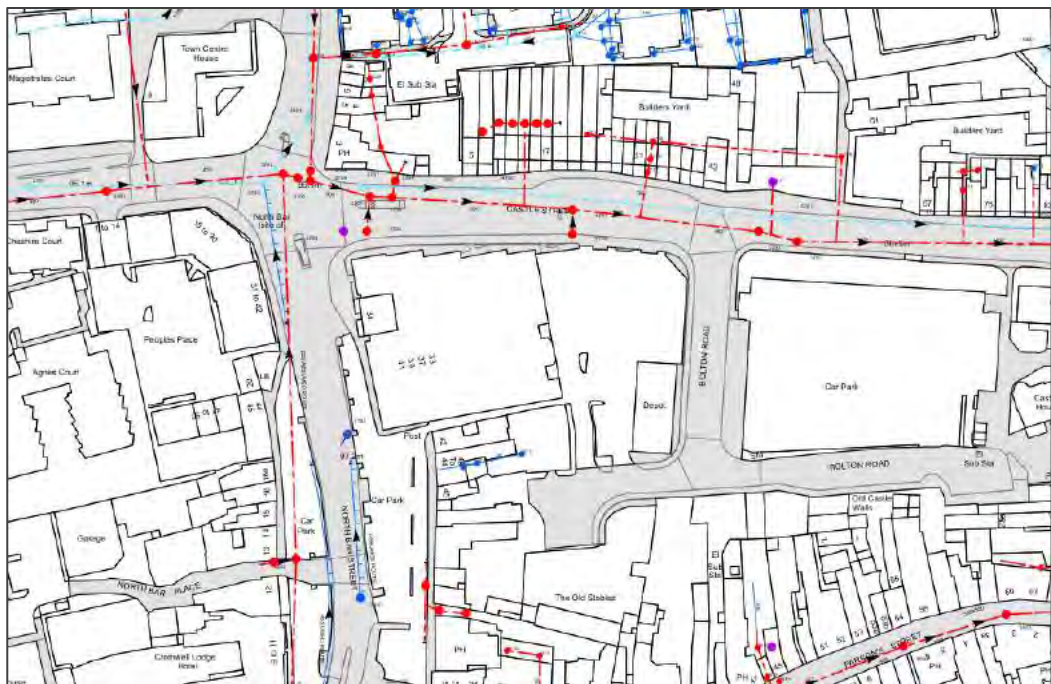
Figure 2.4 – Thames Water sewer asset record

- 2.12 There are no apparent nearby surface water features or watercourses. The Thames Water (TW) records are extracted in Figure 2.4 below which identifies that there are existing surface and foul sewers within Castle Street and North Bar Street to the north and west of the site. There are also combined sewers and gullies indicated south of the site, but these are not operated by TW (ownership is unknown). A full copy of TW records can be found within Appendix C of this report.

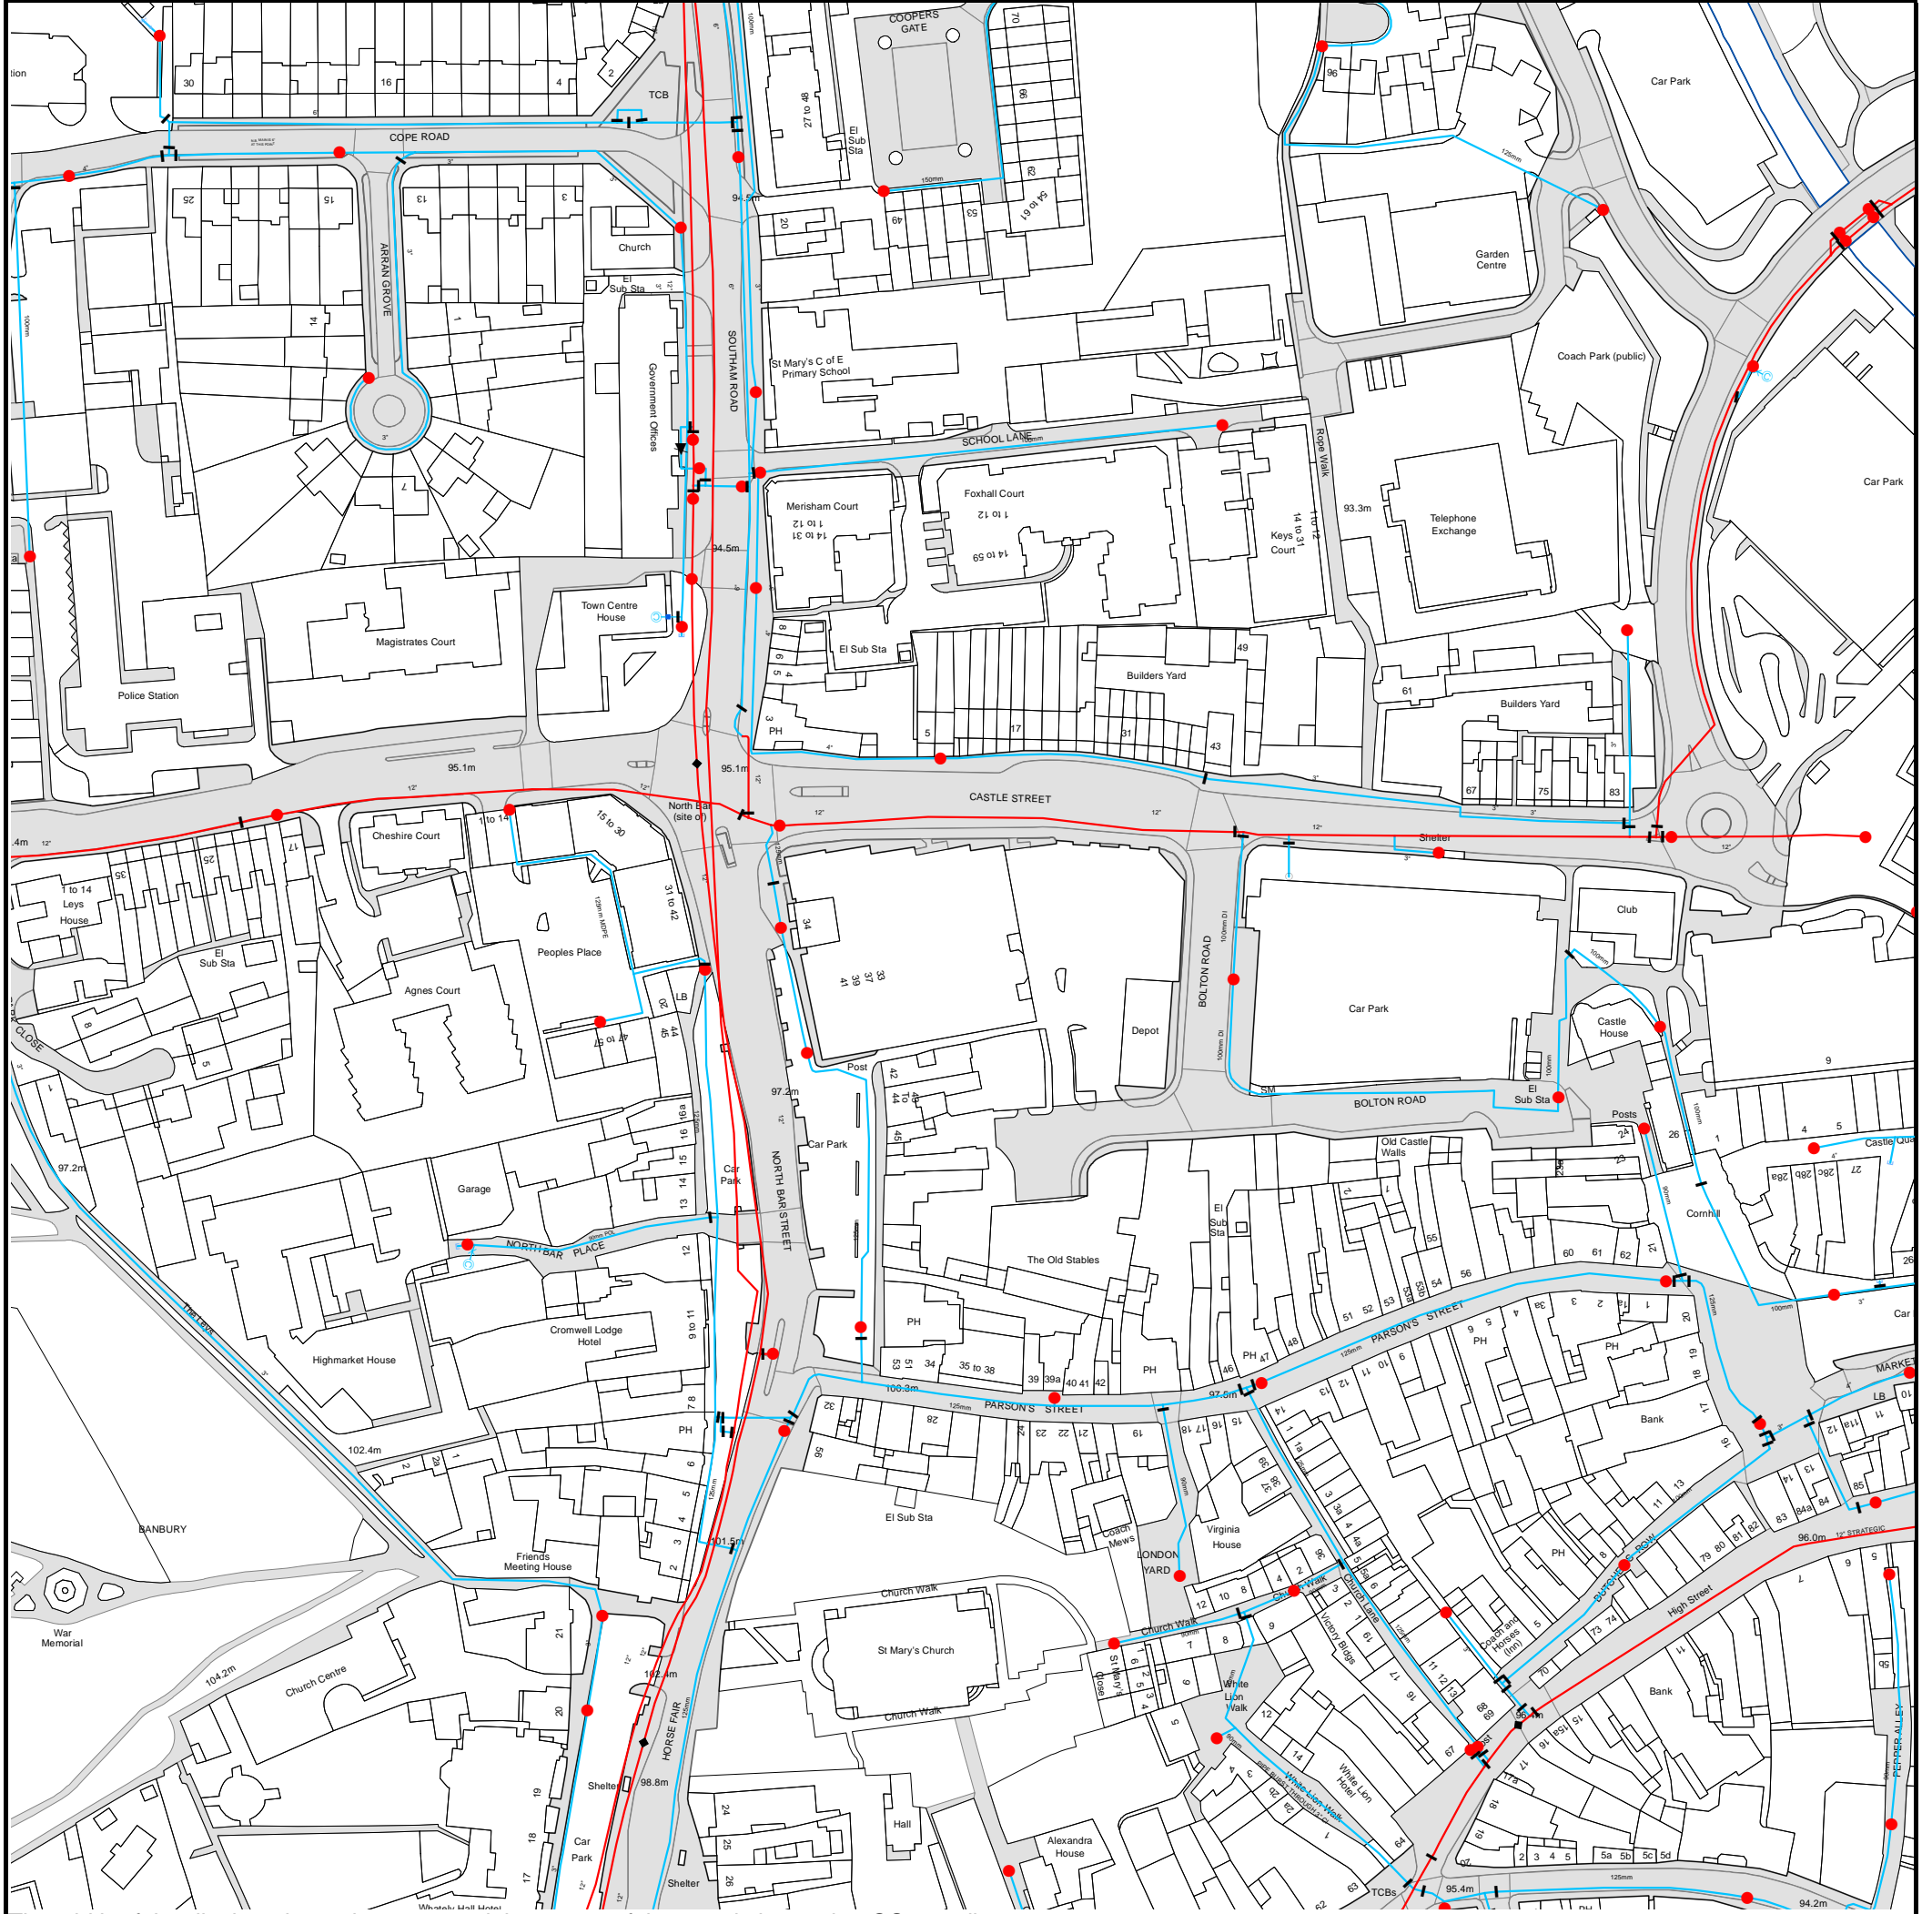
Asset Location Search Water Map - ALS/ALS Standard/2021 4472919

The width of the displayed area is 500 m and the centre of the map is located at OS coordinates 445423, 240735.
