Castle Street, Banbury

Flood Risk & Drainage Technical Note

Project No.	1260
Revision	D (Changes Highlighted)
Date	28 June 2022
Client	Churchill Retirement Living
Prepared	L Blackmore
Checked	C Yalden
Authorised	C Yalden
File Ref.	P:\1260 Castle Street, Banbury\C Documents\Reports\1260 - Castle Street, Banbury - Flood Risk & Drainage Technical Note - D

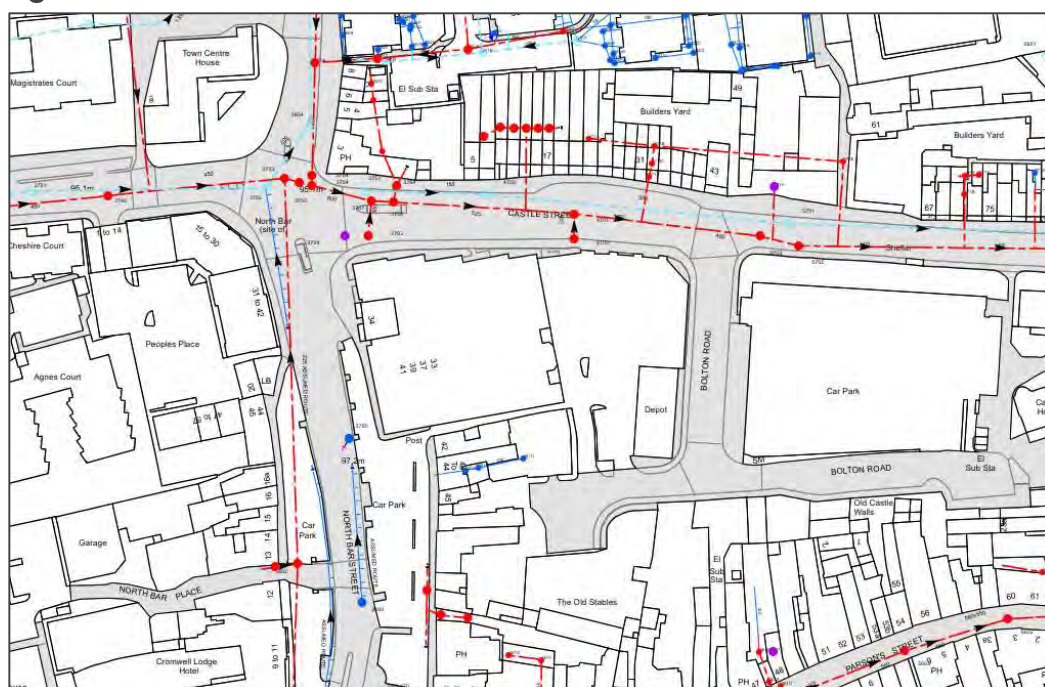
Figure 2.4 – Thames Water sewer asset record

- 2.12 There are no apparent nearby surface water features or watercourses. The Thames Water (TW) records are extracted in Figure 2.4 below which identifies that there are existing surface and foul sewers within Castle Street and North Bar Street to the north and west of the site. There are also combined sewers and gullies indicated south of the site, but these are not operated by TW (ownership is unknown). A full copy of TW records can be found within Appendix C of this report.

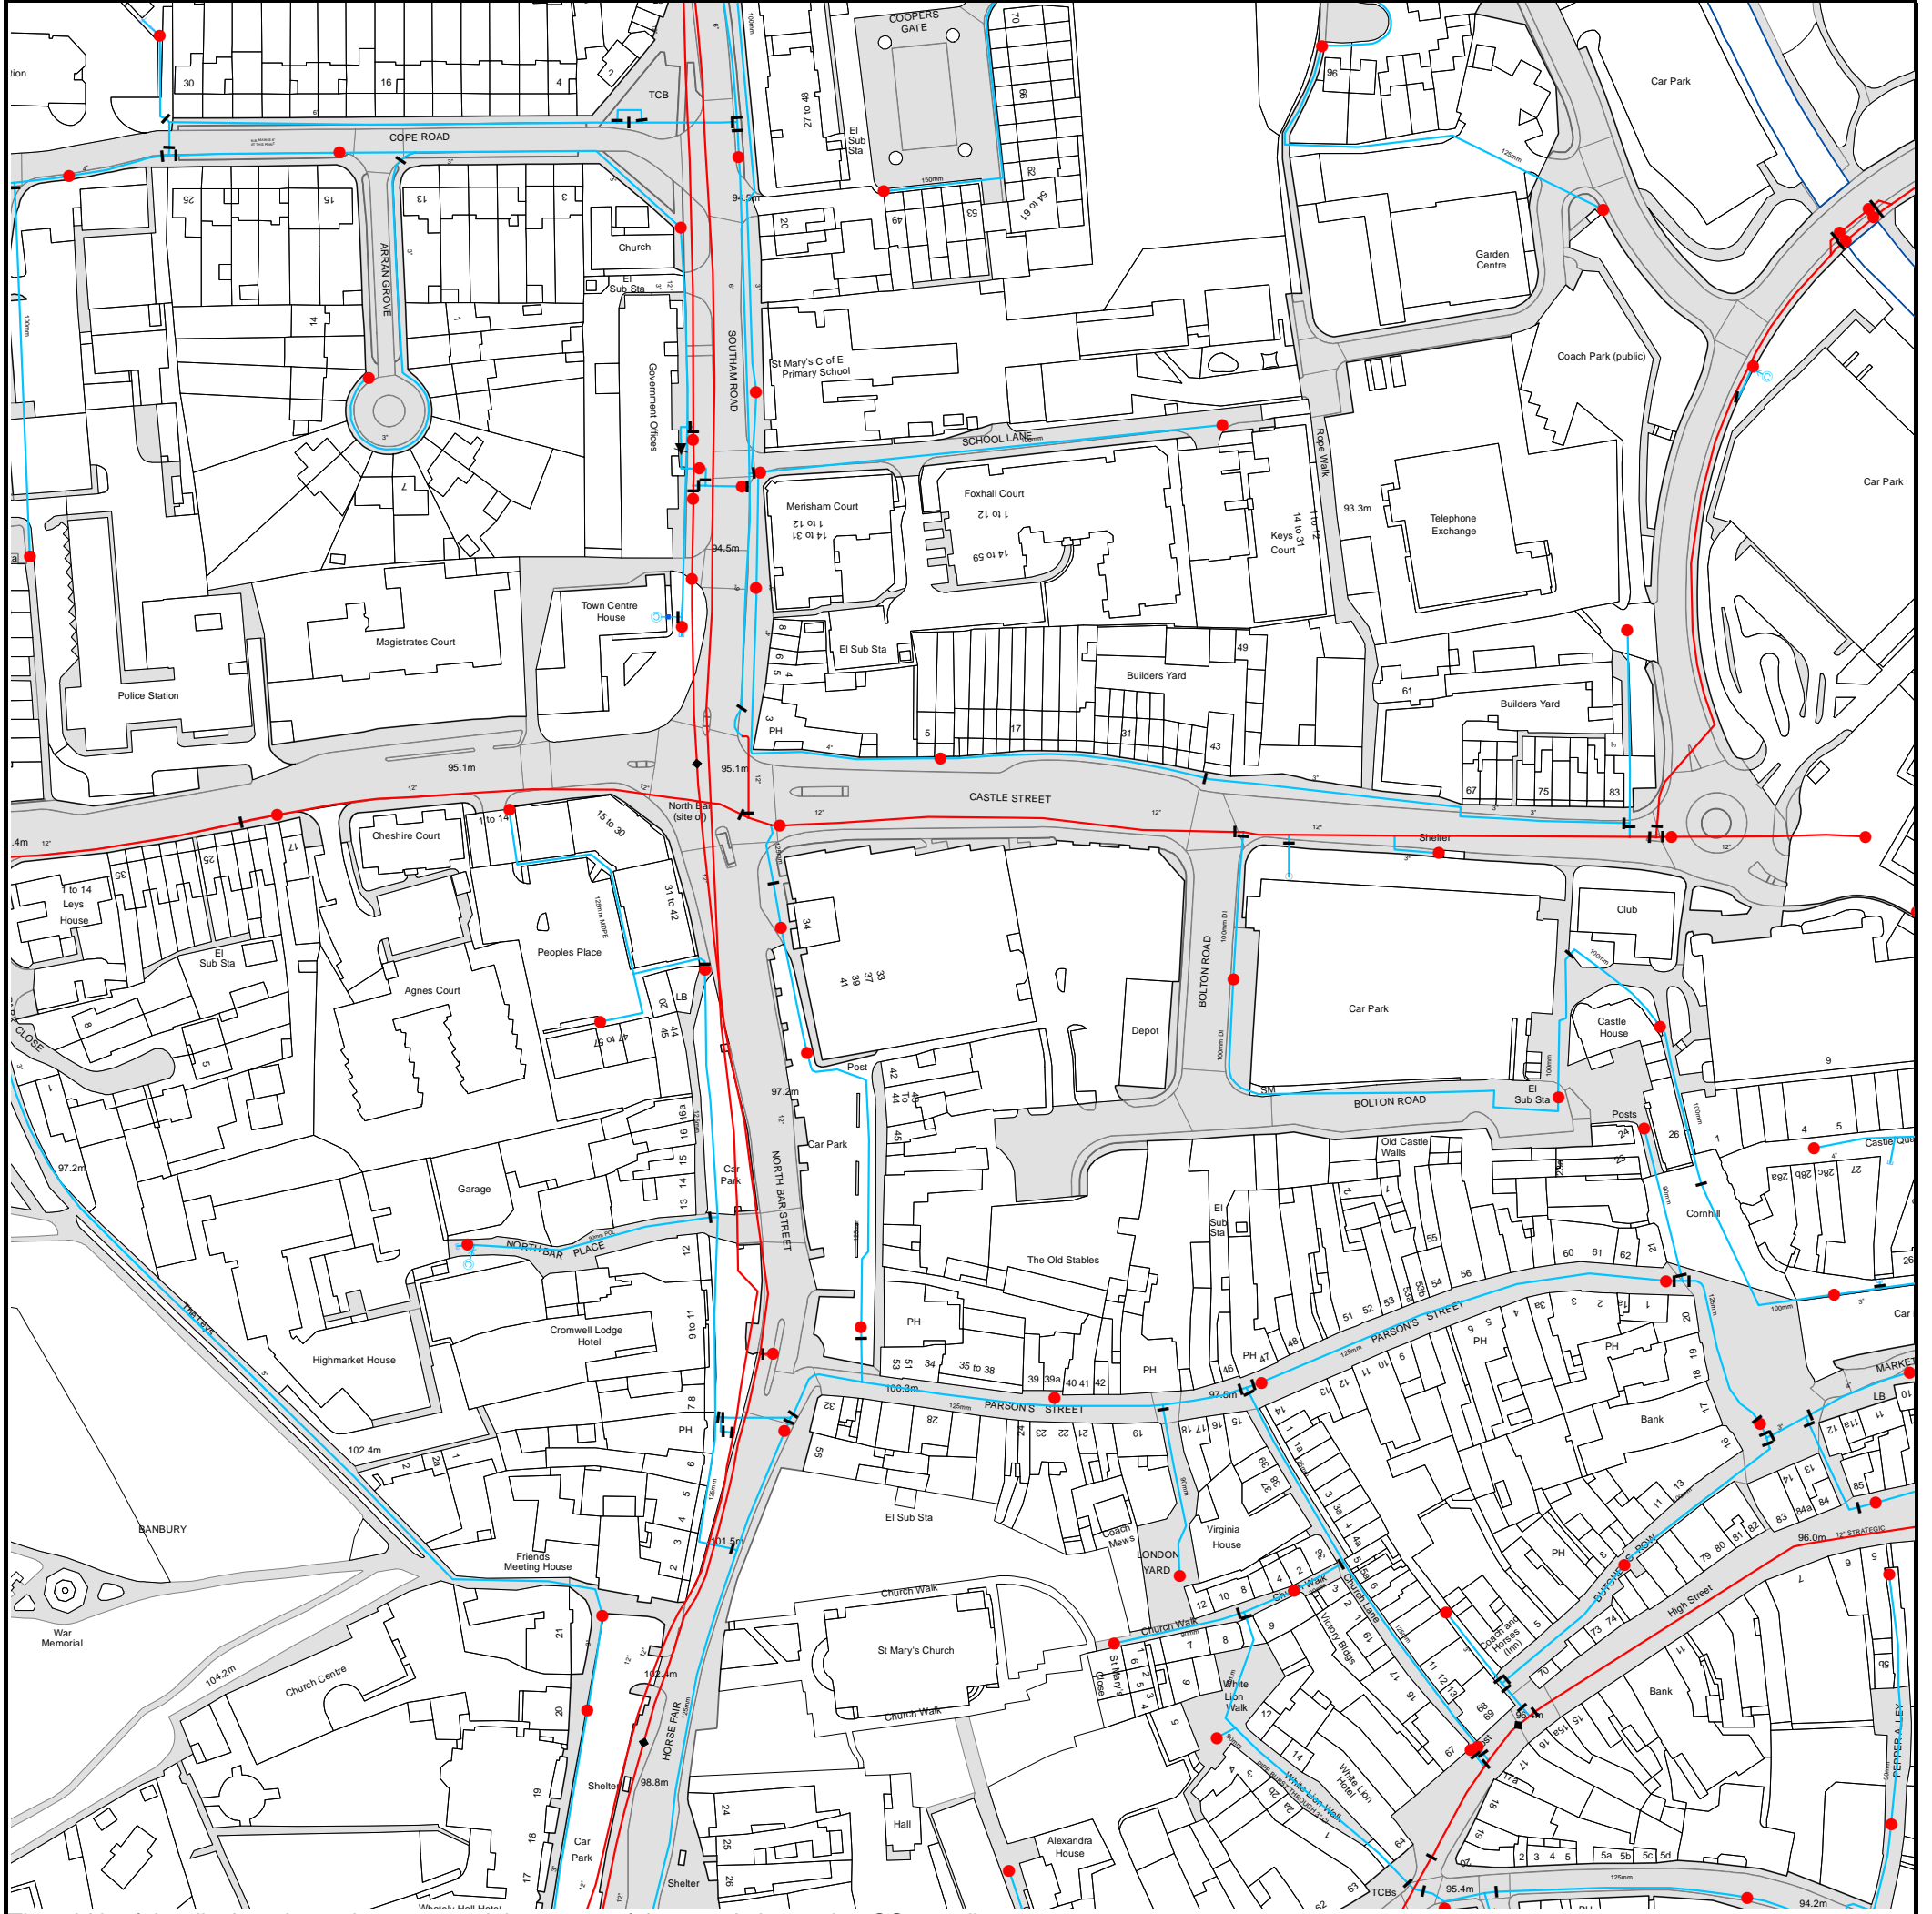
Asset Location Search Water Map - ALS/ALS Standard/2021 4472919

The width of the displayed area is 500 m and the centre of the map is located at OS coordinates 445423, 240735.

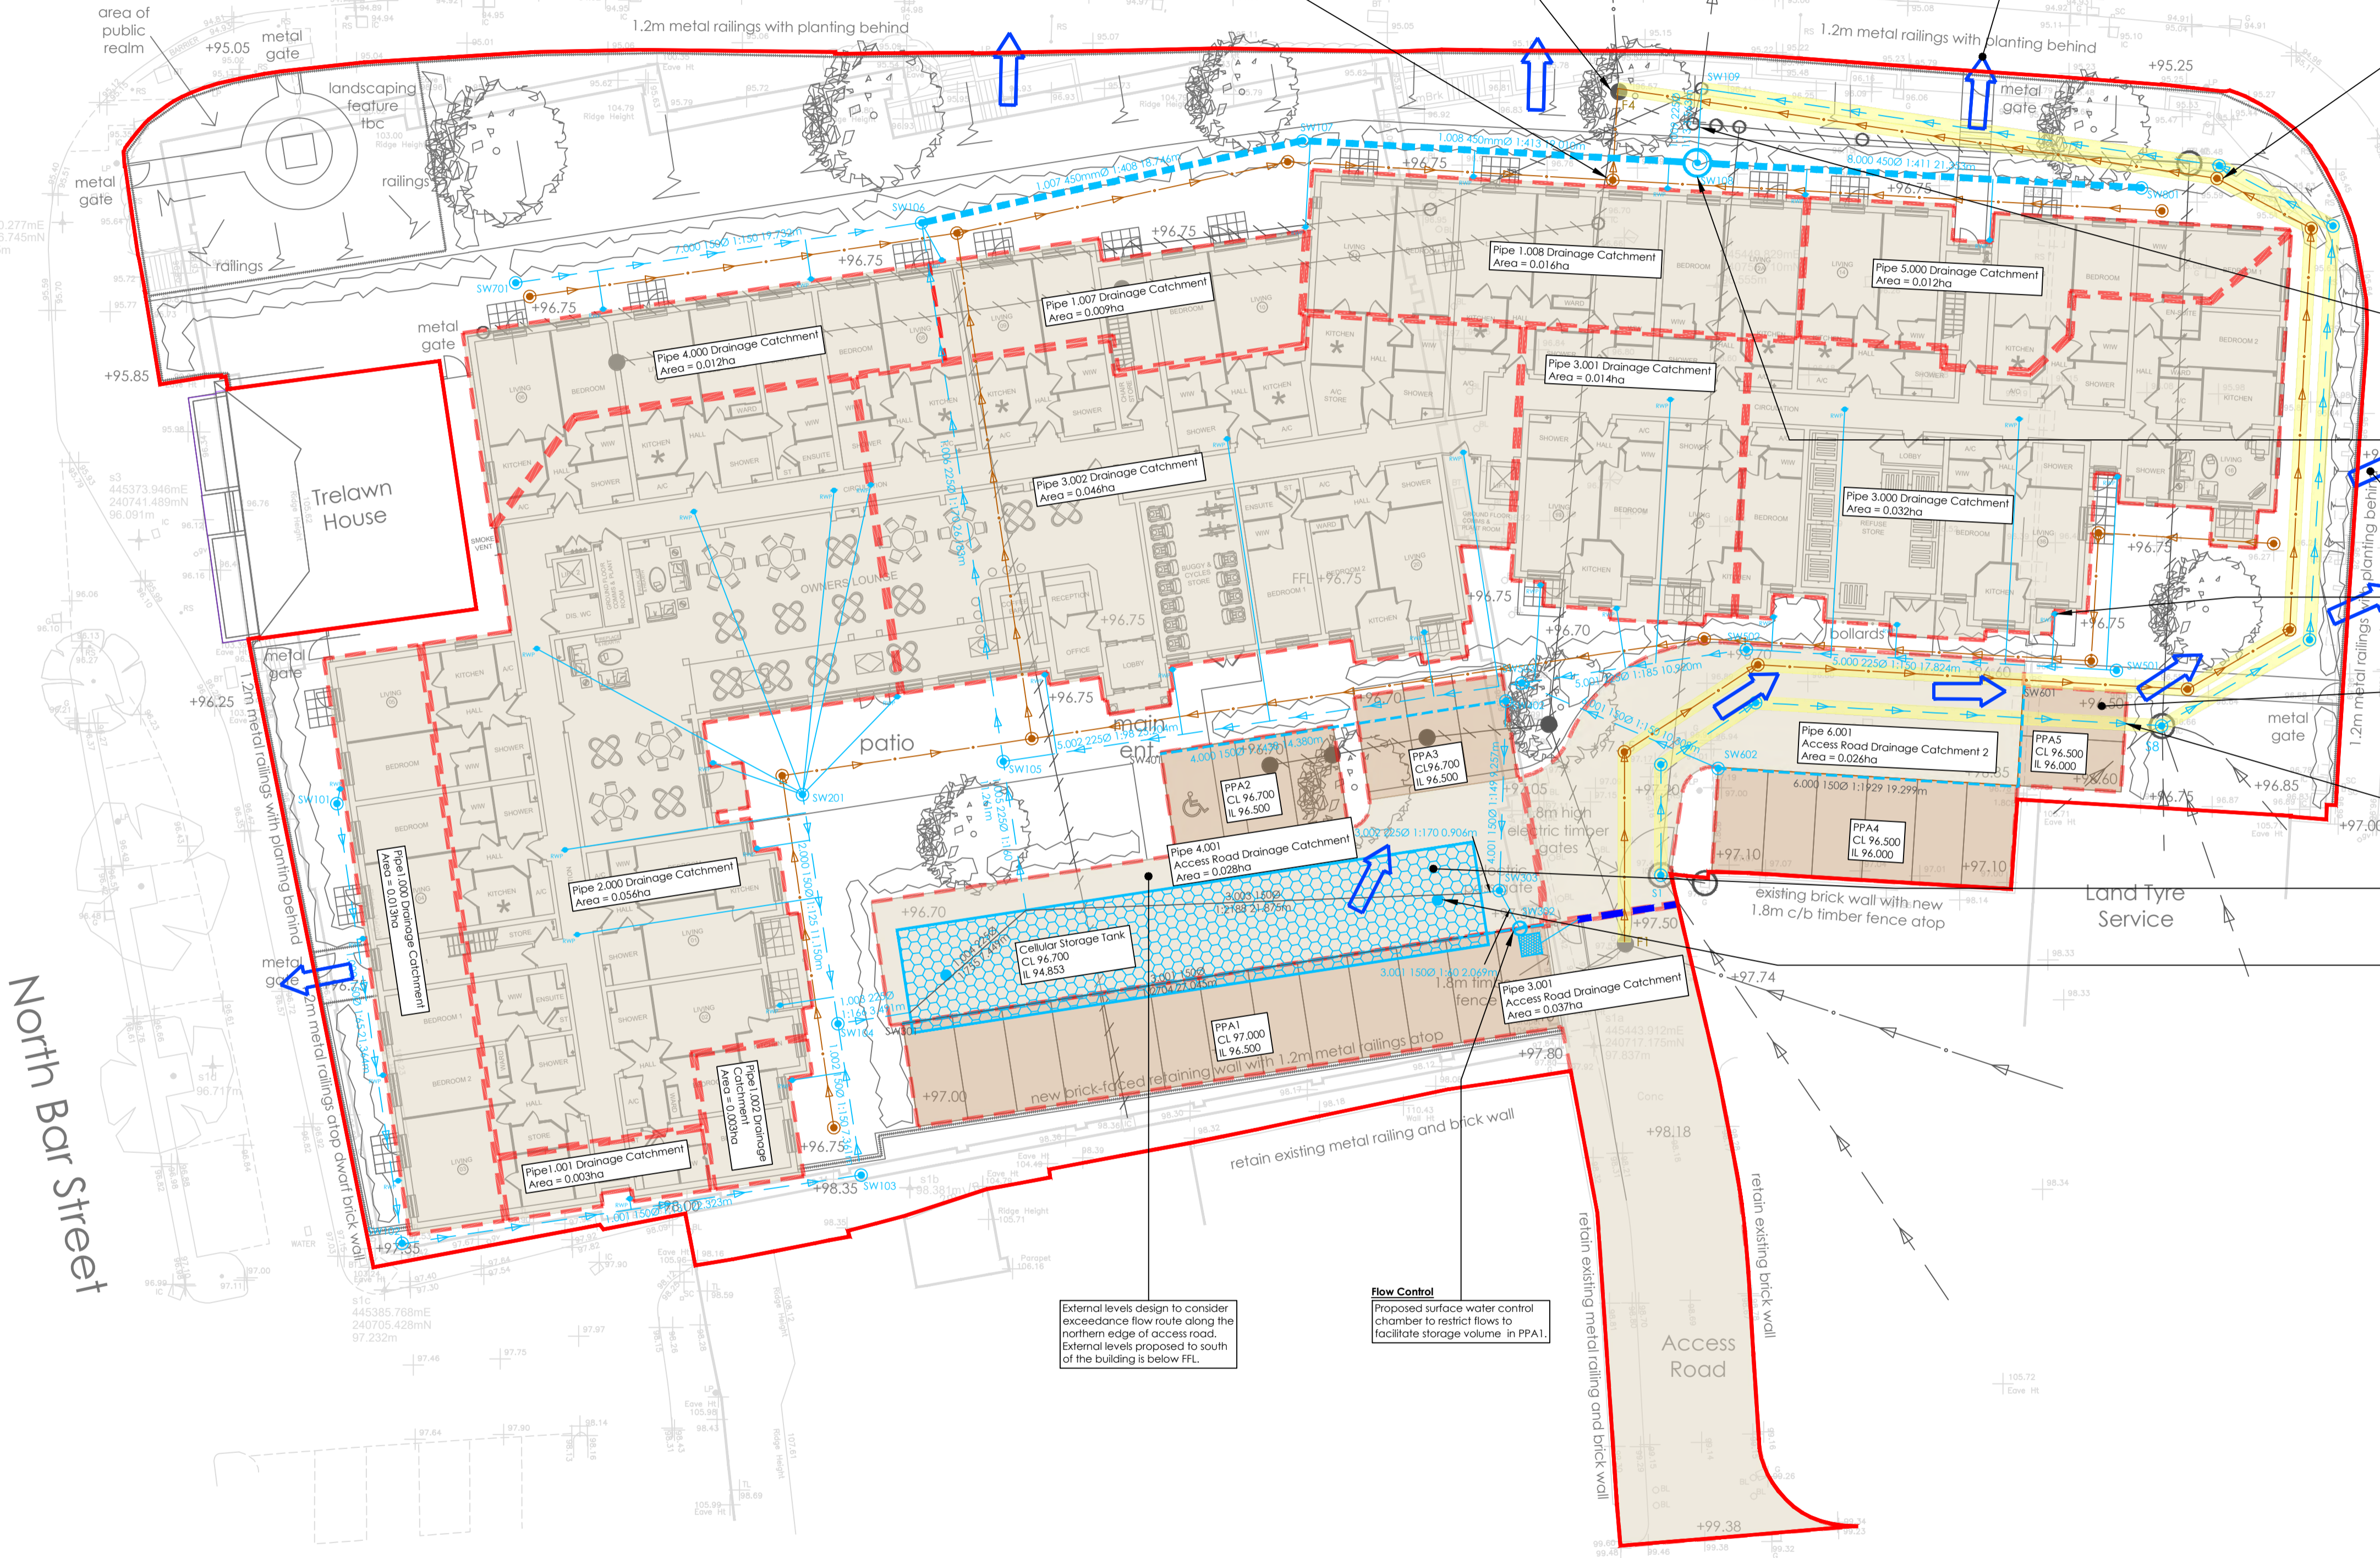
External levels design to consider exceedance flow route along the northern edge of access road. External levels proposed to south of the building is below FFL.

Flow Control
Proposed surface water control chamber to restrict flows to facilitate storage volume in PPA1.

- 4.24 A copy of the updated preliminary drainage layout can be found on drawing 1260-01-PDL-1001 included within Appendix H.

- 8.5 *Remedial works for existing drainage pipes not identified on plan drawing.* Remedial work at point of connection with the surface water network now noted on the updated PDL (Appendix H).

- 8.13 *Surface water catchment plan.* The surface water catchments are shown on the PDL drawing (Appendix H). The total area drained is 0.308ha as stated in the PDL summary notes. Individual catchment areas have been annotated, together with which pipe they are draining to in the network model. It should be noted that some pipe runs receive flow from multiple areas. The text has been made clearer on the PDL drawing.

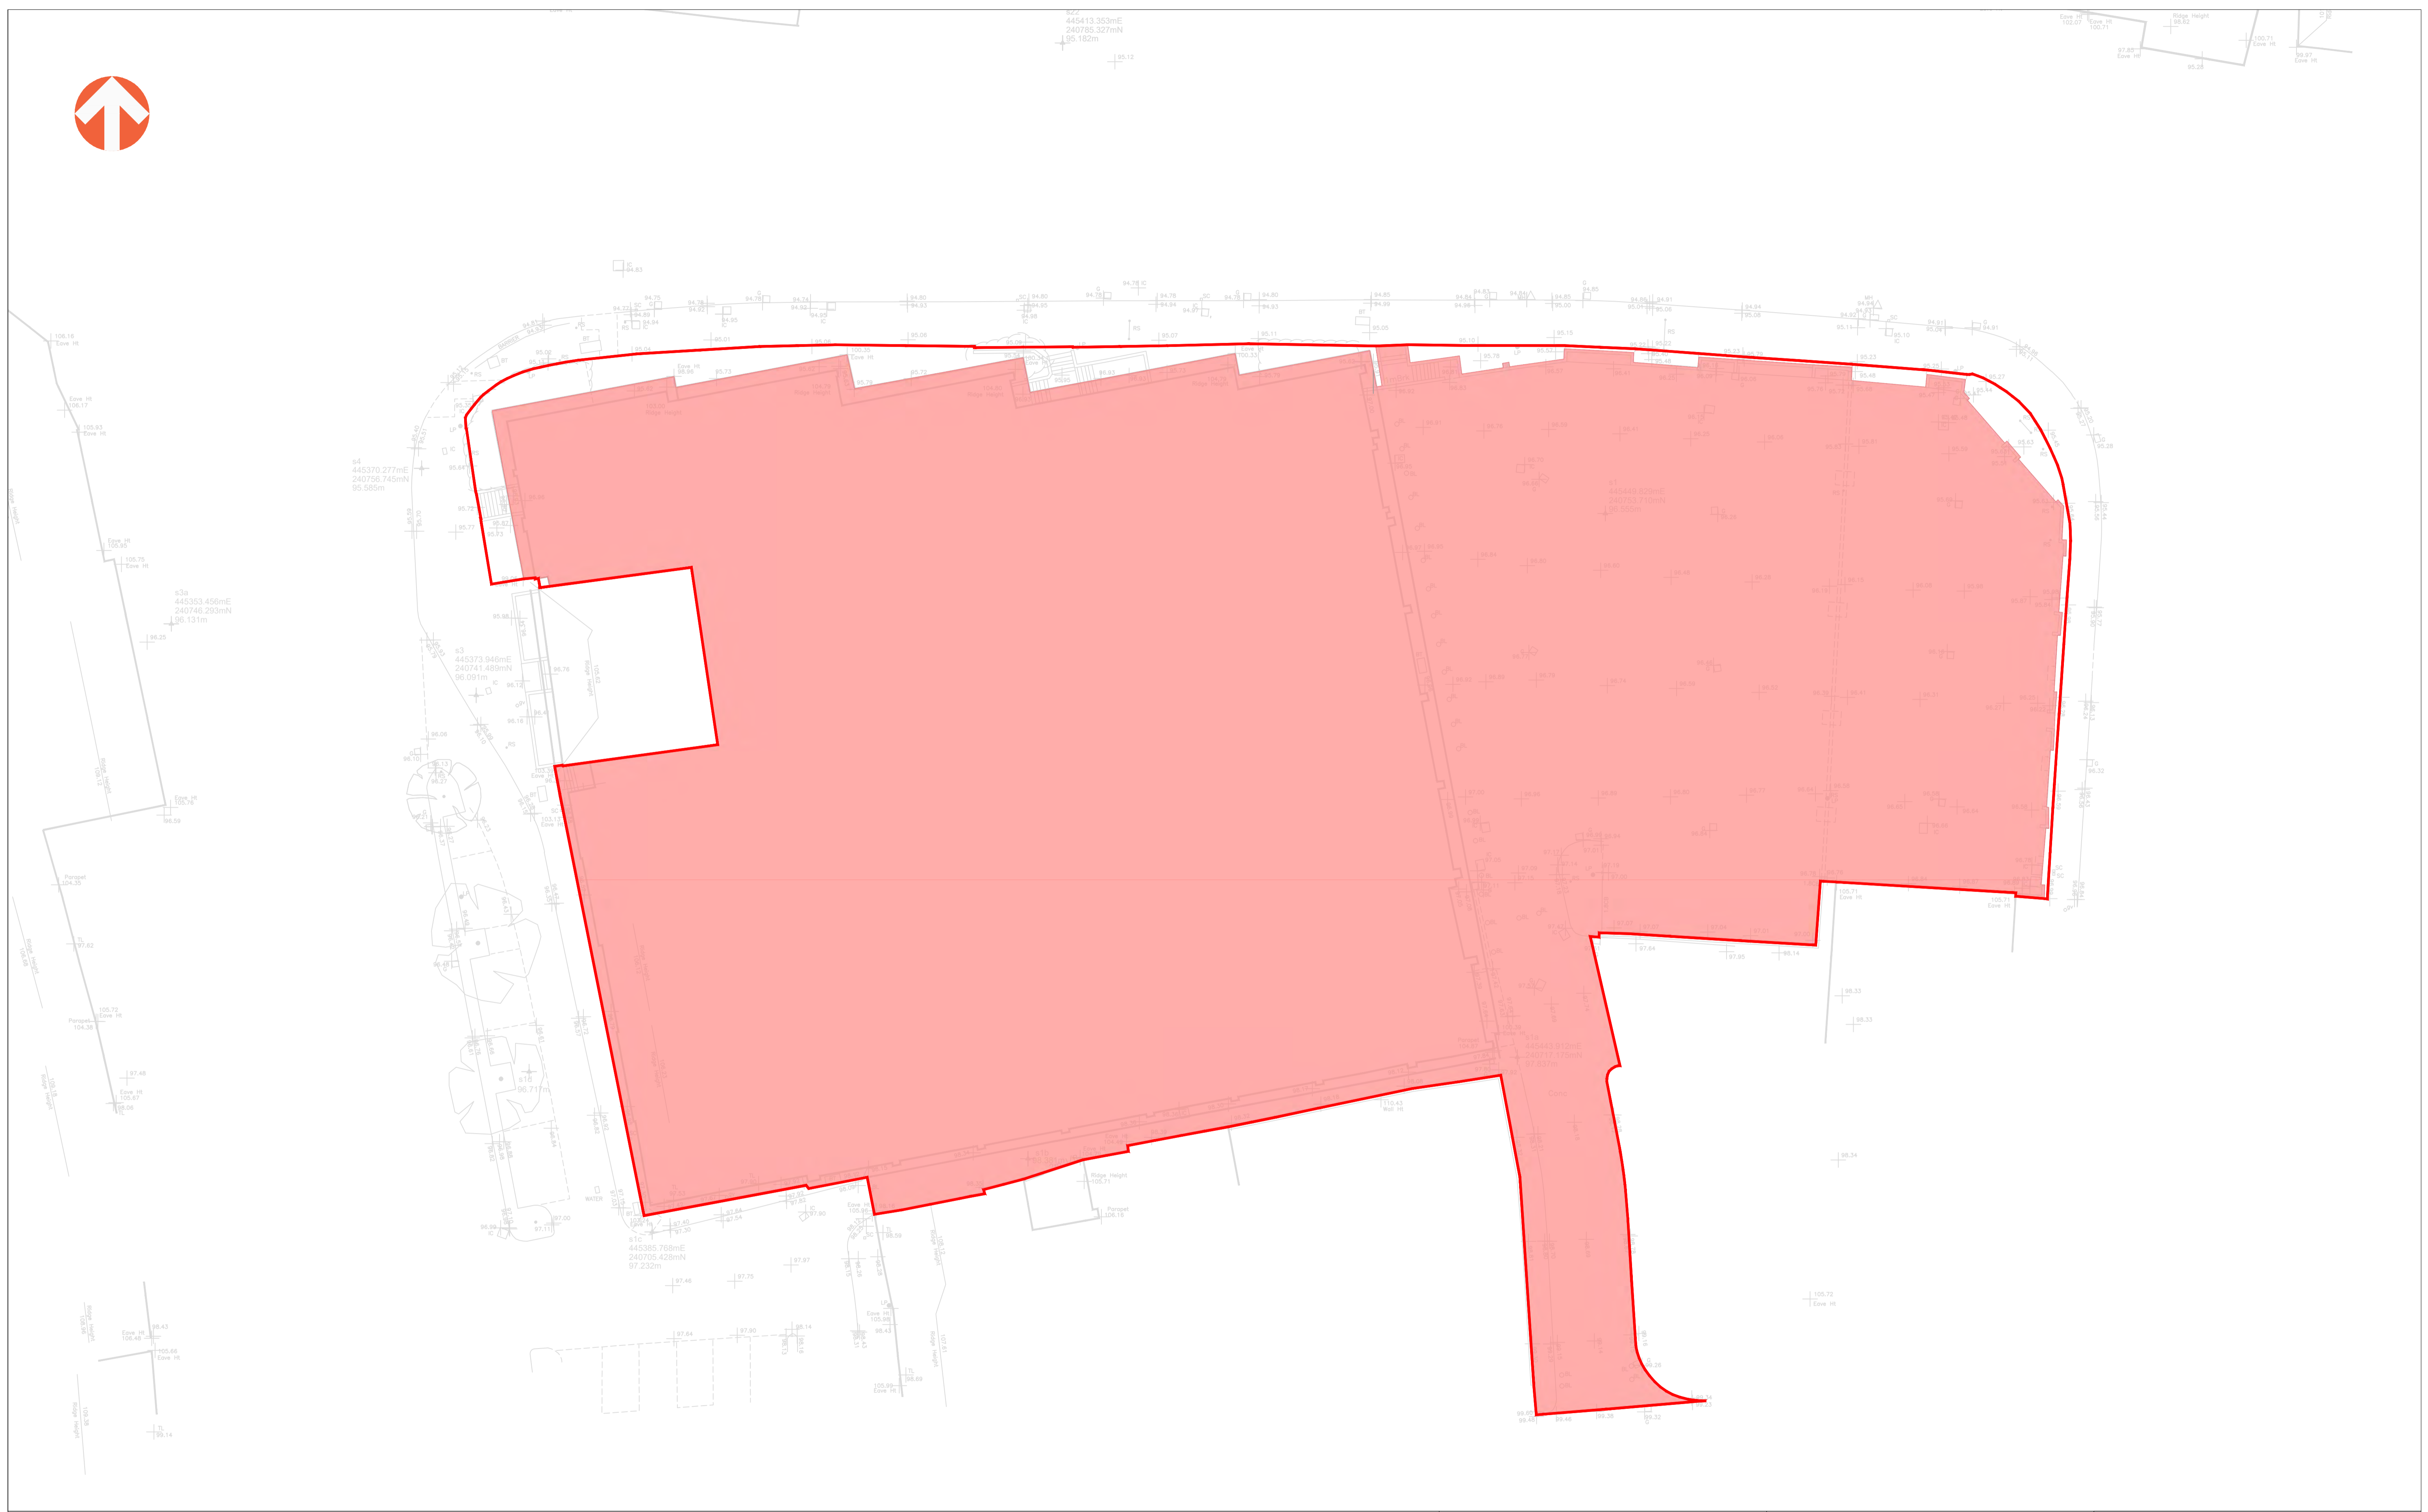
Appendix I Existing Impermeable Areas Plan

- Site Boundary
- Existing Impermeable Areas Catchments
