HISTORIC BUILDING APPRAISAL & STATEMENT OF SIGNIFICANCE

BURDROP FARMHOUSE, BURDROP, OXFORDSHIRE

AHC REF: ND/9797

October 2019

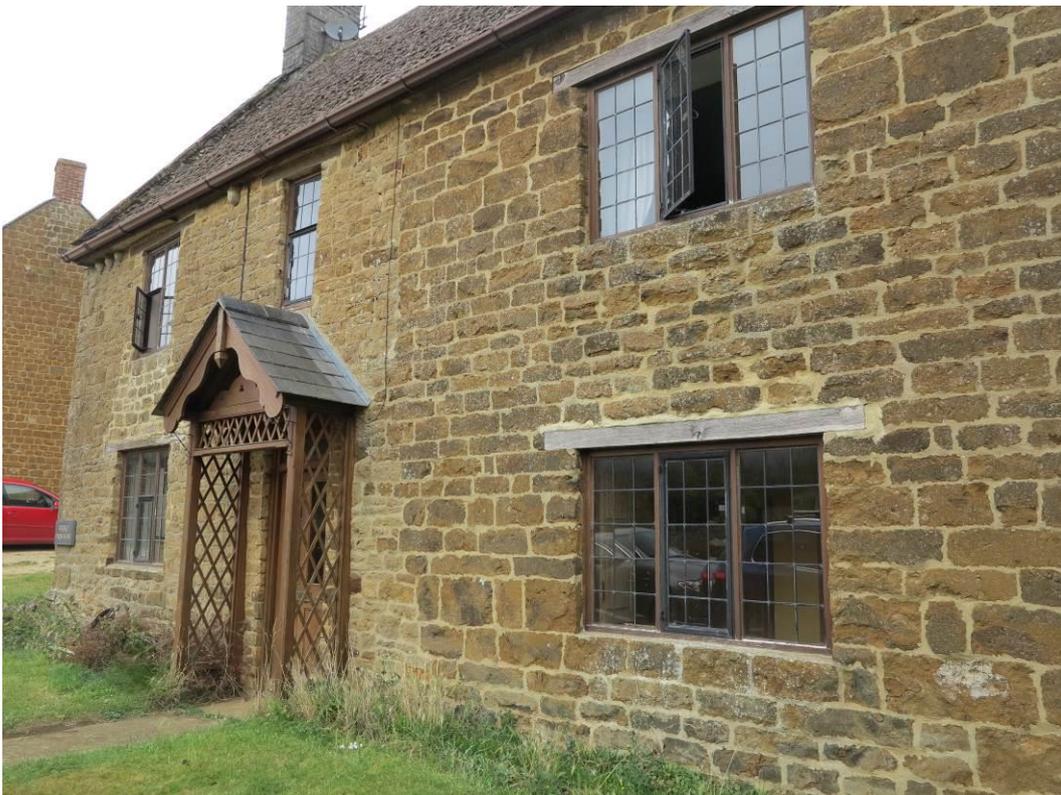
Plate 4. Burdrop Farmhouse, construction joint on south elevation

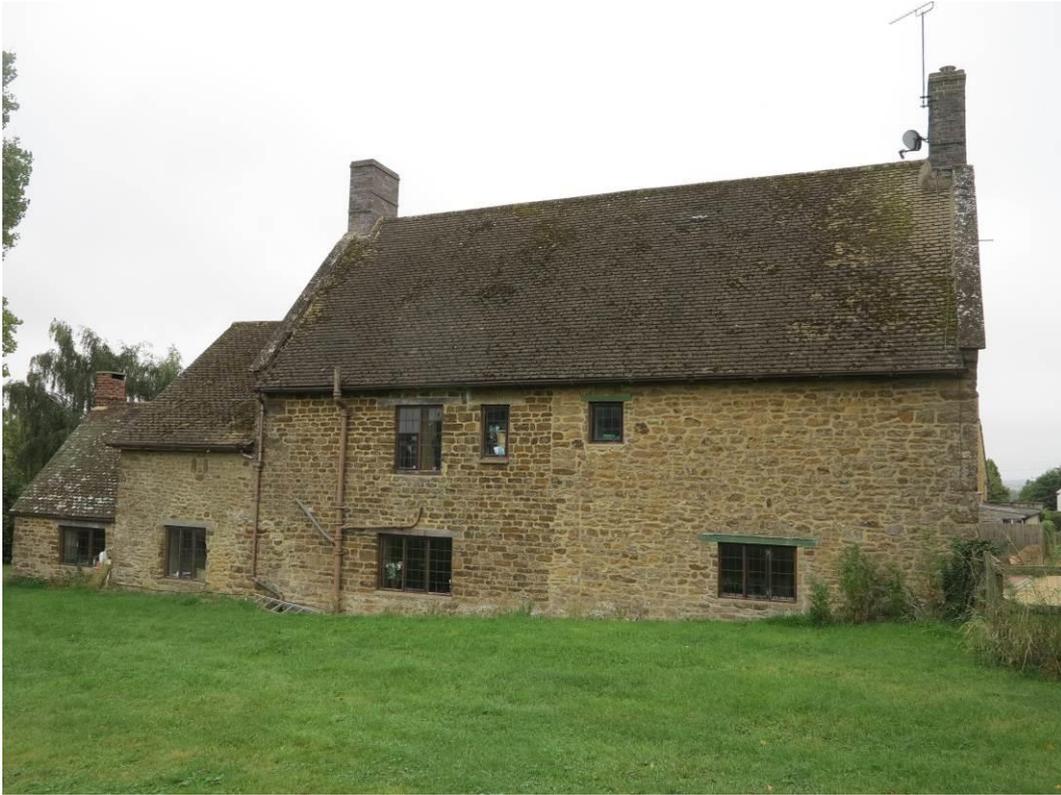
Plate 5. Burdrop Farmhouse, construction joint on north elevation

- 2.7 The clear straight joint on the rear (north) elevation corresponds with the position of that on the south (**plate 5**), and again seems likely simply to mark a break in construction rather than anything more significant in terms of phasing. Certainly, if

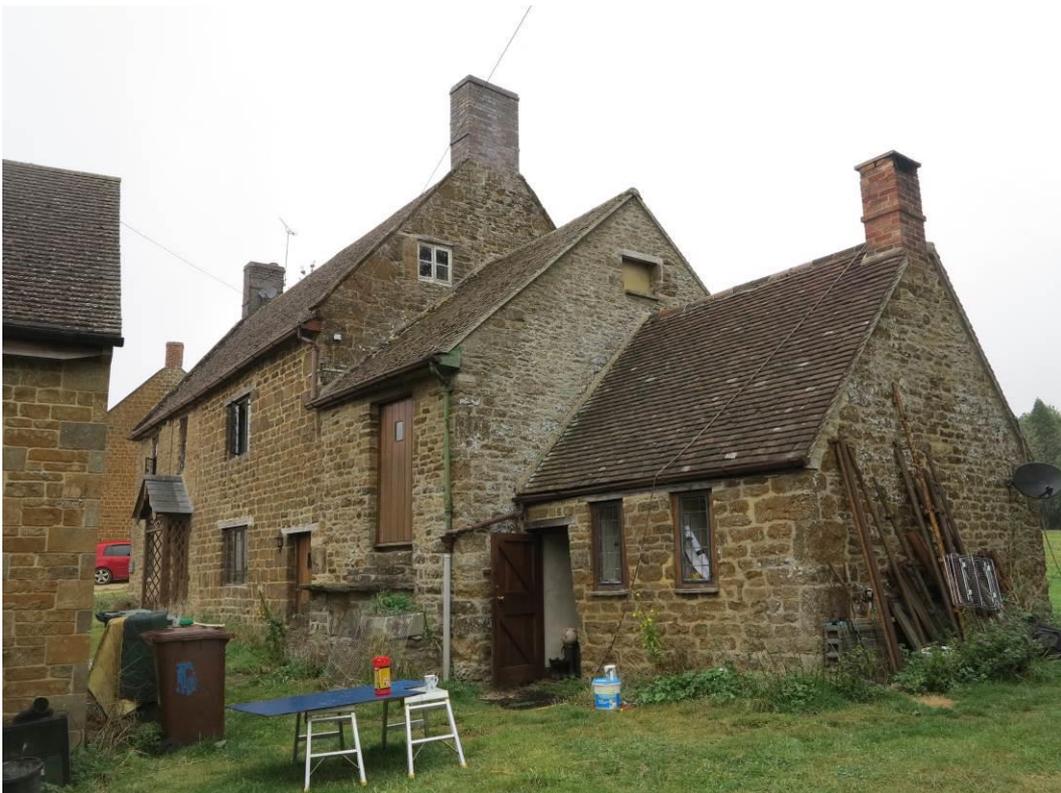
Plate 5A. Former granary and 19th-century extension attached to east end of Burdrop Farmhouse

- 2.9 Attached to the east gable end of the house and with a ridge lower than that of the house is a former granary, the upper level of which is approached by a straight flight of old stone steps on the south elevation, with to the east again a lower still single-storey extension (currently accommodating the kitchen), added in the 19th century (**plate 5B**).

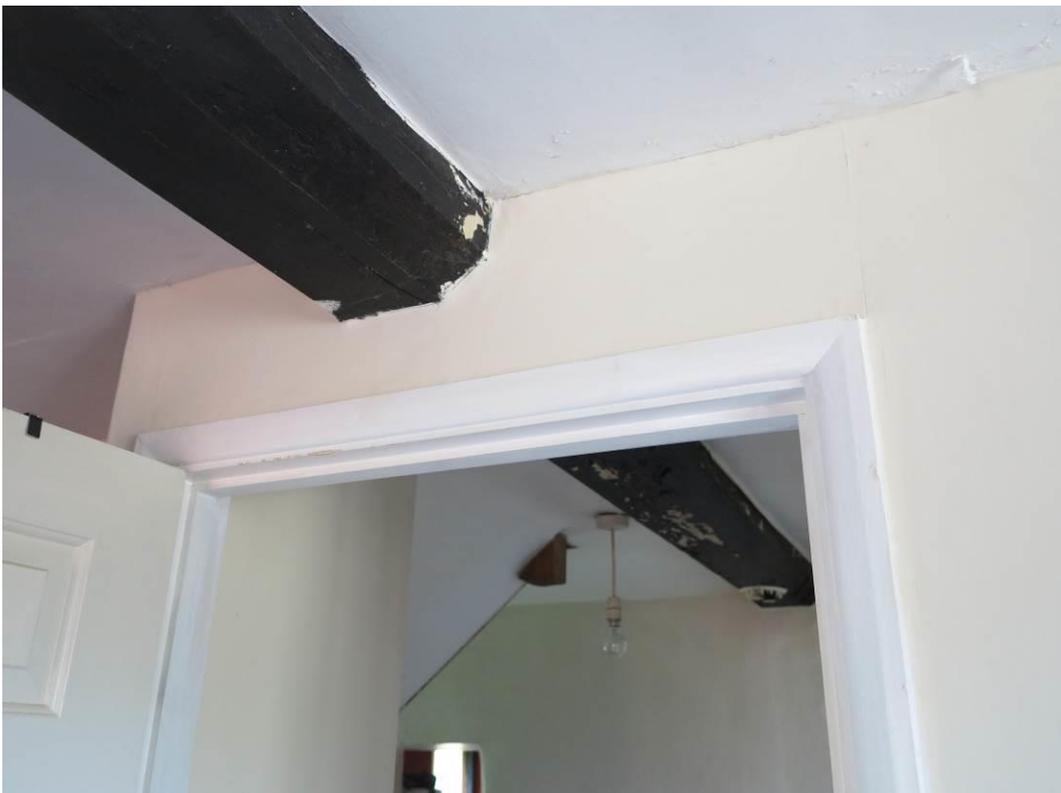
Plate 7. Note the way the ceiling beam runs through the inserted partition wall into the landing

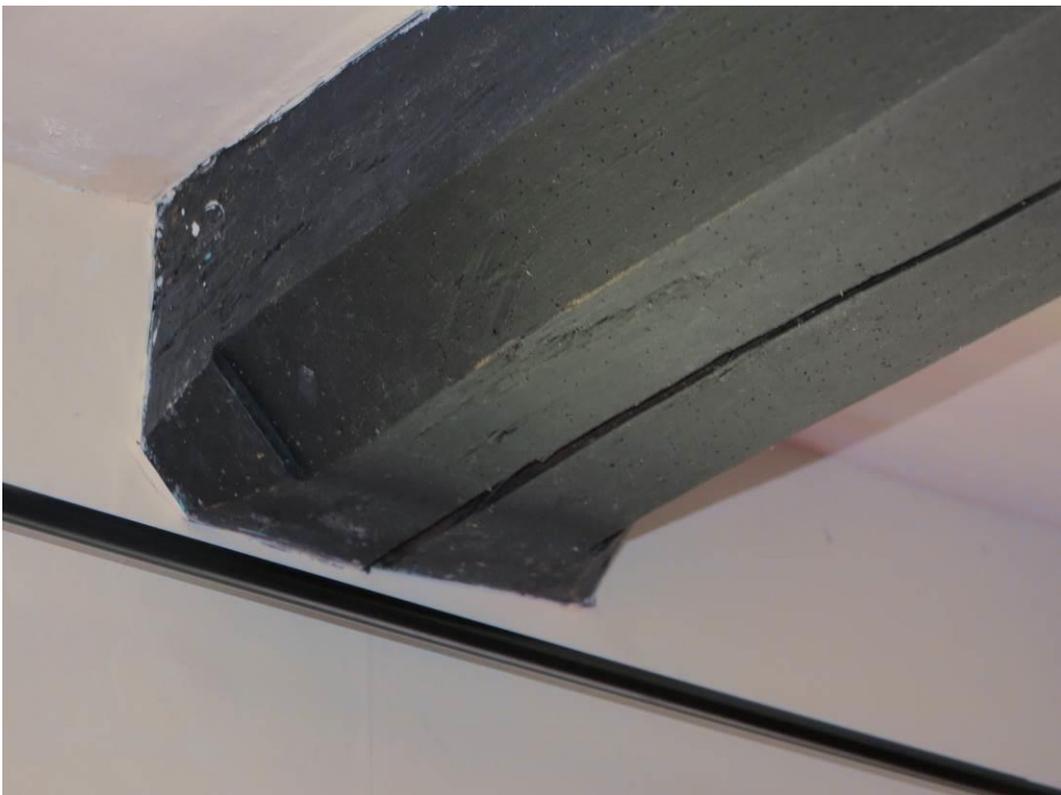
Plate 9. The stop end of the chamfered beam in the bedroom

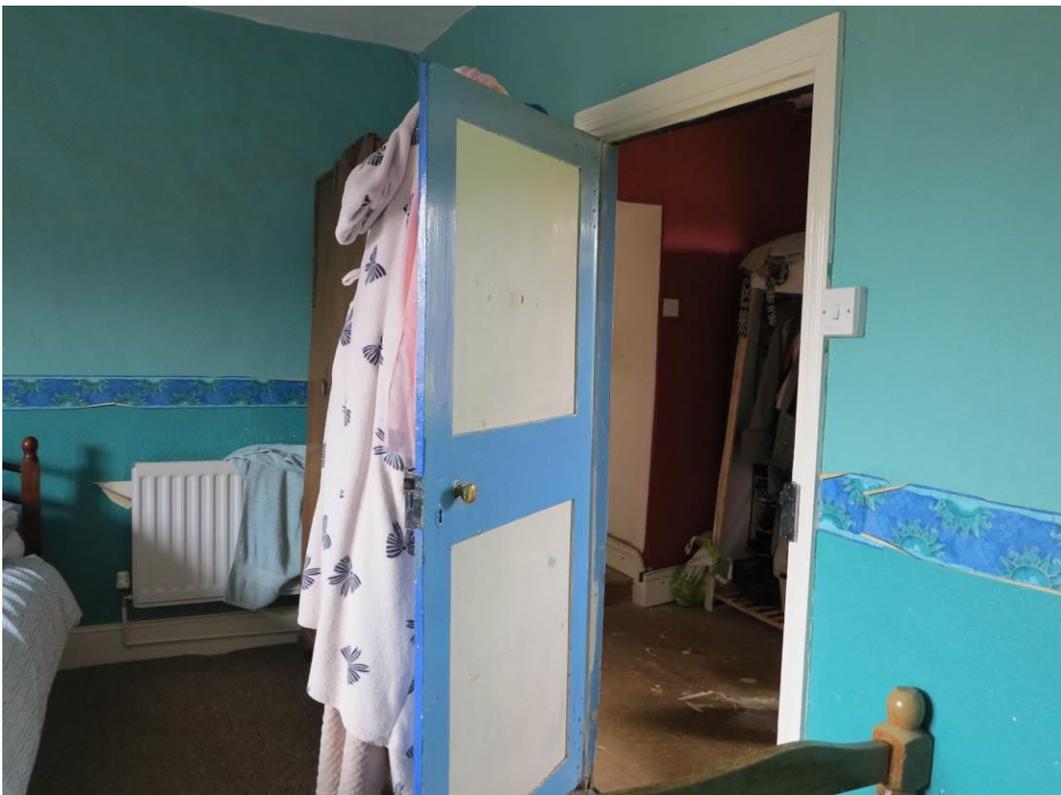
Plate 13. Inserted partition wall between lobby to bathroom and bedroom at east end of house; the 18th-century two-panel door must have been reused

- 2.17 The 18th-century two-panel door to the store cupboard in the east wall of the first-floor room at the eastern end of the main body of the house appears to be *in situ*, as is the decorative cast-iron Victorian fireplace in the same wall (**plates 39-40**), but the two-panel door in the north wall of this room cannot be so as the partition wall in which it sits has clearly been inserted (see **plate 13**).

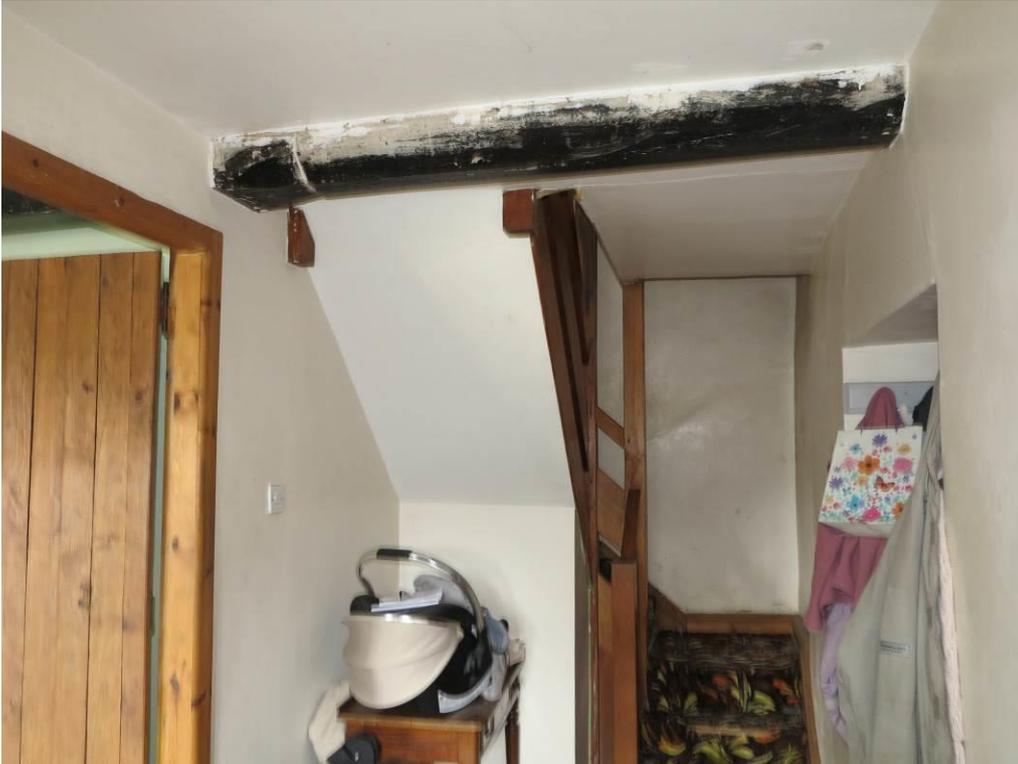
Plate 14. The wall separating the room at the west end of the house on the ground floor must be on a slightly different line from the original as the beam from this room carries through the wall to the present hallway

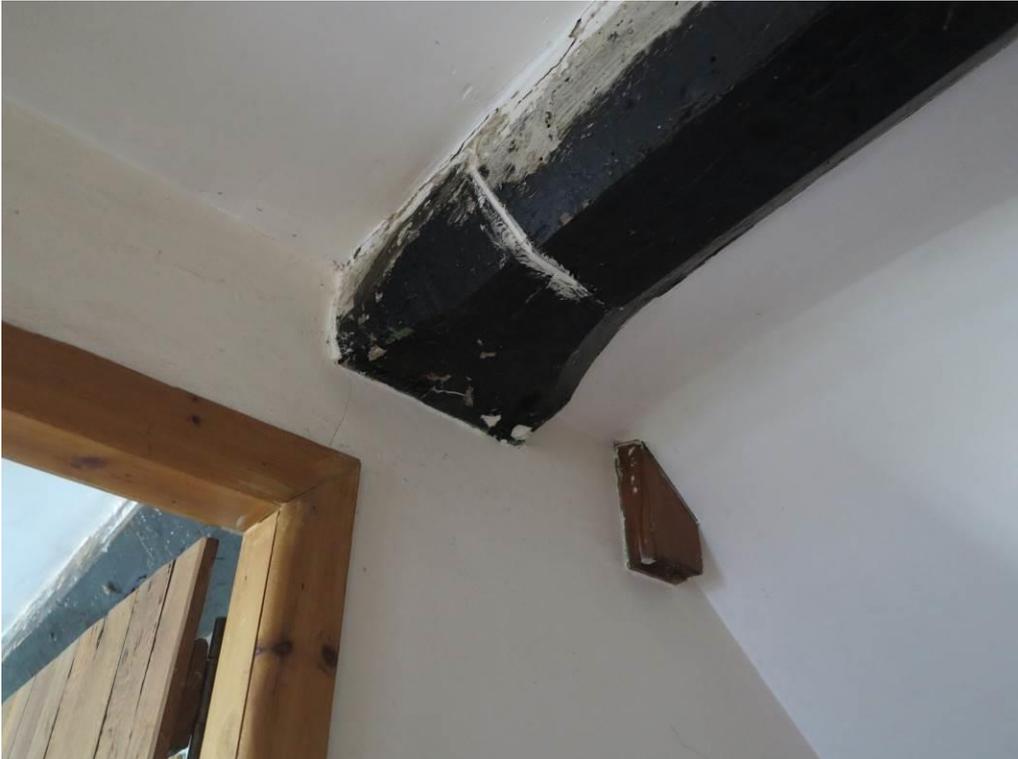
Plate 15. The wall separating the room at the west end of the house on the ground-floor must be on a slightly different line from the original as the beam from this room carries through the wall to the present hallway (detail)

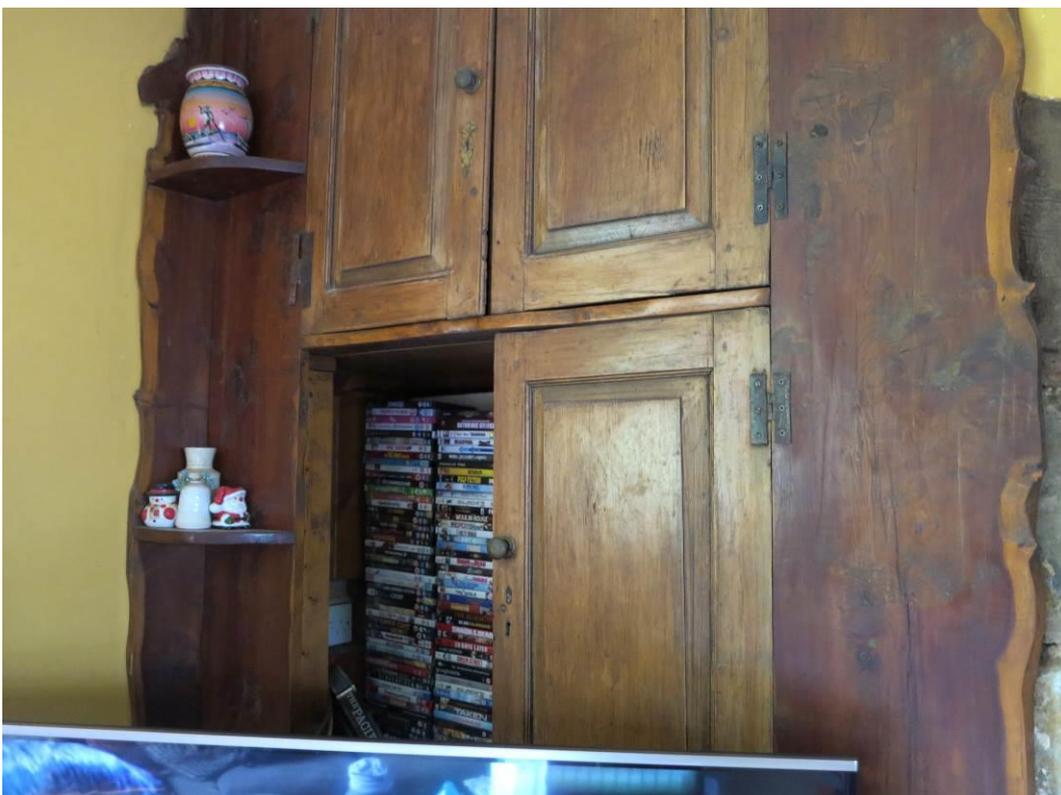
Plate 27. The alcove to the left of the inglenook fireplace, now infilled with a cupboard reusing 18th-century panelling, may be the location of an original staircase

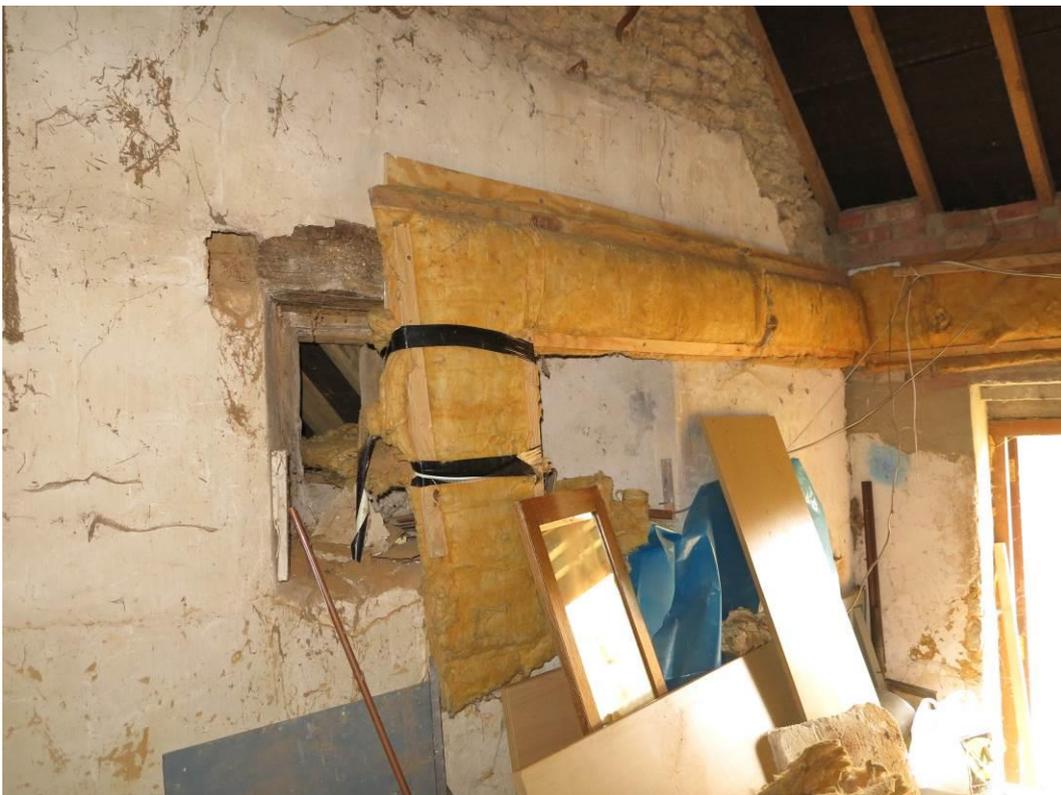
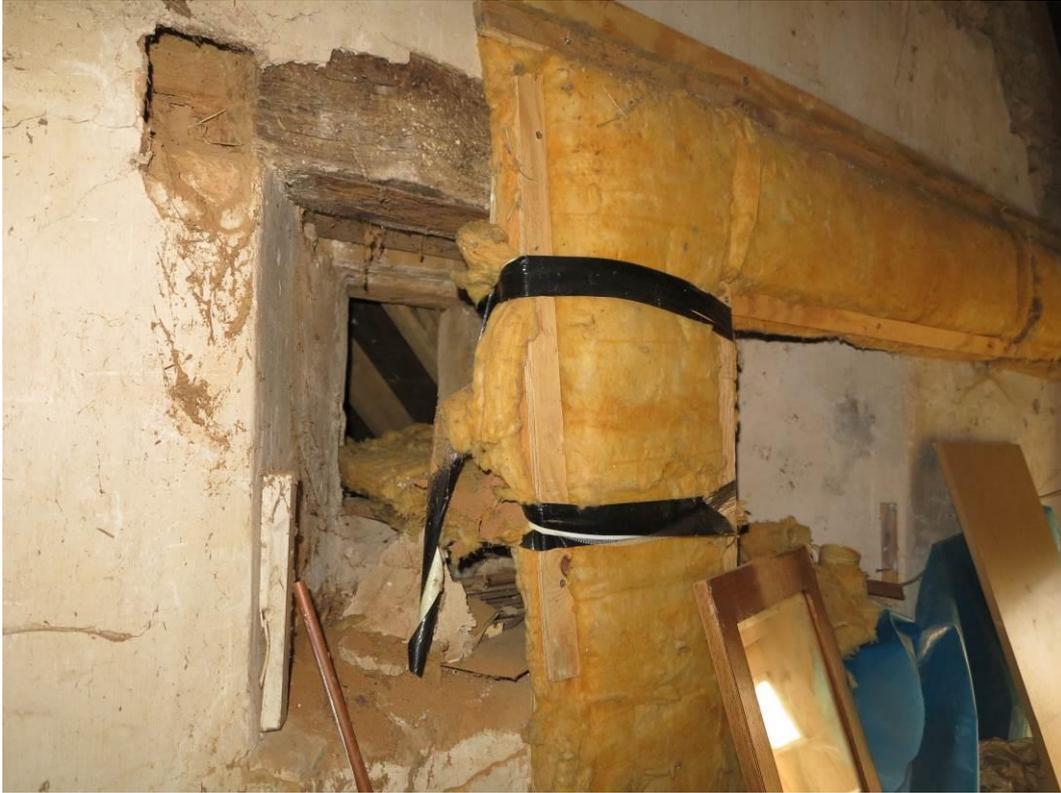
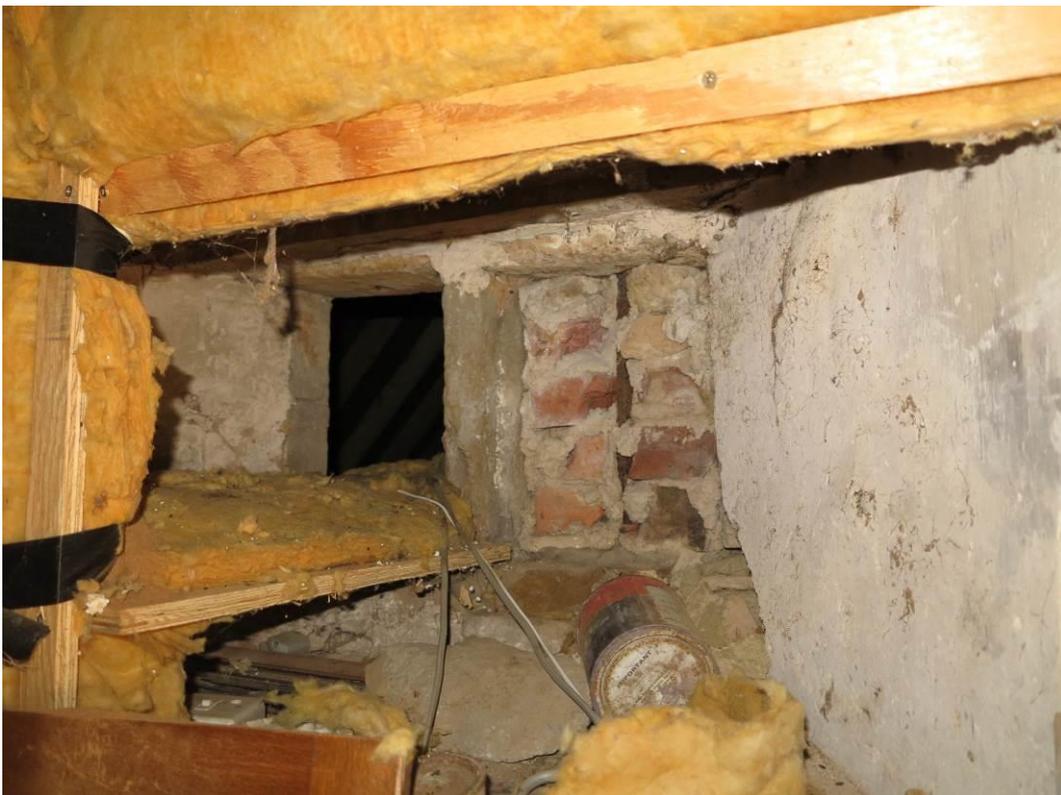
Plate 29. Mullion window in east wall of former granary

Plate 30. Mullion window in east wall of former granary

Plate 31. Mullion window in east wall of former granary

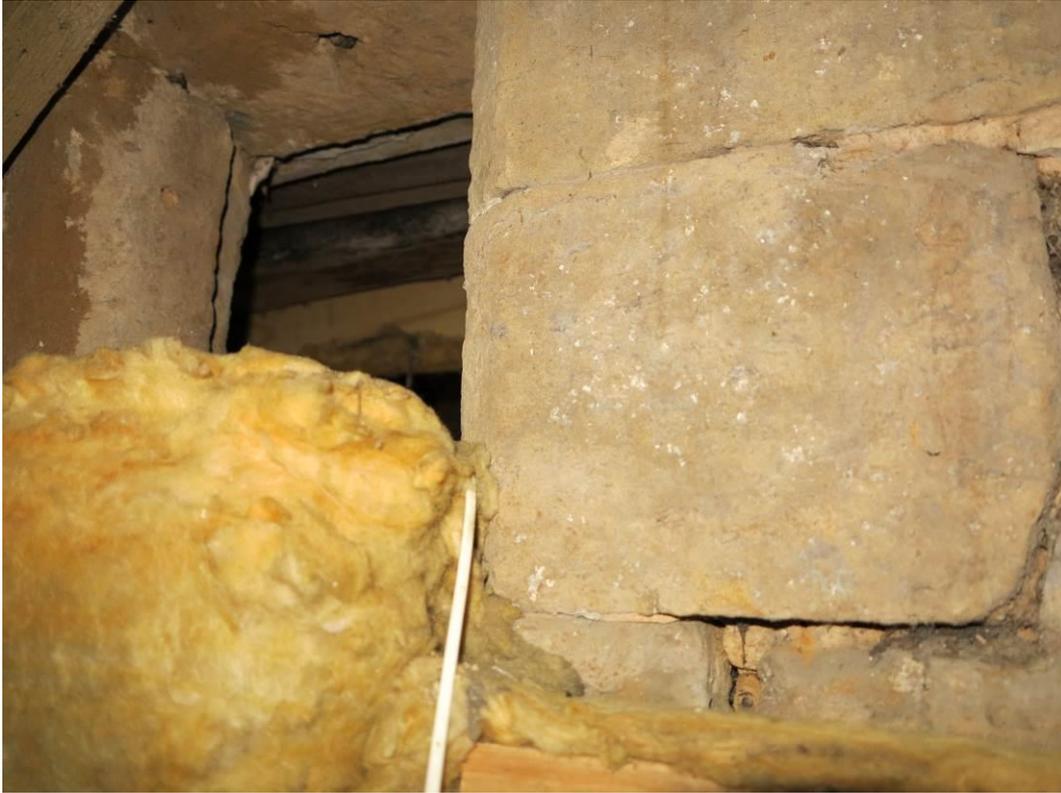
Plate 32. Mullion window in east wall of former granary, viewed from roof space of 19th-century addition attached to east end of former granary

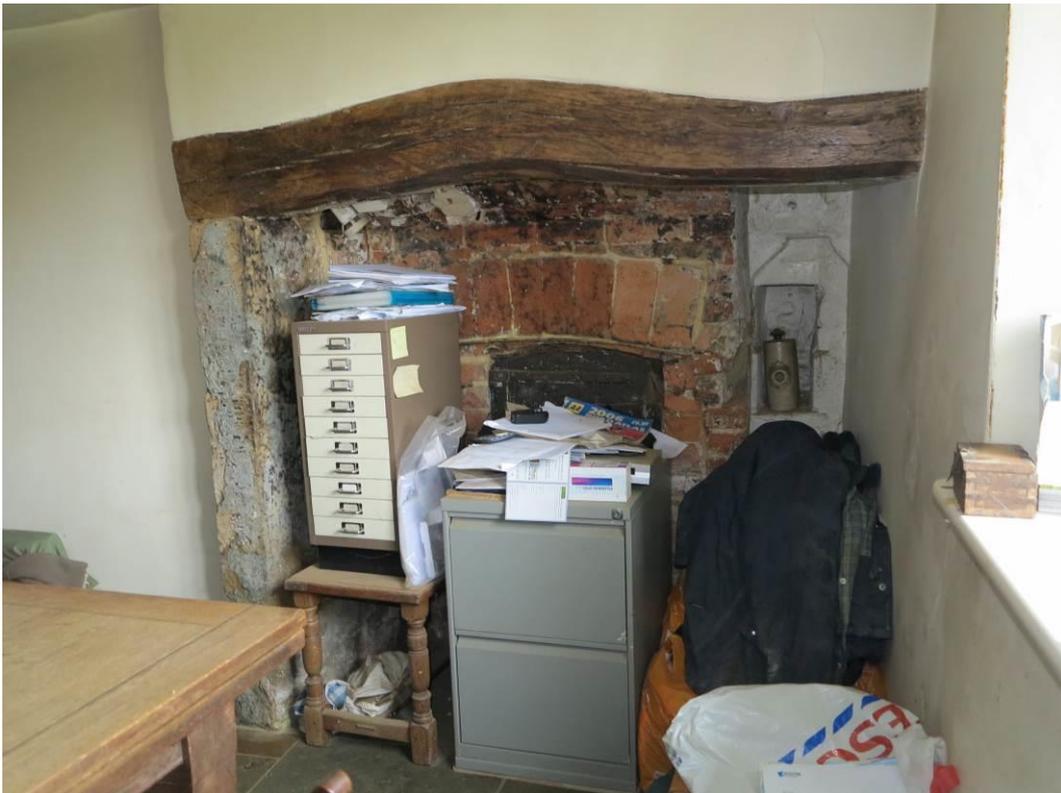
Plate 33. Inglenook fireplace in room below former granary

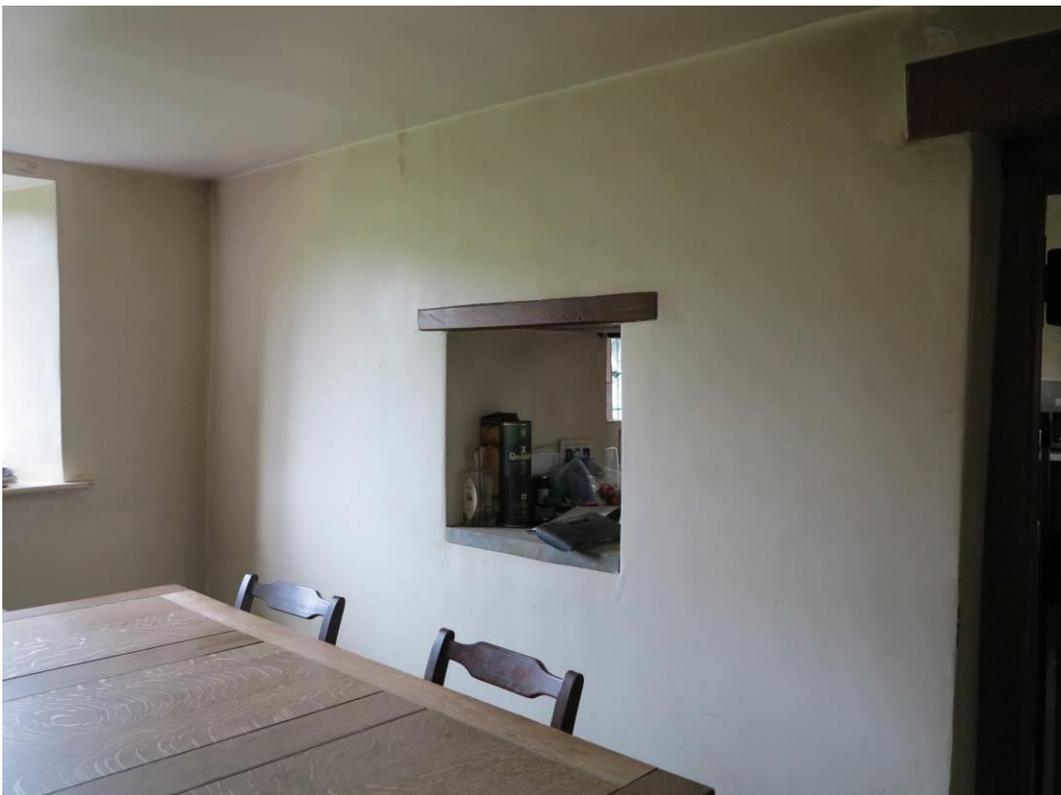
Plate 35. Former window in east wall of room below former granary

- 2.14 From this room a doorway, to the left of which is a former window opening (**plate 35**), leads into the 19th-century single-storey extension housing the present kitchen. There are no features of interest in this room (**plate 36**).

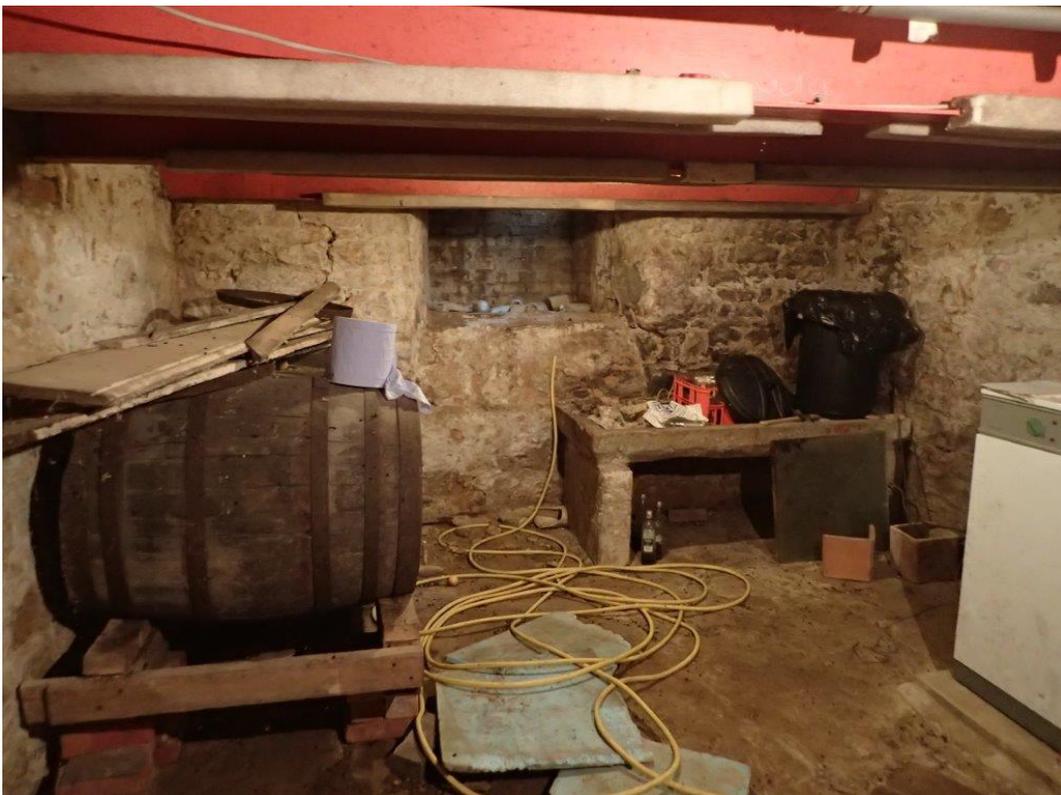
Plate 37. Cellar beneath western part of house

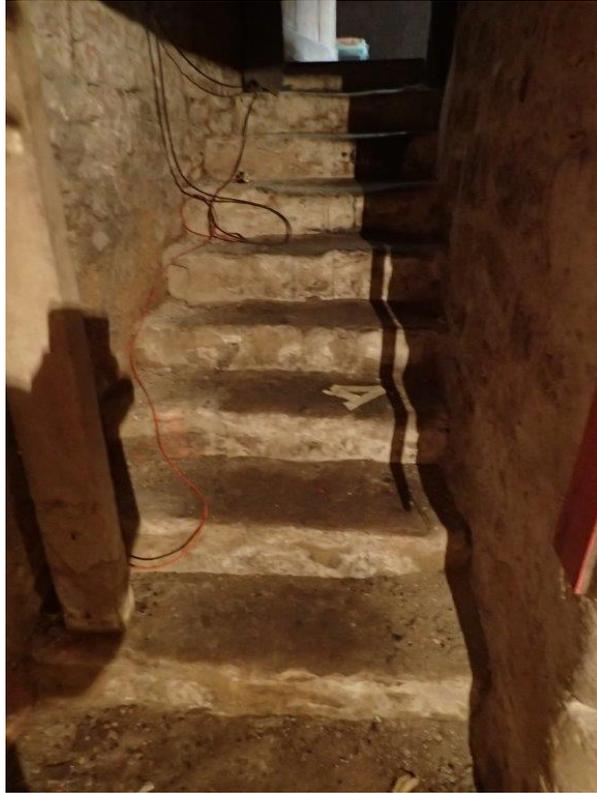
Plate 38. Stone steps to cellar

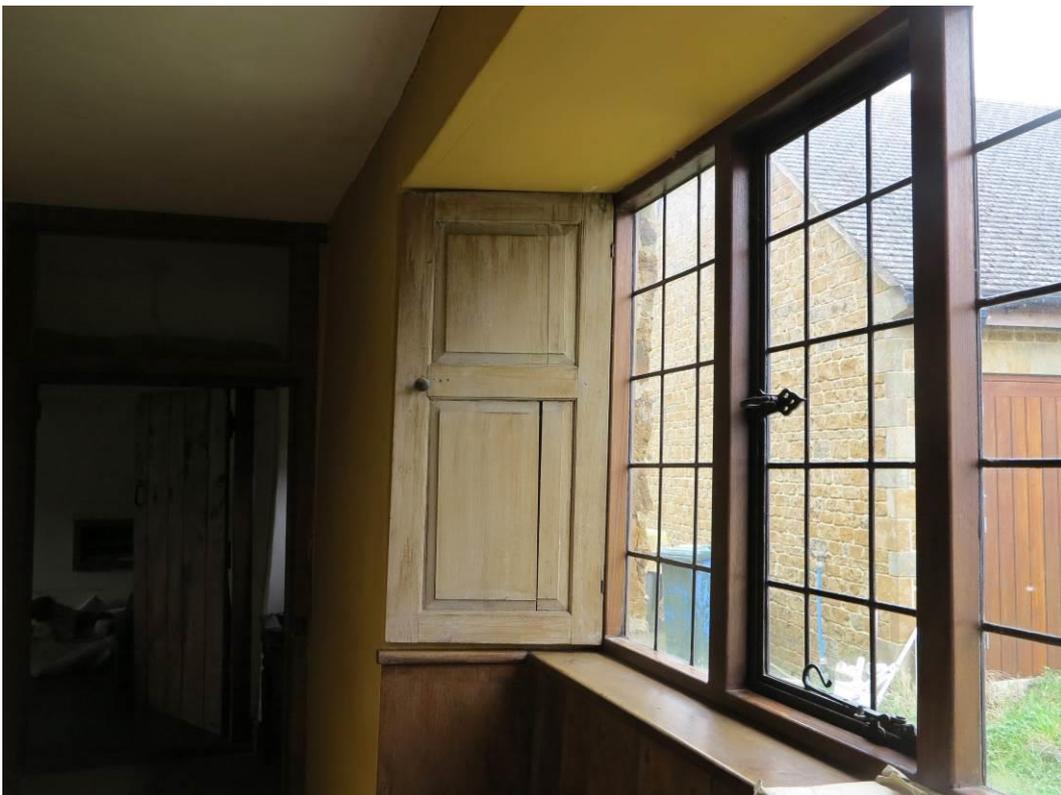
Plate 39. Internal window shutter in south wall of house

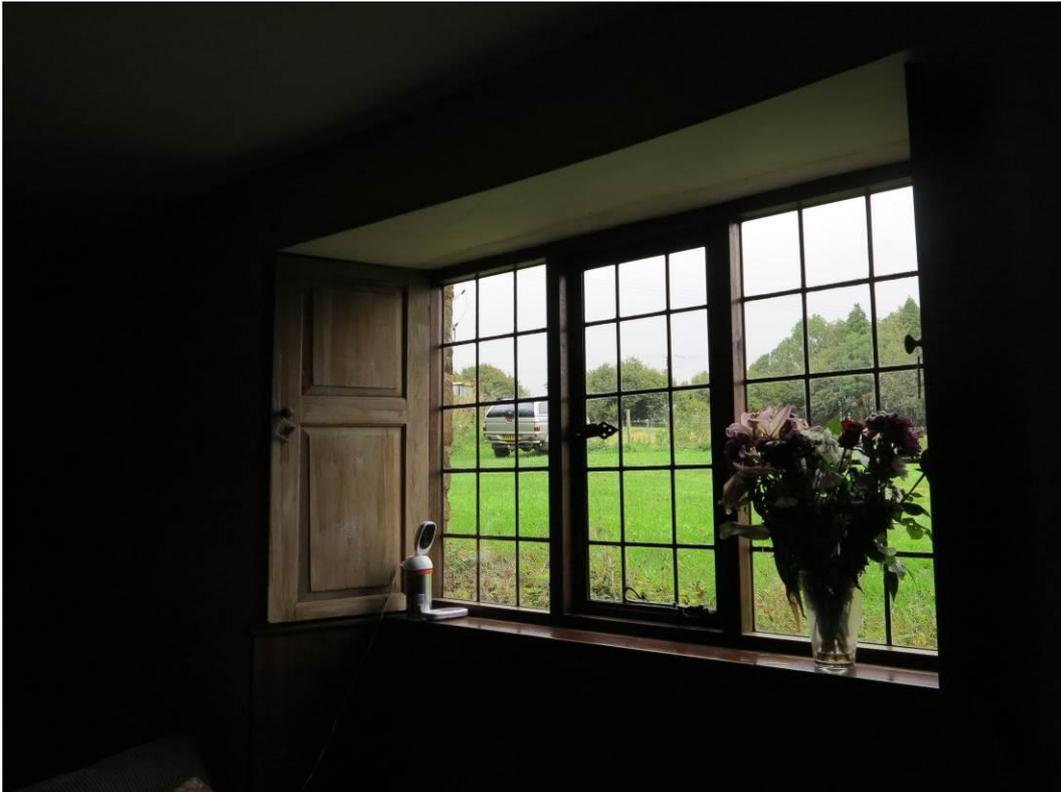
Plate 40. Internal window shutter in north wall of house

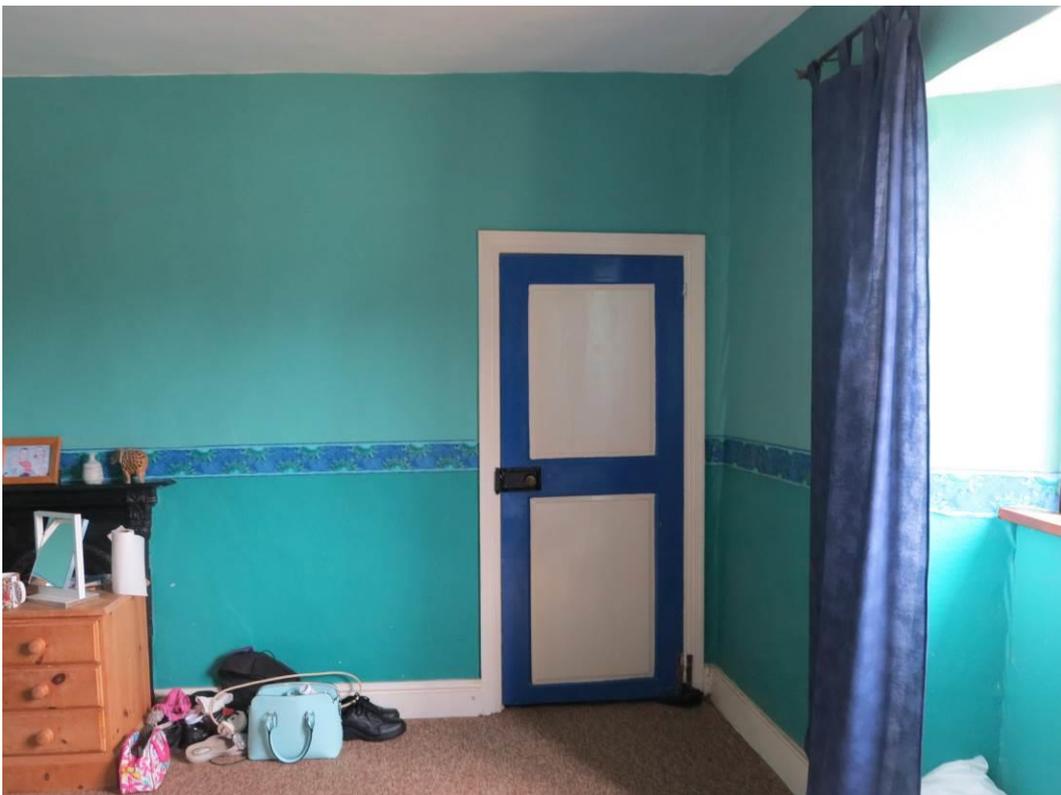
Plate 41. 18th-century two-panel door to built-in cupboard in east wall of main body of house

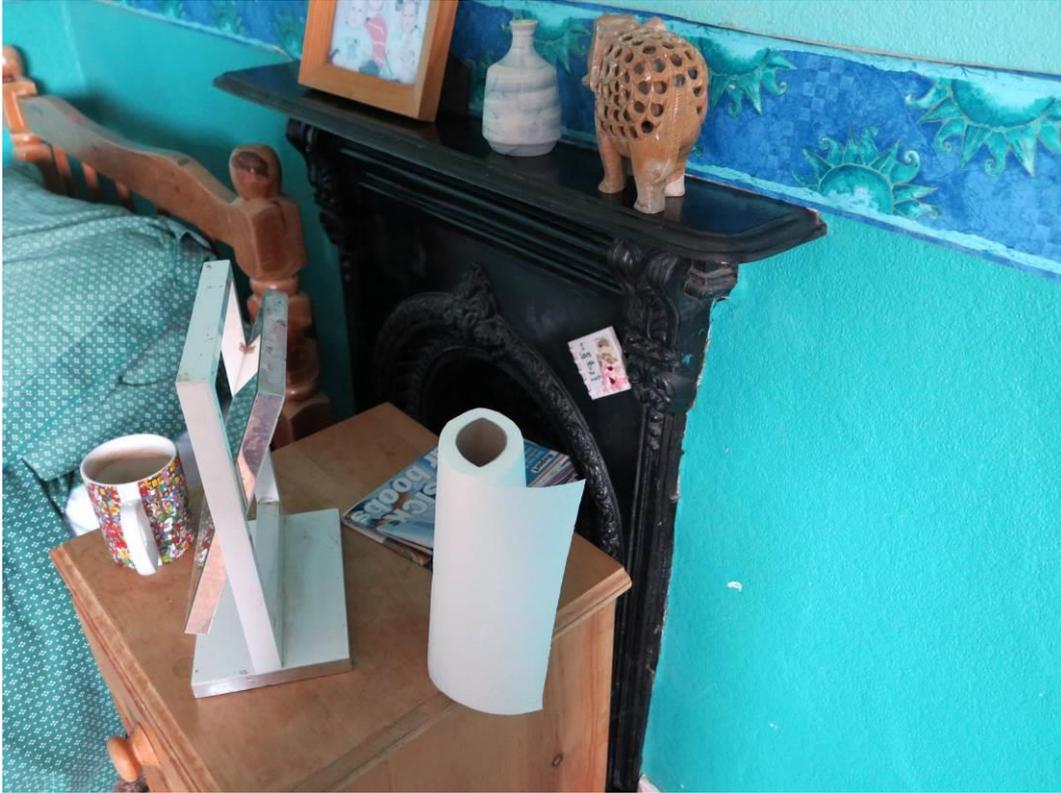
Plate 42. 19th-century cast-iron fireplace to left of built-in cupboard

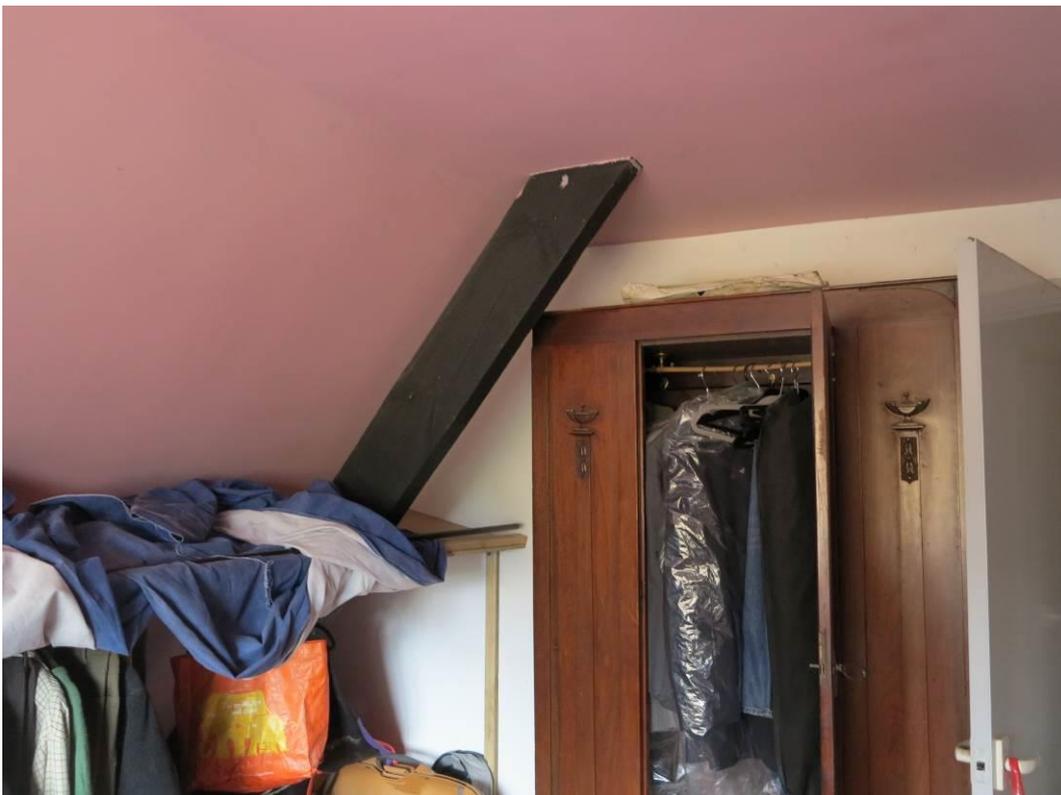
Plate 43. 20th-century roof structure in attic (west room)

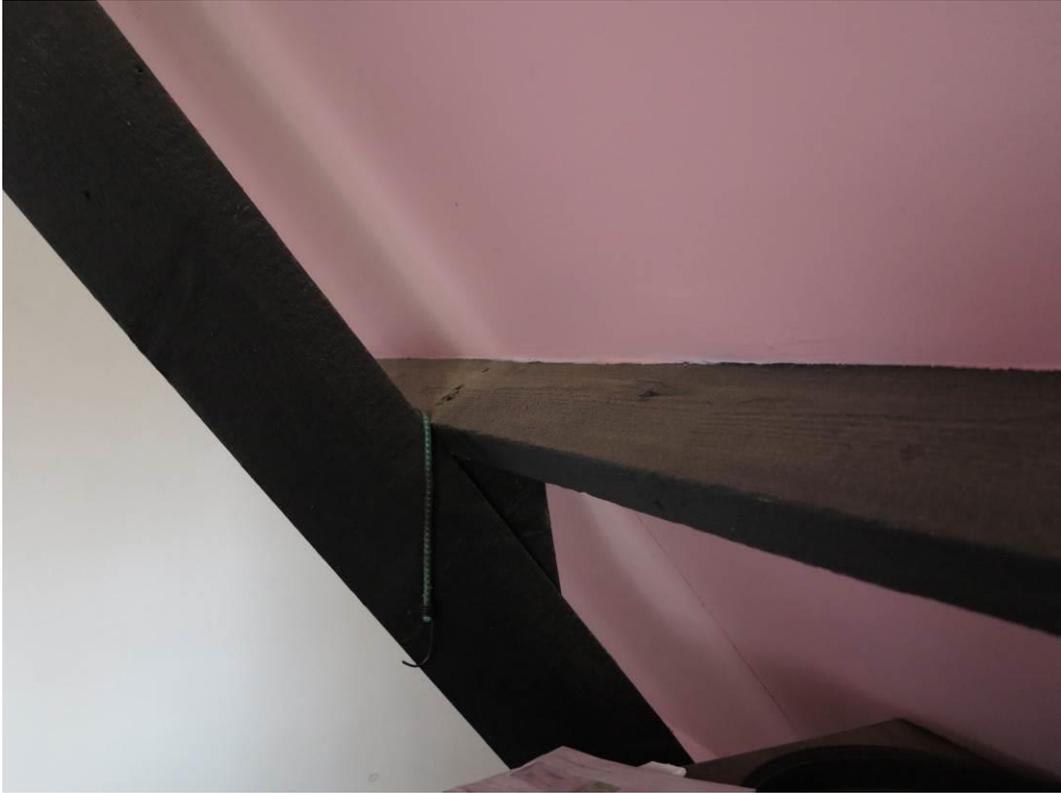
Plate 44. 20th-century roof structure in attic (west room) – detail

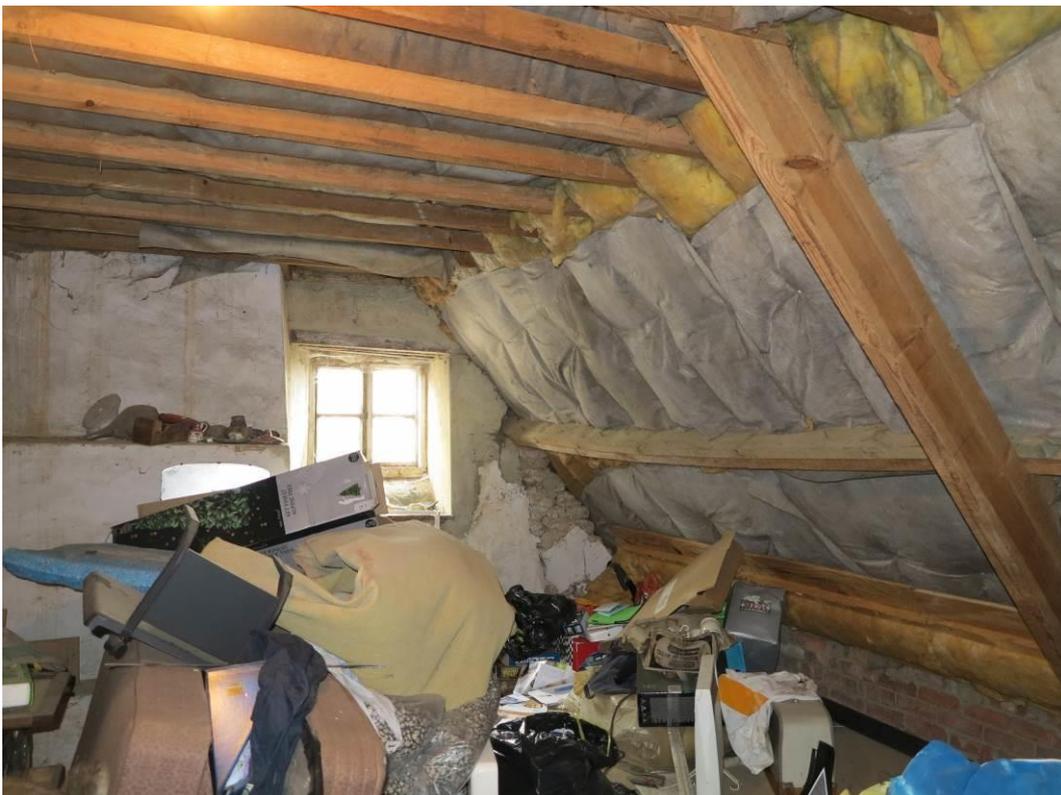
Plate 45. 20th-century roof structure in attic (east room)

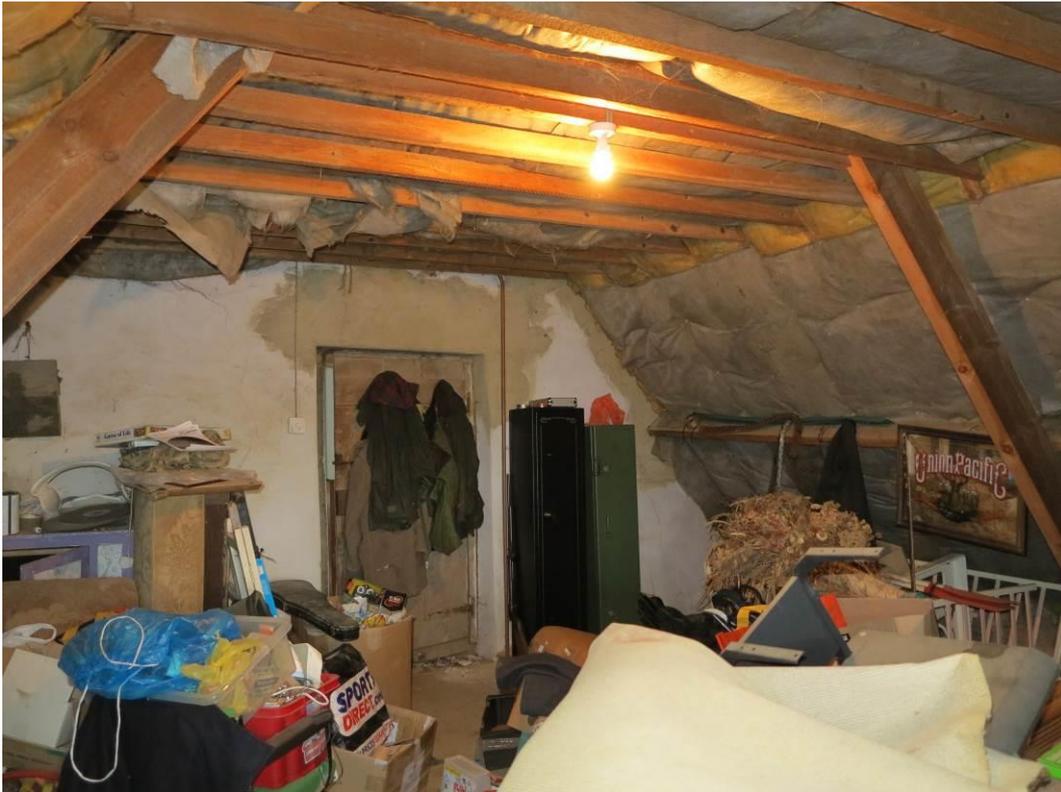
Plate 46. 20th-century roof structure in attic (east room)

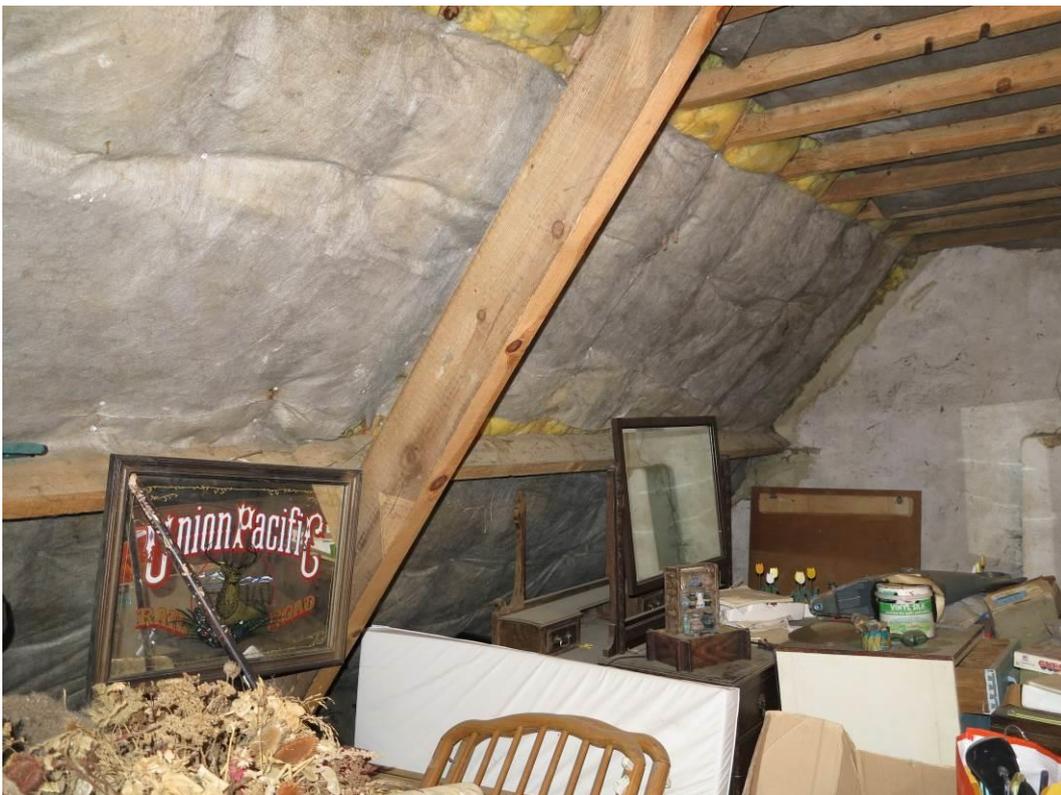
Plate 47. 20th-century roof structure in attic (east room)

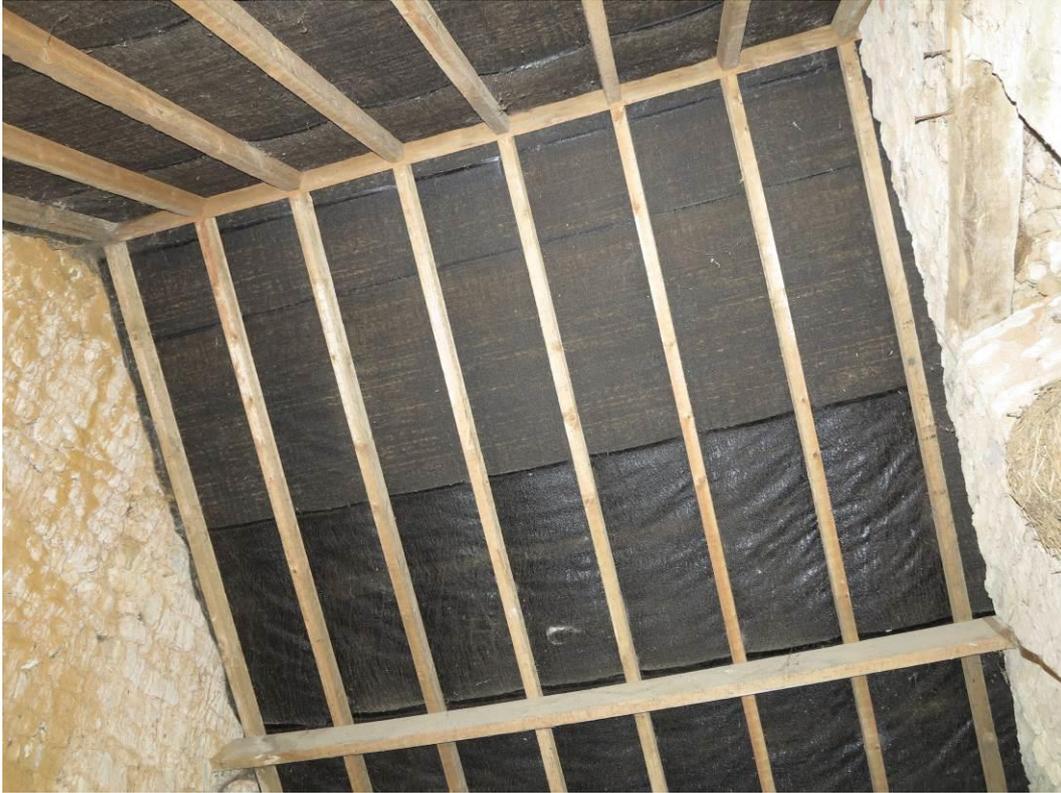
Plate 48. 20th-century roof structure of former granary
