HISTORIC BUILDING APPRAISAL & STATEMENT OF SIGNIFICANCE

BURDROP FARMHOUSE, BURDROP, OXFORDSHIRE

AHC REF: ND/9797

October 2019

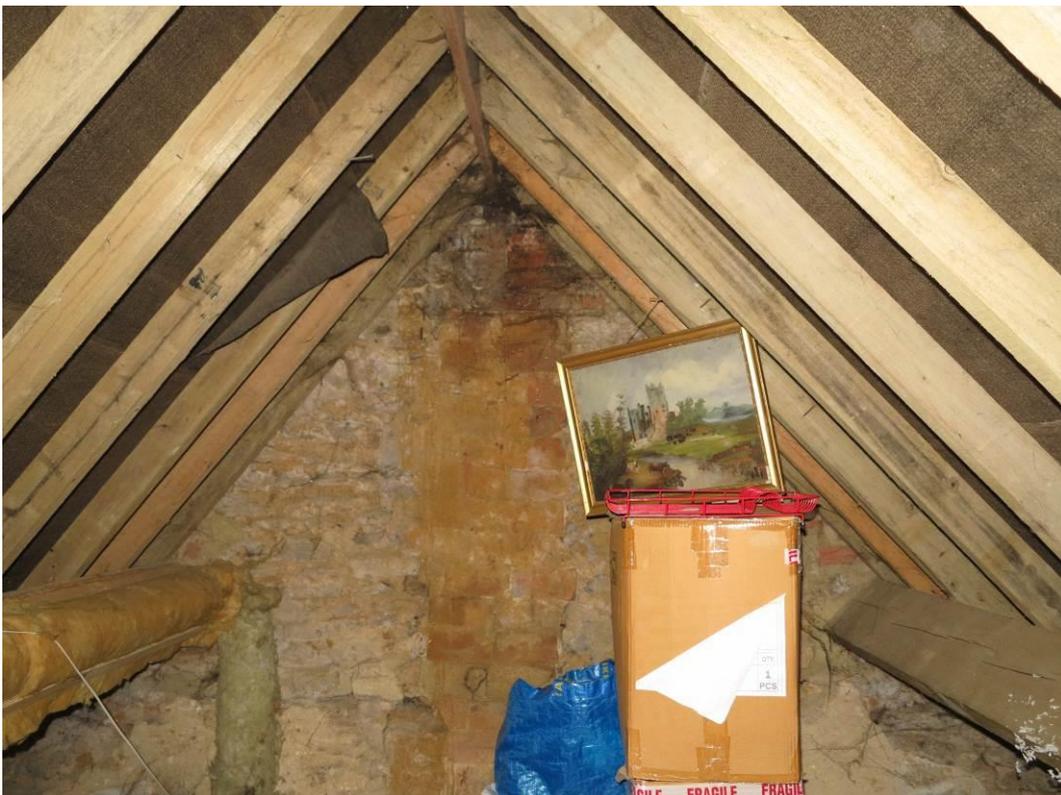
Plate 49. 20th-century roof structure of 19th-century single-storey addition

- 3.10 These options focus on either further extending the existing single-storey addition at the eastern end of the building or demolishing and rebuilding it. Either option could in my view be supported, given the existing extension's 19th-century origin and lack of historic features (all the windows and door are modern, while its roof structure was entirely replaced in the late 20th-century).

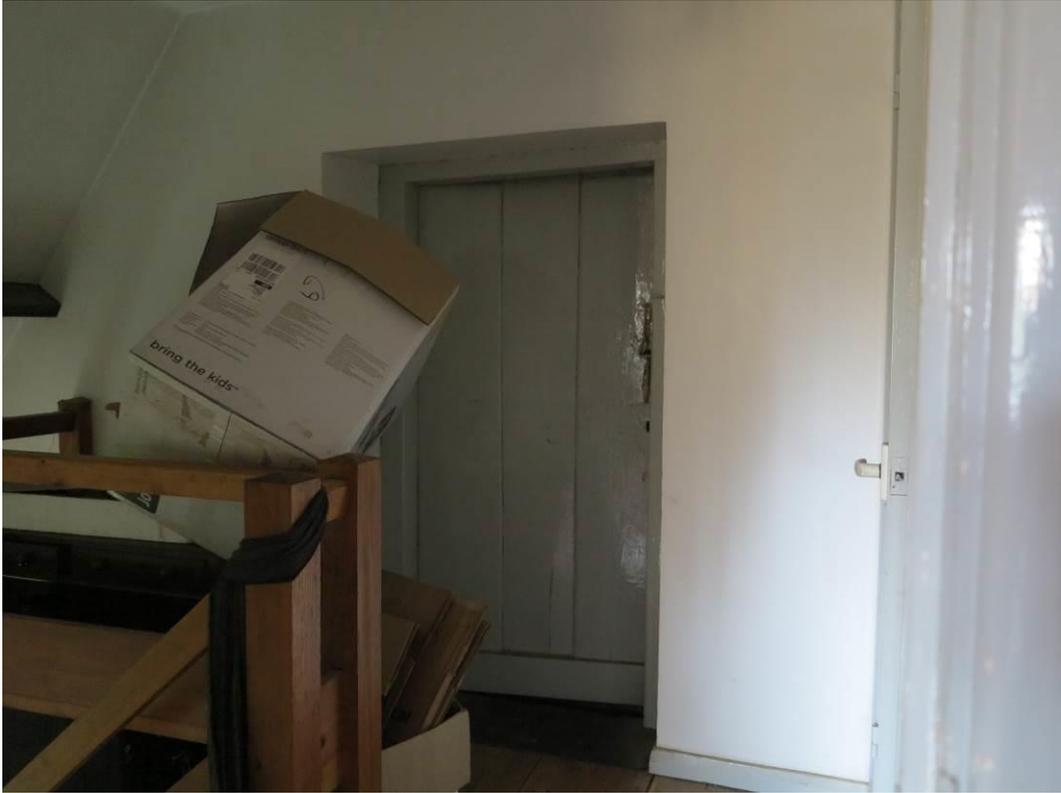
Plate 50. Plank door to east room in attic

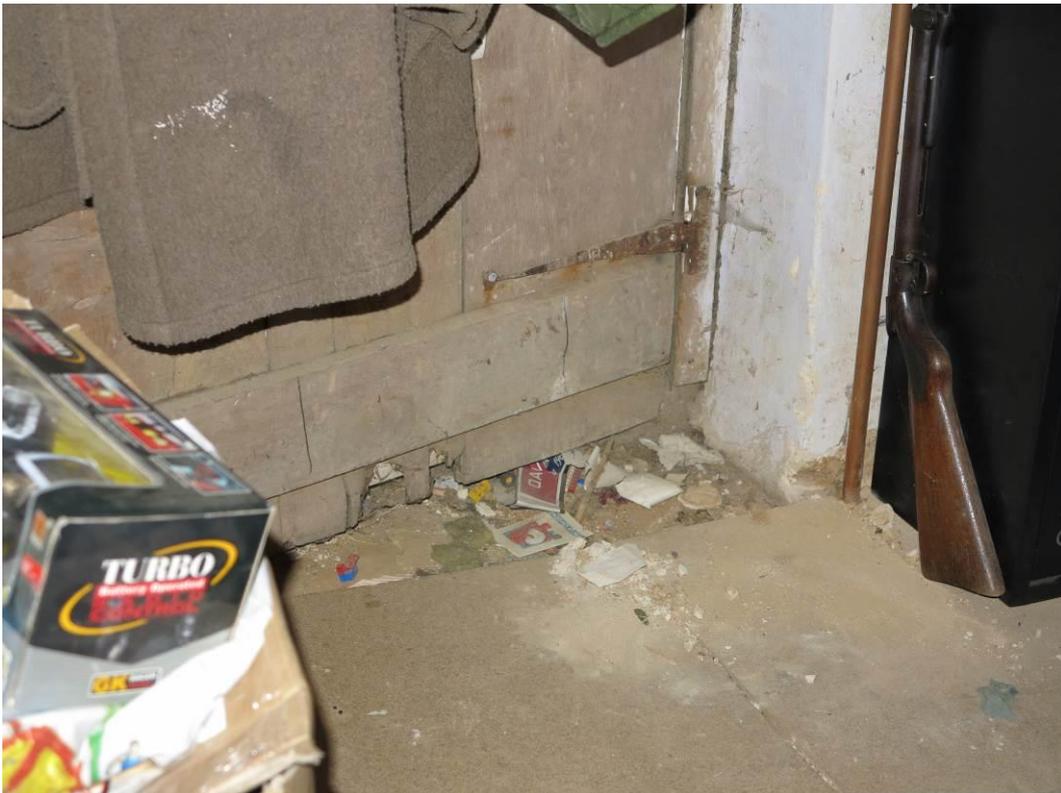
Plate 51. Strap hinges on reverse of plank door

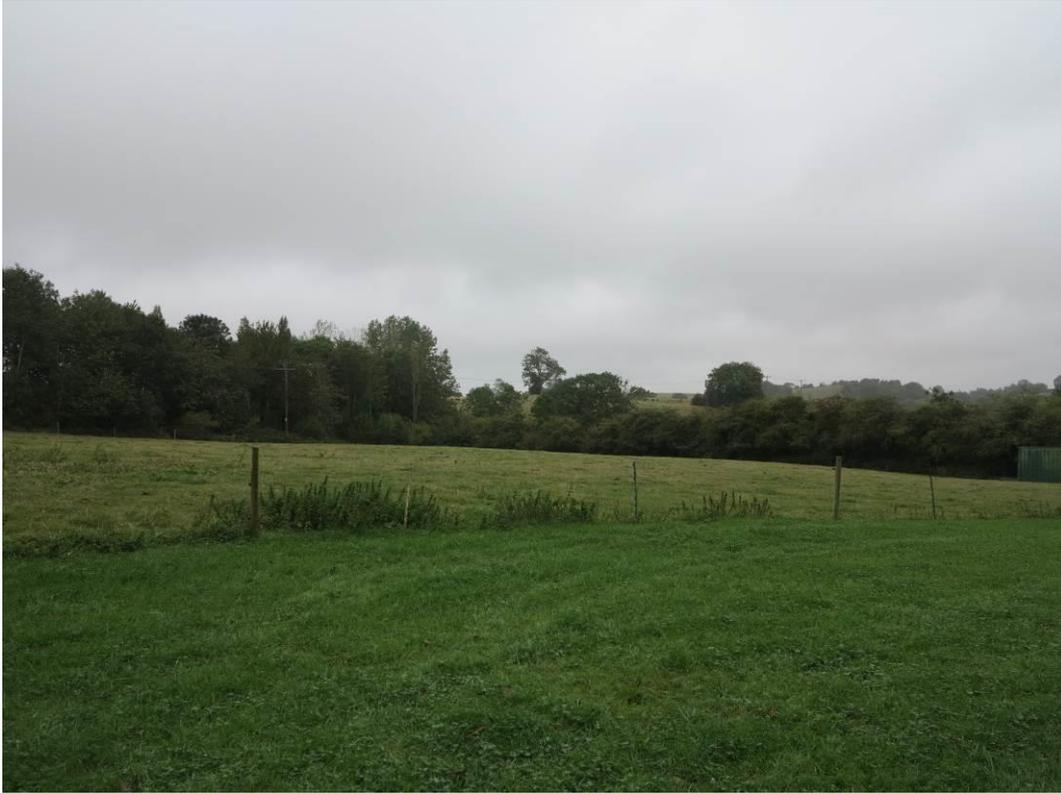
Plate 52. View looking north-east from Burdrop House

- 3.7 Turning now to the possibility of extending the house, the new owners understandably want to take advantage of the fine open views to the north of the house (**plate 52**) and, particularly given that any form of extension to the south and west elevations are out of the question, would like to consider an extension either to the north or east of the existing building.

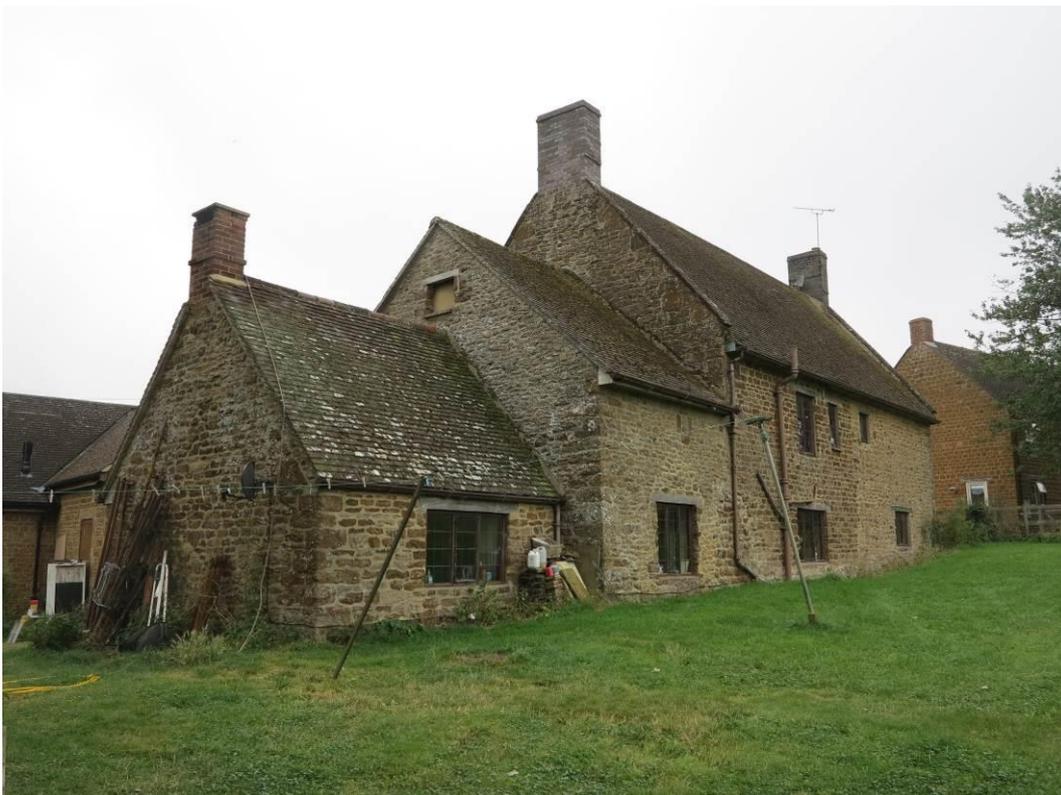
Plate 53. The rear (north) elevation of Burdrop House, seen from the north-east

- 3.8 They are however also mindful of the clear advice offered by the Council's Conservation Officer in her first pre-application response of 7 August 2019 regarding the strong linear form of the existing building and the 'solidity' of the north (rear) elevation with its relatively limited fenestration (**plate 53**).
