# WENDLEBURY LODGE, WENDLEBURY, OXFORDSHIRE

## HERITAGE ASSESSMENT

**PROJECT:** Wendlebury Lodge, Wendlebury, Oxfordshire

**DOCUMENT TITLE:** Heritage Assessment

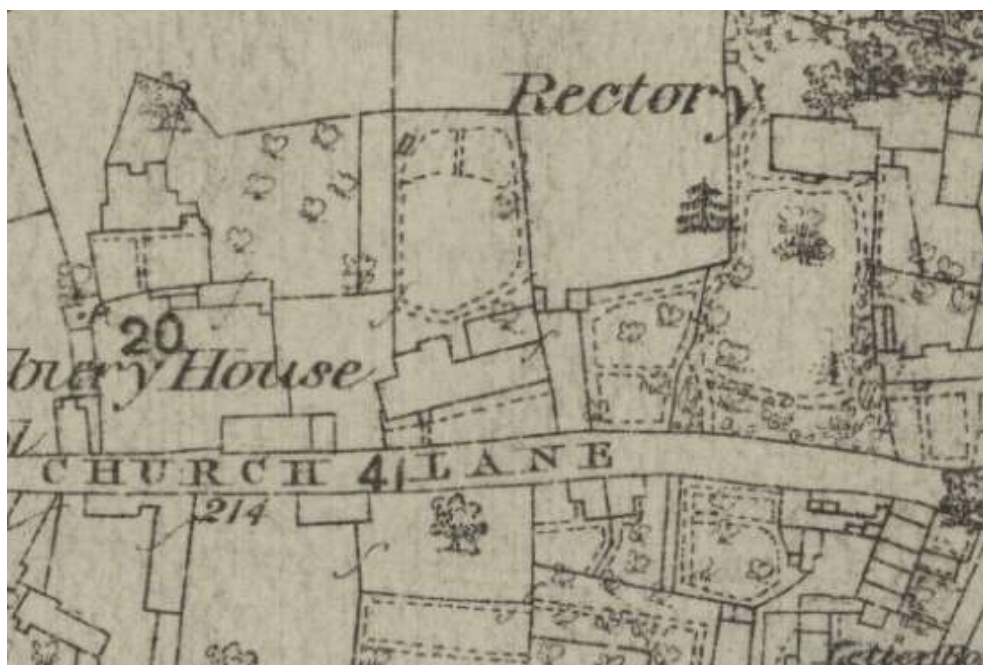
Figure 1: Extract from the 1<sup>st</sup> edition Ordnance Survey map (1880)

3.2.1 The 1<sup>st</sup> edition Ordnance Survey map (1880) shows the footprint of Wendlebury House and the layout of the garden. The western side of the house includes a porch on the south elevation and additions to the rear. By contrast, the eastern side of the house is shown as a long linear range with no additions to the rear. There is, however, an enclosed area shown to the rear which appears to separate the rear of this part of the house from the garden. The rear garden is laid out with paths which follow the line of the boundary of the property. At the front (south) of the house there is a path leading to the porch on the western side of the building. This path appears to extend along the front of the house. Two outbuildings are shown on the north-eastern side of Wendlebury House.

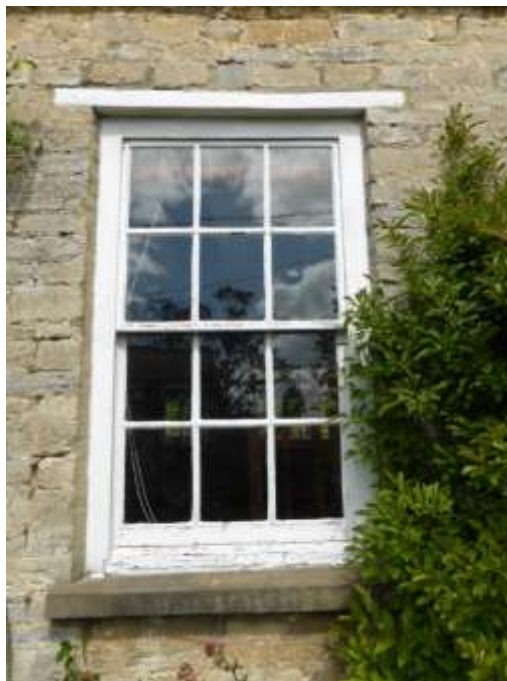
Figure 5: Ground floor six over six sash window with timber lintel and rendered sill

- 5.1.4 All of the windows on the front elevation are later 19<sup>th</sup> or early 20<sup>th</sup> century replacements. It is not clear if the original windows were cross windows with metal casements or sash windows with heavy ovolo glazing bars. The existing windows have rendered sills and slender lintels on

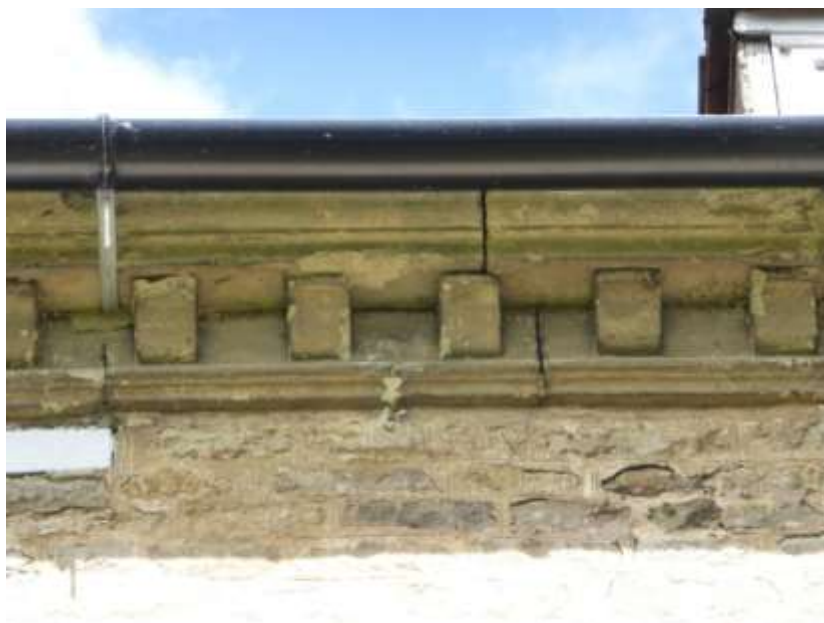
Figure 6: Stone dentil cornice

- 4.1.3 There is a stone plat band which defines the two storeys of the elevation. The head of the wall is decorated with a stone dentil cornice. Stone cornices had superseded the wooden eaves cornice by the second decade of the 18<sup>th</sup> century (Forrester, p. 21).

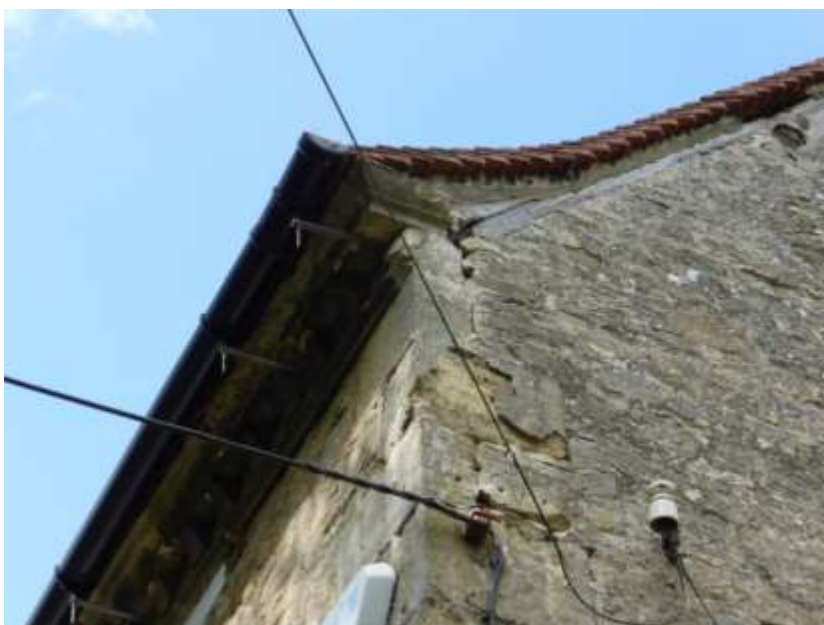
Figure 7: Bellcast eaves and stone quoin details

- 4.1.1 Wendlebury Lodge is of rubble stone construction with plinth and stone quoins. The roof is double pitched with gable ends and bellcast eaves. The roof is finished with clay tiles. Originally part of a six window range, the front elevation of Wendlebury Lodge has four first floor window openings with six over six unhorned sash windows and one blind window to the left. This blind window is in line with the chimney stack and was probably inserted to maintain a symmetrical front. The window openings on the ground and first floors have slender timber lintels, rendered sills and exposed sash boxes. There is a horned sash on the right hand side of the ground floor which suggests a later 19<sup>th</sup> or early 20<sup>th</sup> century alteration. The exposed sash boxes suggest an earlier date but six over six sash windows continue in use into the mid-19<sup>th</sup> century and became popular in the early 20<sup>th</sup> century as part of Neo-Georgian and Arts and Crafts style. The sash fasteners of these windows are all typical of the second half of the 19<sup>th</sup> century (Pearce, p. 111). The chamfered glazing bars are also typical of later 19<sup>th</sup> and early 20<sup>th</sup> century construction techniques for sash windows.

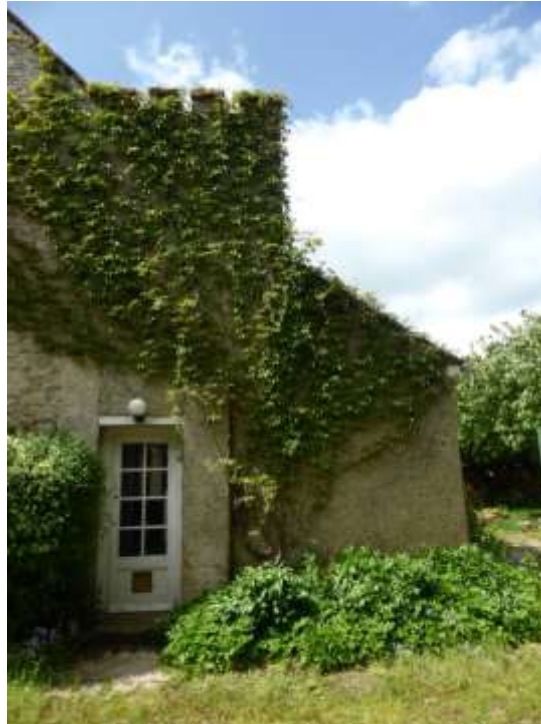
Figure 12: Early 20<sup>th</sup> century extensions to the rear

- 4.2.3 The Attic window has a wooden frame and contains three metal casements with leaded lights. Window fittings suggest a late 19<sup>th</sup> or early 20<sup>th</sup> century date for this window.
- 4.2.4 To the right there is an extension which includes a two storey element with crenelated parapet and a single storey lean-to. These two elements are both pebble dashed and it is not therefore possible to determine whether this represents one or two phases of development. Historic mapping suggests that they had both been built by 1920. This appears to be supported by a butt joint between the rubble stone construction of the lean-to and the brick piers and first floor walling of the two storey crenelated extension. There is a modern door on the left hand side of a brick buttress finished with pebble dash.

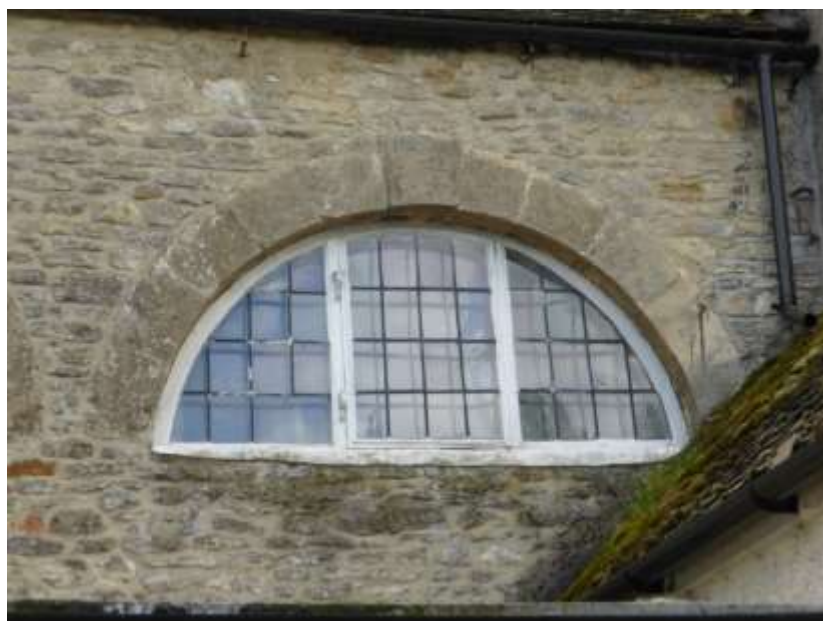
Figure 14: Detail of the early 18<sup>th</sup> century thermal window on the right hand side

- 4.3.1 The north elevation of the original house is predominantly masked by later additions. Two thermal windows remain visible on the first floor. These include stone surrounds with keystones. The windows include two mullions with a central side opening casement and fixed lights either side. The opening casement is metal and is hung on decorative spiral pintles. This form of decoration for the ironwork on windows is typical of the later 17<sup>th</sup> and early 18<sup>th</sup> centuries.

- 4.5.7 Other than the thermal window on the northern side of F3, nothing of interest was observed. Details of this window include an L-shaped bar catch, spiral handle and a window stay. The catch and handle may date from the 18<sup>th</sup> century but the stay appears more 19<sup>th</sup> century in character.

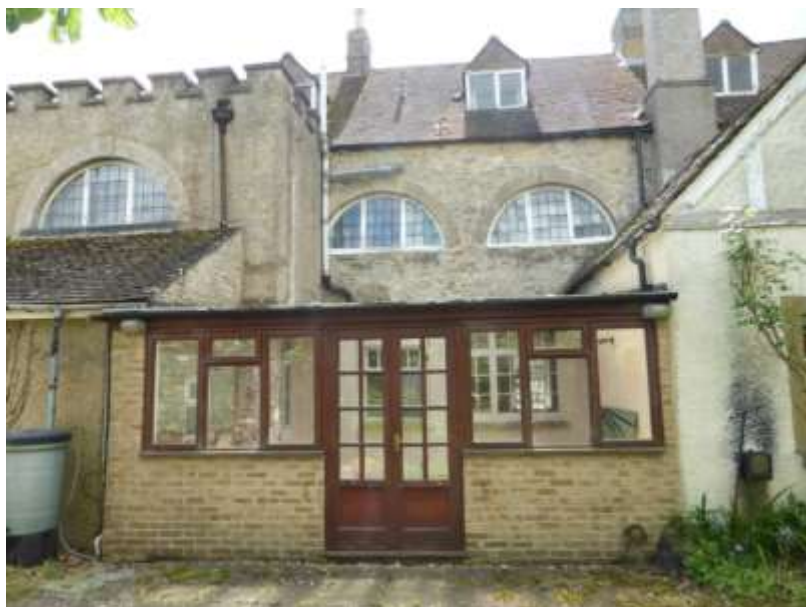
Figure 17: Modern conservatory

- 4.3.4 The rear wall of the lean-to is finished with pebble dash and the roof with clay tiles. There is a modern storm casement with top hung light.
- 4.3.5 At the centre of the rear elevation there is a modern conservatory. This is of brick construction in stretcher bond with dark stained window and door joinery

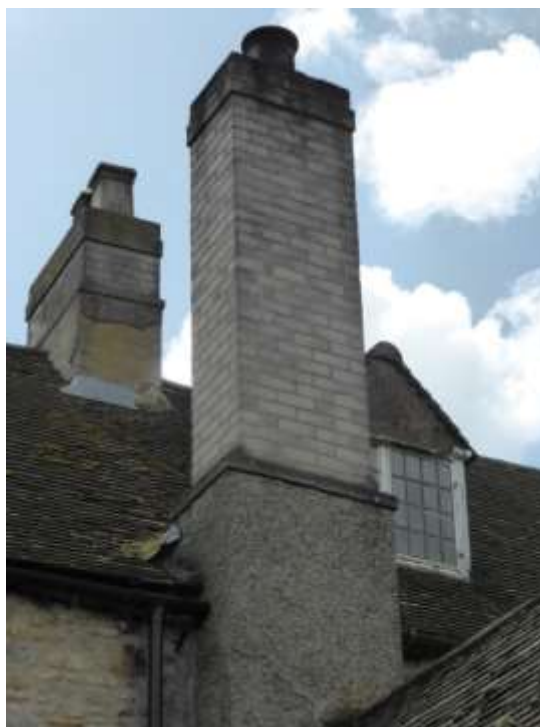
Figure 19: 20<sup>th</sup> century chimney stack on the right hand side of the rear elevation

this extension there is a stack which has been partly pebble dashed, suggesting that it was inserted as part of the early 20<sup>th</sup> century alterations to the house. The upper part of the stack appears to have been rebuilt using white bricks.

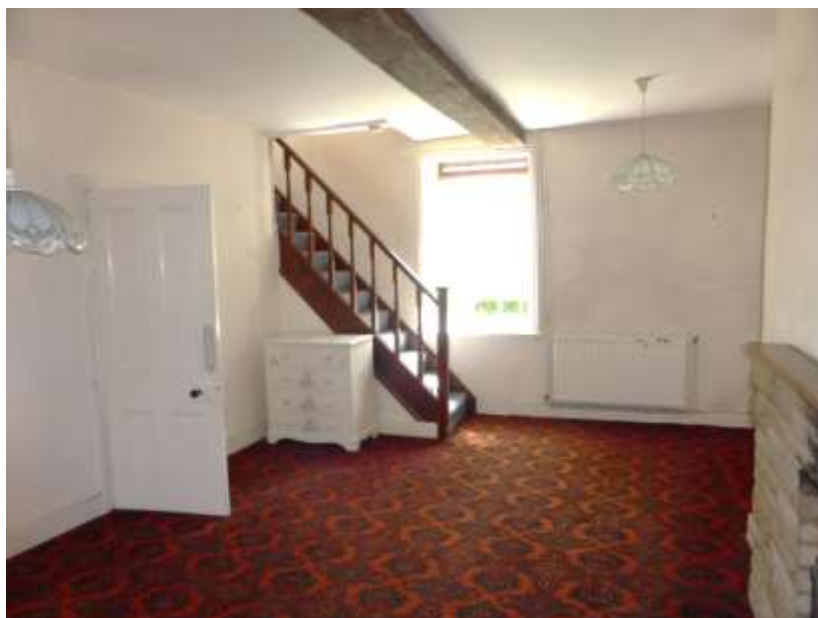
Figure 20: The Dining Room (G1)

- 4.4.3 There is a large chimney breast on the west wall with modern stone fire surround and wood burner. The staircase and enclosure along the front wall of G1 are modern. A transverse beam passes through the centre of the room and appears to rest on a very shallow lintel over the sash window on the front elevation.

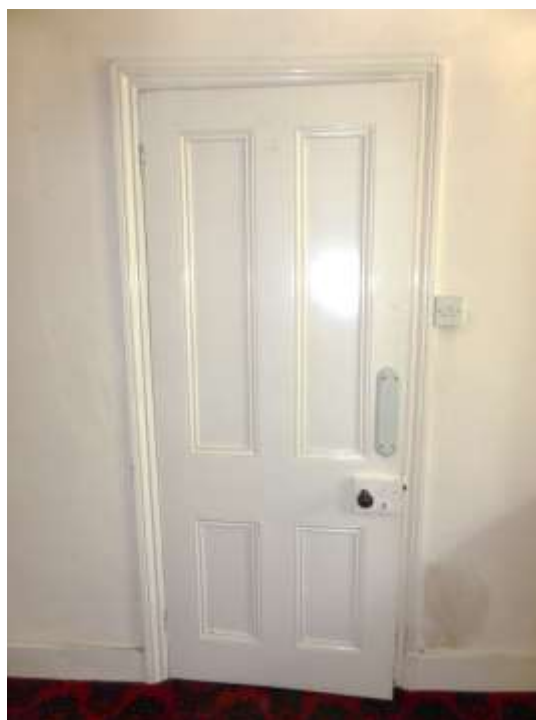
Figure 21: An early 20<sup>th</sup> century door and architrave between G1 and G2

- 4.4.1 The Dining Room (G1) is accessed from the Hall (G2) through a four panel door. The mouldings around the sunk panels and the door architrave suggest a later 19<sup>th</sup> or early 20<sup>th</sup> century date. The door on the rear wall of G1 leading to the Kitchen (G10) is of similar design. The breach through the wall in this location was created in the first two decades of the 20<sup>th</sup> century and this provides a date for the insertion of the door.

4.4.7 G3 is accessed from the Hall (G2). The door and architrave to G3 are of the same design as the door to G1 from the Hall (G2), i.e. probably early 20<sup>th</sup> century (see figure 25).

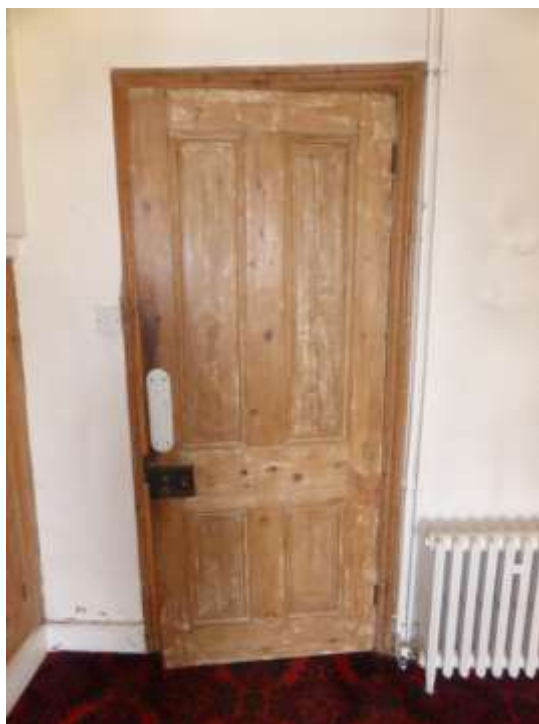
Figure 22: An early 20<sup>th</sup> century door leading to the Kitchen (G10)

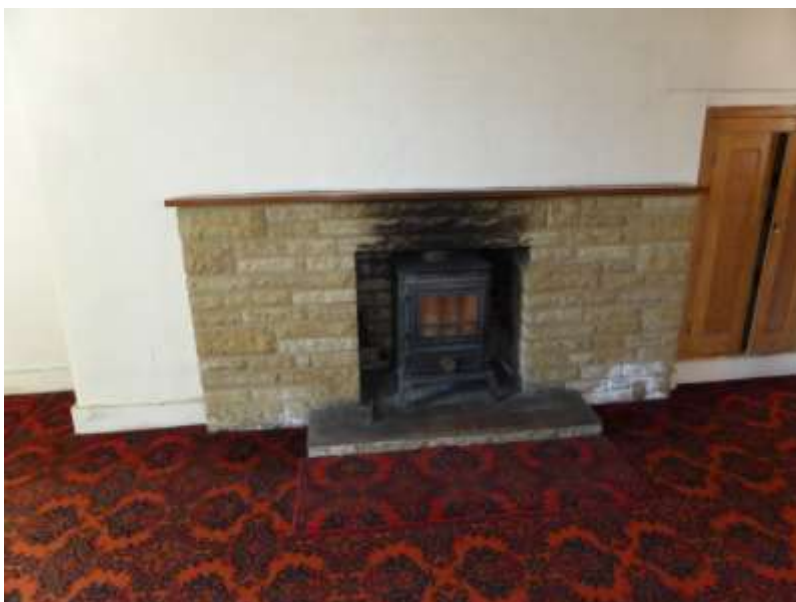
Figure 24: Modern fireplace in G1

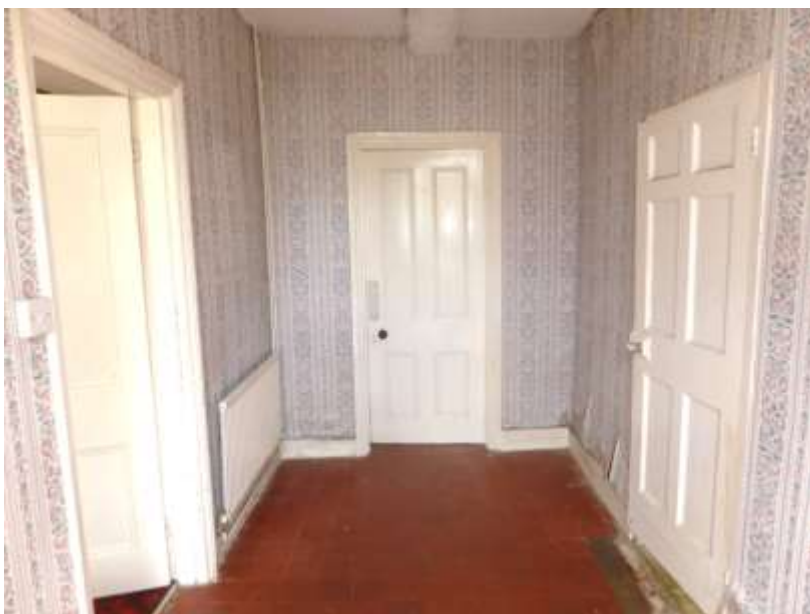
Figure 25: The Hall (G2) looking north

- 4.4.4 The Hall (G2) is accessed externally through a door on the south elevation. This front door possibly dates to the early part of the 20<sup>th</sup> century as suggested by the three panels below the lock rail. The upper glazed part of the door is probably a modern alteration.
- 4.4.5 The floor is finished with quarry tiles. This is a typical floor finish used for the halls of late Victorian and Edwardian houses and continued to be used in kitchens and sculleries into the 1930s and 40s.
- 4.4.6 A transverse beam crosses through the centre of G2 and, similar to G1, appears to rest on a slender lintel over the front door. The Hall provides access to G3 and G4.

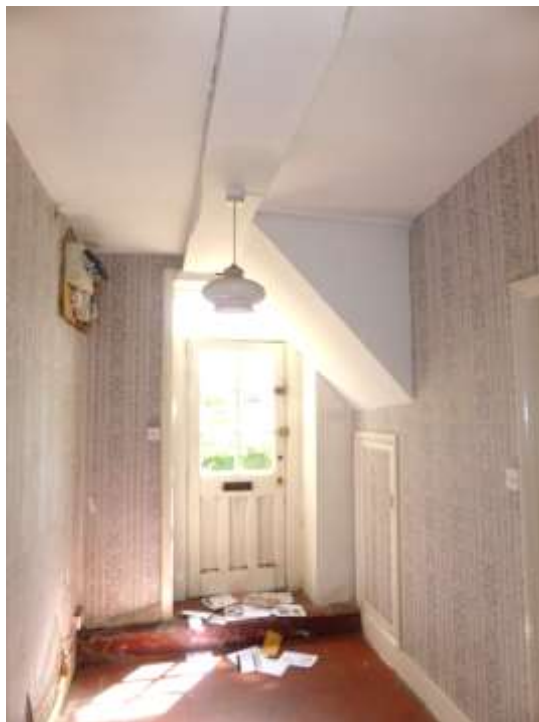
Figure 26: The Hall (G2) looking south towards the front door

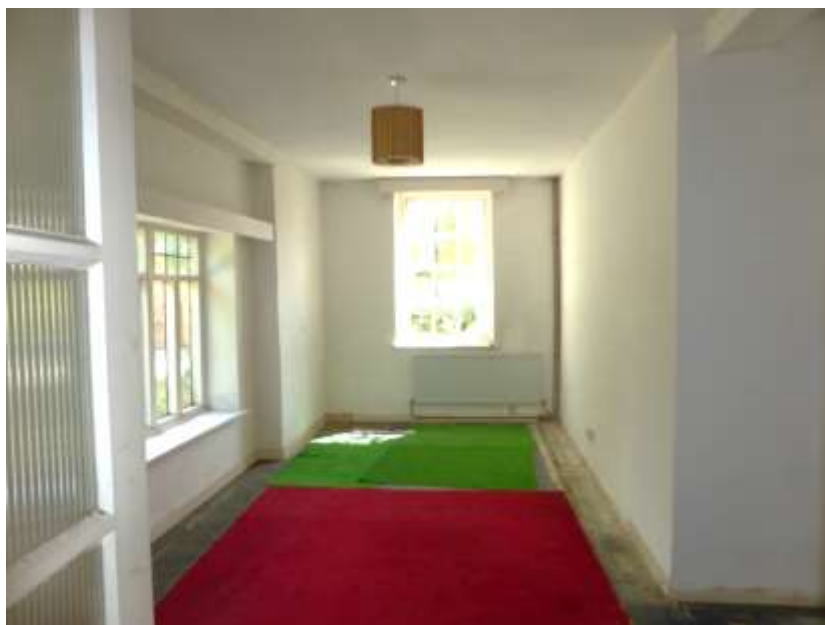
Figure 29: The Study (G6) looking south

4.4.10 The Study (G6) is accessed from G7 through a modern glazed door. The window along the south wall includes sash horns which have a similar profile to later 19<sup>th</sup> and early 20<sup>th</sup> century examples (Hall, p. 80) and a 19<sup>th</sup> century sash fastener which is of different design to those observed for the rest of the house. There is an early 20<sup>th</sup> century window with fixed casements

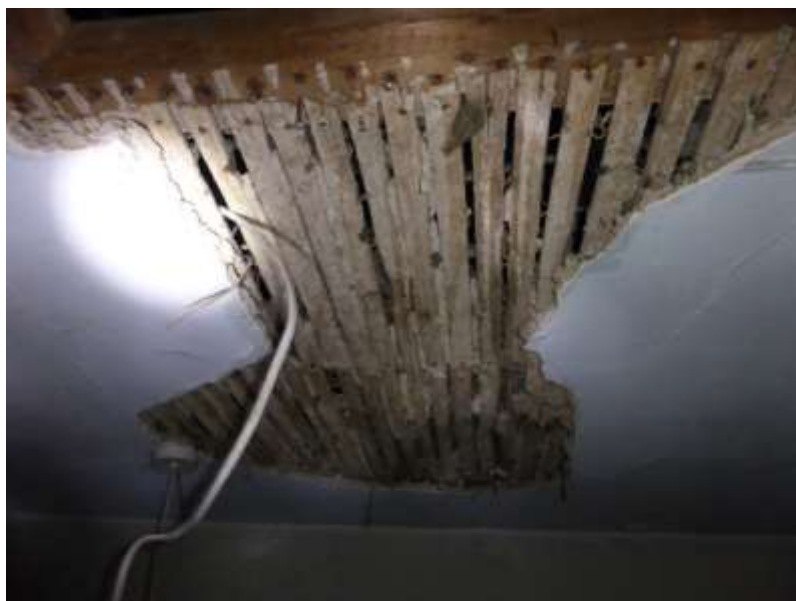
Figure 36: Lath and plaster ceiling above the modern ceiling

4.4.14 The Kitchen (G10) is accessed through an earlier 20<sup>th</sup> century door from the Conservatory (G9). There is a chimney breast with blocked up fireplace on the south wall. The modern suspended ceiling conceals the early 20<sup>th</sup> century lath and plaster ceiling above. The roof structure, which is common rafter with ridge plank and side purlins can be observed through a ceiling hatch. There is a window opening with 20<sup>th</sup> century casements multi-pane lights on the north wall.

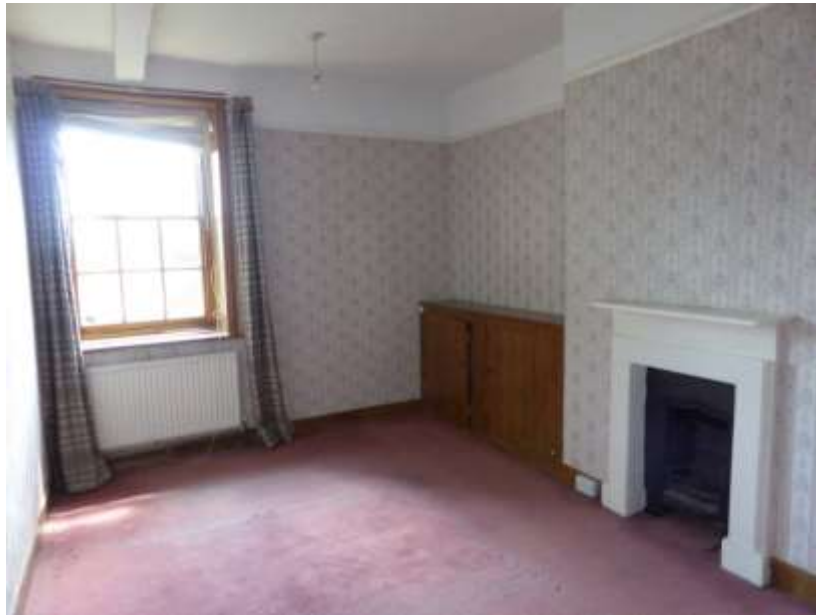
Figure 38: Bedroom F1 looking south

- 4.5.1 Access to F1 is through a six-panel door with metal lock case and butt hinges. The door design is typical of 18<sup>th</sup> and early 19<sup>th</sup> century doors. The simple ovolo moulding around the sunk panels is, however, characteristic of the second quarter of the 19<sup>th</sup> century and early 20<sup>th</sup> century Arts and Crafts/Neo-Georgian influenced designs. It appears that this door has either been re-used, perhaps from elsewhere within the house, or is an early 20<sup>th</sup> century door. Given the changes noted elsewhere this is likely to be an early 20<sup>th</sup> century door. The architrave is reminiscent of designs found from the middle of the 19<sup>th</sup> century and into the early 20<sup>th</sup> century.

- 4.5.2 The six over six sash window along the south wall includes a later 19<sup>th</sup> century type fastener similar to the one in G6. The lamb's tongue glazing bars are similar to early 20<sup>th</sup> century examples (Rivington, p. 100).

- 4.5.2 There is a transverse beam which, similar to the ground floor, is positioned in line with the sash window on the front elevation. The room is decorated modestly with a picture rail and plain fire surround. The fireplace includes a cast iron grate with ogee decoration and a lining of bricks. These details suggest a post-1850 date for insertion of the grate. The skirting board is of plain design.

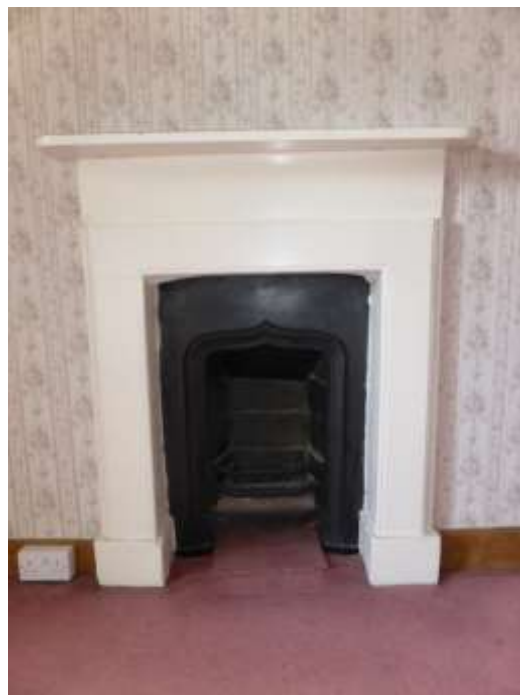
Figure 39: Later 19<sup>th</sup> century coal grate in F1

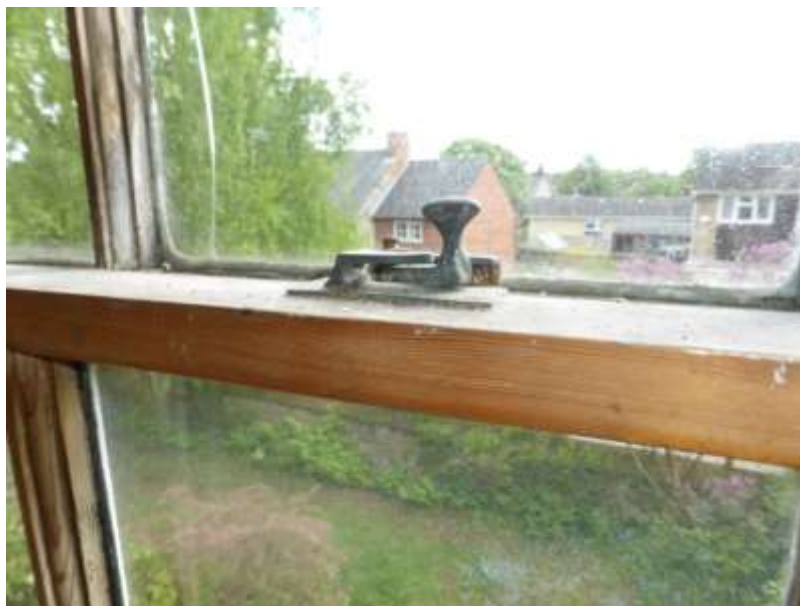
Figure 41: Later 19<sup>th</sup> to early 20<sup>th</sup> century window details in F1

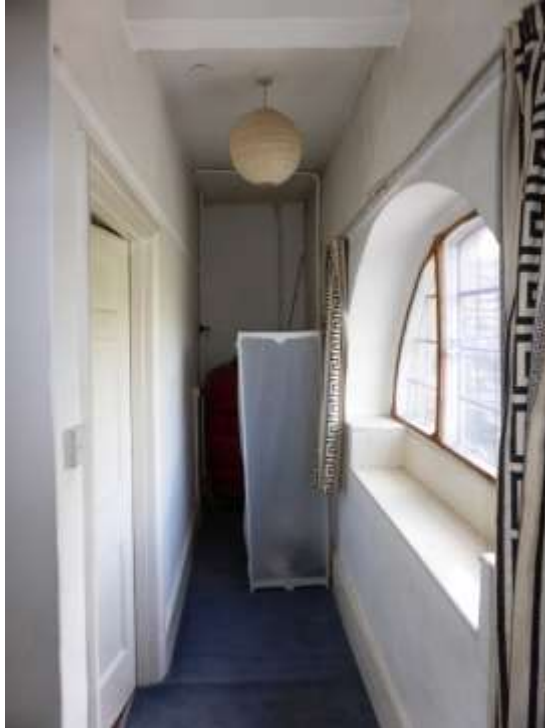
- 4.5.4 The rear section of F2 is illuminated by a thermal window. This window includes a central iron framed casement. Window fittings include a spiral casement handle and a turnbuckle catch which terminates in a small spiral. These details are consistent with an early 18<sup>th</sup> century date.
- 4.5.5 The front section of F2 provides access to a straight flight staircase with winder. This staircase has simple square section spindles, hand rail and simple square section newel post. This may have been inserted as part of the early 20<sup>th</sup> century alterations.

Figure 42: Rear section of F2 with early 18<sup>th</sup> century thermal window to the right

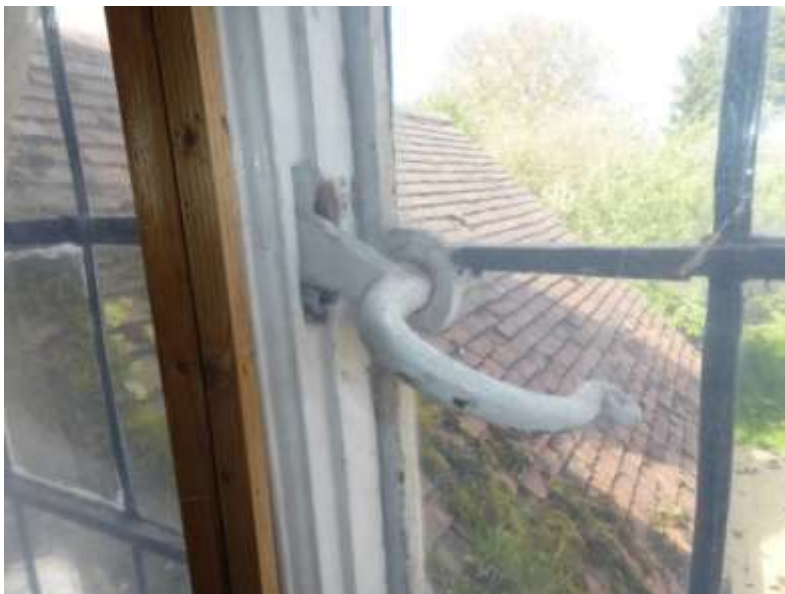
Figure 43: Detail of the window catch of the thermal window

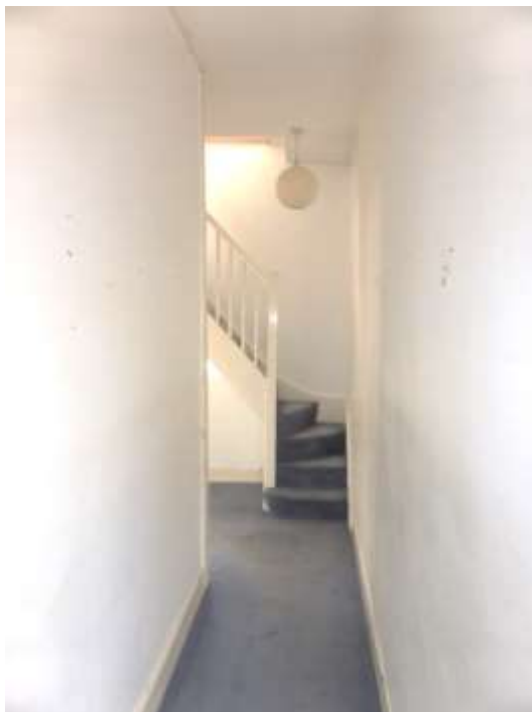
Figure 44: Central section of F2 leading to the stairs to the Attic and to Bedroom F5

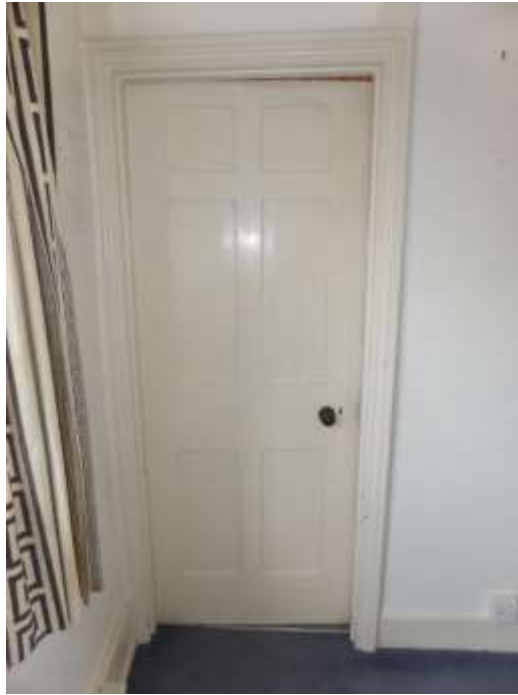
4.5.6 Unlike the other rooms on the first floor, the door to F3 has fielded door panels. The door architrave is the same style as the architraves to F1 and F5, i.e. of a style which is common in the later 19<sup>th</sup> and early 20<sup>th</sup> centuries. It is likely that both door and architrave are 20<sup>th</sup> century. It should be noted that reproduction doors with fielded panels have been used where other 20<sup>th</sup> century partitions have been inserted within the building.

Figure 45: Early 20<sup>th</sup> century door to F3

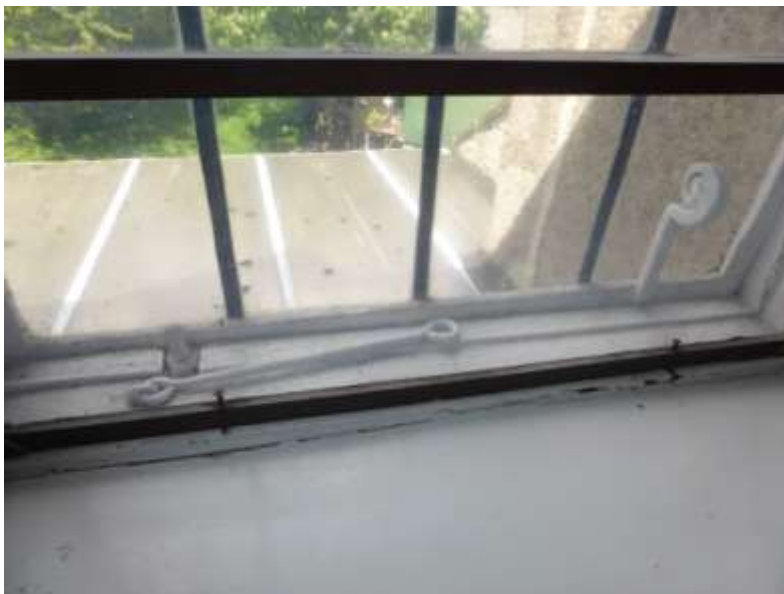
Figure 47: Casement handle and stay in F3

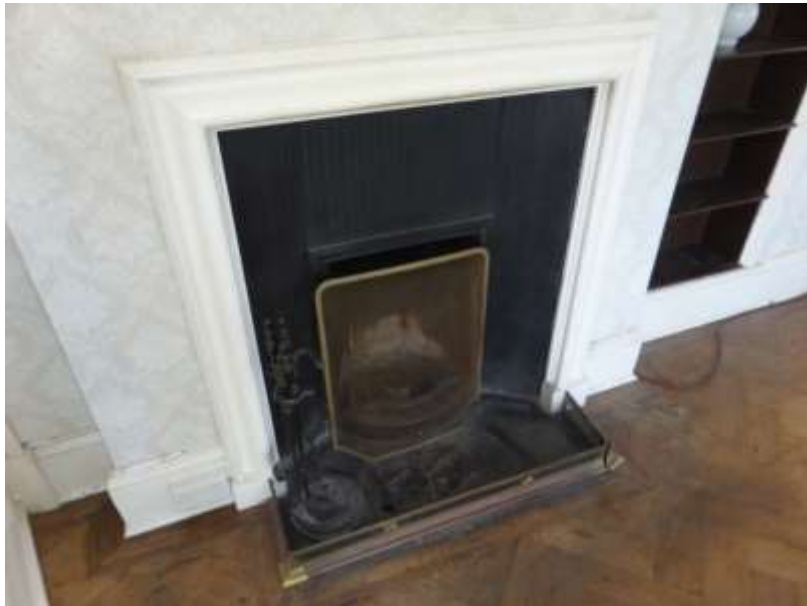
4.5.10 The wooden fire surround includes bolection moulding which appears to be Edwardian in date rather than earlier. The cast iron cheeks of the grate are unusual but appears to also be of early 20<sup>th</sup> century date, as is the grate itself.

Figure 50: Early 20<sup>th</sup> century coal grate with bolection moulding surround

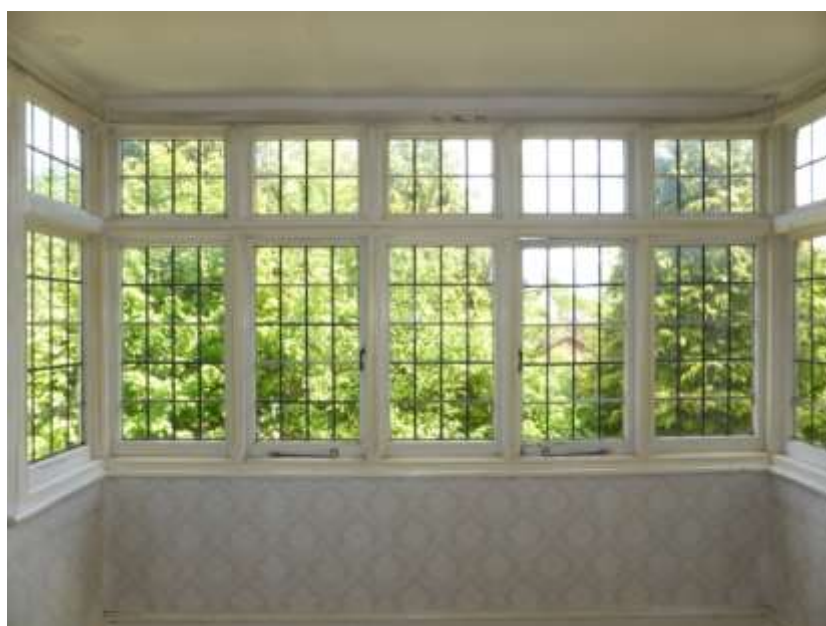
Figure 53: Detail of the early 20<sup>th</sup> century leaded lights to the oriel window in F5

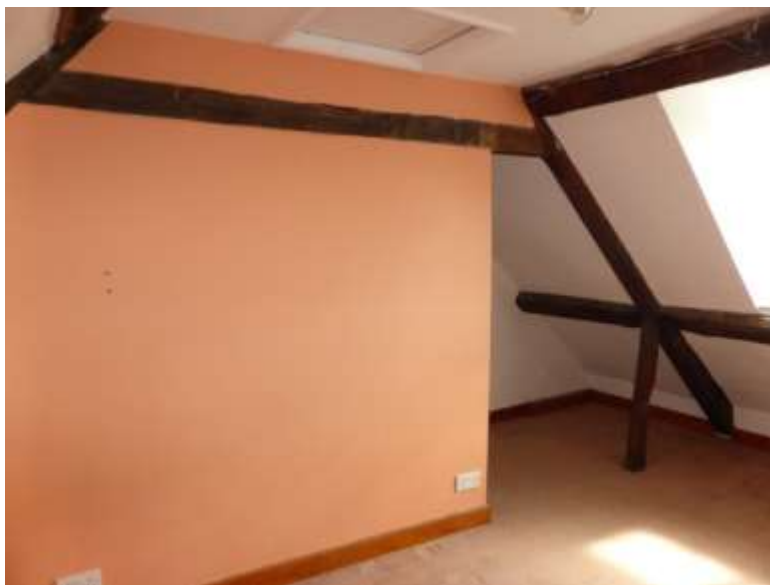
- 4.6.1 The attic is of four bays, the central eastern bay is bisected by a transverse wall. The roof structure throughout includes two purlins on each side of the roof. These purlins include chamfers 35mm wide and simple run-out stops. The purlins are cut back where they are tenoned into the principal rafters. Each truss includes a collar positioned between the purlins and tenoned into the principal rafters and double pegged. The apex of the principal rafters have bridled joints and small plated yokes. Another feature of the apex is a ridge plank. Below the collar there are raking struts which have been nailed to the principal rafters. All of these characteristics are consistent with an 18<sup>th</sup> century date for construction.

Figure 54: Collar truss in A1

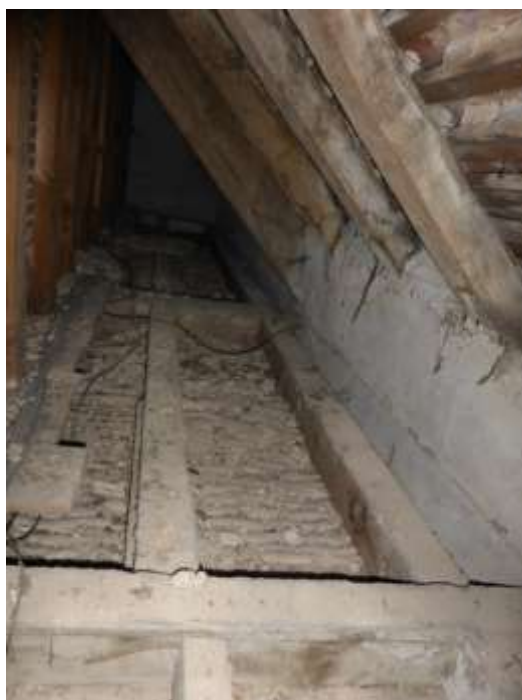
- 4.6.3 The structure of the ceiling in A5 can be observed through a hatch to the rear of a cupboard. This consists of a tie beam, transverse beams and joists with a lath and plaster ceiling below. The lower section of the roof slope has been finished with plaster. The floor boards visible in the cupboard are 140mm wide and probably date from the 19<sup>th</sup> or early 20<sup>th</sup> centuries. The existing wall on the southern side of A5 is made from regularly sawn ashlar and finished with lath and plaster, again probably created as part of the early 20<sup>th</sup> century alterations.

Figure 58: Structure of the ceiling over F5 and machine sawn timbers of an ashlar wall in A5

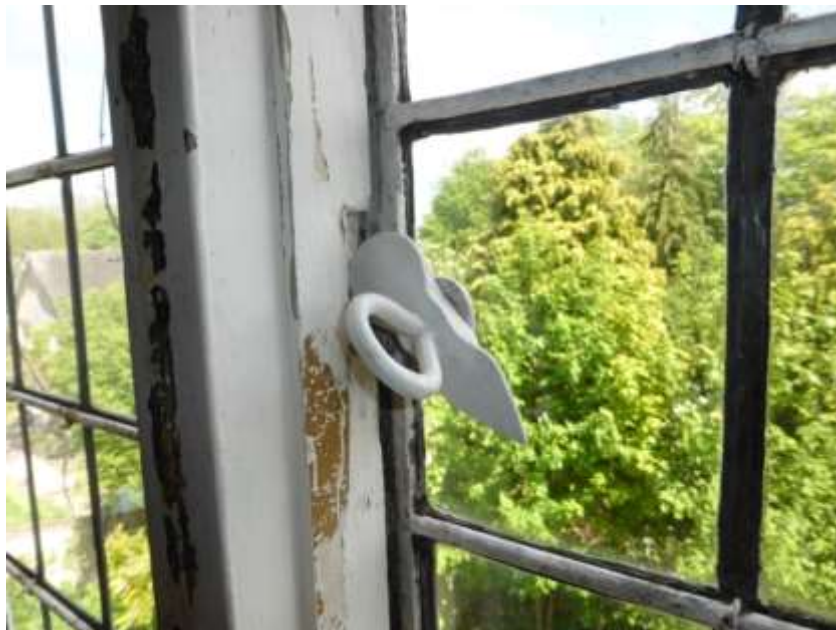
Figure 60: Early 20<sup>th</sup> century window catch on the window in the eastern gable end

- 4.6.5 By contrast, the dormer window in A5 includes metal framed casements with stanchions and a window catch which is of later 19<sup>th</sup> or early 20<sup>th</sup> century design. There are some sawn laths exposed on one side of the dormer, suggesting a 19<sup>th</sup> century or later date for this finish. There is also a mix of machine sawn and hand sawn timbers with forged nail joints. The window on the east elevation of A5 includes metal framed casements with stanchions and a late 19<sup>th</sup> to early 20<sup>th</sup> century style catch. The mullions are timber.
