# WENDLEBURY LODGE, WENDLEBURY, OXFORDSHIRE

## HERITAGE ASSESSMENT

**PROJECT:** Wendlebury Lodge, Wendlebury, Oxfordshire

**DOCUMENT TITLE:** Heritage Assessment

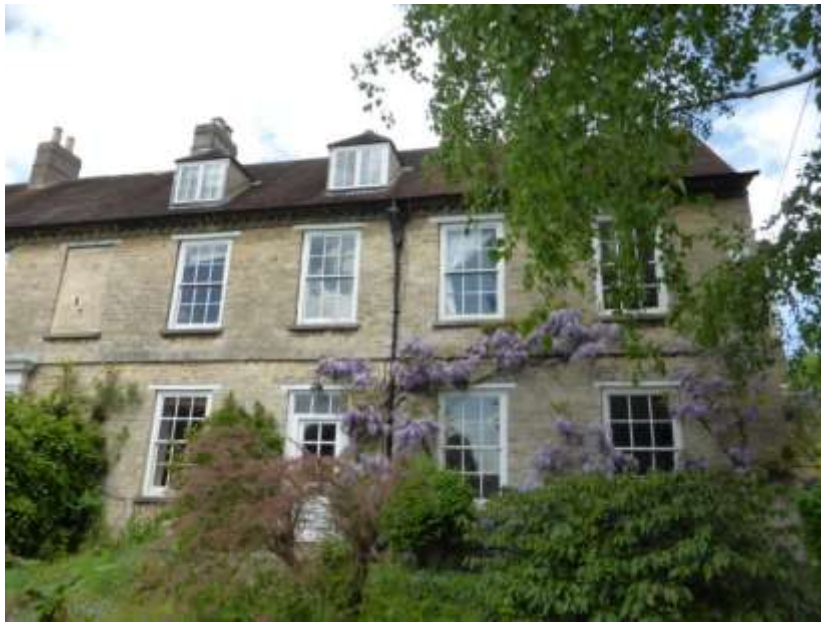
Figure 4: Front elevation of Wendlebury Lodge

- 4.1.1 Wendlebury Lodge is of rubble stone construction with plinth and stone quoins. The roof is double pitched with gable ends and bellcast eaves. The roof is finished with clay tiles. Originally part of a six window range, the front elevation of Wendlebury Lodge has four first floor window openings with six over six unhorned sash windows and one blind window to the left. This blind window is in line with the chimney stack and was probably inserted to maintain a symmetrical front. The window openings on the ground and first floors have slender timber lintels, rendered sills and exposed sash boxes. There is a horned sash on the right hand side of the ground floor which suggests a later 19<sup>th</sup> or early 20<sup>th</sup> century alteration. The exposed sash boxes suggest an earlier date but six over six sash windows continue in use into the mid-19<sup>th</sup> century and became popular in the early 20<sup>th</sup> century as part of Neo-Georgian and Arts and Crafts style. The sash fasteners of these windows are all typical of the second half of the 19<sup>th</sup> century (Pearce, p. 111). The chamfered glazing bars are also typical of later 19<sup>th</sup> and early 20<sup>th</sup> century construction techniques for sash windows.

- 4.1.2 The off-centre door is 20<sup>th</sup> century. The door opening includes an overlight with two glazing bars. The front door is access by concrete steps.

- 4.1.3 There is a stone plat band which defines the two storeys of the elevation. The head of the wall is decorated with a stone dentil cornice. Stone cornices had superseded the wooden eaves cornice by the second decade of the 18<sup>th</sup> century (Forrester, p. 21).

- 4.1.4 There are two dormers on the front elevation. Unlike the examples at Wendlebury House, which are aligned with the window openings on the front elevation, the dormers at

Wendlebury House are irregularly positioned in relation to the window openings on the façade. The hipped dormers include rendered cheeks. The windows are modern storm casements.

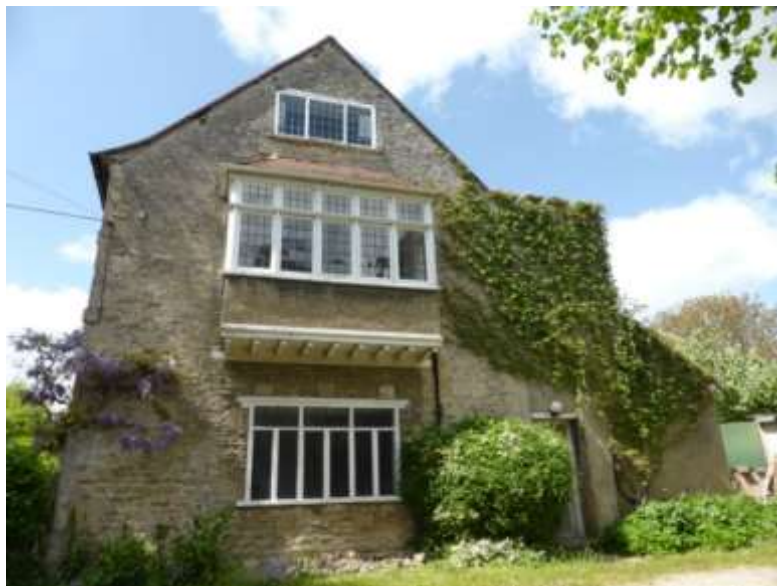
Figure 8: East elevation of Wendlebury Lodge

- 4.2.1 The east elevation is dominated by an early 20<sup>th</sup> century oriel window on the first floor. This feature is characterised by side opening leaded timber casements and fixed top lights. The mullions and transoms include chamfers. The lower half of the oriel is finished with pebble dash and the whole is supported on carved brackets.
- 4.2.2 The ground floor includes a long timber window with a row of fixed lights. The top lights are leaded and are wider than the plain fixed casements below. The design and proportions of the openings appear rather odd and internal evidence suggests the window arrangement has been modified. There are clear straight joints and stone rubble infill either side of this window opening. This demonstrates that there was larger opening in this location but it is unclear what

it was for. Of note are the straight joints for a narrower opening above the oriel window. This suggests that there may have been a chimney stack on this elevation which was removed as part of the early 20<sup>th</sup> century alterations.

- 4.2.3 The Attic window has a wooden frame and contains three metal casements with leaded lights. Window fittings suggest a late 19<sup>th</sup> or early 20<sup>th</sup> century date for this window.
- 4.2.4 To the right there is an extension which includes a two storey element with crenelated parapet and a single storey lean-to. These two elements are both pebble dashed and it is not therefore possible to determine whether this represents one or two phases of development. Historic mapping suggests that they had both been built by 1920. This appears to be supported by a butt joint between the rubble stone construction of the lean-to and the brick piers and first floor walling of the two storey crenelated extension. There is a modern door on the left hand side of a brick buttress finished with pebble dash.

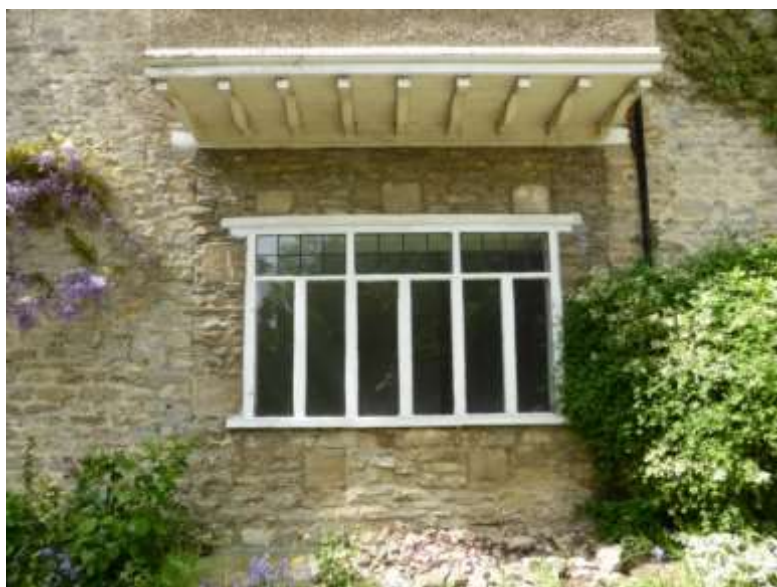
Figure 9: Modified ground floor window and evidence for straight joints to the left and right

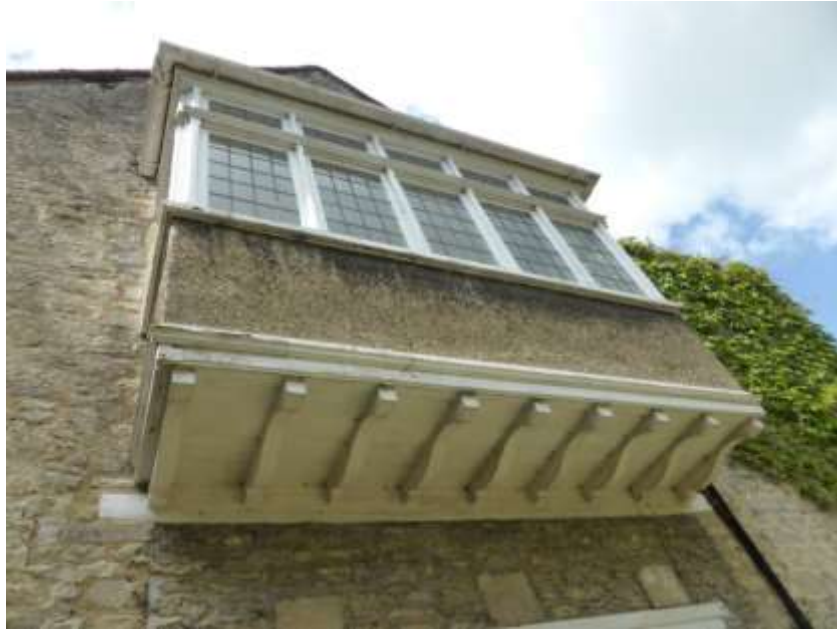
Figure 10: Early 20<sup>th</sup> century oriel window

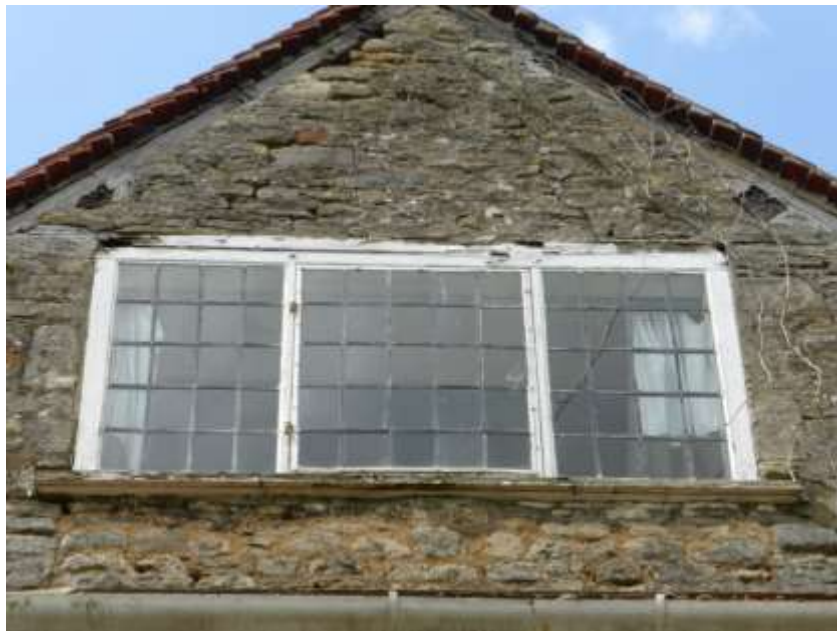
Figure 11: Late 19<sup>th</sup> to early 20<sup>th</sup> century metal casements to the attic

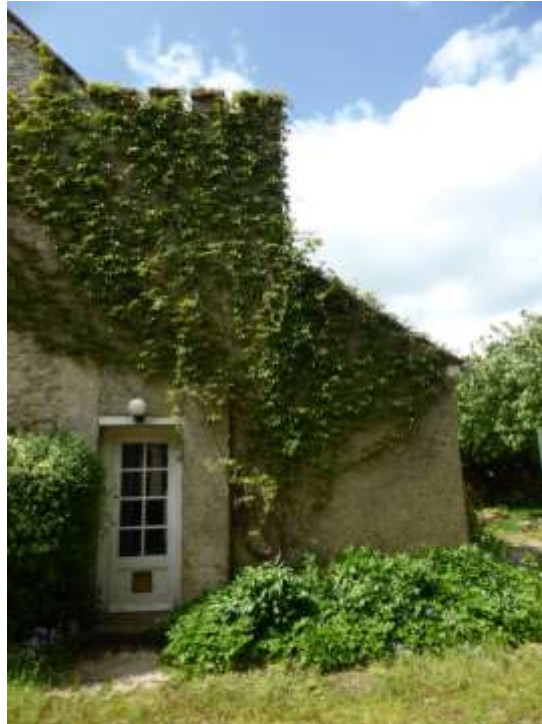
Figure 12: Early 20<sup>th</sup> century extensions to the rear

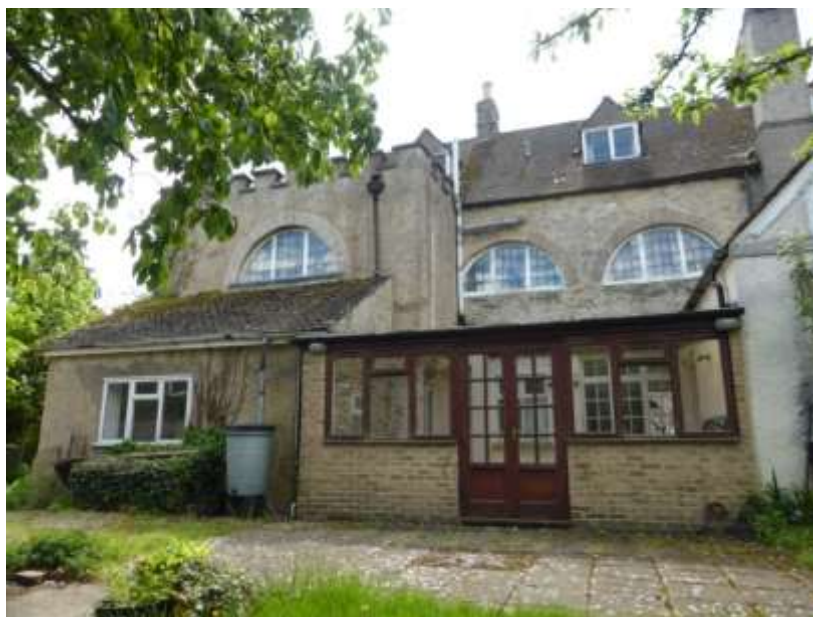
Figure 13: Rear elevation of Wendlebury Lodge

- 4.3.1 The north elevation of the original house is predominantly masked by later additions. Two thermal windows remain visible on the first floor. These include stone surrounds with keystones. The windows include two mullions with a central side opening casement and fixed lights either side. The opening casement is metal and is hung on decorative spiral pintles. This form of decoration for the ironwork on windows is typical of the later 17<sup>th</sup> and early 18<sup>th</sup> centuries.

- 4.3.2 The roof includes two gabled dormers with rendered cheeks and gables. The windows are modern storm casements.
- 4.3.3 On the left hand side of the elevation is the early 20<sup>th</sup> century two storey extension with crenelated parapet. It is clear from this aspect that the lean-to was added slightly later; the rubble stone wall abuts the pebble dash finish of the two storey addition. Of particular note is the presence of a thermal window with stone voussoirs, keystone and tripartite window with central side opening metal casement. It seems likely that this window was repositioned when the rear wall in F5 was removed to create a larger room in the early 20<sup>th</sup> century.

- 4.3.4 The rear wall of the lean-to is finished with pebble dash and the roof with clay tiles. There is a modern storm casement with top hung light.
- 4.3.5 At the centre of the rear elevation there is a modern conservatory. This is of brick construction in stretcher bond with dark stained window and door joinery

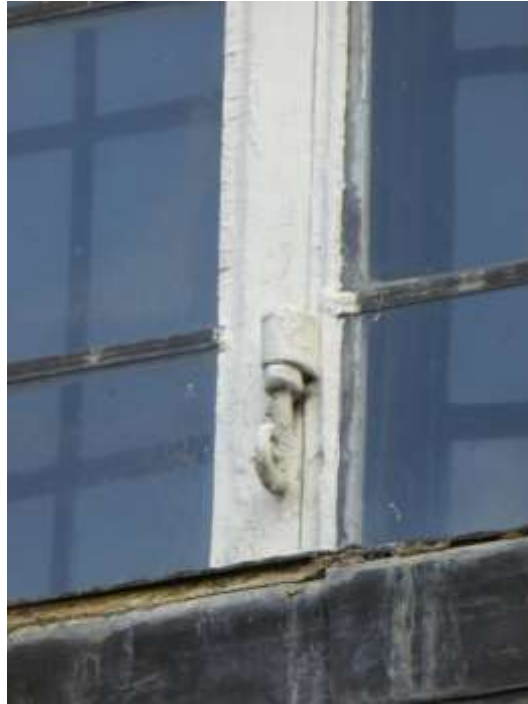
Figure 15: Detail of a spiral decorated pintle

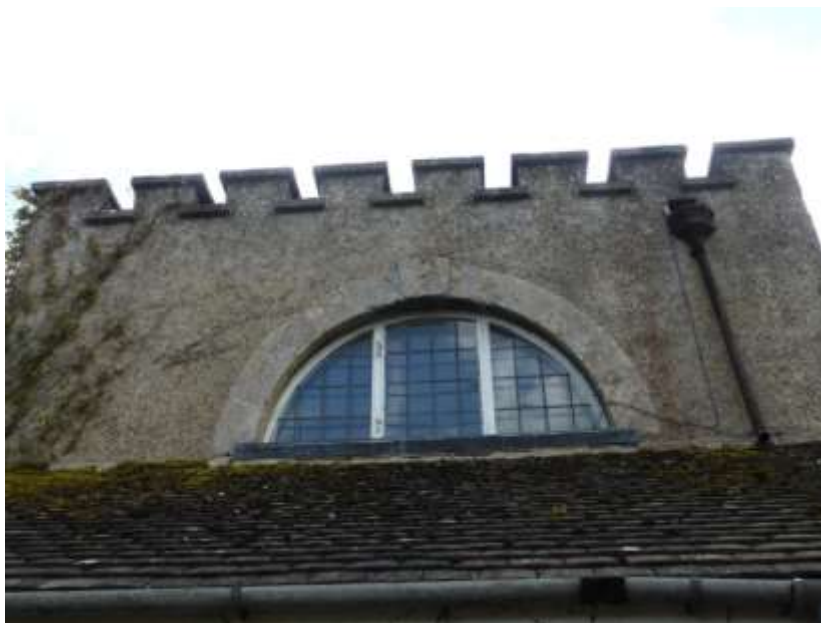
Figure 16: Repositioned thermal window on the north elevation of the early 20<sup>th</sup> century crenelated extension

4.5.12 It appears that the thermal window to the rear of F5 was re-set from the original elevation. The casements have a metal frame, the simple L-shaped bar catch may be a later replacement associated with the repositioning of the window.

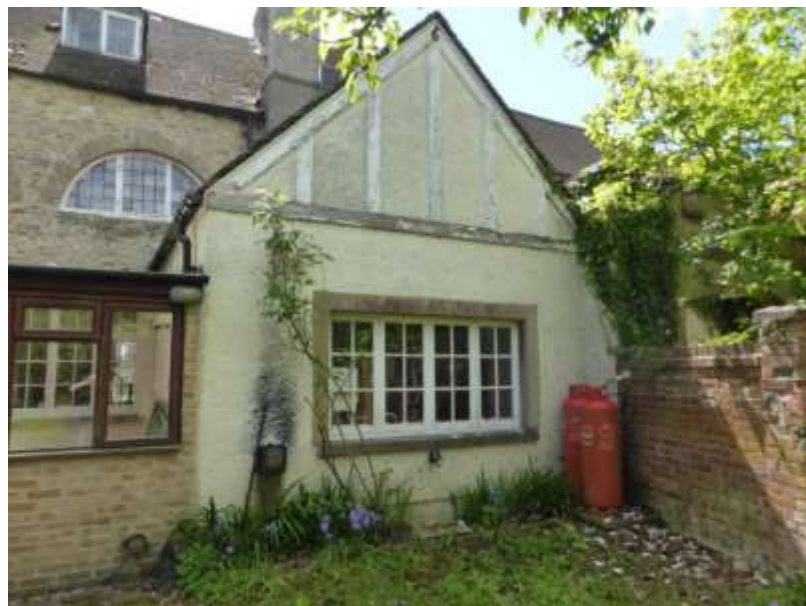
Figure 18: Early 20<sup>th</sup> century single storey extension on the right hand side of the rear elevation

- 4.3.6 On the right hand side of the rear elevation is a single storey extension with a gabled roof. The wall finish is painted pebble dash. Planks have been applied to the gable end in imitation of timber framing. These are typical early 20<sup>th</sup> century details. The window surround is cement rendered and the opening contains multi-paned timber casements. At the southern end of

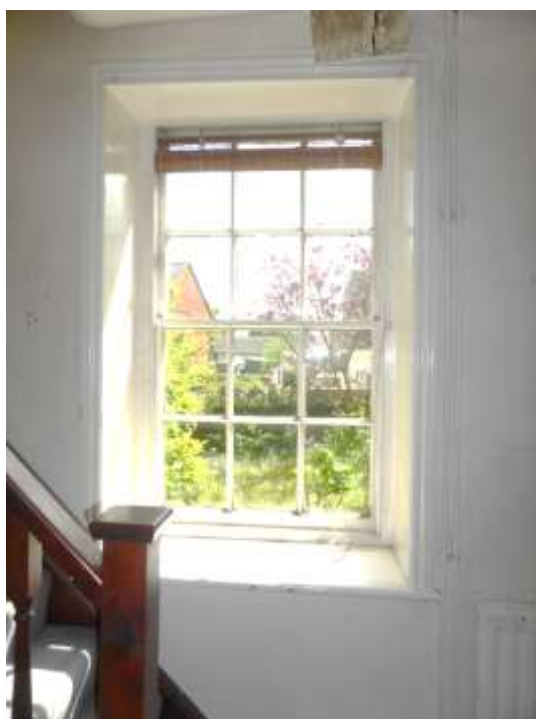
Figure 23: Six over six sash window in G1 with chamfered glazing bars and later 19<sup>th</sup> century style fastener

- 4.4.2 The sash window on the front elevation includes a sash fastener which was in common use in the second half of the 19<sup>th</sup> century. The architrave has similar mouldings to the door architraves in G1 and was probably added in the early 20<sup>th</sup> century. The window opening on the north wall of G1 includes 20<sup>th</sup> century casements with multi-paned and top hung lights.

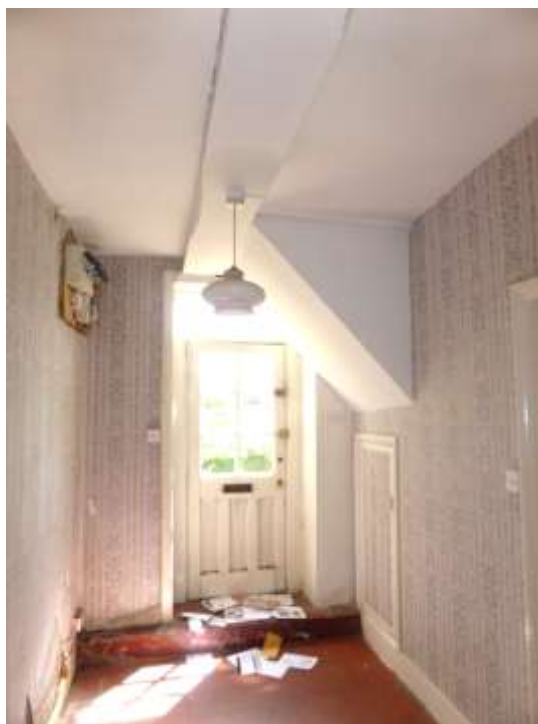
Figure 26: The Hall (G2) looking south towards the front door

- 4.4.4 The Hall (G2) is accessed externally through a door on the south elevation. This front door possibly dates to the early part of the 20<sup>th</sup> century as suggested by the three panels below the lock rail. The upper glazed part of the door is probably a modern alteration.
- 4.4.5 The floor is finished with quarry tiles. This is a typical floor finish used for the halls of late Victorian and Edwardian houses and continued to be used in kitchens and sculleries into the 1930s and 40s.
- 4.4.6 A transverse beam crosses through the centre of G2 and, similar to G1, appears to rest on a slender lintel over the front door. The Hall provides access to G3 and G4.

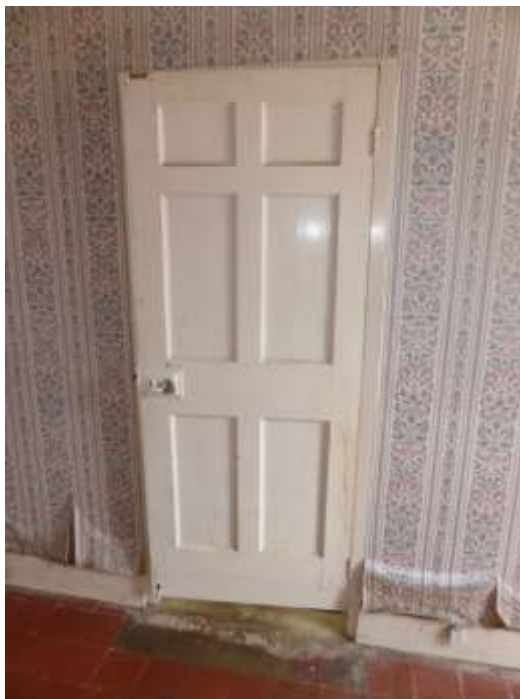
Figure 27: Door to G4 from G2

4.4.8 The Snug (G4) is accessed through a poorly fitted door from the Hall (G2). The door itself appears to be a re-used six panel door. The door frame is plain and not of traditional construction. The chimney breast has been removed from G4 and three metal brackets support the hearth on the first floor.

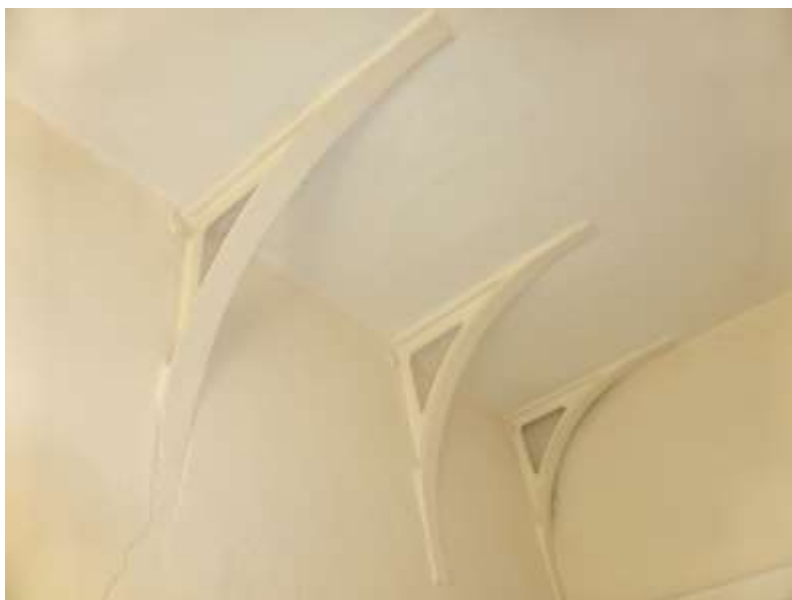
Figure 28: Brackets supporting a first floor hearth

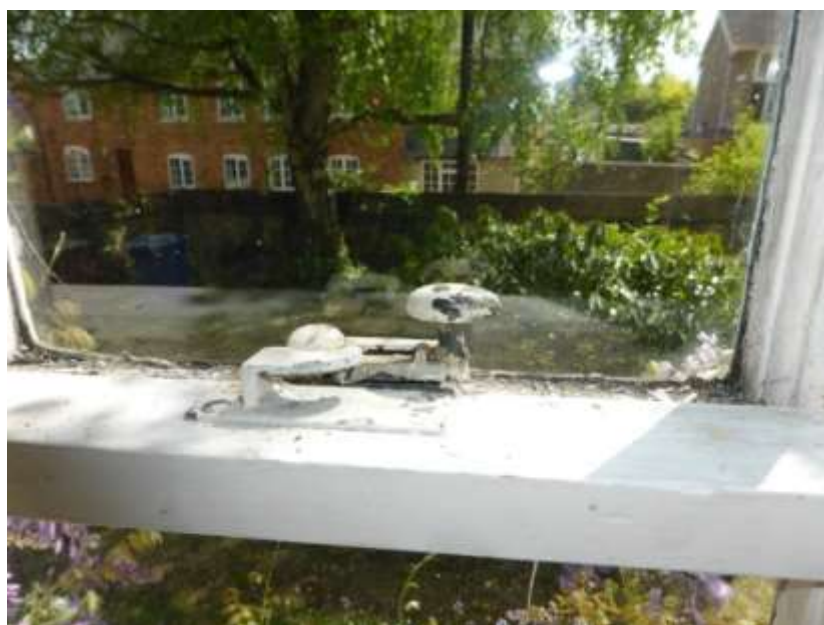
Figure 30: Late 19<sup>th</sup> century style sash fastener in G6

4.4.10 The Study (G6) is accessed from G7 through a modern glazed door. The window along the south wall includes sash horns which have a similar profile to later 19<sup>th</sup> and early 20<sup>th</sup> century examples (Hall, p. 80) and a 19<sup>th</sup> century sash fastener which is of different design to those observed for the rest of the house. There is an early 20<sup>th</sup> century window with fixed casements

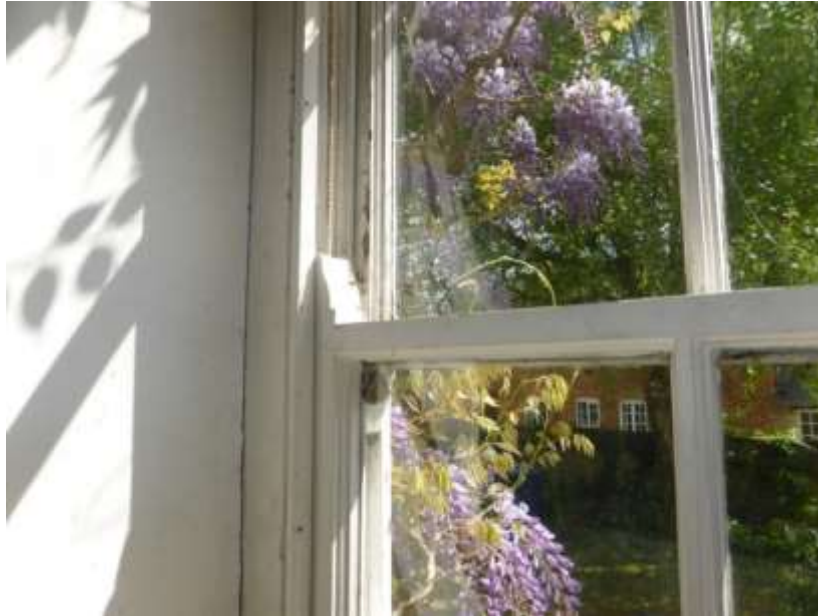
Figure 31: Sash horn detail in G6

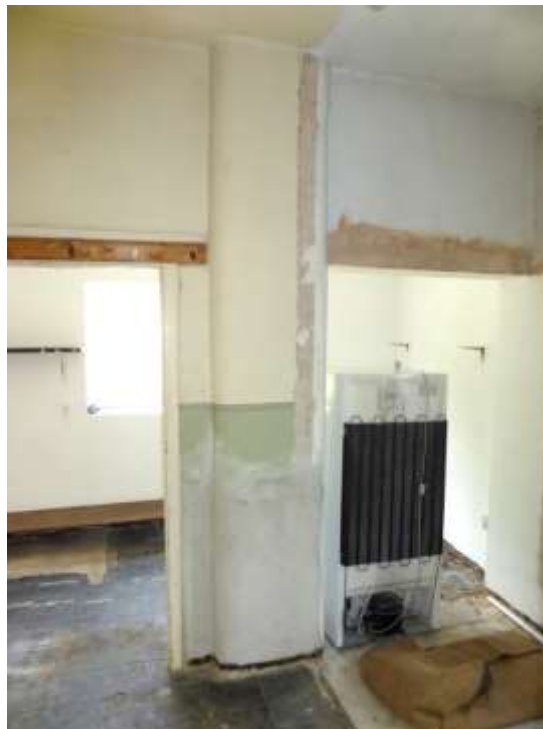
Figure 32: Plaster finish over a brick pier in G7

4.4.11 G7 is accessed from the outside through a modern door on the east elevation. This space has been much altered and has plastered walls a concrete slab floors finished with lino tiles. There is, however, evidence for brick piers which are partly embedded in later walls and partly truncated by later openings. The presence of these piers suggests that the ground floor of the earlier 20<sup>th</sup> century extension was a loggia and therefore open sided.

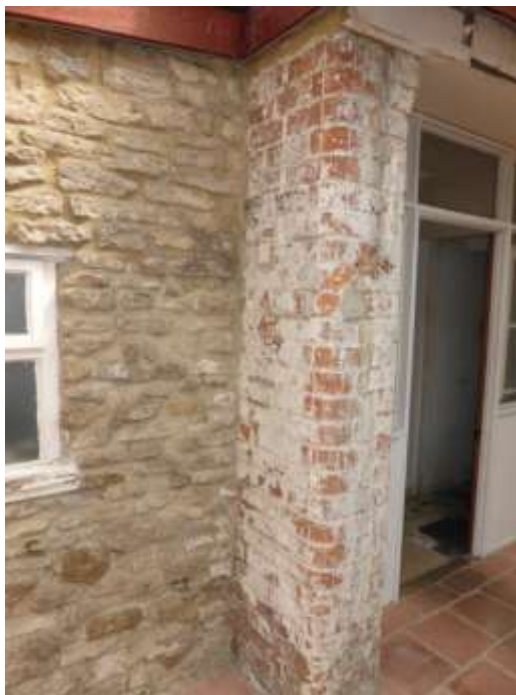
Figure 33: Brick pier at the western end of G7

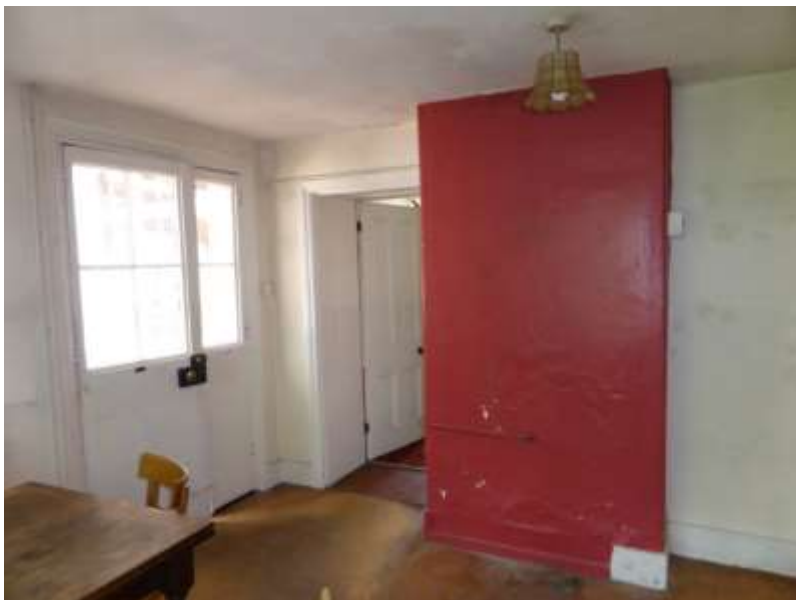
Figure 36: Early 20<sup>th</sup> century chimney breast along the south wall of G10

4.4.14 The Kitchen (G10) is accessed through an earlier 20<sup>th</sup> century door from the Conservatory (G9). There is a chimney breast with blocked up fireplace on the south wall. The modern suspended ceiling conceals the early 20<sup>th</sup> century lath and plaster ceiling above. The roof structure, which is common rafter with ridge plank and side purlins can be observed through a ceiling hatch. There is a window opening with 20<sup>th</sup> century casements multi-pane lights on the north wall.

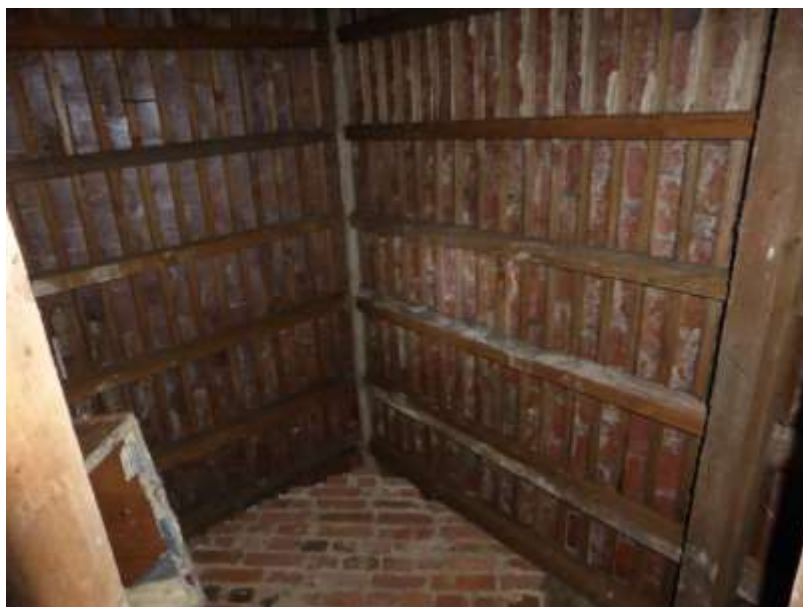
Figure 37: Common rafter roof over G10

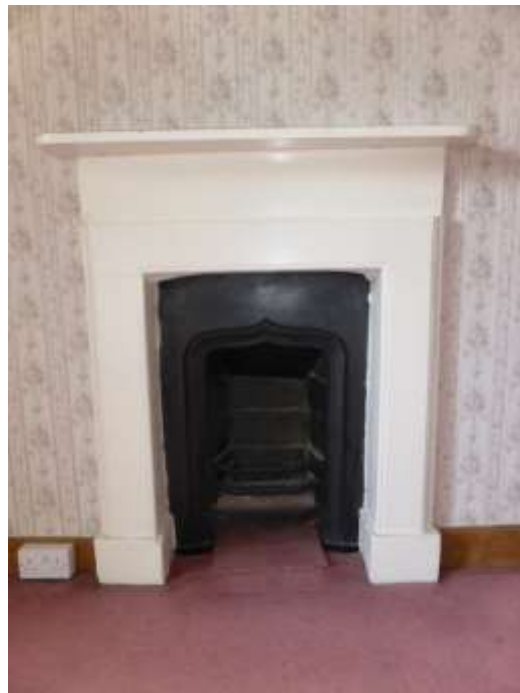
Figure 39: Later 19<sup>th</sup> century coal grate in F1

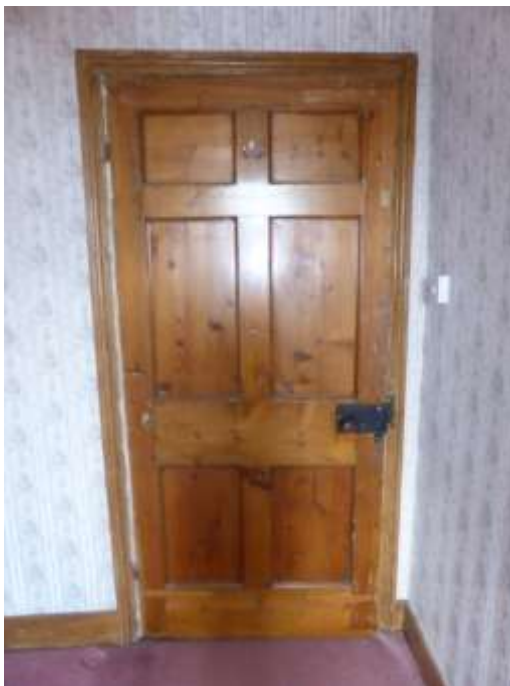
Figure 40: Probable early 20<sup>th</sup> century door to F1

- 4.5.1 Access to F1 is through a six-panel door with metal lock case and butt hinges. The door design is typical of 18<sup>th</sup> and early 19<sup>th</sup> century doors. The simple ovolo moulding around the sunk panels is, however, characteristic of the second quarter of the 19<sup>th</sup> century and early 20<sup>th</sup> century Arts and Crafts/Neo-Georgian influenced designs. It appears that this door has either been re-used, perhaps from elsewhere within the house, or is an early 20<sup>th</sup> century door. Given the changes noted elsewhere this is likely to be an early 20<sup>th</sup> century door. The architrave is reminiscent of designs found from the middle of the 19<sup>th</sup> century and into the early 20<sup>th</sup> century.

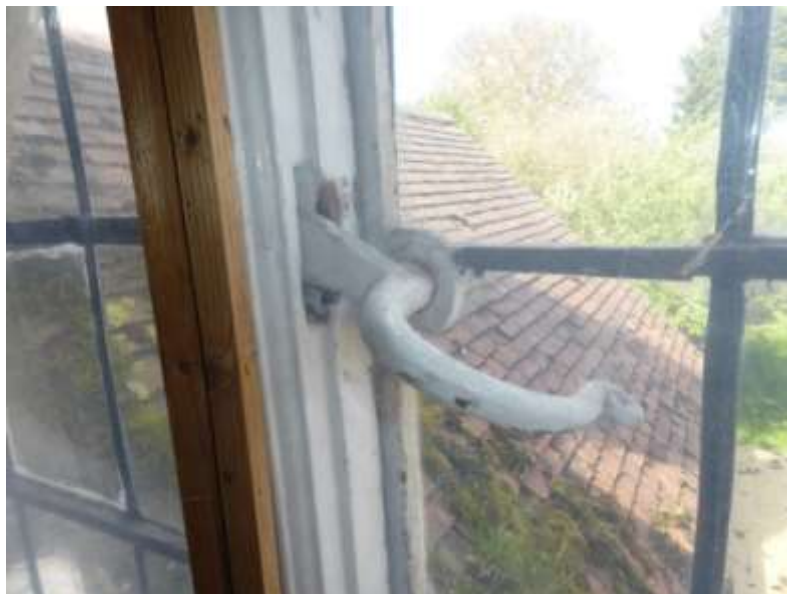
Figure 43: Detail of the window catch of the thermal window

- 4.5.4 The rear section of F2 is illuminated by a thermal window. This window includes a central iron framed casement. Window fittings include a spiral casement handle and a turnbuckle catch which terminates in a small spiral. These details are consistent with an early 18<sup>th</sup> century date.
- 4.5.5 The front section of F2 provides access to a straight flight staircase with winder. This staircase has simple square section spindles, hand rail and simple square section newel post. This may have been inserted as part of the early 20<sup>th</sup> century alterations.

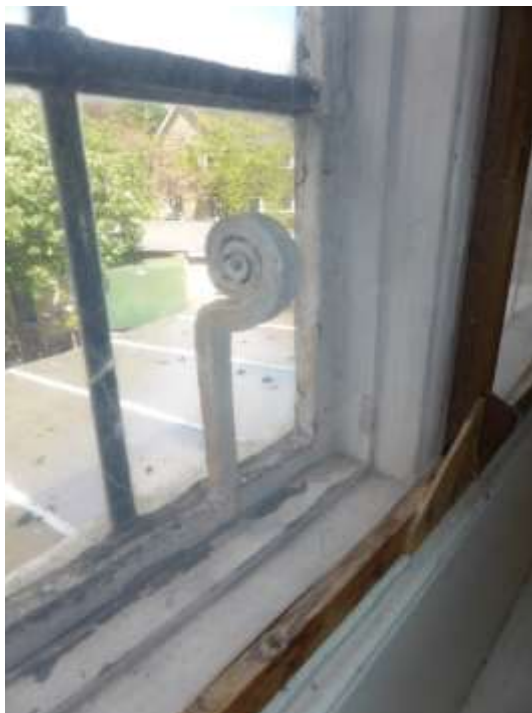
Figure 43: Detail of the spiral casement handle of the thermal window

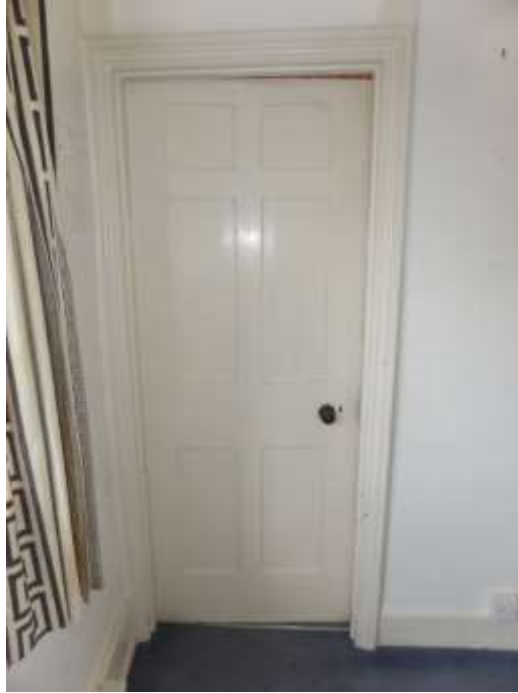
Figure 45: Early 20<sup>th</sup> century door to F3

4.5.6 Unlike the other rooms on the first floor, the door to F3 has fielded door panels. The door architrave is the same style as the architraves to F1 and F5, i.e. of a style which is common in the later 19<sup>th</sup> and early 20<sup>th</sup> centuries. It is likely that both door and architrave are 20<sup>th</sup> century. It should be noted that reproduction doors with fielded panels have been used where other 20<sup>th</sup> century partitions have been inserted within the building.

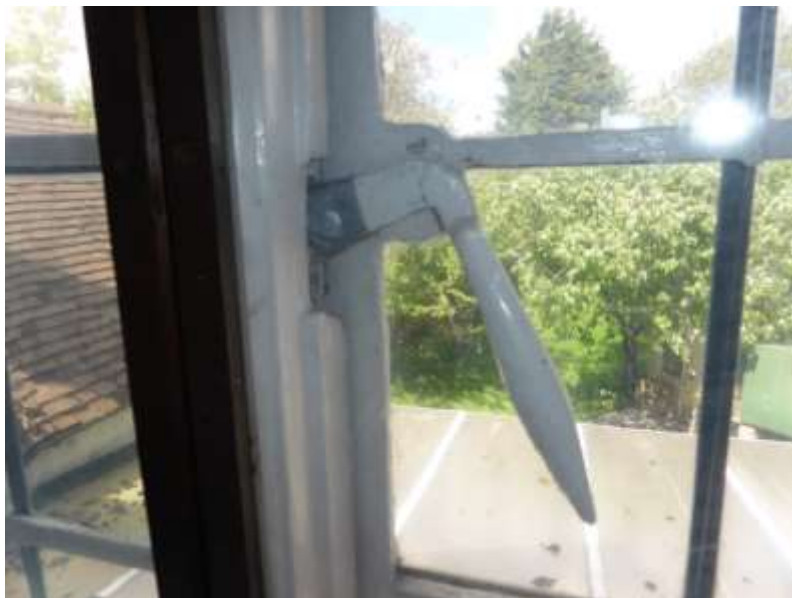
Figure 46: L-shaped bar catch to the central casement of the thermal window in F3

- 4.5.7 Other than the thermal window on the northern side of F3, nothing of interest was observed. Details of this window include an L-shaped bar catch, spiral handle and a window stay. The catch and handle may date from the 18<sup>th</sup> century but the stay appears more 19<sup>th</sup> century in character.

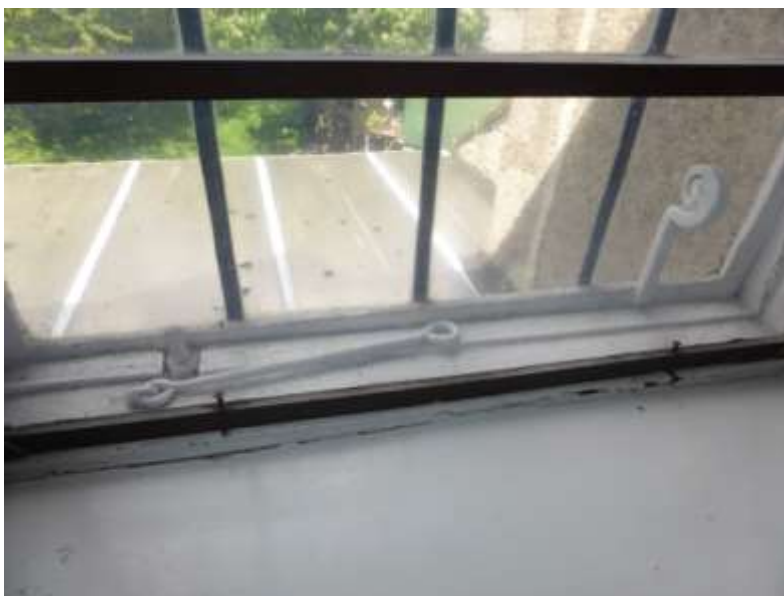
Figure 47: Casement handle and stay in F3

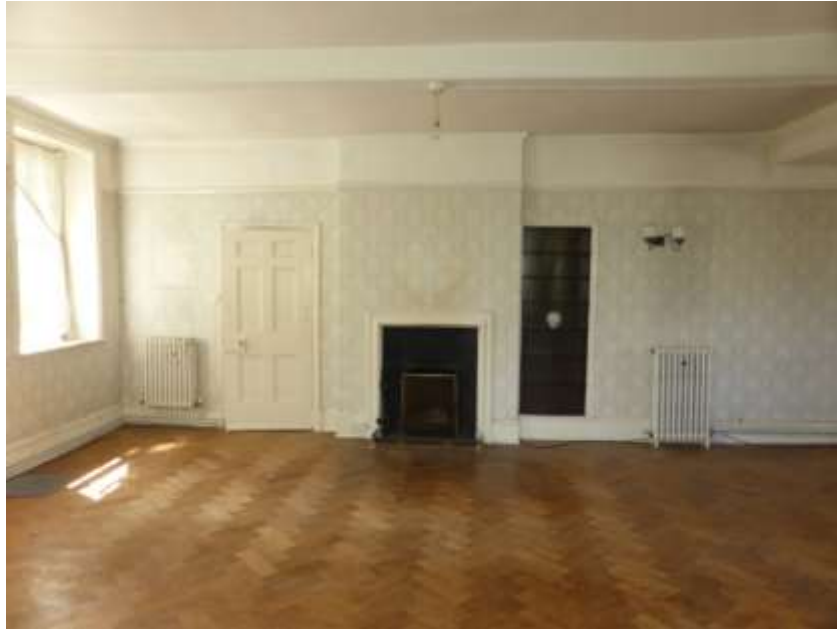
Figure 48: West wall of Bedroom F5

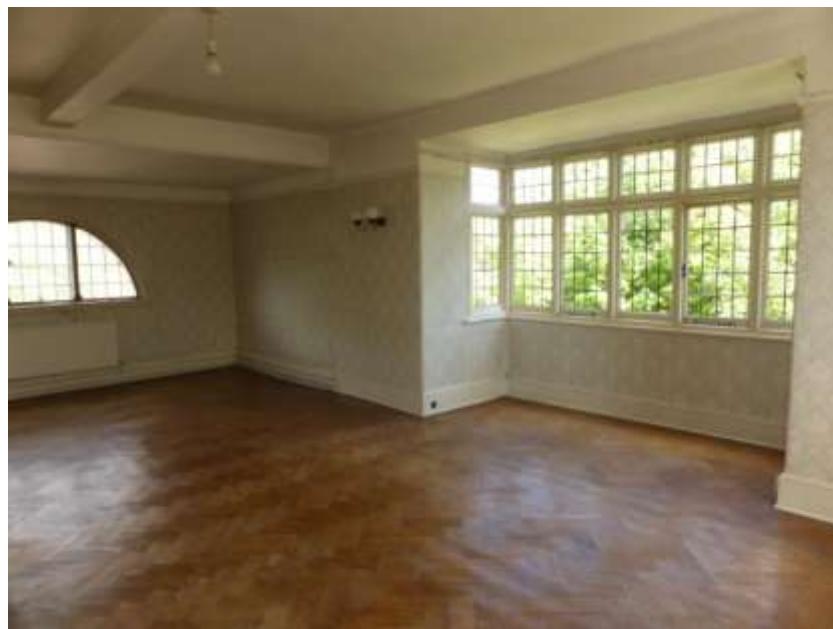
Figure 49: Re-set thermal window to the left and early 20<sup>th</sup> century oriel to the right

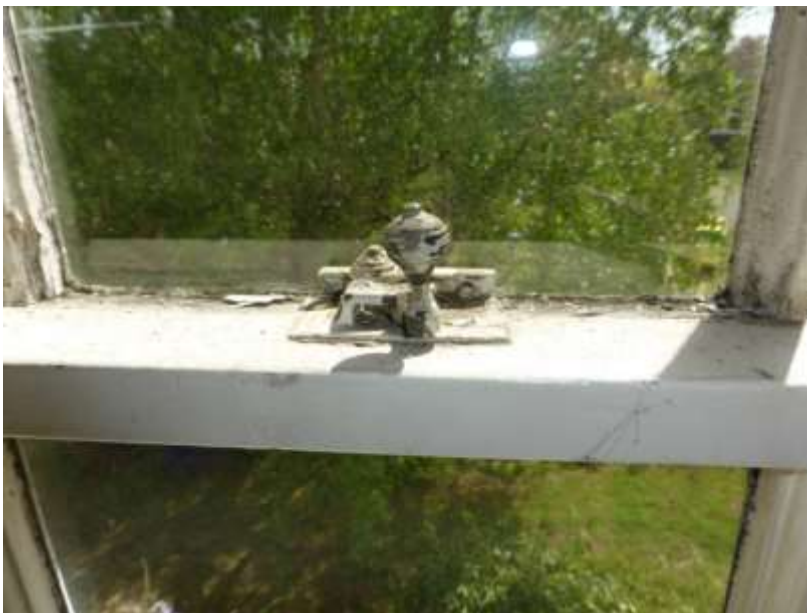
Figure 51: Later 19<sup>th</sup> century type sash fasteners in F5

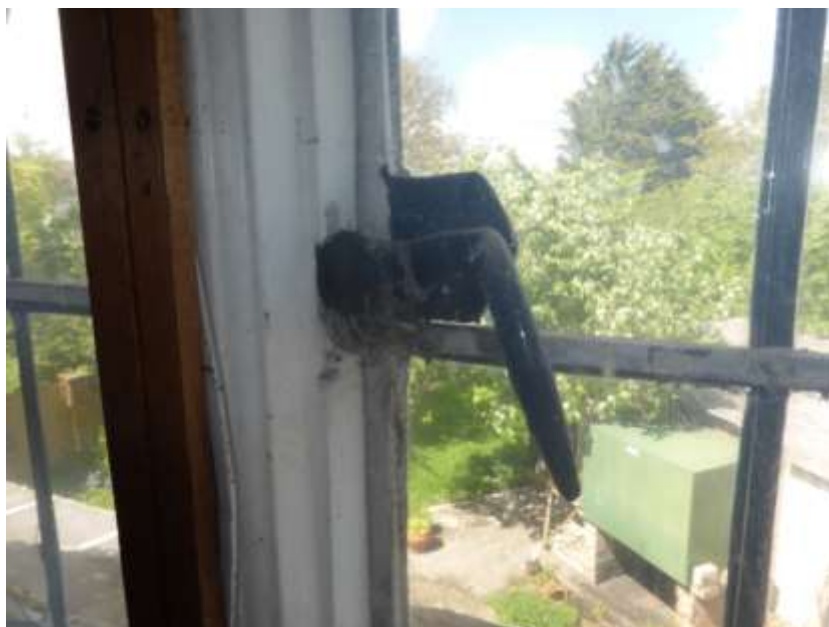
Figure 52: Detail of L-shaped bar catch to the casement of the thermal window in F5

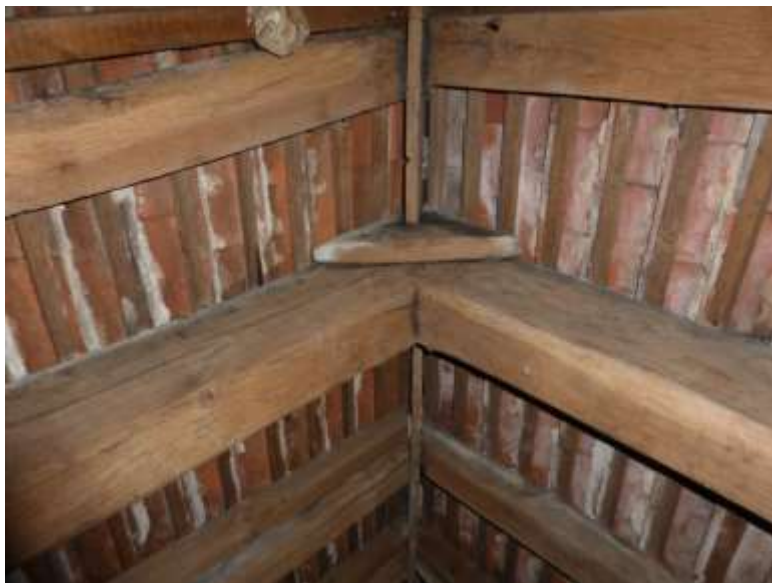
Figure 55: Apex of principal rafters at A1

- 4.6.1 The attic is of four bays, the central eastern bay is bisected by a transverse wall. The roof structure throughout includes two purlins on each side of the roof. These purlins include chamfers 35mm wide and simple run-out stops. The purlins are cut back where they are tenoned into the principal rafters. Each truss includes a collar positioned between the purlins and tenoned into the principal rafters and double pegged. The apex of the principal rafters have bridled joints and small plated yokes. Another feature of the apex is a ridge plank. Below the collar there are raking struts which have been nailed to the principal rafters. All of these characteristics are consistent with an 18<sup>th</sup> century date for construction.

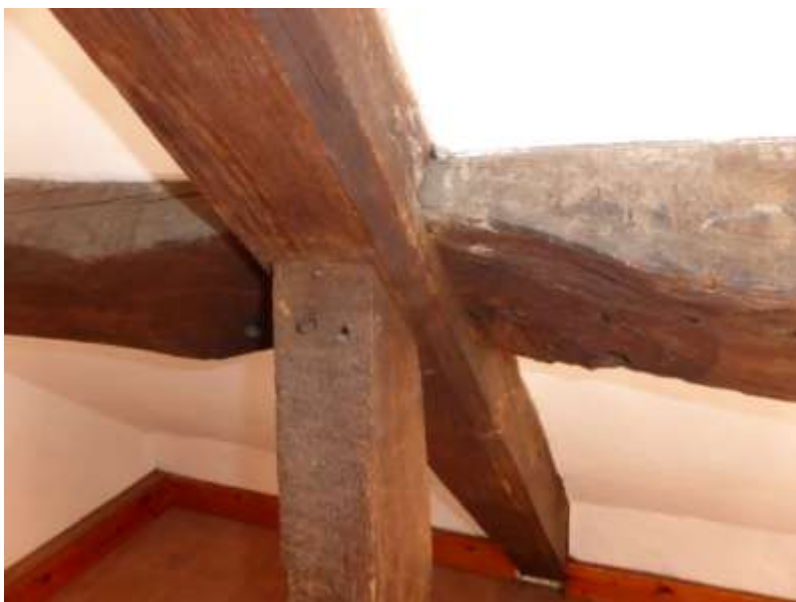
Figure 56: Tenoned purlin in A1

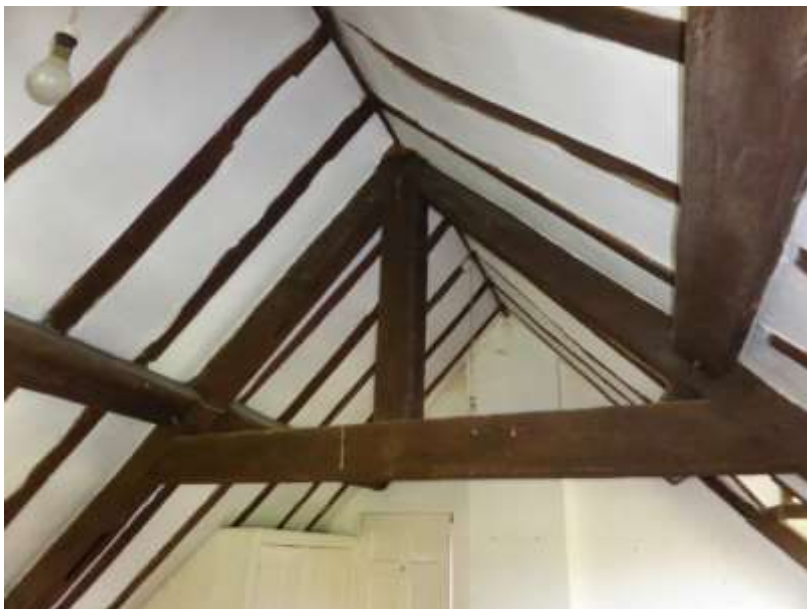
Figure 57: Machine sawn collar and king post in A5

- 4.6.2 By contrast the eastern end truss (A5) is a king post type consisting of a collar, king post and ridge plank. Closer observation demonstrates that both the collar and the king post are machine sawn with regular parallel ridges. The soffit of the principal rafters contain evidence of mortices which suggest the position of a former collar and struts.

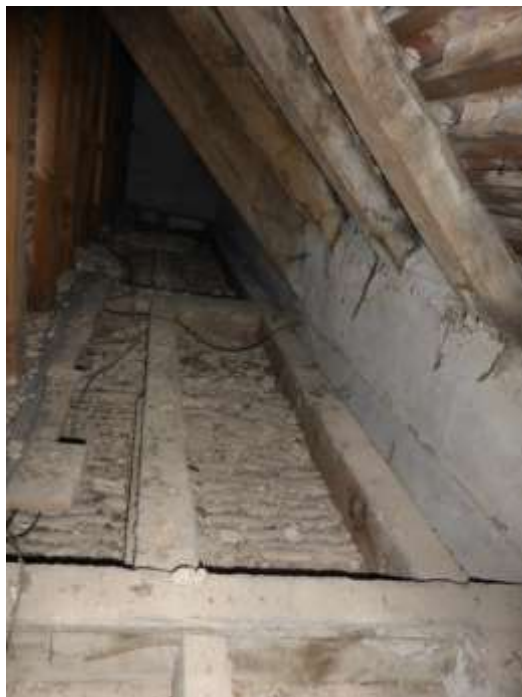
Figure 58: Structure of the ceiling over F5 and machine sawn timbers of an ashlar wall in A5

- 4.6.3 The structure of the ceiling in A5 can be observed through a hatch to the rear of a cupboard. This consists of a tie beam, transverse beams and joists with a lath and plaster ceiling below. The lower section of the roof slope has been finished with plaster. The floor boards visible in the cupboard are 140mm wide and probably date from the 19<sup>th</sup> or early 20<sup>th</sup> centuries. The existing wall on the southern side of A5 is made from regularly sawn ashlar and finished with lath and plaster, again probably created as part of the early 20<sup>th</sup> century alterations.

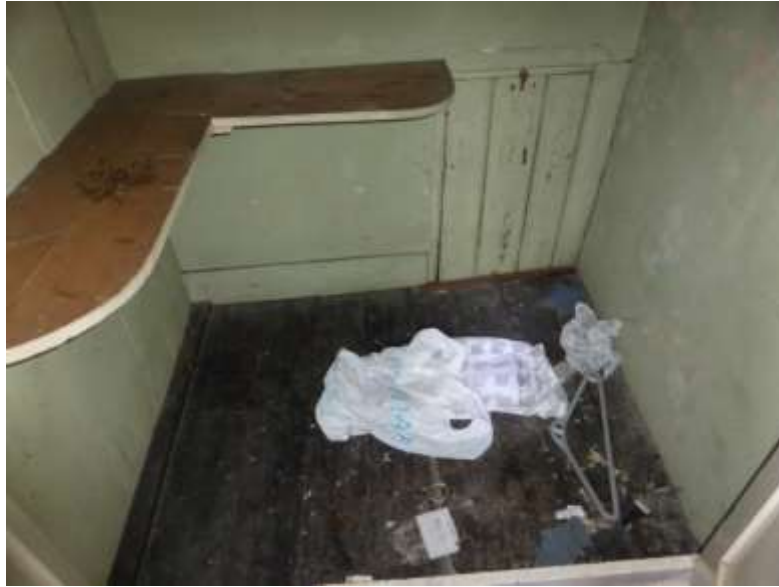
Figure 59: Narrow floorboards in A5

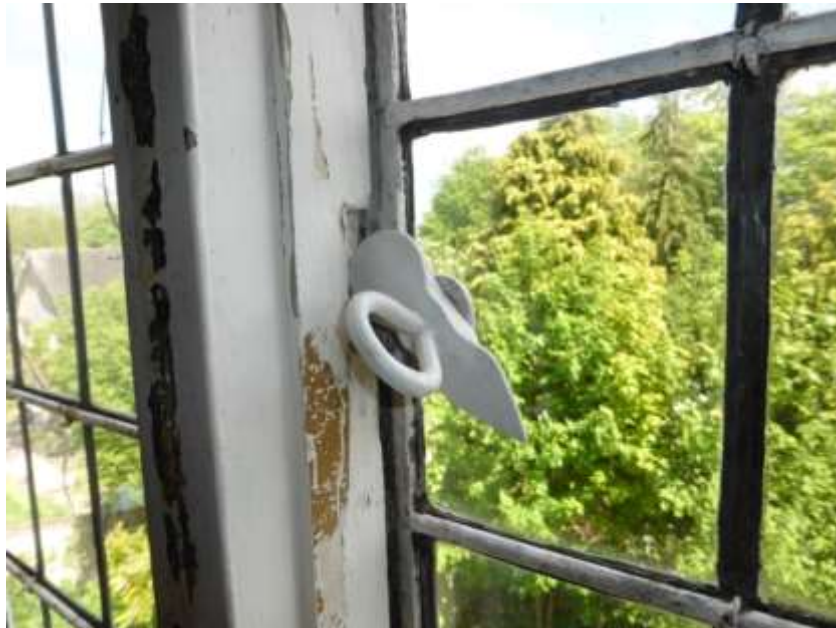
Figure 60: Early 20<sup>th</sup> century window catch on the window in the eastern gable end

- 4.6.5 By contrast, the dormer window in A5 includes metal framed casements with stanchions and a window catch which is of later 19<sup>th</sup> or early 20<sup>th</sup> century design. There are some sawn laths exposed on one side of the dormer, suggesting a 19<sup>th</sup> century or later date for this finish. There is also a mix of machine sawn and hand sawn timbers with forged nail joints. The window on the east elevation of A5 includes metal framed casements with stanchions and a late 19<sup>th</sup> to early 20<sup>th</sup> century style catch. The mullions are timber.

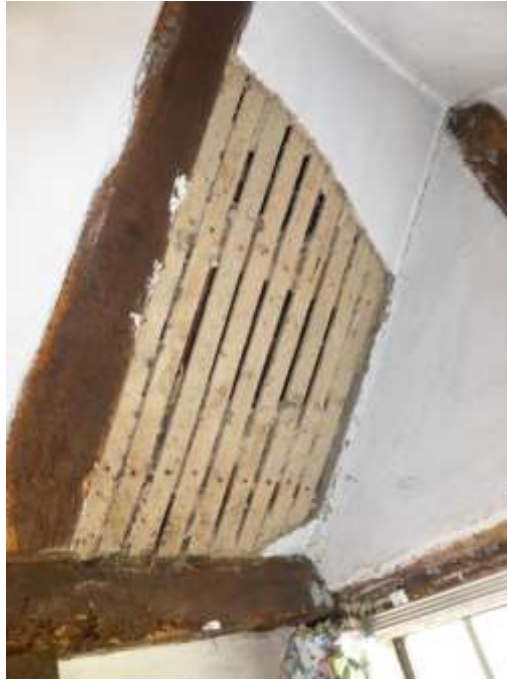
Figure 61: Rear dormer in A5 with sawn laths and plaster finish
